Development of a framework for sustainable repair of adobe building in an urban area in Nigeria

**DEVELOPMENT OF A FRAMEWORK FOR SUSTAINABLE REPAIR OF
ADOBE BUILDING IN AN URBAN AREA IN NIGERIA**

School of Architecture, Design and the Environment

April 2012

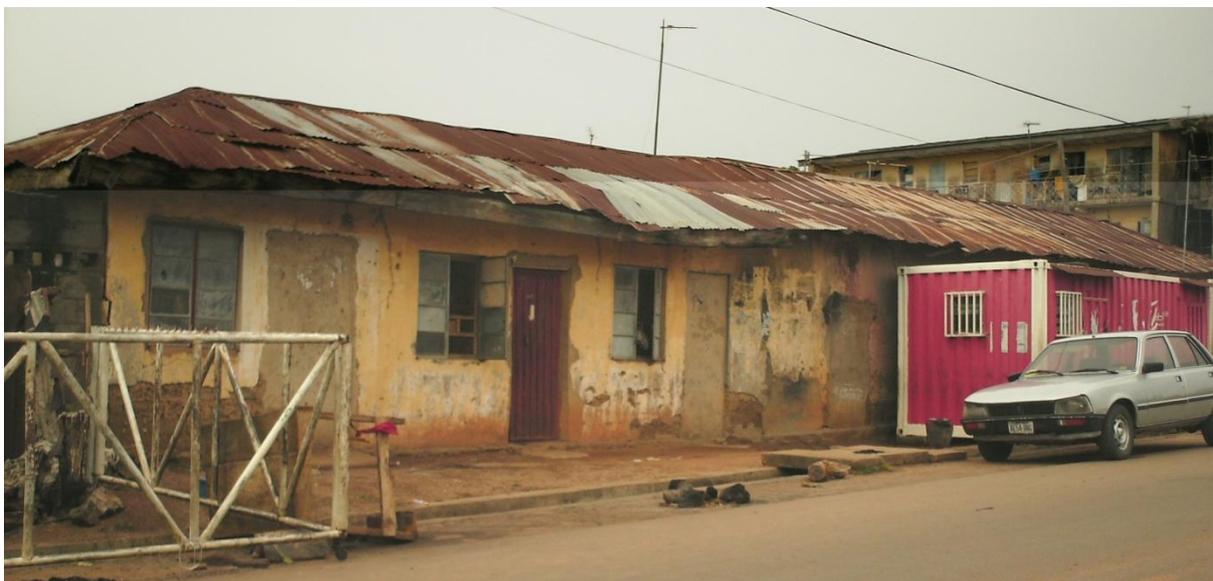
Inappropriate repair could be the reason for the leakages in the other 2 compounds. It was noticed in these 2 other compounds that some of the roofing sheets have been replaced recently with new ones but the leakage still persists. The difference between the old and new roofing sheets can be distinguished from the physical appearance of the two. The old sheets have corroded, while the new ones are still shining (see figures 4.9 and 4.10).

Figure 4.9: Adobe building with sagged roof, replaced roofing sheets, two sealed doors and cement based rendering. Note also the steel container use as part the building extension.

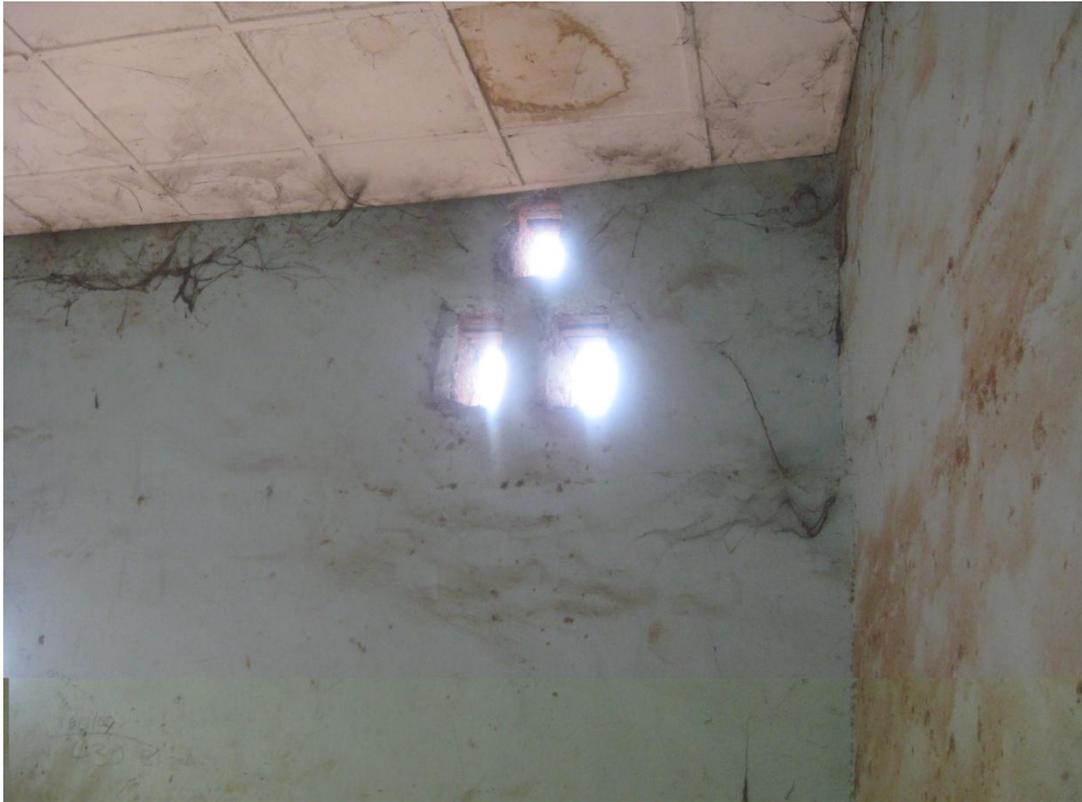
Figure 4.10: Interior of a house with leaking roof. Note the stained ceiling cause by the leakage

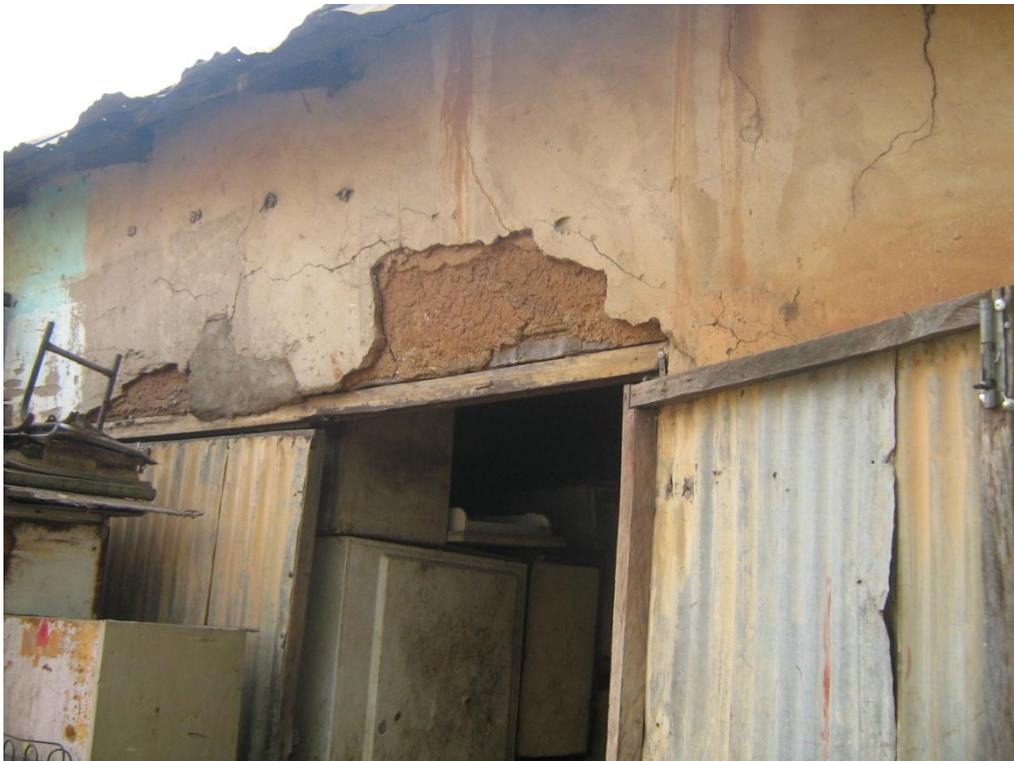
Traditionally, arches were introduced on openings wider than 900mm (Dmochowski, 1990, vol. 1:1.24). Openings in the adobe buildings in Sabon Gari were therefore originally limited to 900mm. However, the spans of the lintels were increased during the remodelling, because shops and other commercial activities require wider doors. The original doors were therefore replaced with wider ones of between 1200 and 2400mm widths and the *azara* replaced with timber lintels. The resultant effect of this action is the bending of timber lintels due to the use of under size timber and excessive point loadings (see figure 4.11).

Figure 4.11: A partially deformed timber lintel caused by excessive loading. Note the cracked cementitious rendering

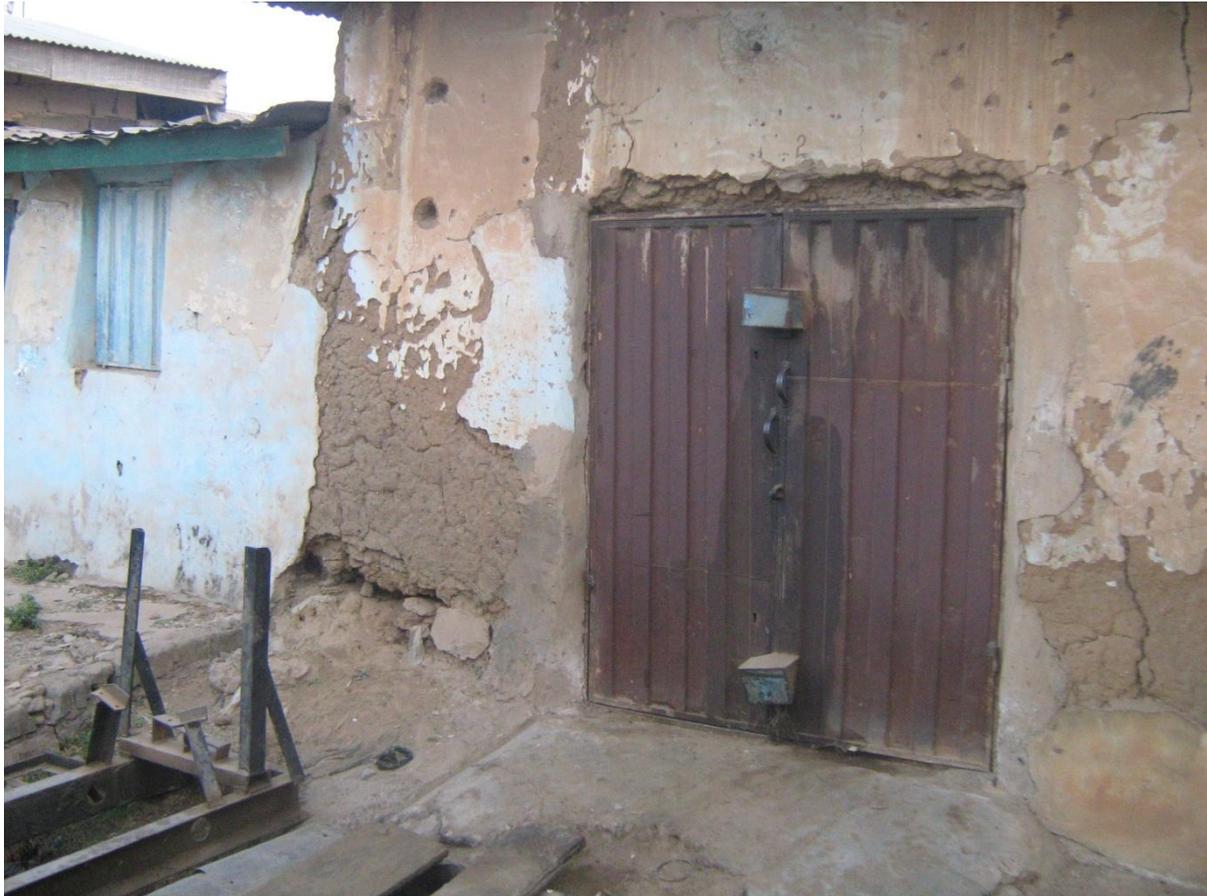
I. Basal erosion: 17 of the 20 compounds surveyed have their buildings are affected by erosion at the base of the walls. This erosion is accelerated by the cementious render in all the 17 buildings. The erosion in 14 out of these 17 buildings is caused by rain water from the roof as a result of lack of guttering (which is not common in Nigeria) and the lack of appropriate drainage system (see figure 4.12). The other 3 compounds with buildings not affected by basal erosion have external earth render. In fact 2 of these 3 compounds have both internal and external walls rendered with earth. This confirms that cementious render accelerates the rate of erosion on the wall base of these buildings.□

Figure 4.12: Accelerated basal erosion on adobe wall due to lack of drainage and the application of cementitious render

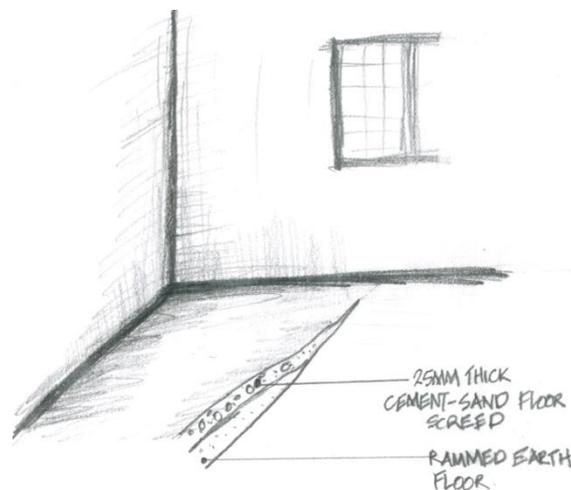
III. Floor cracks: All the 20 compounds surveyed have floors made from rammed earth hardcore and finished with cementitious screed. Cracks were noticed in all the floors. The cracks are due to lack of strong flooring that could with stand wear and tear. The thickness of the cementitious floor screeding in 3 buildings is just 25mm, while in another 2 the thicknesses are 35mm. The floor thickness of the remaining 15 buildings could not be ascertained because the cracks have not got through to the rammed earth hard core filling. Unfortunately, because of the restriction in photographing the interior of these buildings the floor defect can only be illustrated by the author as shown in figure 4.13. According to the occupants, the cracks have been patched up on numerous occasions, but continued to reappear.

Figure 4.13: Cracks on cementitious screed floor of adobe building

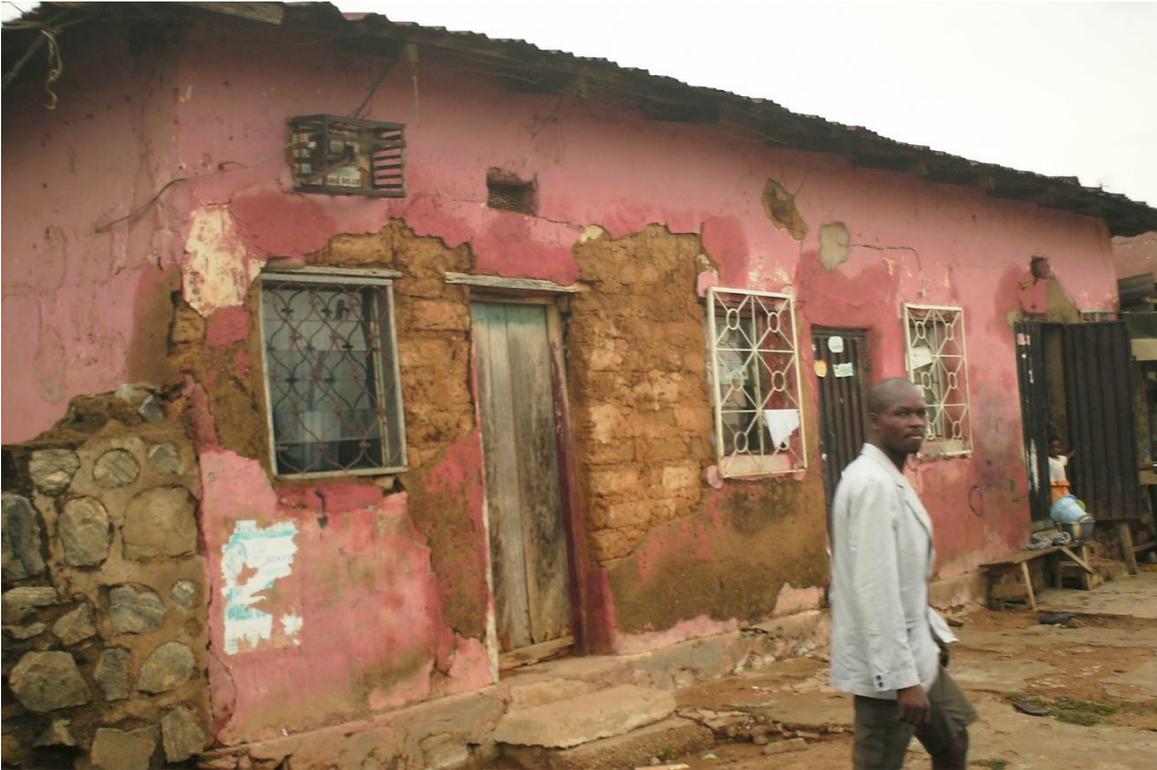
Figure 4.14: An adobe building with cementious rendering. Note the iron grills and the dampness on walls due to the rendering

I. Damp associated with wall signs: Telecommunication, food and beverages companies do advertise their products and services on walls of residential buildings. Many buildings not only those made from adobe in Sabon Gari carry these adverts, because of the high financial reward. 4 adobe buildings have these adverts. The walls were rendered with cement base material and painted to allow the advert to be written in oil paint. The effects of both cement base rendering and oil paints on adobe wall can be seen in figure 4.14 above.

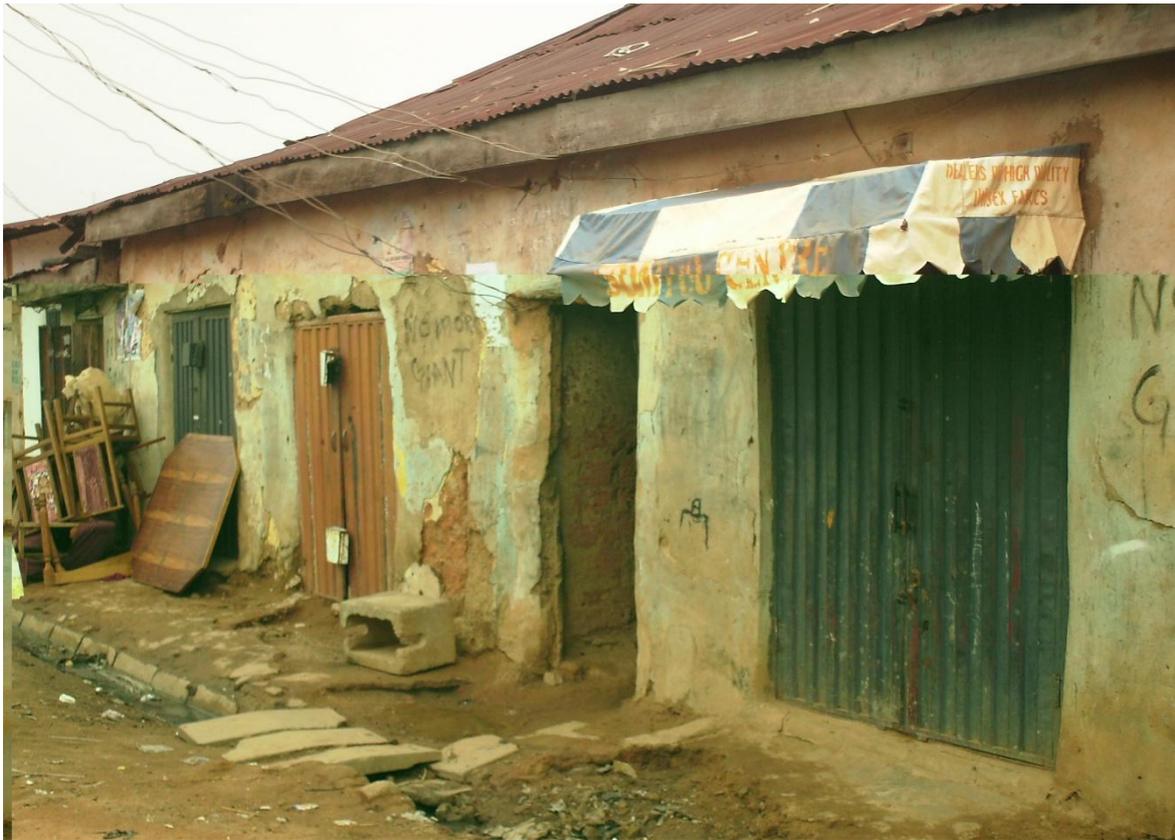
Figure 4.15: Adobe building with canopy, new doors, filled up window opening and new extension with lean-to roof at the far end

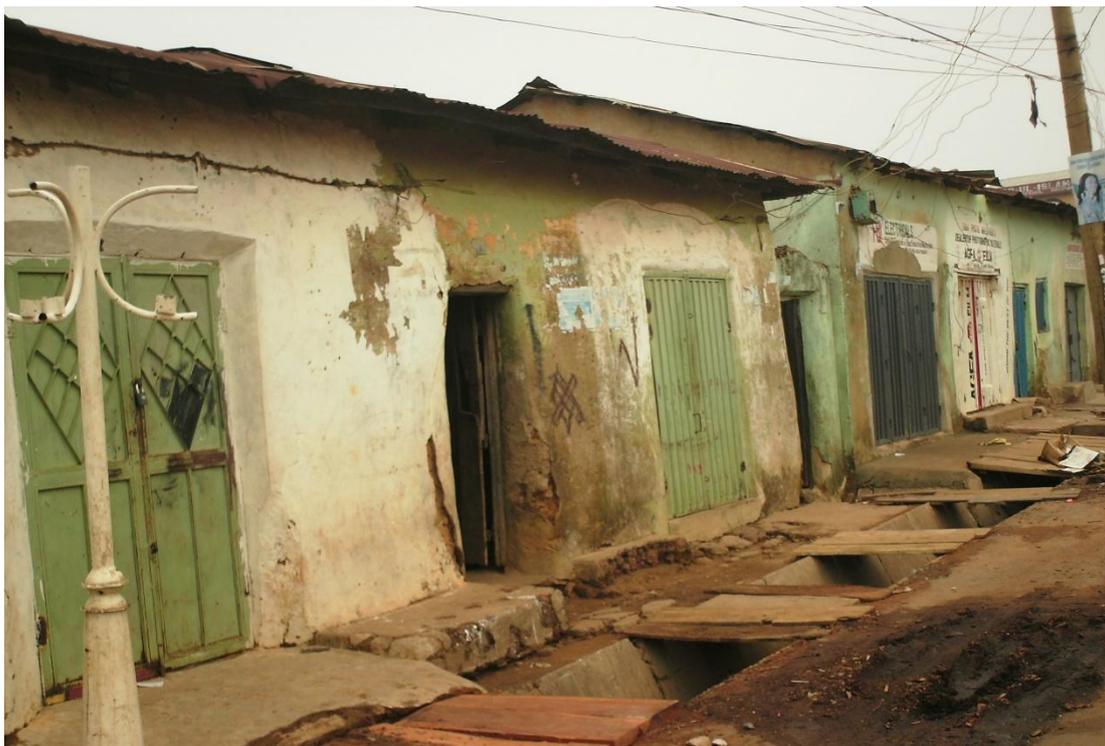
IIc. Wall cracks in areas where electrical appliances were introduced: The introduction of electrical fittings such as ventilation fans (mostly ceiling fans) and other appliances requiring new wiring, sockets, switches etc. usually accompanied remodelling and conversions. In the process of installing these electrical services, the adobe walls were hacked off and patch up with cementious mix. Cracks were noticed in 2 buildings in which electrical fittings were installed. This is not only an eye sore as can be seen in figure 4.16 below, but can affect the structurally stability of the adobe walls.

Figure 4.16: The effect of electrical installation and government services (road, drainage, etc.) on adobe buildings

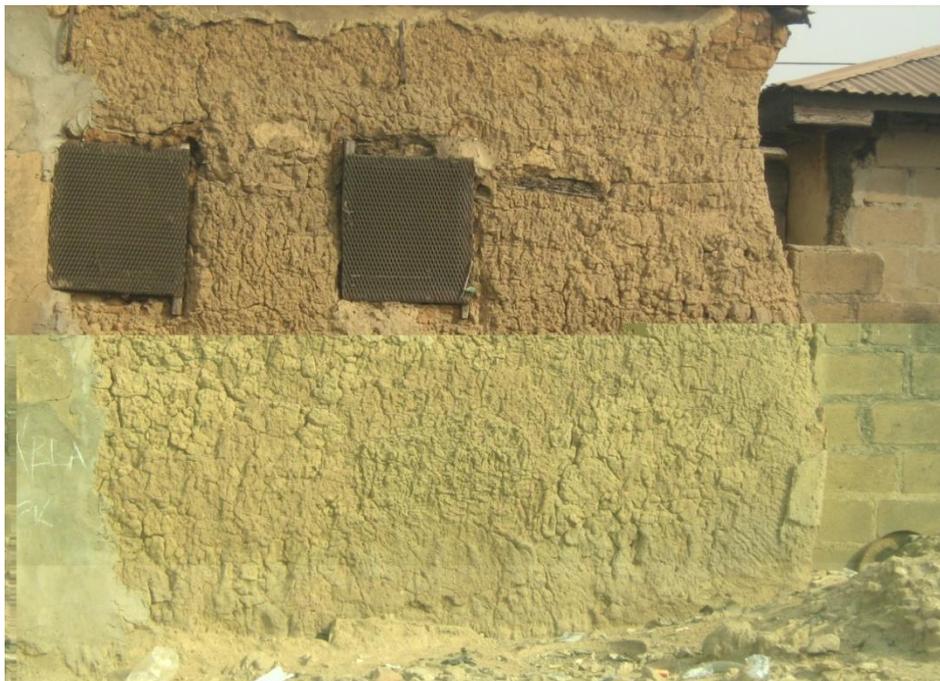
IV. Wall cracks by the burglary proof areas: In Nigeria security screens on windows are now compulsory in every building to make them burglary proof as can be seen in figures 4.14 and 4.17. Since these buildings were built when security screens were not a necessity, none of the 20 buildings had the security screens originally. But these were introduced according to the occupants in the 1990s when house burglary became too rampant in Kaduna. Patches of cementious mortar could be noticed in the areas where these burglary proofs screens were fixed to the walls in almost all the buildings and severe cracks caused by their introduction in 32 rooms in 12 compounds.

□Figure 4.17: Adobe building with security screen on the windows

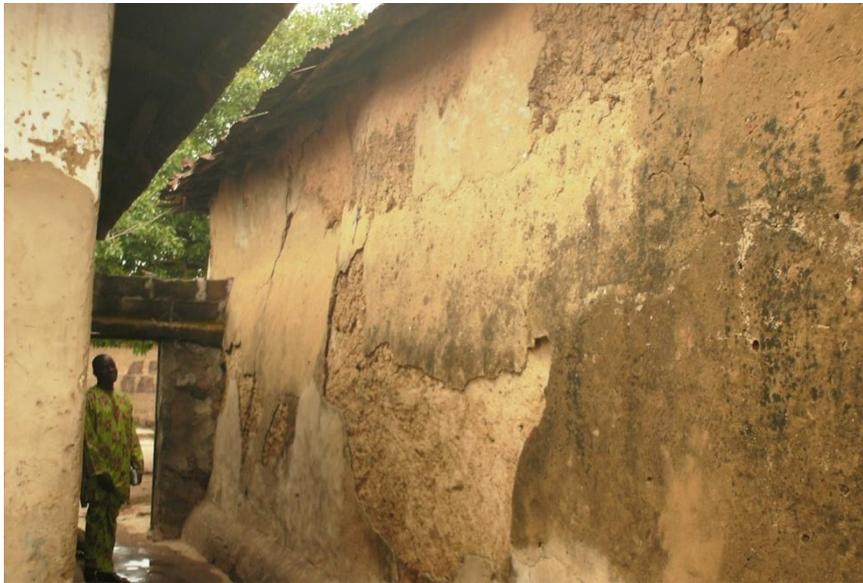
draining rainwater onto the adobe wall in another property (see figures 4.18 and 4.19). The rain water that drains on these buildings causes accelerated erosion of the adobe walls.

Figure 4.18: Roof of adjoining property affecting adobe wall in another property

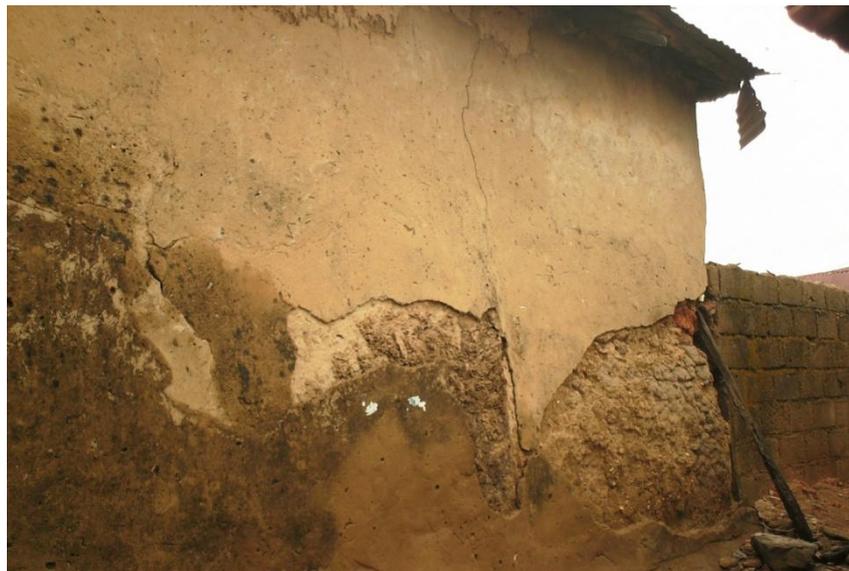
Figure 4.19: This picture is of the same building above (figure 4.16) but taken from the opposite side. The effect of rain on the adjoining property is clearer from this view

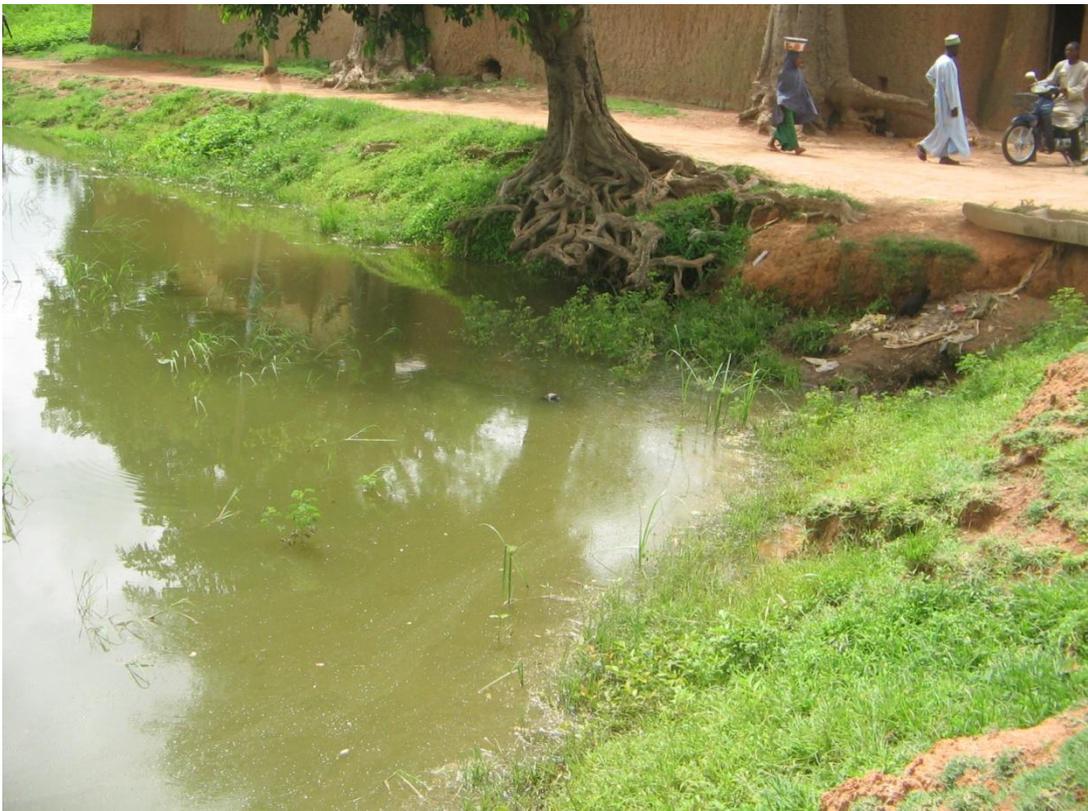
Figure 5.8: An eroded burrow pit, which is already a threat to the adjoining adobe buildings

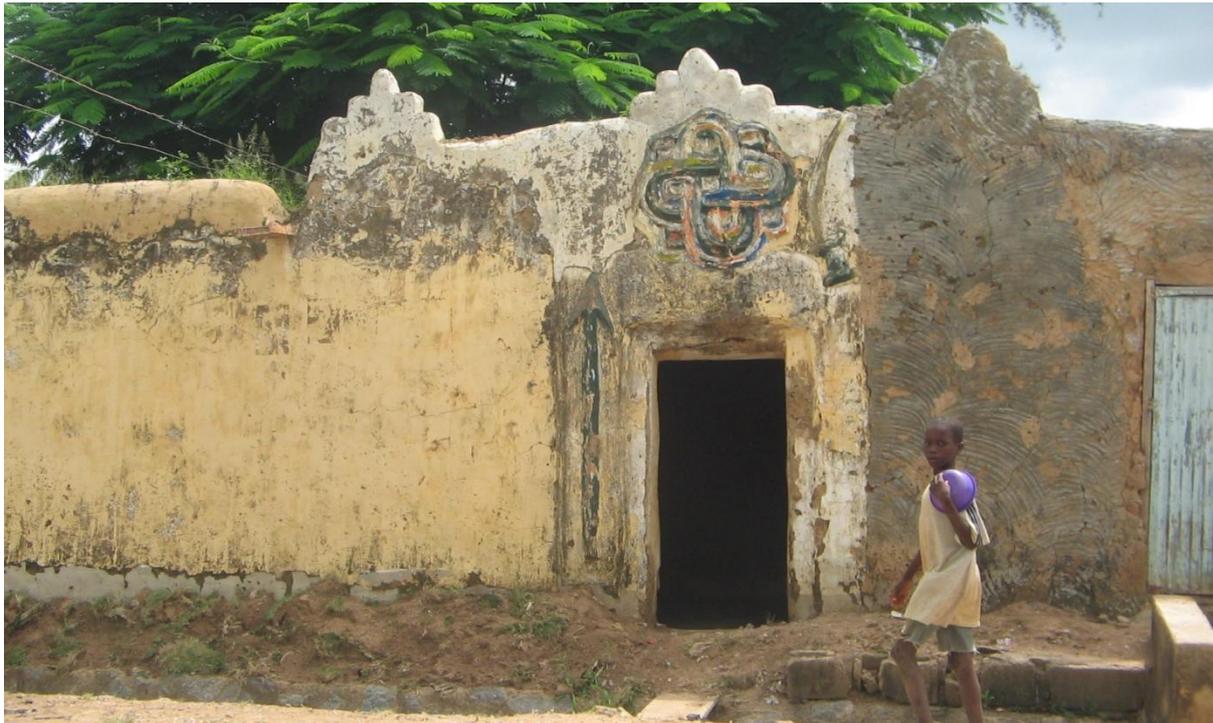
Figure 5.20: A dilapidated adobe building with cementious render

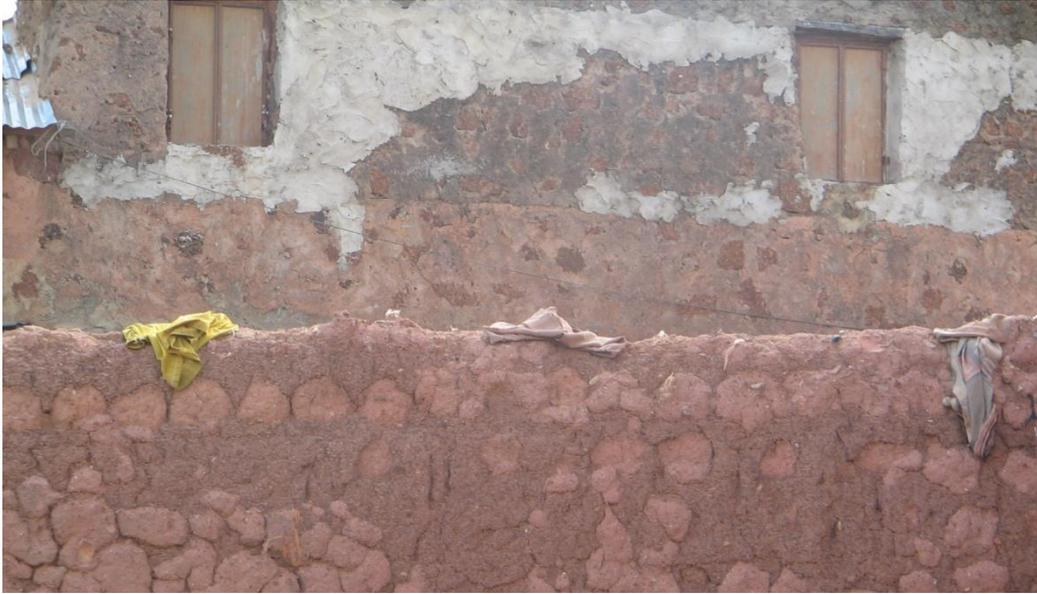
Figure 5.21: A cracked cementitious render on adobe wall

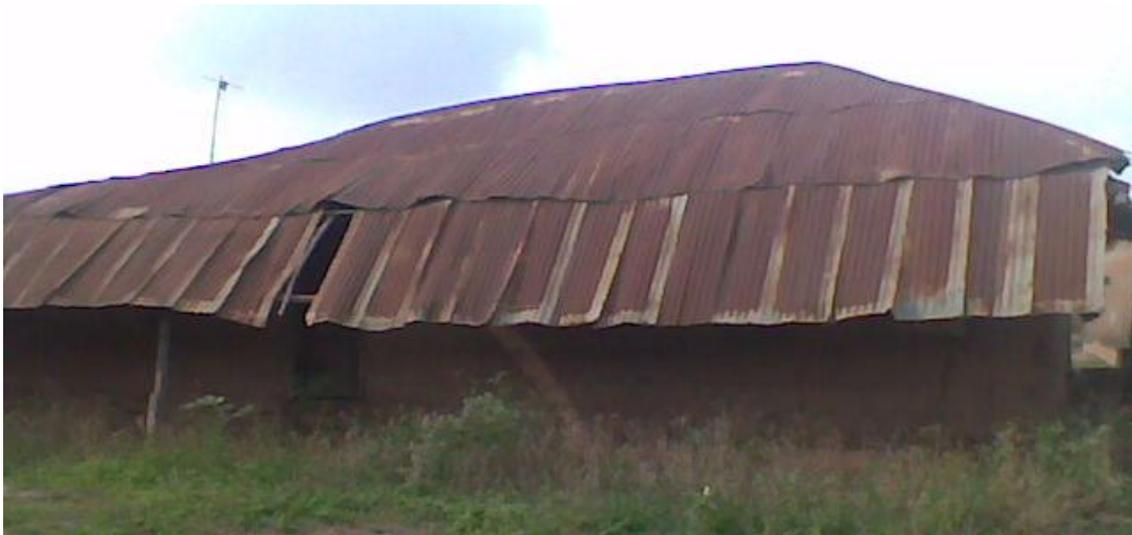
Figure 5.27: An abandoned cob building in Offa

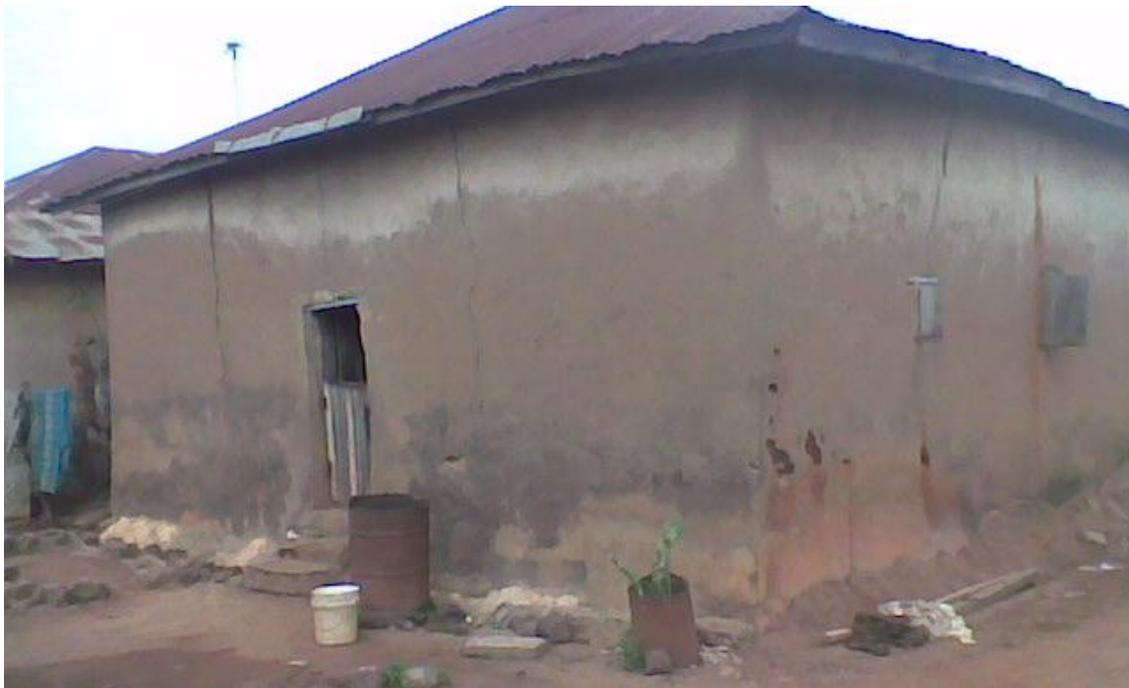
Figure 5.28: A cob building with cementitious render in Offa

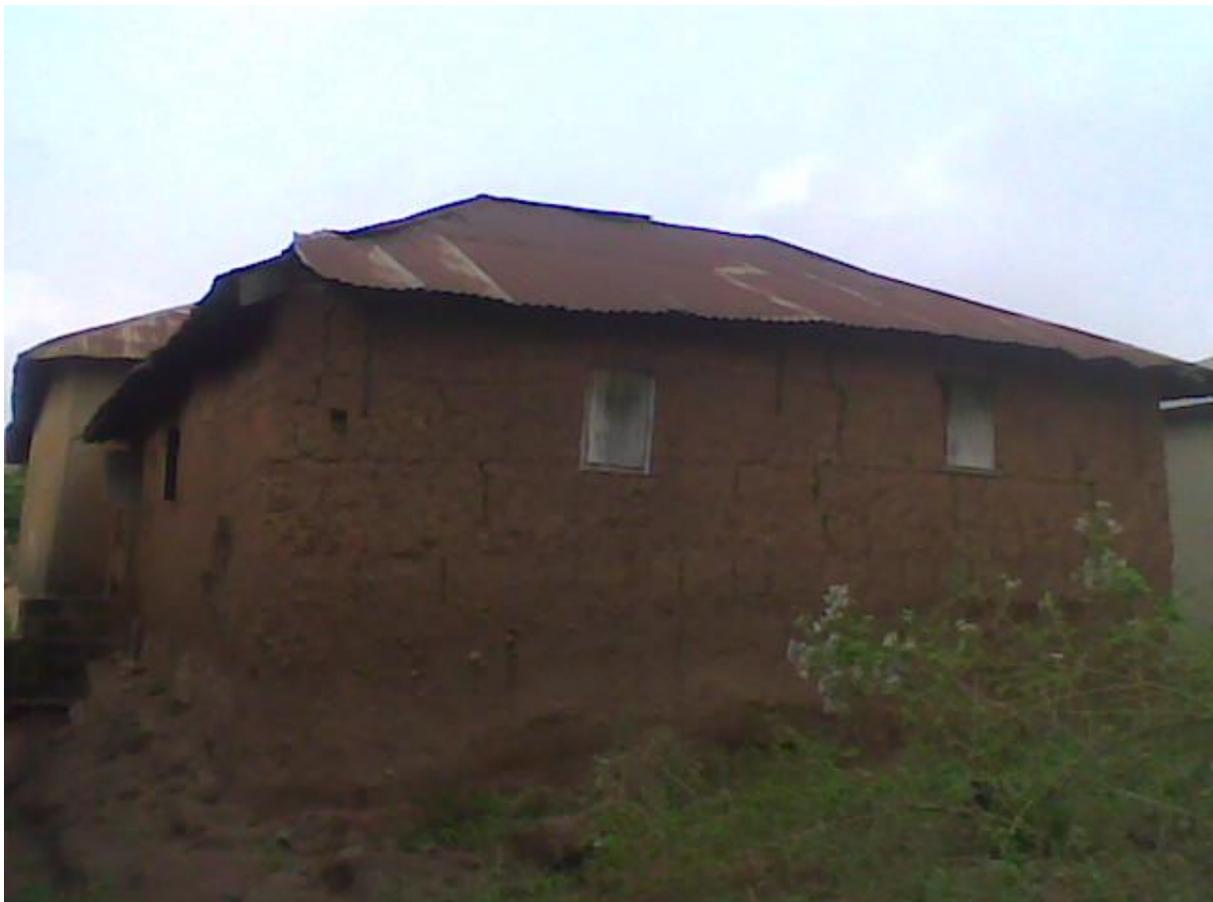
Figure 5.29 Cob buildings with cracks between lifts

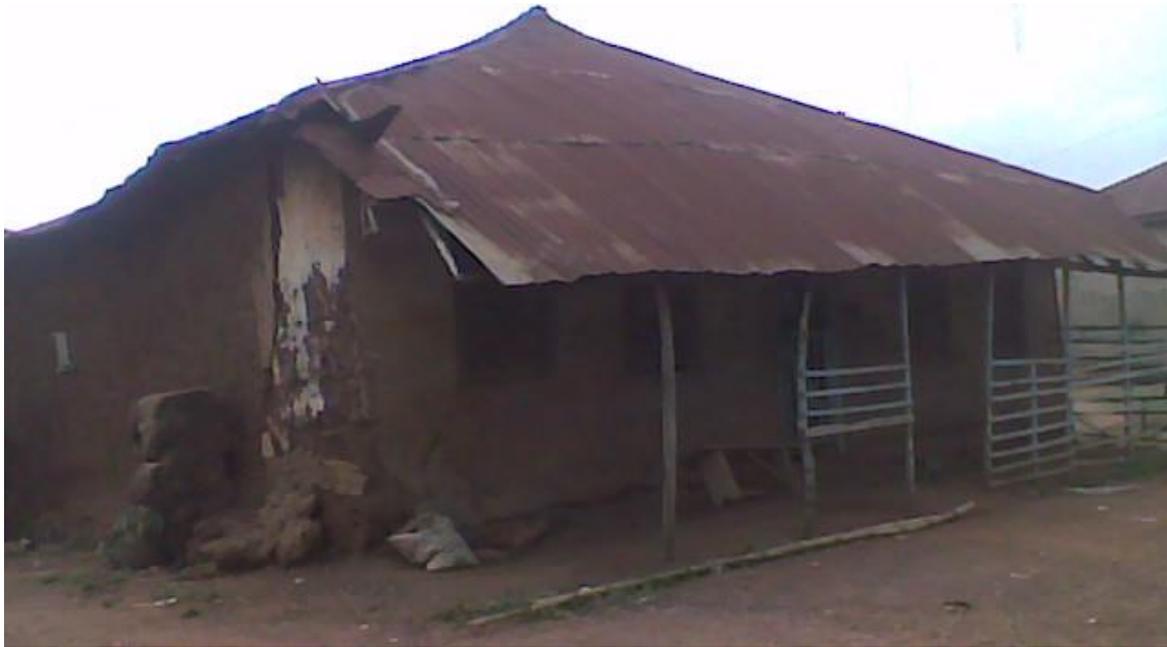
Figure 5.30: A cob building with vertical crack

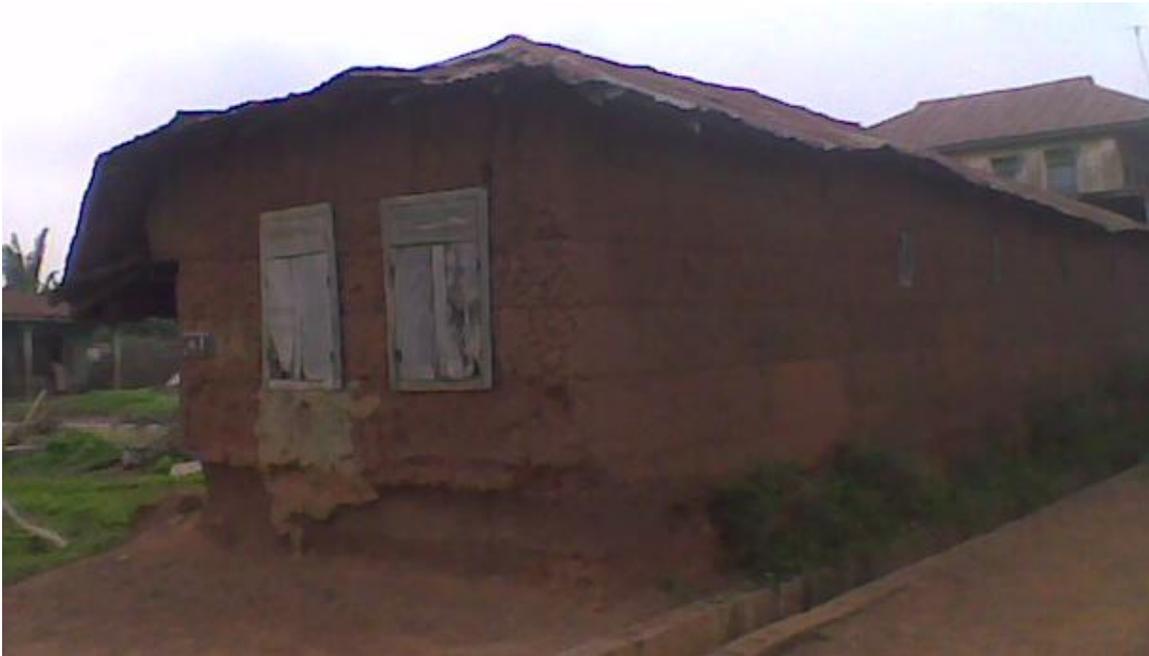
Figure 5.31: Basal erosion on a cob building in Offa

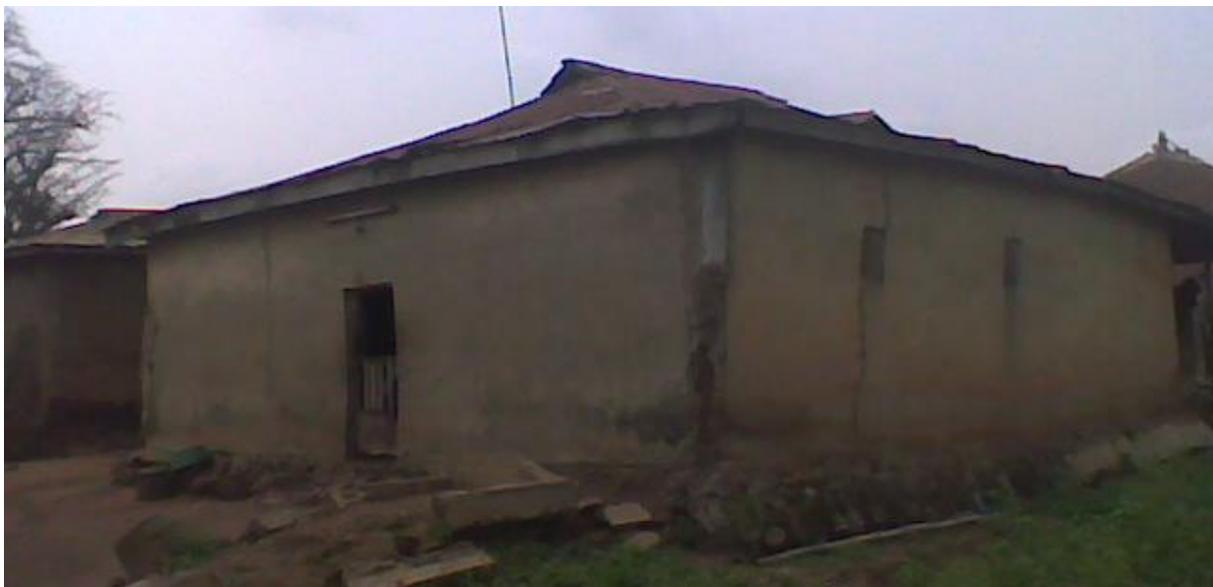
Figure 5.32: Cob building with cementious render and stone plinth bonded with cementious mortar

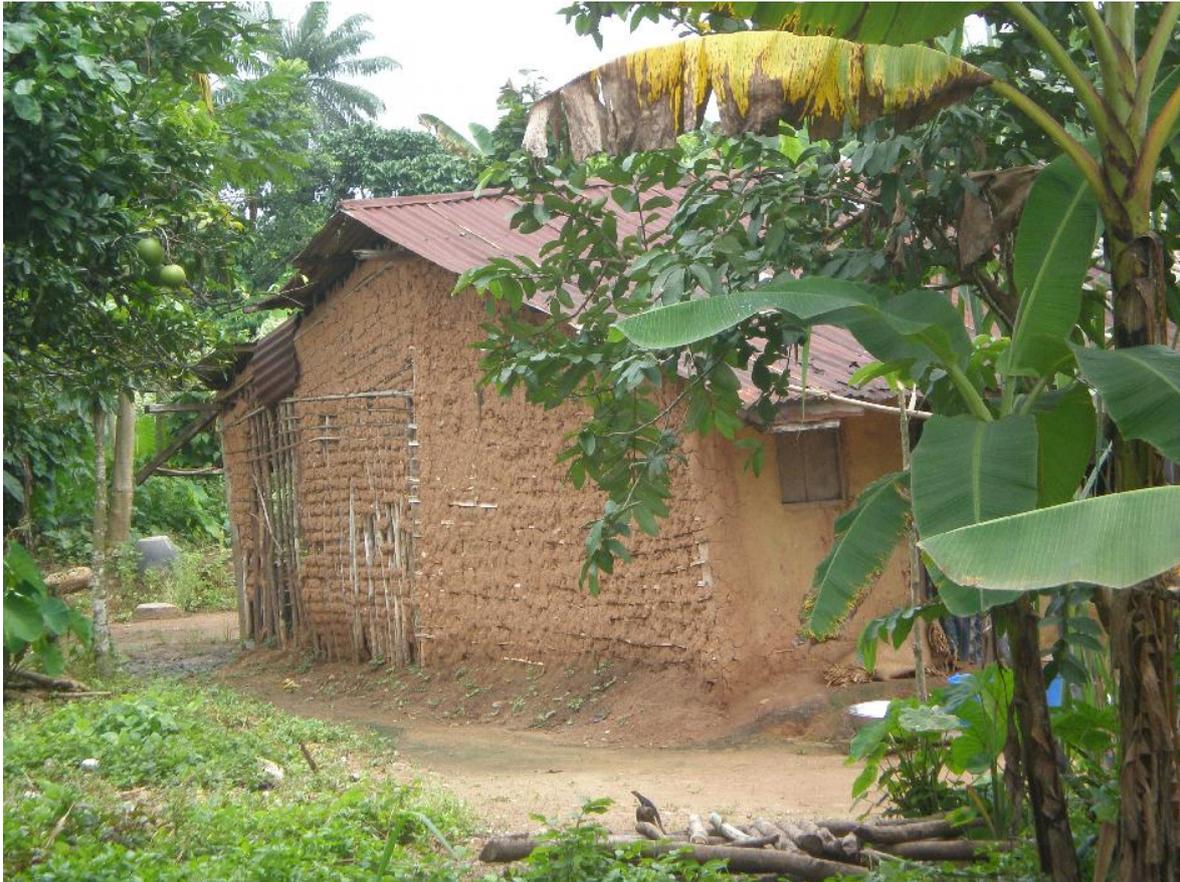
Figure 5.34: An eroded wattle and daub
