The Conclusion from One Million Tonnes of Experience in Galvanizing Steel – LMAC is not a Primary Instigator of Cracking

C Leighfield ¹ and M N James ^{2,3}

Abstract

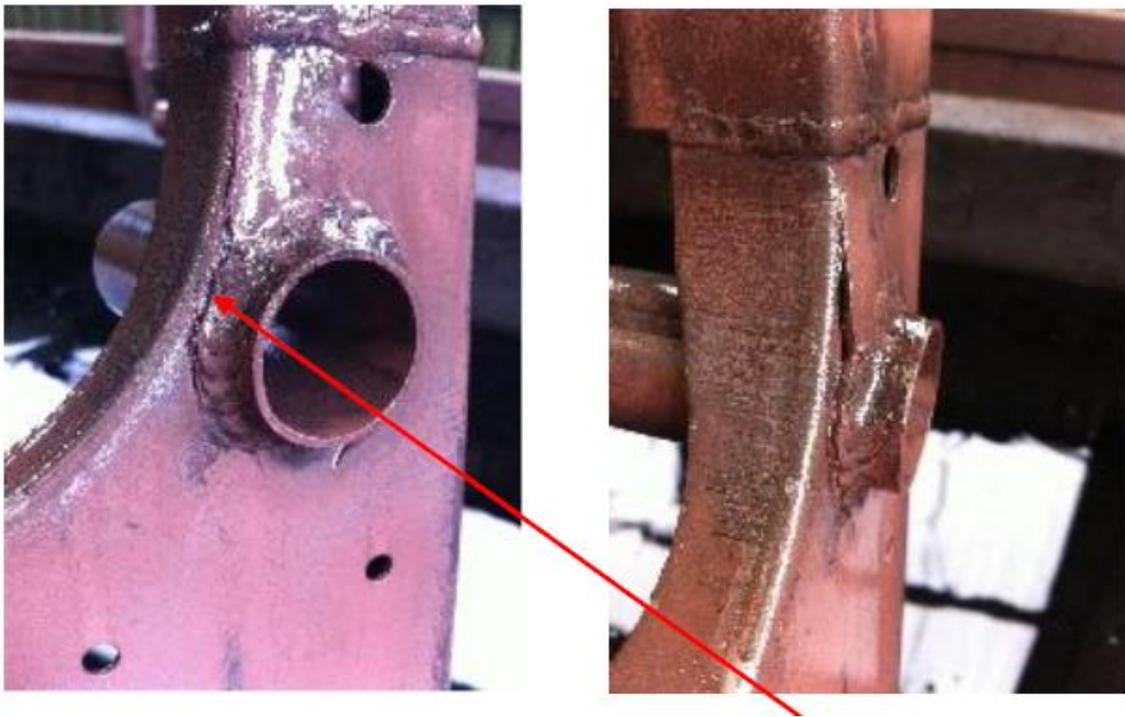
The types of crack identified as existing after fabrication were usually related to detail types with known susceptibility to cracking, and can hence usually be ascribed to sub-optimum design. Figure 2 shows one example of such cracking associated with a tubular insert in a hollow section, where the weld run is too close to the edge of the component and the welding-induced residual stresses have combined with those existing from the fabrication at the corner of the hollow section to initiate cracking. Figure 3 shows another example of cracking that occurred during fabrication arising from the superposition of welding residual stress and hardness gradients with other pre-existing fabrication stresses. Figure 4 shows cracking observed in steel checker or tread plate, which is more susceptible to cracking during bending than a plane component because of the raised tear drop shapes. If the usual minimum bend radius is perhaps $1.5t$, where t is the plate thickness, then checker plate would require a larger inner radius of at least $3t$.

Figure 2 Weld run around an insert that was too close to an existing fabrication-induced region of plasticity/residual stress.

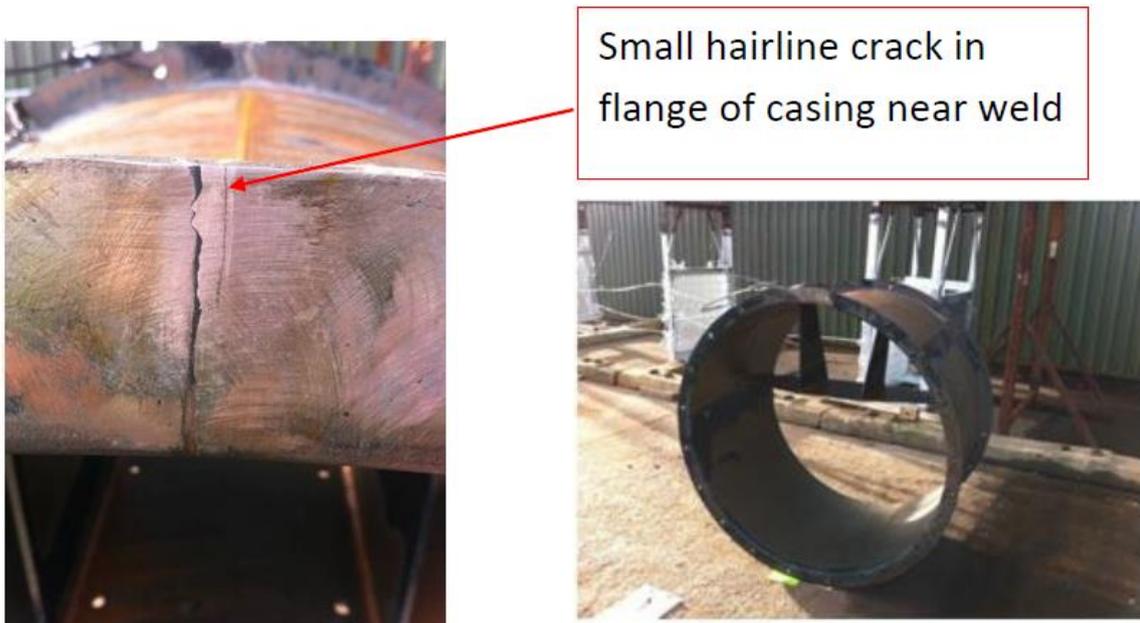
Figure 3 This crack is probably again due to a combination of the welding process (residual stress and hardness gradients) and the stresses induced during forming of the cylindrical casing.

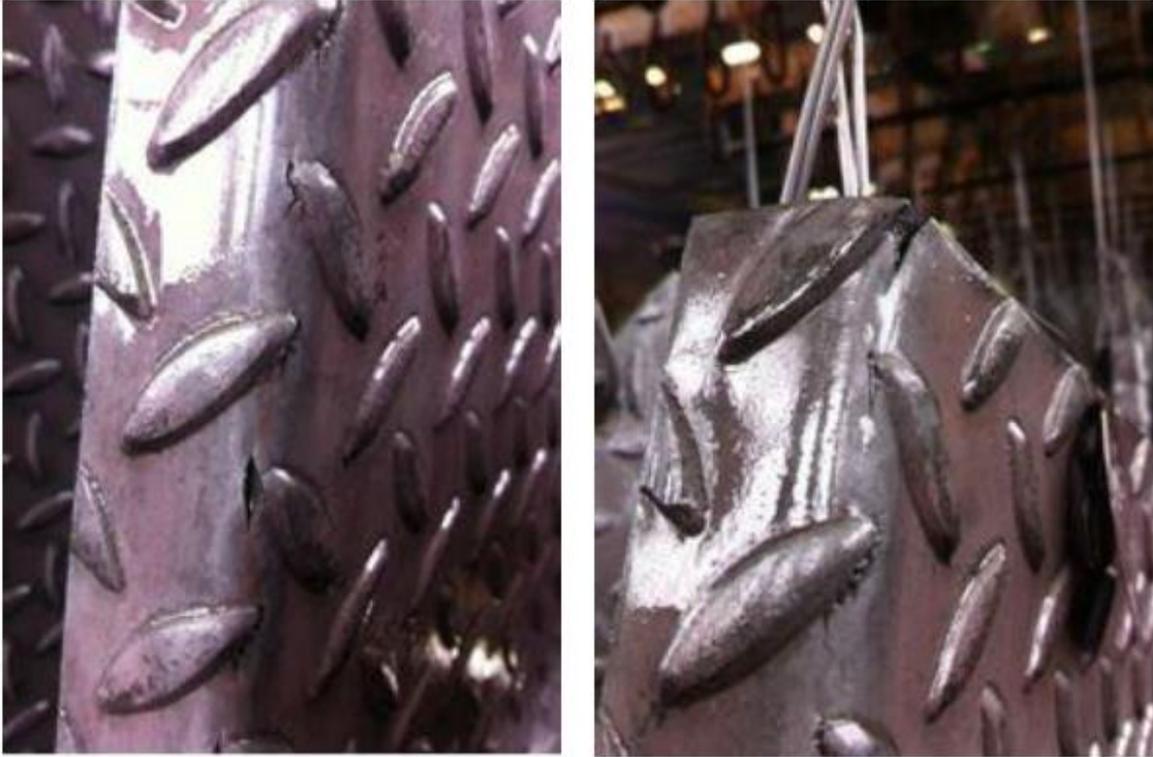
Figure 4 The cracking seen here is due to the steel checker plate having too tight a bend radius.

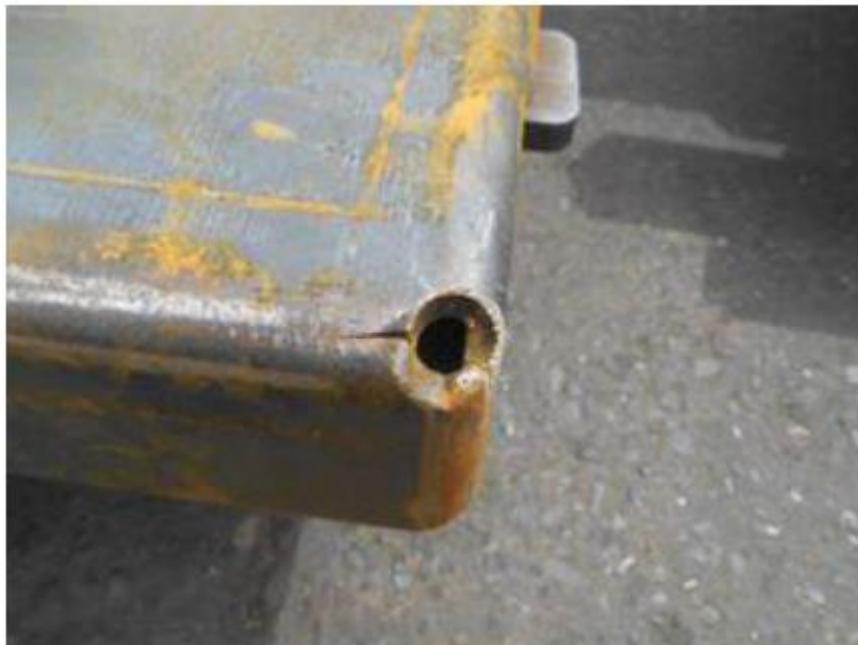
Figure 5 shows an interesting example of cracking that occurred during galvanizing and that is similar to a cope hole. A weld crack has initiated at a cut-out intended to avoid the defect-prone intersection of multiple welds. Cope holes and 'snipes', i.e. vent or drain holes and openings, are a common cause of cracking problems during fabrication and galvanizing and Figure 6 shows fabrication cracking induced at flame-cut snipe that was introduced to facilitate making a multipass weld. This crack would generally be ascribed to LMAC, rather than having its root cause as poor fabrication practice.

Figure 5 Weld cracking initiated from a small cut-out intended to avoid the problem of intersecting welds in fabrication of a hollow section.

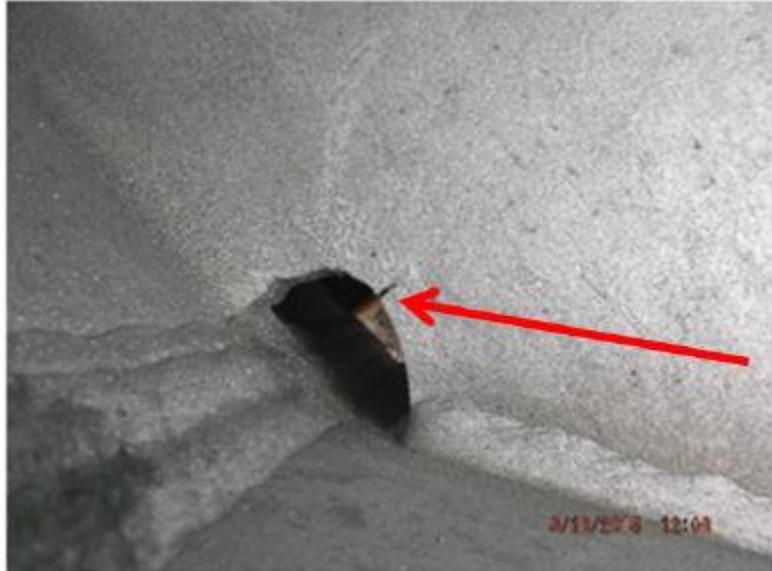
Figure 6 A crack that has initiated at a flame-cut 'snipe' intended to facilitate making a multipass weld. Cracking is due to the high local hardness and stress concentrations induced during flame cutting.

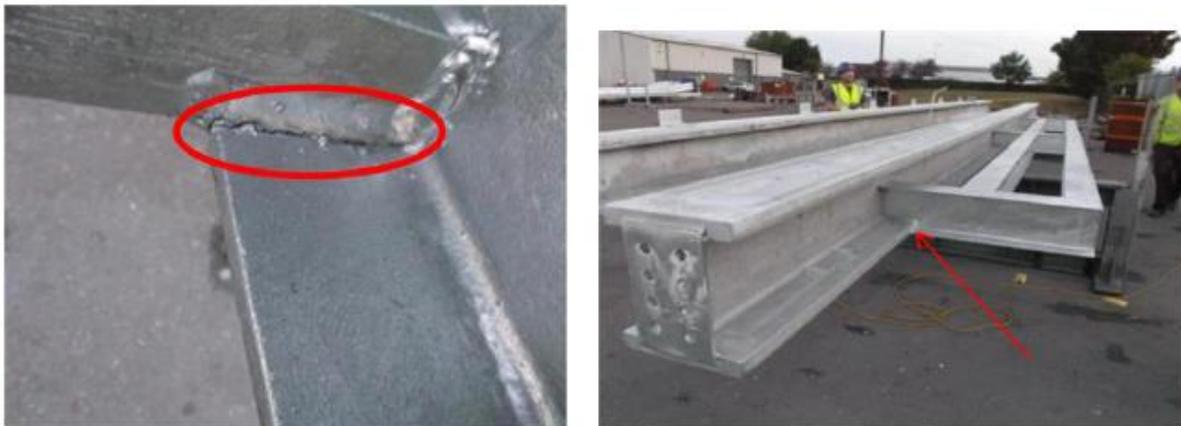
Complex welded fabrications involving the joining of plates of significantly different thickness can lead to cracking during galvanizing because of the differential cooling rates, hardness values and stress concentrations associated with such joints. Figure 7 shows one such example where discussions between the fabricator and the galvanizer would have enabled a minor change to fabrication to be made, perhaps utilising bolting together of the two assemblies, and the problem would have been eliminated. Figure 8 illustrates another problem sometimes encountered during galvanizing of relatively heavy and complex welded fabrications. The square box section shown in Figure 8b has welds coincident with regions of high residual stress at high constraint corners. The interplay among geometric stress concentrations, hardness gradients and residual stresses can very easily either initiate micro-cracks that extend during galvanizing, or initiate LMAC in the galvanizing bath (Figure 8c). Possible design changes that could be implemented to avoid this problem include the use of hot formed seamless tube.

Figure 7 Cracking at the highly constrained joint between a smaller sub-assembly and a large I-beam. Separate fabrication of the two components and subsequent bolting would have eliminated the problem.

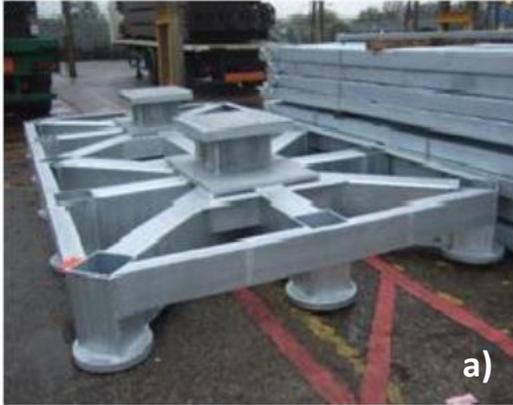
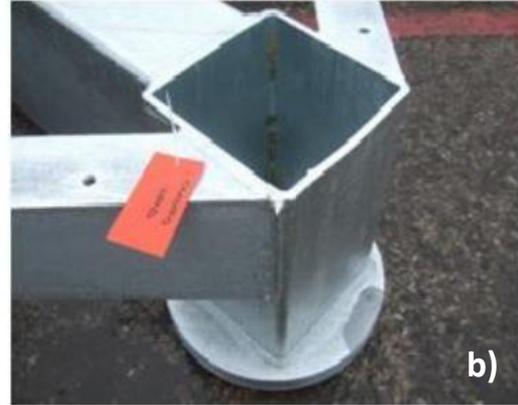
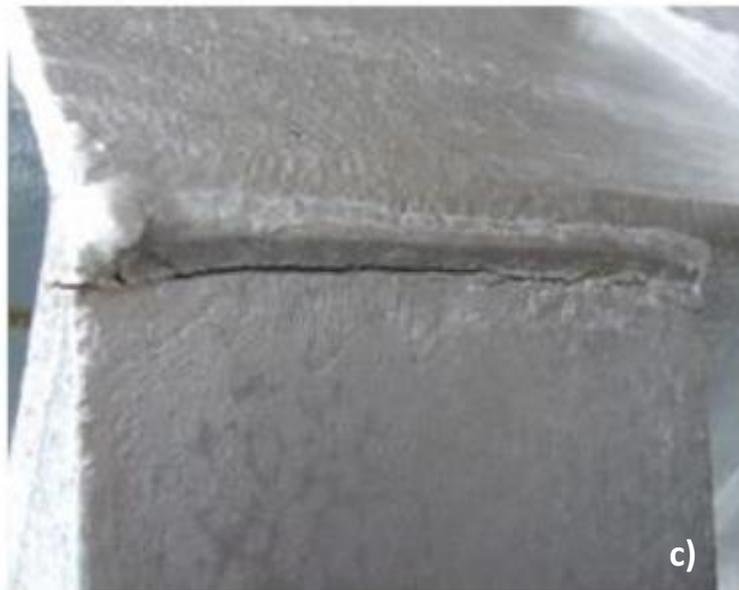
Figure 8 The complex fabrication shown in a) has square box sections b) where several welds are coincident at the highly constrained corners. The interplay among geometric stress concentrations, hardness gradients and residual stresses can very easily either initiate micro-cracks that extend during galvanizing, or initiate LMAC in the galvanizing bath

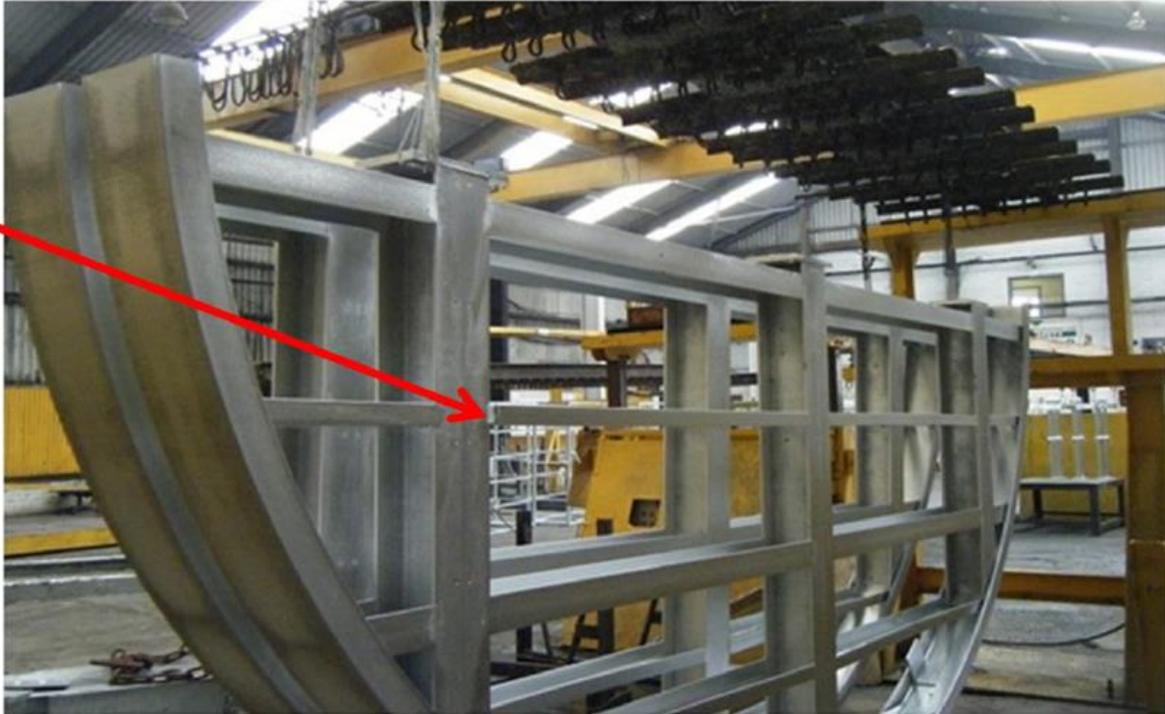
The stresses induced in highly constrained steelwork can combine with poor welding practice, such as partial penetration, to create cracking problems during galvanizing. Figure 9 shows one example of this where partial weld penetration and subsequent weld grinding have led to cracking. A number of instances of cracking arising from insufficient weld thickness as a result of weld dressing and/or partial penetration were observed in other components during this investigation into galvanizing of steelwork.

Figure 9 In this complex welded fabrication, partial weld penetration and subsequent weld grinding have led to cracking occurring during galvanizing from the under-sized weld.

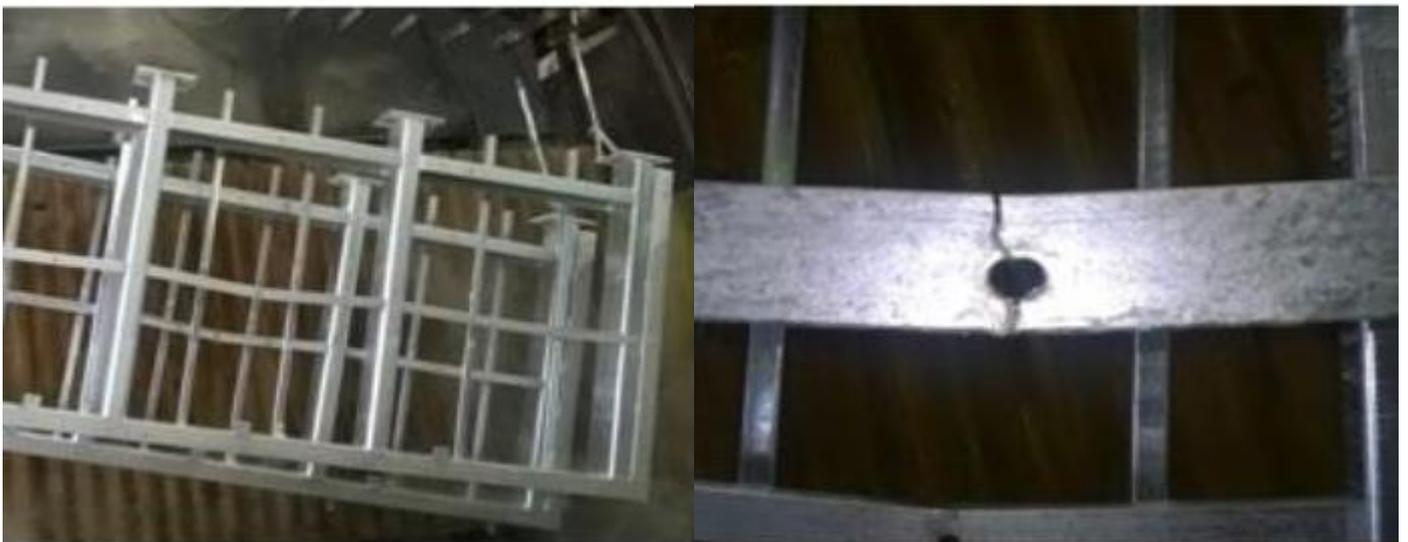
High levels of distortion-induced stresses can occur during galvanizing and an example of cracking induced by distortion is shown in Figure 10, where distortion in a smaller and highly constrained member has combined with additional stress localisation at an off-centre hole to initiate cracking. Distortion of members can also occur due to inadequate venting in steelwork intended for galvanizing. This problem is illustrated in Figure 11, where smaller and properly vented members were welded onto a larger section that was not adequately vented. Trapped internal gases have led to local bulging of the main member in the thermally-affected weld zone and hence initiated cracking at its junction with the cross-members.

Figure 10 Significant distortion has occurred in the highly constrained smaller cross-members in this steel fabrication, and the off-centre hole has led to an additional localisation of stress, causing cracking to occur during galvanizing.

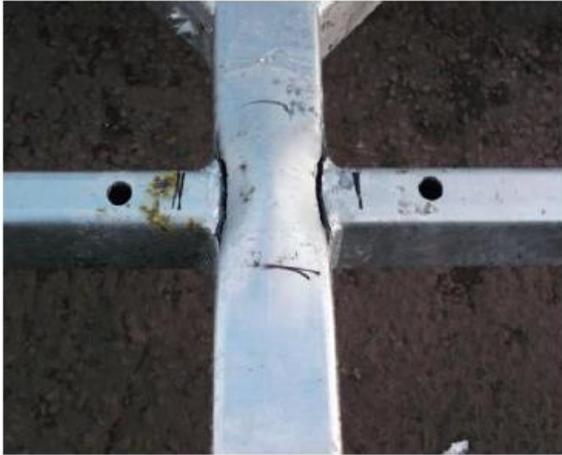
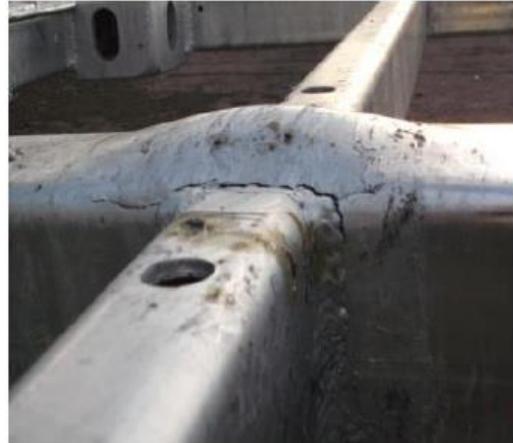
Figure 11 Inadequate venting provision has led to bulging of the main member in the thermally weakened zone where the cross-members were welded to it, causing cracking.

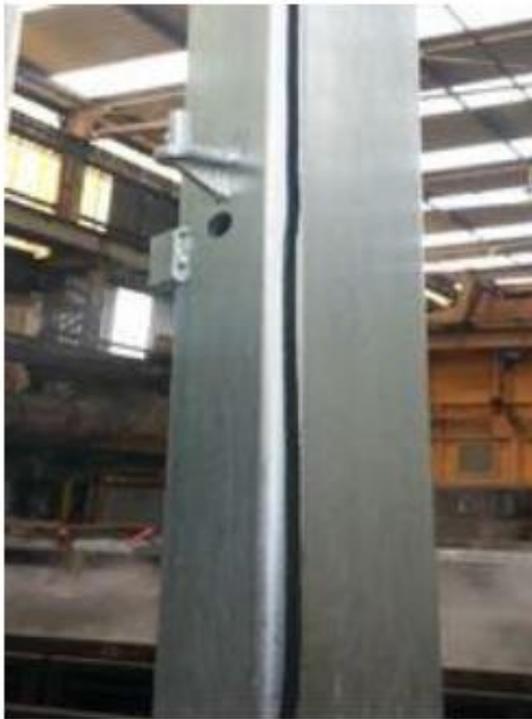
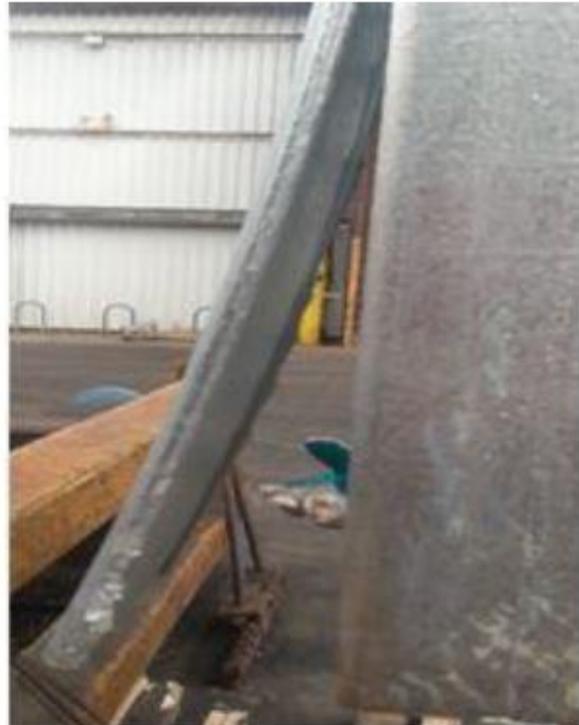
As a final example of the range of problems sometimes experienced during galvanizing, Figure 12 shows cracking in a cold formed rectangular hollow section. The residual stresses induced in either cold-rolled or welded hollow sections at the corners, tend to increase with increase in length of the component. Cracking can initiate or extend during galvanizing from either small defects at the weld ends or local stress concentrations/hard spots at flame cut edges. The high levels of tensile residual stress that existed in the outer surface are evidenced in the deformation seen in the plate after cracking.

Figure 12 Cracking in a cold formed steel section that has initiated from one end due to the high levels of residual stresses existing in the cold formed section at the corners.
