Weld solidification cracking in a 304L stainless steel water tank

Engineering Failure Analysis

Weld Solidification Cracking in a 304L Stainless Steel Water Tank

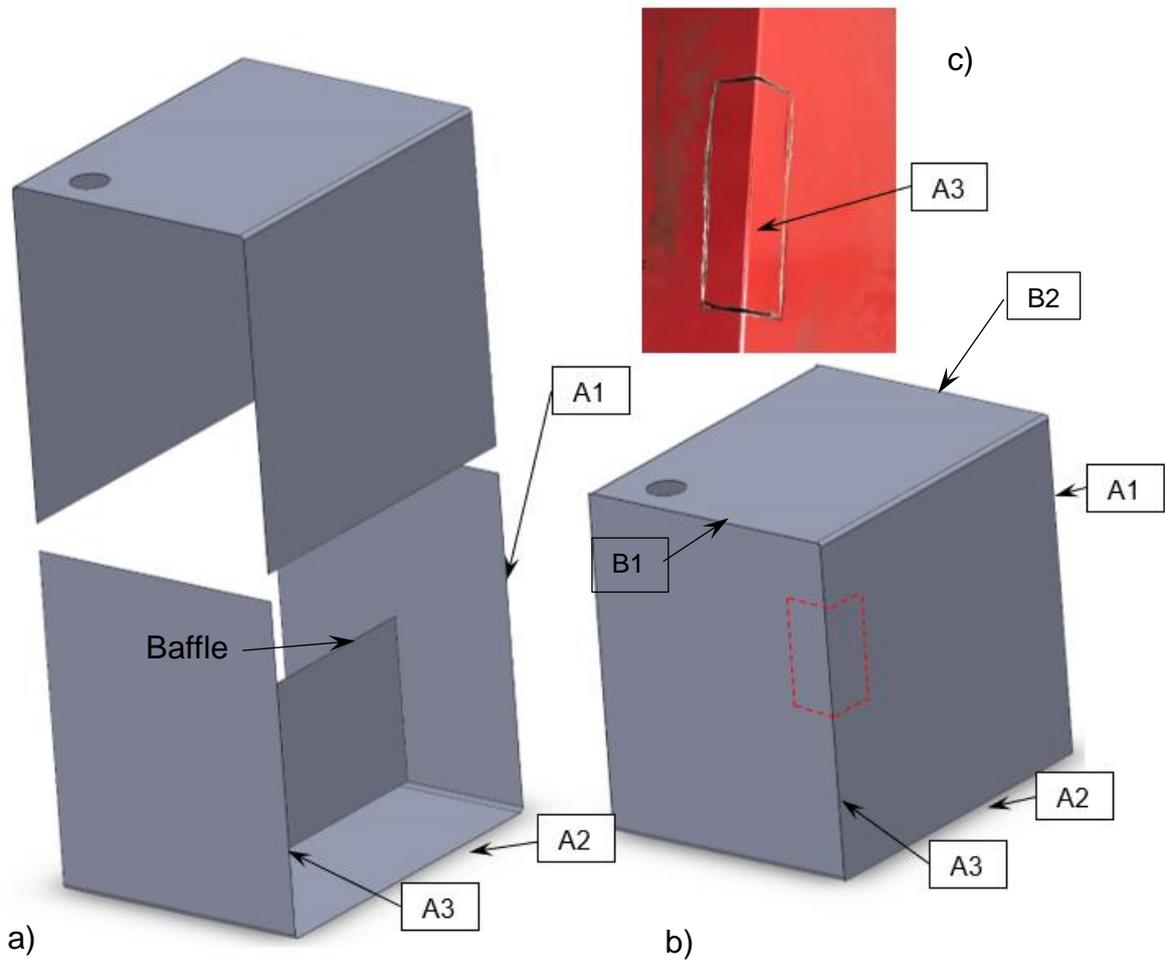
The rectangular 200 litre water tank is shown in Figure 1 and is formed by welding together two pieces of type 304L stainless steel, each bent into a 'U' shape (Figure 1a), to complete the rectangular shaped tank (Figure 1b). Horizontal dimensions in Figure 1 are 640 mm by 662 mm with a vertical height of 504 mm. Chemical composition of the 304L alloy was measured using spectroscopy and the data is given in Table 1. The alloy conforms to the specification for commercial 304L plate and it should be highly resistant to solidification cracking.

The welded seams on one side of the tank are marked with the letters 'A1' to 'A3' with the welding sequence apparently following A1 → A2 → A3. Welding on the opposite side presumably followed an equivalent sequence and closure of the tank was accomplished via welds B1 and B2. The crack origin was approximately in the centre of one of the 640 mm sides, as shown with the red dotted shape in Figure 1b and the arrow in Figure 1c. The hole shown in the top surface is where the filling valve for the tank is located and there is an internal baffle plate that extends to the half-height position. This baffle plate was tack welded on the

vertical sides and bottom of the tank, but free on the top surface. The baffle plate welding showed that tank closure had been achieved by making the welds A1, A2 and A3, probably continuously in that order. Hence a considerable restraint on the seam weld A3 would have arisen during solidification from the residual stresses induced during cooling by this welding sequence.

Figure 1 Illustrations of the water tank and its design; welding of the two sections occurred in the sequence of A1 → A2 → A3:

- An exploded view of the two tank sections that were bent to form 'U'-shapes and were then welded together to make the tank. The position of an internal baffle is also shown.
- The assembled water tank showing the position where seam cracking was found (red dotted rectangle on corner A3).
- The actual sample that was sectioned from the tank for further analysis.

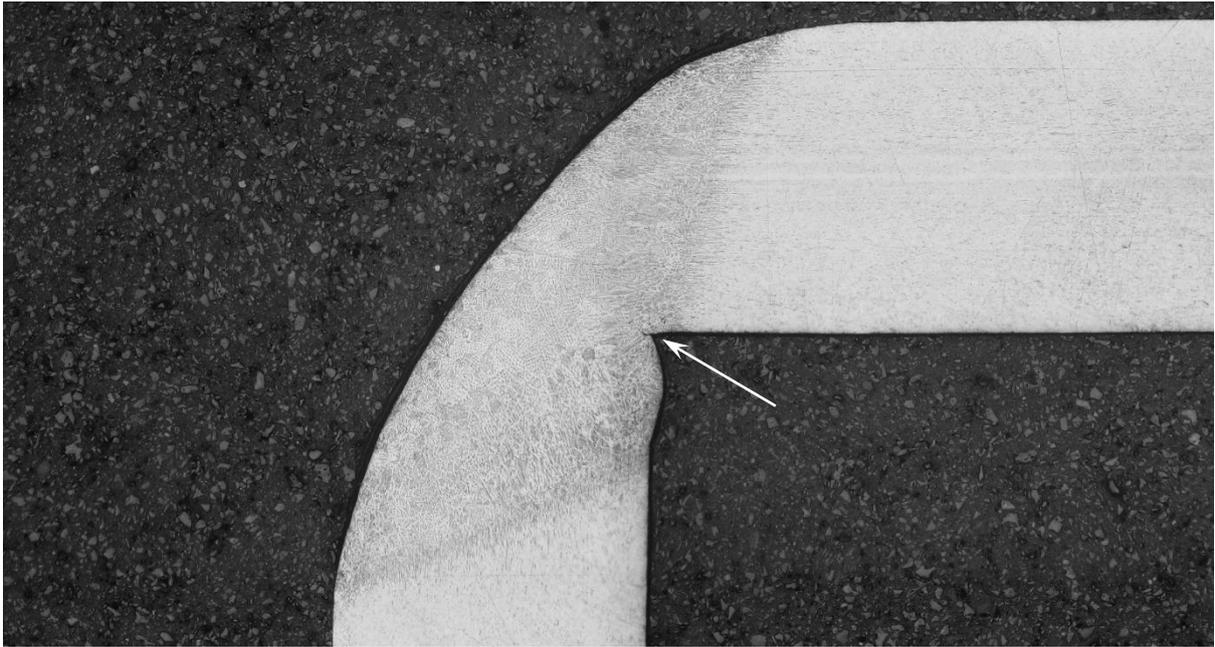
Welding was performed using a GTAW process with a type 309L filler metal (chemical composition given in Table 1). However, the tank manufacture had been subcontracted to the water tank designer, and it proved to be impossible to obtain details of the welding process used. What is clear, however, is that the weld was poorly detailed in the drawings and that the process used was inappropriate in at least some of the details. The weld crown was subsequently ground to provide a smooth transition before painting the tank (see Figure 2).

A piece of the weld seam, some 200 mm in length, that contained the complete fracture was sectioned from the failed joint (shown in Figure 1c). An adjacent piece was also cut out to allow measurement of the reduction in plate cross-section arising from the corner grinding. Figure 2 shows that this cosmetic attention to detail reduced the metal thickness at the critical weld root position, which coincides with the presence of a small crack, from 2.04 mm to 1.34 mm, equivalent to a reduction of 34%. The sharp weld root and its associated defect is shown at higher magnification in Figure 3. The defect has a total length of around 100 μm . It started from a partial penetration defect (A), and comprises a sharp weld toe intrusion (B) and a final section of cracking that occurred during welding (C). The blue and straw yellow temper colours seen in Figure 4 prove that the initial crack extension occurred during welding and that it is therefore due to an embrittlement problem. Figure 3 indicates that the cracking occurring during welding was assisted by the presence of a sharp weld toe intrusion resulting from undercut at a partial penetration weld.

Figure 2 Macro-etched section of the seam weld that cracked, showing the reduction in thickness at the critical region where there is a small weld root crack (marked with the arrow).

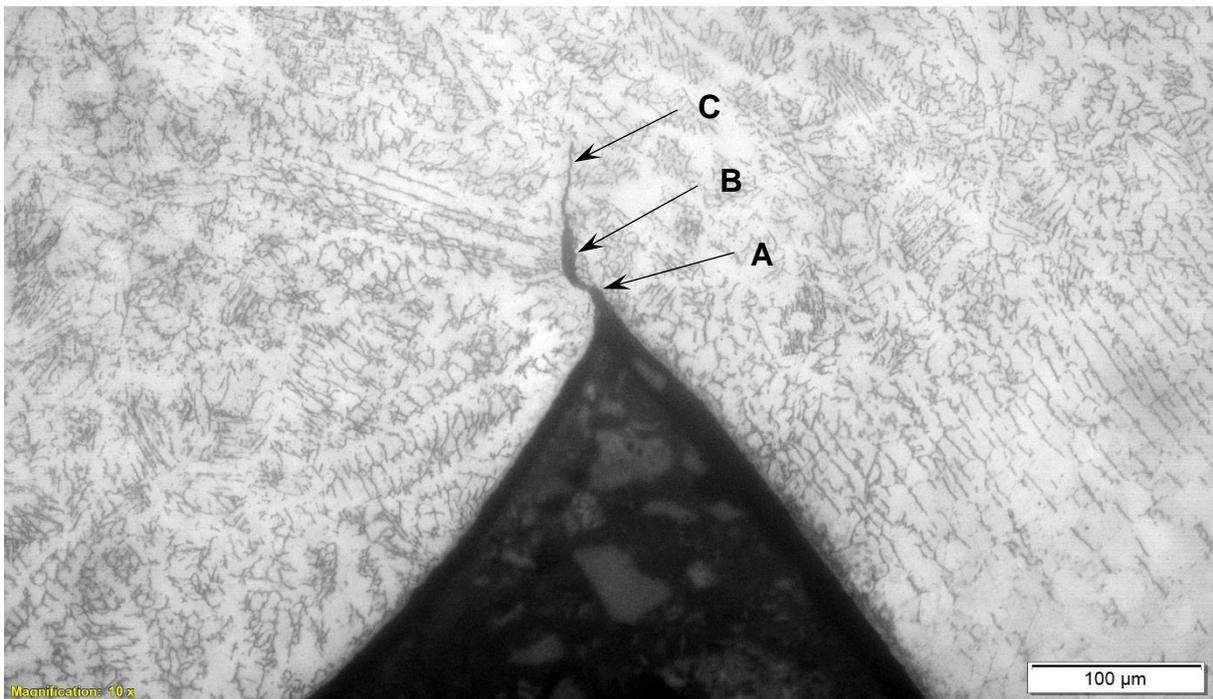
Figure 3 Higher magnification image of the weld root crack induced during welding. The crack has a total length of around 100 μm. It starts from a partial penetration defect (A), and comprises a sharp weld toe intrusion (B) and a final section of solidification cracking (C).

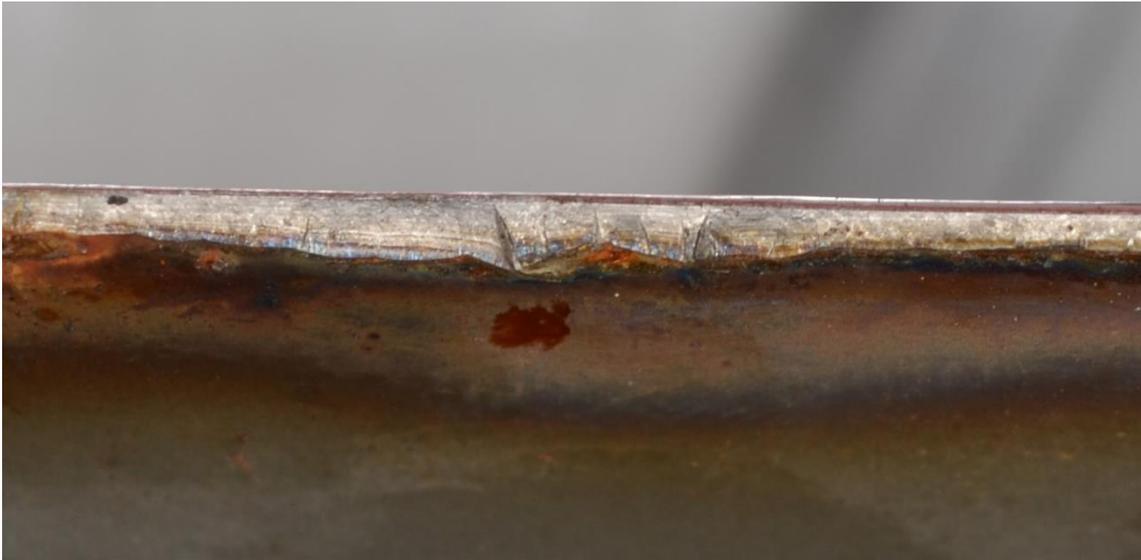
The throat of the weld should be at least the thickness of the parent plate and a fast travel speed is required to avoid melt-through to the inside corner. However, a fast travel speed is likely to result in a lower heat input per millimetre and a faster cooling of the joint which can then trigger solidification cracking. The torch angle should bisect the angle formed by the two pieces of metal to be joined in order to apply equal heat to both sides of the joint. As can be seen in Figure 2, the heat input does not appear to be uniform in the two sides of the joint and this has led to the sharp lack-of-penetration defect, associated weld root undercut and the resultant solidification cracking from a combination of high joint restraint and fast cooling (Figure 4).

Figure 4 The fracture surface showing evidence of blue and straw temper colours, proving that the crack originated as a hot crack during solidification.

A change in welding practice should resolve this problem, although a redesign of the tank could also be undertaken utilising, for example, rolled plate with a single butt weld joint and a flanged approach to attaching top and bottom pieces. These could then be either bolted or employ an edge weld on the flanged corner.

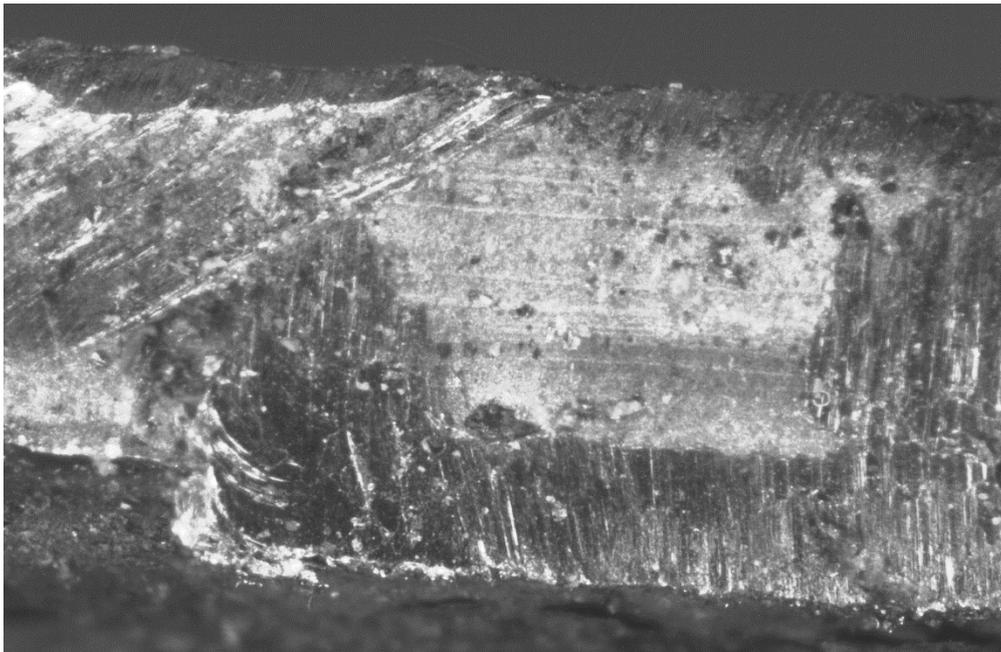
Part of the fracture surface containing the original through-thickness crack (indicated by screwdriver damage on the fracture surface – Figure 5) was sectioned from the larger specimen, cleaned and mounted for fractographic examination with stereo binoculars and with a scanning electron microscope. Low magnification inspection using stereo binoculars showed that a number of beachmarks were present both in the region of the initial water leak (Figure 5) and more generally along the fracture (Figure 6). The considerable number of beachmarks through the thickness indicates that their formation cannot be due only to a change in fracture mechanism from the pre-existing solidification crack to subsequent fatigue crack growth and/or fast fracture.

Figure 5 Beachmarks present on the fracture surface at the site of the original water leak, whose position was identified from the surface damage (seen here) inflicted by insertion of the screwdriver.

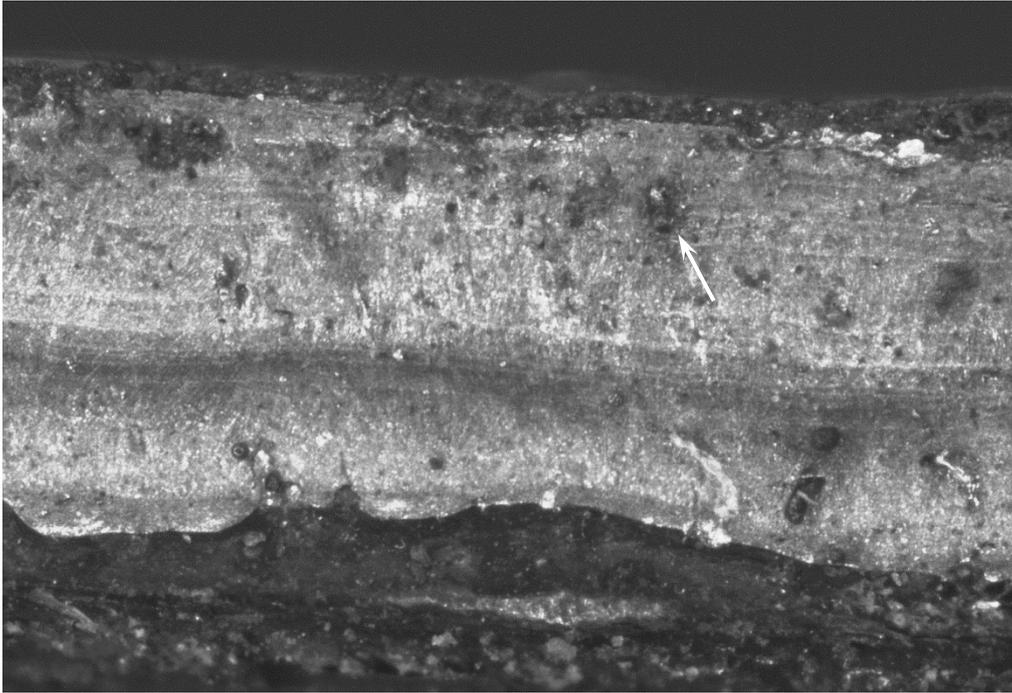
Figure 6 The beachmarks were present all along the fracture surface and therefore reflect influences other than mechanism changes.

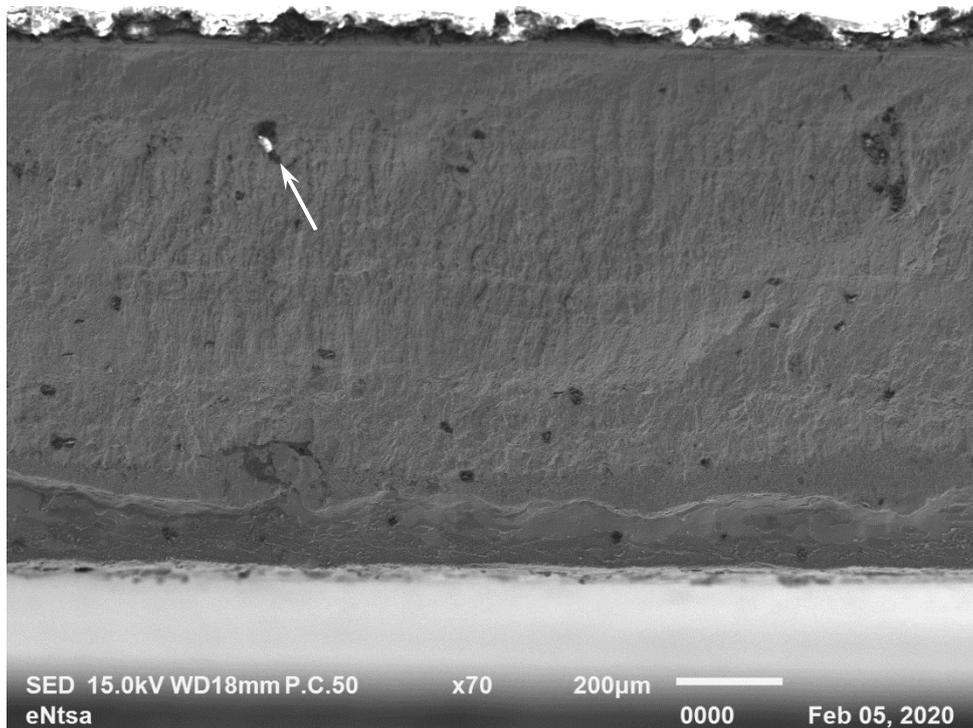
Figure 7 shows an scanning electron microscopy (SEM) fractograph of the complete fracture surface for comparison with the light fractograph in Figure 6 and to approximately locate the position of subsequent images of the fracture mechanisms. An arrow marks the same inclusion in both Figures 6 and 7. Figure 8 depicts the initial part of the fracture surface (seen in section in Figure 3) which contains the partial penetration defect, a sharp weld root intrusion

Figure 7 Low magnification SEM image of some of the region shown in Figure 5, with the weld root at the bottom of the image. The arrows in the two figures mark the same inclusion.

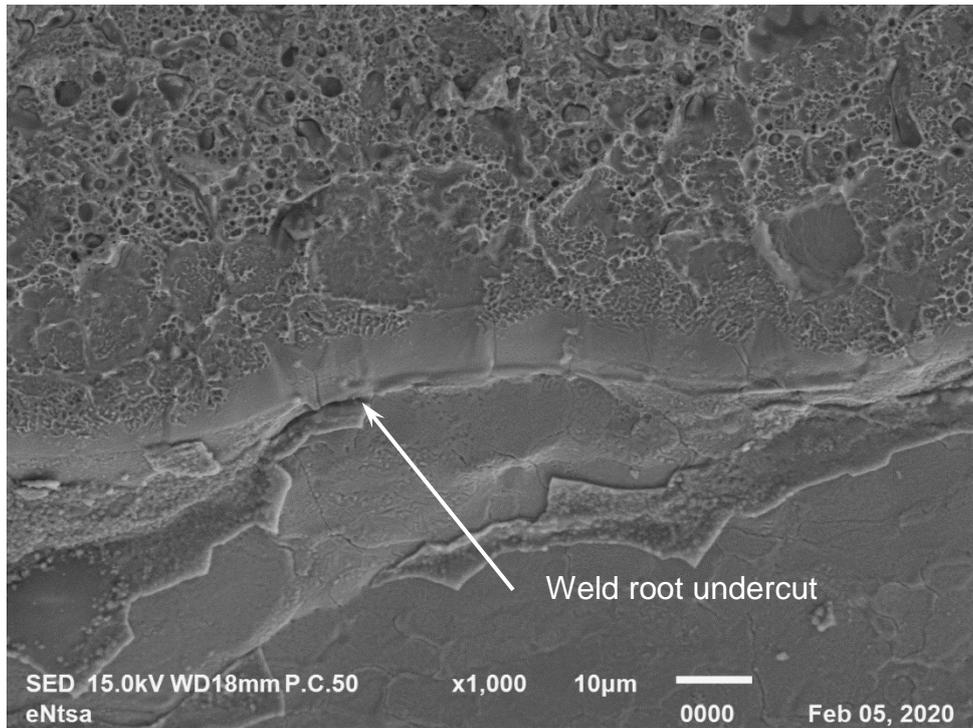
resulting from undercut (marked in the image) and the initial region of the solidification crack. The microvoids reflect the high temperature at which the solidification cracking occurred and their size is likely to be related to the dendritic interstices.

Figure 8 At high magnification the initial part of the fracture shows the partial penetration defect, a sharp weld root intrusion and the initial region of the solidification crack.

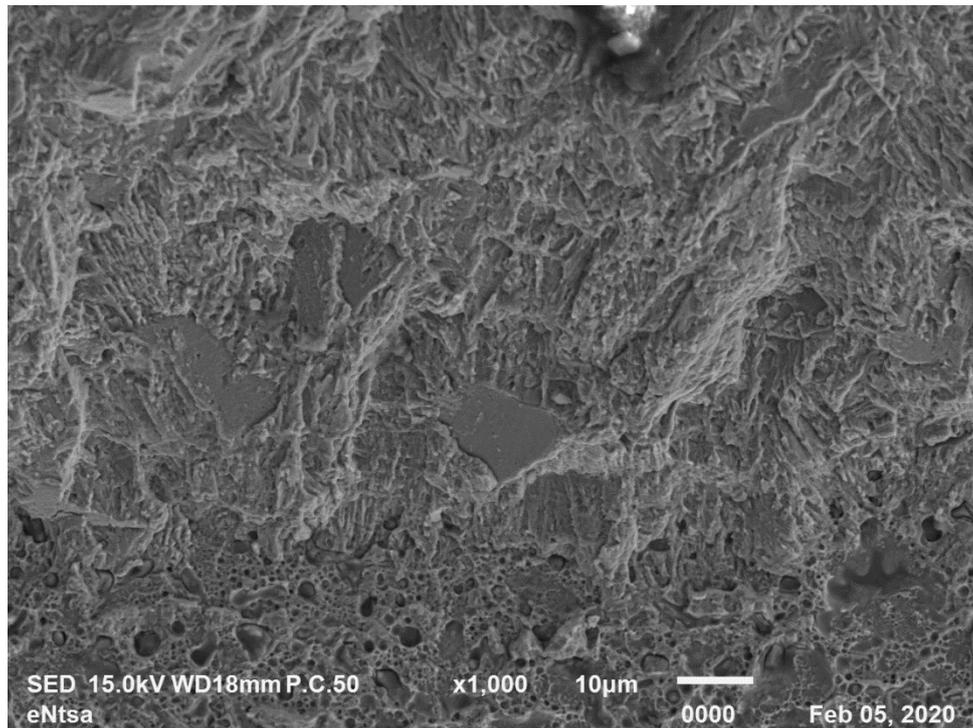
A fatigue mechanism is believed to have caused crack extension through the seam weld thickness during delivery of the water tank to the customer. The tank is never completely filled with water and will experience slosh during the delivery journey, while the very sharp weld toe intrusion crack would require only small applied stresses to grow. It is also possible that a resonance problem existed, where a natural frequency of the tank coincided with the frequency of road-induced vibration. In this respect Figure 9 shows the transition from the initial solidification defect to a fracture mechanism that is typical of slow fatigue crack growth in 300 series austenitic stainless steels, where occasional intergranular facets reflect an environmental component to crack growth e.g. [14].

Figure 9 Transition from the initial solidification crack to a region that has an appearance typical of slow fatigue crack growth in 300 series austenitic alloys.

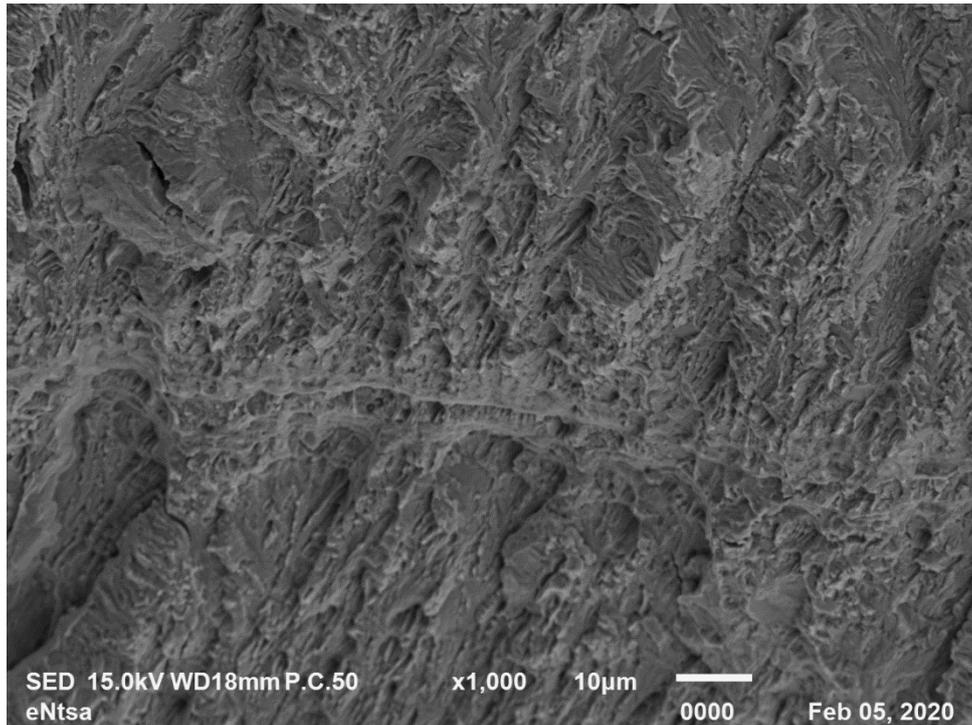
Moving further from the root of the weld, Figure 10 indicates that the fracture surface mechanism changes to one that represents brittle interdendritic fracture, with the possible origin being loads arising from liquid slosh during heavy braking or accelerating, or from significant irregularities in the road surface, e.g. potholes. The beachmarks on the fracture surface (Figures 5 and 6) can therefore be ascribed to a sequence of changes from one interdendritic interface to another. This is proposed to be a result of microfissuring in the interdendritic regions opening up into a crack under strains induced during transportation of the tank [2]. This interdendritic mechanism is clearly seen in Figure 11 at higher magnification and was also the mechanism involved in the crack extension when the screwdriver was inserted into the original crack.

The crack extension from insertion of a screwdriver into the initial leaking fissure reflected the extensive interdendritic solidification microfissuring across the throat of the weld (Figures 10 and 11).

Figure 10 Brittle interdendritic fracture comprises the bulk of the fracture surface, reflecting microfissuring that opens up into a macro-crack under applied strain.

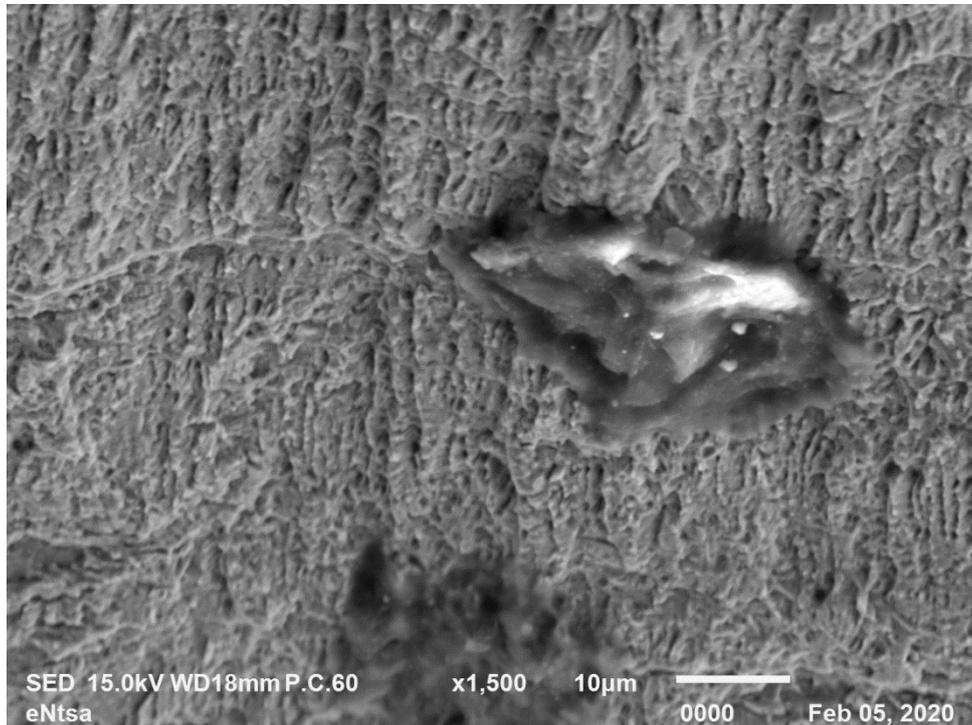
Figure 11 The mechanism of interdendritic fracture can be clearly seen in this image.

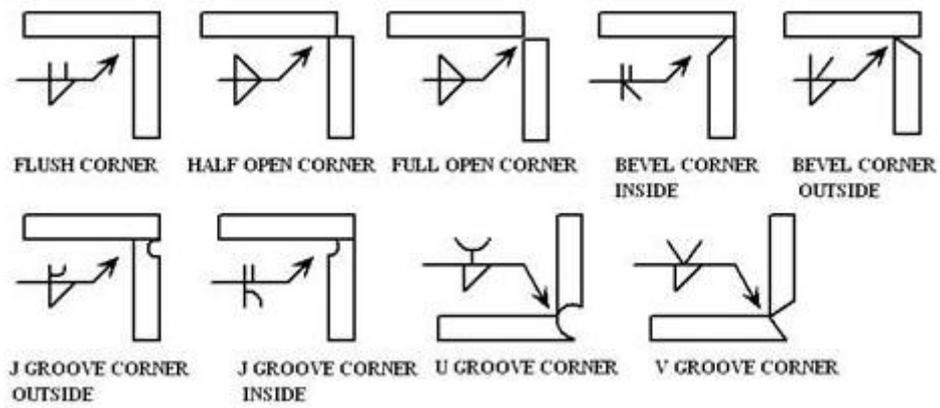
Guidance on GTAW of common welded joints is widely available on the internet, e.g. [15] and the full-open or half-open corner joint that was used for the failed seam weld (illustrated in Figure 12), although simple, requires some attention in terms of fit-up. According to the guide in reference [15] open corner joints demand precise fixturing because of the shallow joint depth and the ease with which the edge of the material melts. Stainless steel open corner joints are particularly susceptible to warping and tack welds may be required at a spacing ~50-75 mm in thin material to maintain a consistent joint. There was no evidence of such tack welds being used in the present case.

Figure 12 Types of corner joint edge preparation, illustrating the full-open or half-open corner joint that was used for the failed seam weld
