# Weld Solidification Cracking in a 304L Stainless Steel Water Tank

M N James<sup>1,2</sup>, L Matthews<sup>2</sup> and D G Hattingh<sup>2</sup>

*Abstract:* Type 304L stainless steel alloy is known to be highly resistant to solidification cracking. In the present case the particular design of the welded seams in a simple 200 litre water tank, along with the likely manner in which the closing welds were made, has led to an interesting example of interdendritic hot cracking in 304L GTA welded using a 309L filler metal. The paper presents a short introduction to hot cracking in austenitic stainless steels and uses the fractographic evidence to demonstrate that this form of cracking has occurred. The cracking has occurred primarily from excessive residual restraint stresses arising from weld -fit-up and welding practice, combined with the particular sequence of welds made in finally closing the tank.

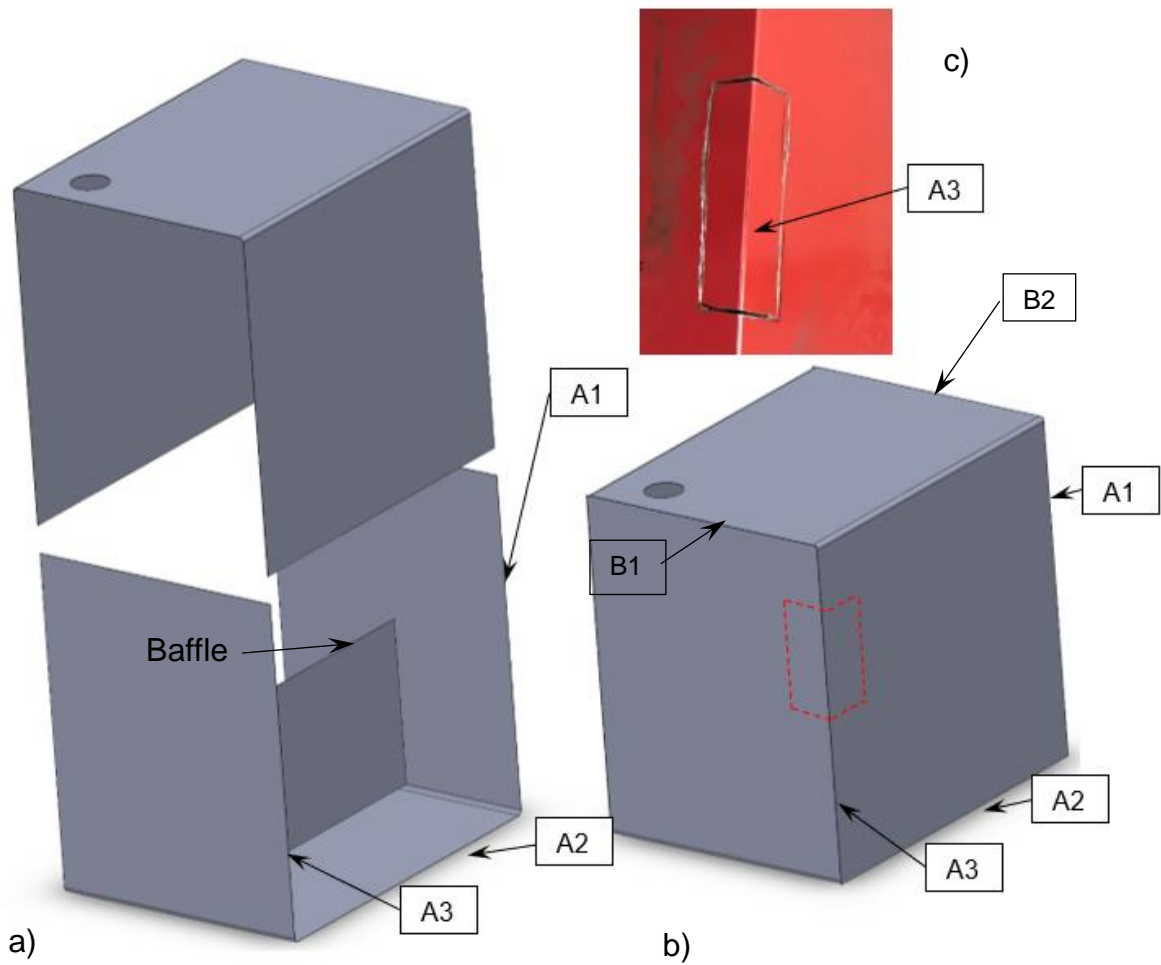
The welded seams on one side of the tank are marked with the letters 'A1' to 'A3' with the welding sequence apparently following A1 → A2 → A3. Welding on the opposite side presumably followed an equivalent sequence and closure of the tank was accomplished via welds B1 and B2. The crack origin was approximately in the centre of one of the 640 mm sides, as shown with the red dotted shape in Figure 1b and the arrow in Figure 1c. The hole shown in the top surface is where the filling valve for the tank is located and there is an internal baffle plate that extends to the half-height position. This baffle plate was tack welded on the

vertical sides and bottom of the tank, but free on the top surface. The baffle plate welding showed that tank closure had been achieved by making the welds A1, A2 and A3, probably continuously in that order. Hence a considerable restraint on the seam weld A3 would have arisen during solidification from the residual stresses induced during cooling by this welding sequence.

Figure 1 Illustrations of the water tank and its design; welding of the two sections occurred in the sequence of A1 → A2 → A3:

- a) An exploded view of the two tank sections that were bent to form 'U'-shapes and were then welded together to make the tank. The position of an internal baffle is also shown.
- b) The assembled water tank showing the position where seam cracking was found (red dotted rectangle on corner A3).
- c) The actual sample that was sectioned from the tank for further analysis.

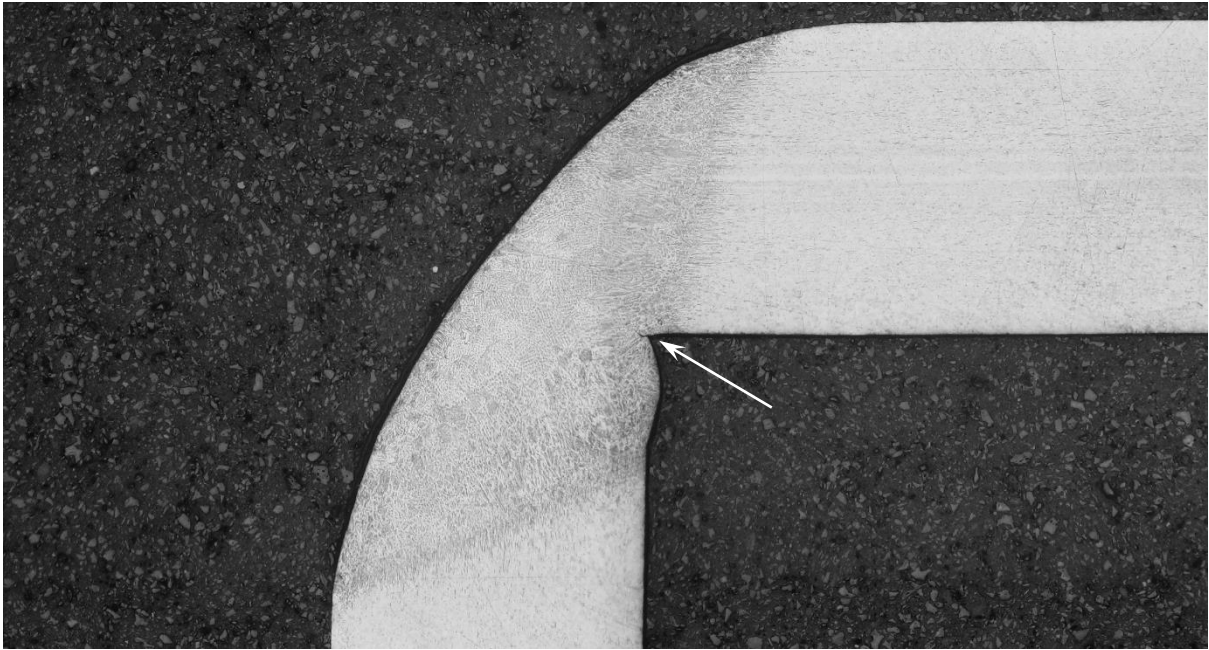
A piece of the weld seam, some 200 mm in length, that contained the complete fracture was sectioned from the failed joint (shown in Figure 1c). An adjacent piece was also cut out to allow measurement of the reduction in plate cross-section arising from the corner grinding. Figure 2 shows that this cosmetic attention to detail reduced the metal thickness at the critical weld root position, which coincides with the presence of a small crack, from 2.04 mm to 1.34 mm, equivalent to a reduction of 34%. The sharp weld root and its associated defect is shown at higher magnification in Figure 3. The defect has a total length of around 100  $\mu\text{m}$ . It started from a partial penetration defect (A), and comprises a sharp weld toe intrusion (B) and a final section of cracking that occurred during welding (C). The blue and straw yellow temper colours seen in Figure 4 prove that the initial crack extension occurred during welding and that it is therefore due to an embrittlement problem. Figure 3 indicates that the cracking occurring during welding was assisted by the presence of a sharp weld toe intrusion resulting from undercut at a partial penetration weld.

Figure 2 Macro-etched section of the seam weld that cracked, showing the reduction in thickness at the critical region where there is a small weld root crack (marked with the arrow).

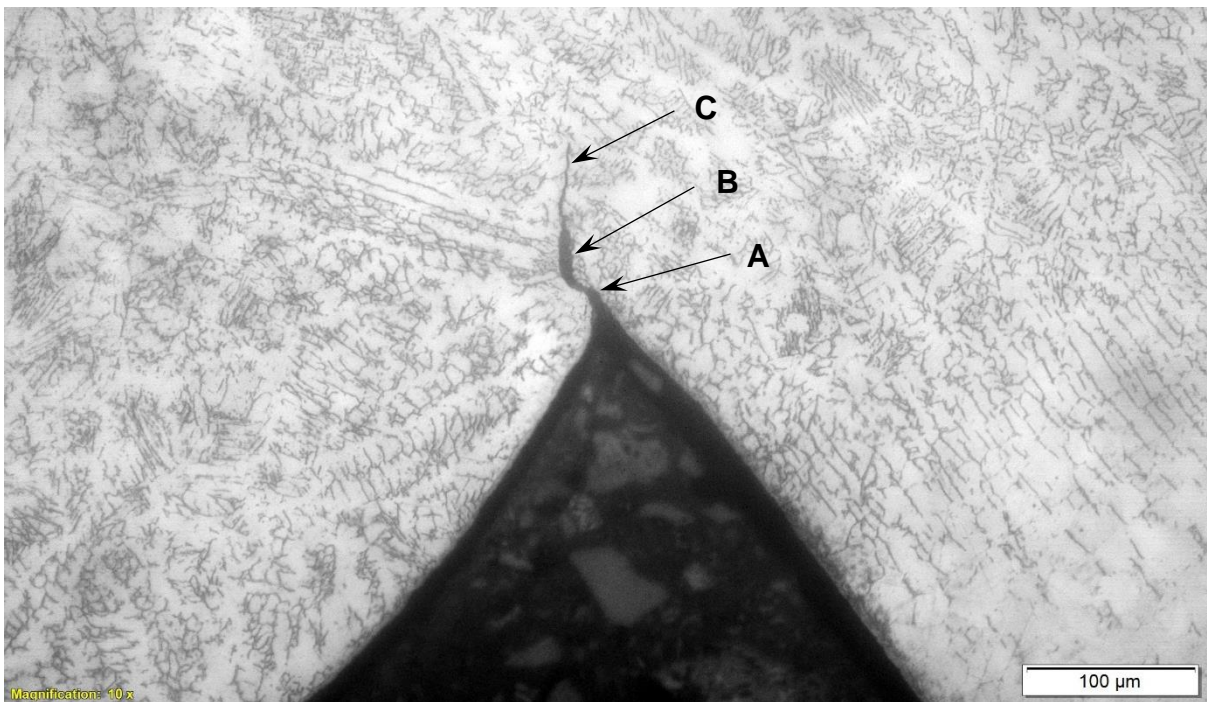
Figure 7 shows an scanning electron microscopy (SEM) fractograph of the complete fracture surface for comparison with the light fractograph in Figure 6 and to approximately locate the position of subsequent images of the fracture mechanisms. An arrow marks the same inclusion in both Figures 6 and 7. Figure 8 depicts the initial part of the fracture surface (seen in section in Figure 3) which contains the partial penetration defect, a sharp weld root intrusion

resulting from undercut (marked in the image) and the initial region of the solidification crack. The microvoids reflect the high temperature at which the solidification cracking occurred and their size is likely to be related to the dendritic interstices.

Figure 3 Higher magnification image of the weld root crack induced during welding. The crack has a total length of around 100 μm. It starts from a partial penetration defect (A), and comprises a sharp weld toe intrusion (B) and a final section of solidification cracking (C).

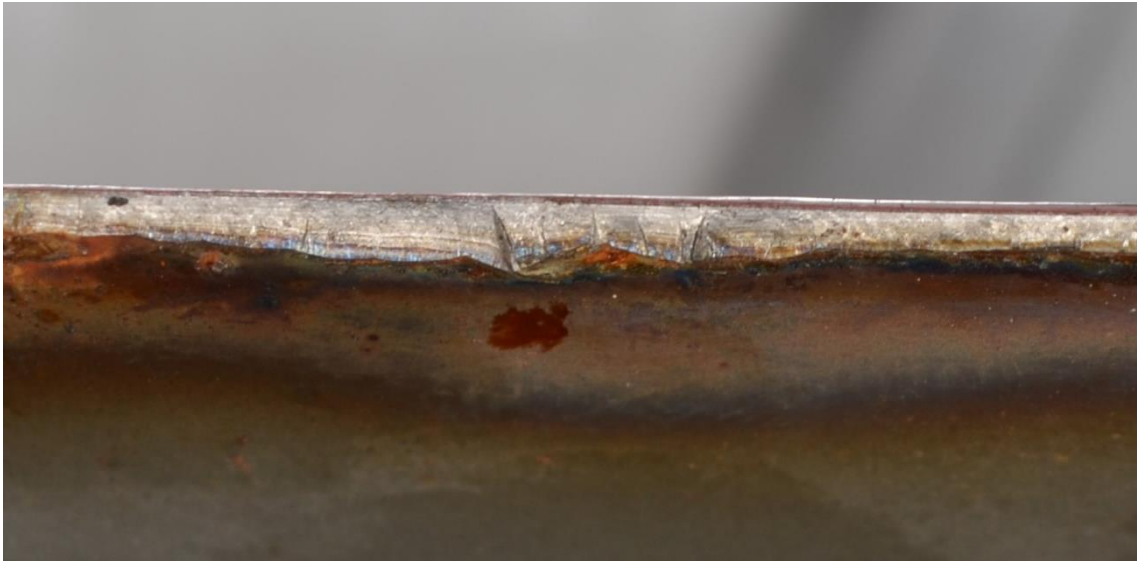
The throat of the weld should be at least the thickness of the parent plate and a fast travel speed is required to avoid melt-through to the inside corner. However, a fast travel speed is likely to result in a lower heat input per millimetre and a faster cooling of the joint which can then trigger solidification cracking. The torch angle should bisect the angle formed by the two pieces of metal to be joined in order to apply equal heat to both sides of the joint. As can be seen in Figure 2, the heat input does not appear to be uniform in the two sides of the joint and this has led to the sharp lack-of-penetration defect, associated weld root undercut and the resultant solidification cracking from a combination of high joint restraint and fast cooling (Figure 4).

Figure 4 The fracture surface showing evidence of blue and straw temper colours, proving that the crack originated as a hot crack during solidification.

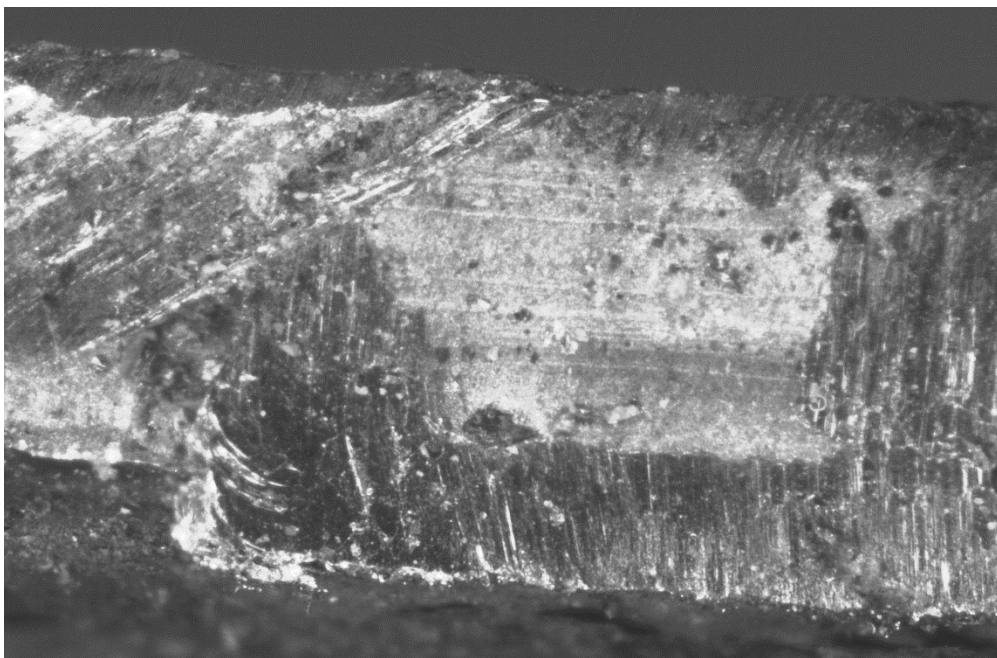
Part of the fracture surface containing the original through-thickness crack (indicated by screwdriver damage on the fracture surface – Figure 5) was sectioned from the larger specimen, cleaned and mounted for fractographic examination with stereo binoculars and with a scanning electron microscope. Low magnification inspection using stereo binoculars showed that a number of beachmarks were present both in the region of the initial water leak (Figure 5) and more generally along the fracture (Figure 6). The considerable number of beachmarks through the thickness indicates that their formation cannot be due only to a change in fracture mechanism from the pre-existing solidification crack to subsequent fatigue crack growth and/or fast fracture.

Figure 5 Beachmarks present on the fracture surface at the site of the original water leak, whose position was identified from the surface damage (seen here) inflicted by insertion of the screwdriver.

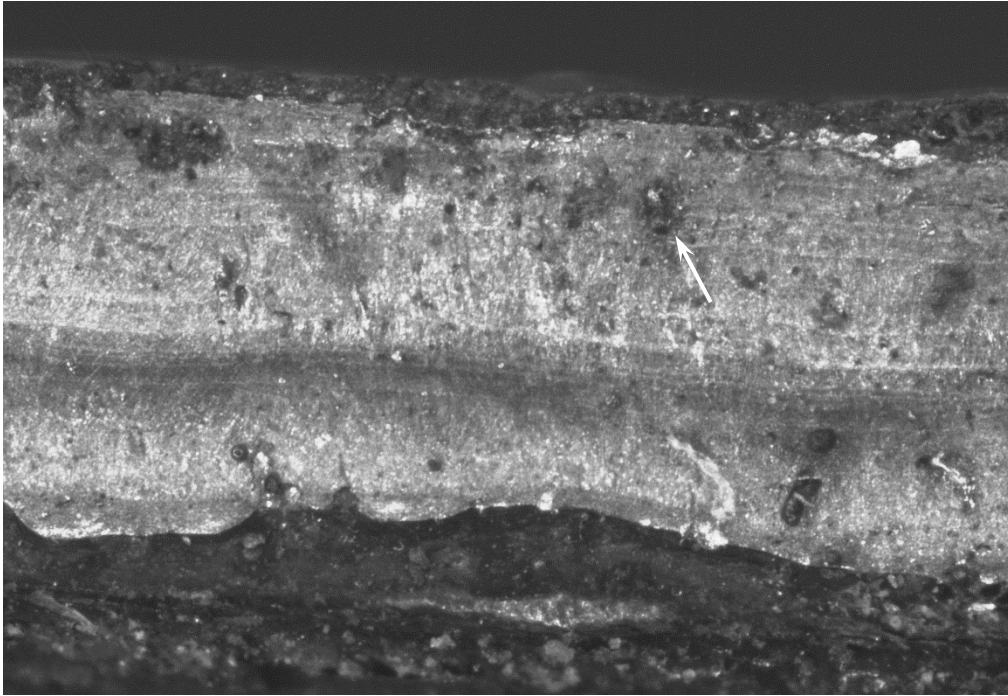
Figure 6 The beachmarks were present all along the fracture surface and therefore reflect influences other than mechanism changes.

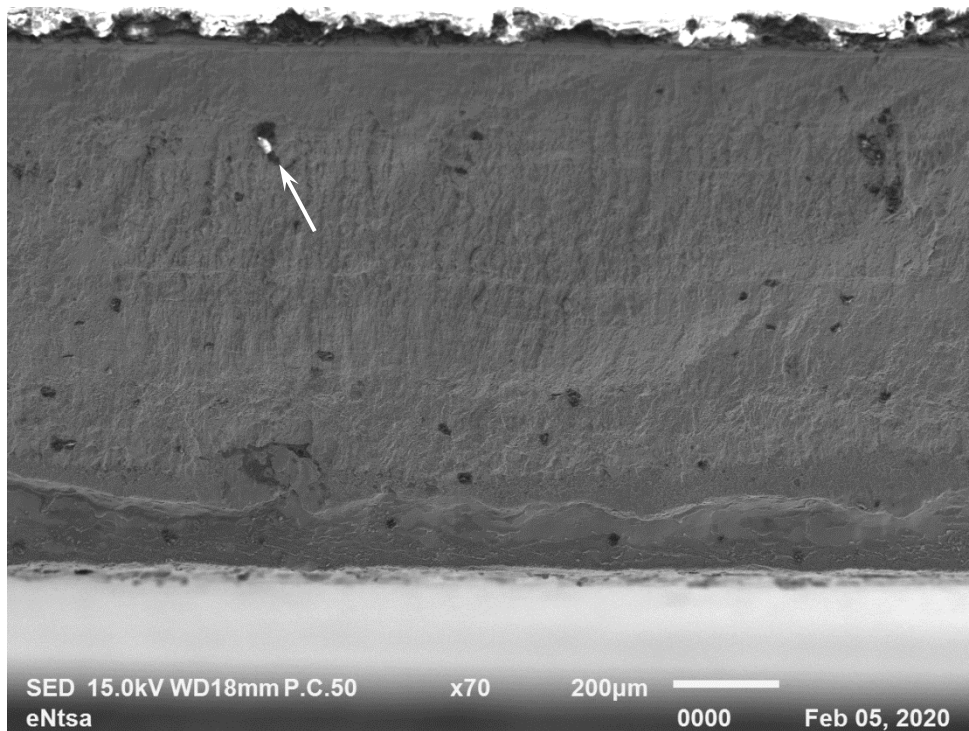
Figure 7 Low magnification SEM image of some of the region shown in Figure 5, with the weld root at the bottom of the image. The arrows in the two figures mark the same inclusion.

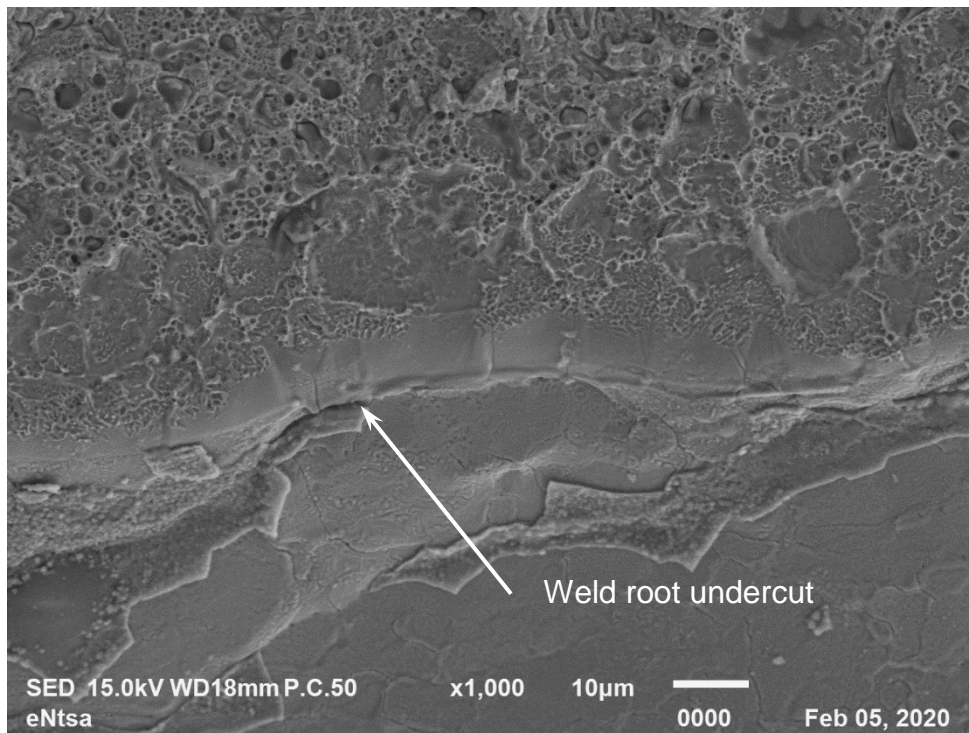
Figure 8 At high magnification the initial part of the fracture shows the partial penetration defect, a sharp weld root intrusion and the initial region of the solidification crack.

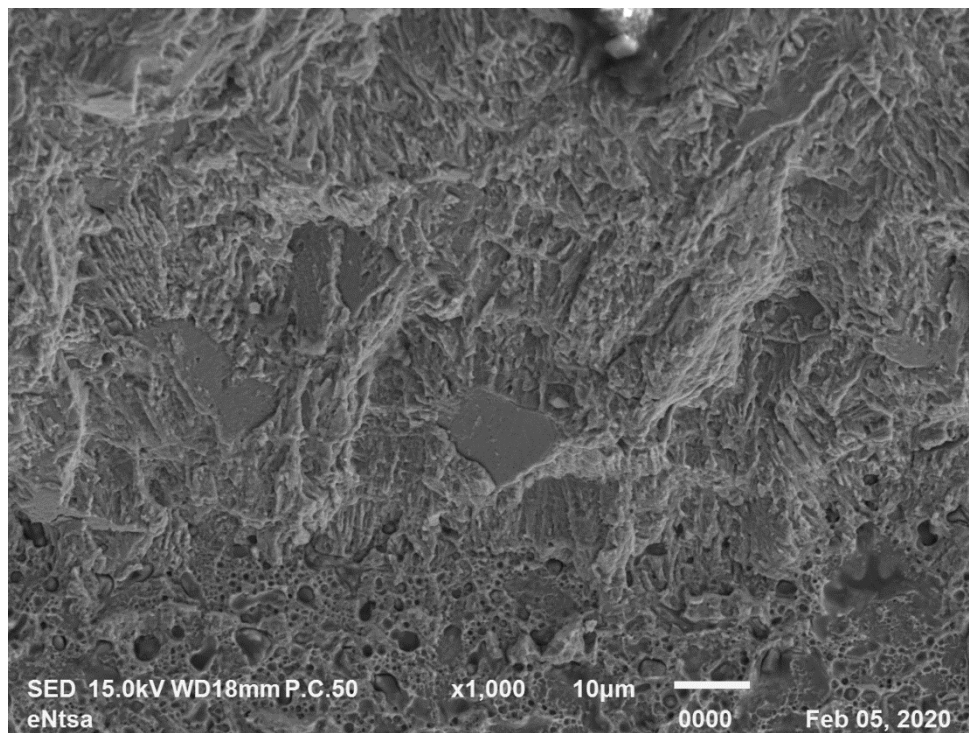
A fatigue mechanism is believed to have caused crack extension through the seam weld thickness during delivery of the water tank to the customer. The tank is never completely filled with water and will experience slosh during the delivery journey, while the very sharp weld toe intrusion crack would require only small applied stresses to grow. It is also possible that a resonance problem existed, where a natural frequency of the tank coincided with the frequency of road-induced vibration. In this respect Figure 9 shows the transition from the initial solidification defect to a fracture mechanism that is typical of slow fatigue crack growth in 300 series austenitic stainless steels, where occasional intergranular facets reflect an environmental component to crack growth e.g. [14].

Figure 9 Transition from the initial solidification crack to a region that has an appearance typical of slow fatigue crack growth in 300 series austenitic alloys.

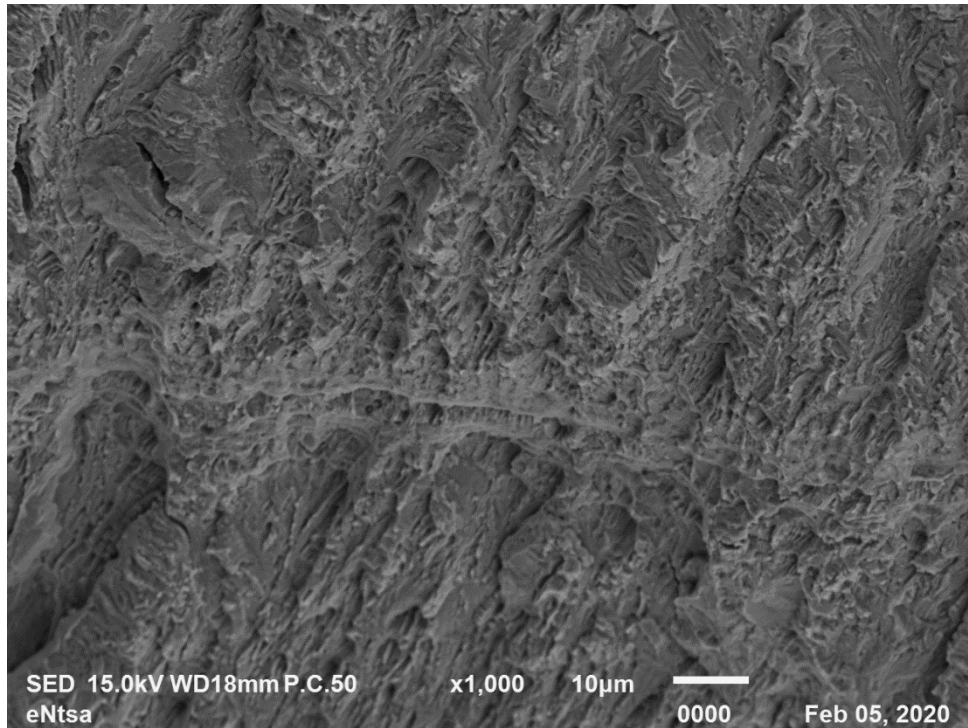
Moving further from the root of the weld, Figure 10 indicates that the fracture surface mechanism changes to one that represents brittle interdendritic fracture, with the possible origin being loads arising from liquid slosh during heavy braking or accelerating, or from significant irregularities in the road surface, e.g. potholes. The beachmarks on the fracture surface (Figures 5 and 6) can therefore be ascribed to a sequence of changes from one interdendritic interface to another. This is proposed to be a result of microfissuring in the interdendritic regions opening up into a crack under strains induced during transportation of the tank [2]. This interdendritic mechanism is clearly seen in Figure 11 at higher magnification and was also the mechanism involved in the crack extension when the screwdriver was inserted into the original crack.

The crack extension from insertion of a screwdriver into the initial leaking fissure reflected the extensive interdendritic solidification microfissuring across the throat of the weld (Figures 10 and 11).

Figure 10 Brittle interdendritic fracture comprises the bulk of the fracture surface, reflecting microfissuring that opens up into a macro-crack under applied strain.

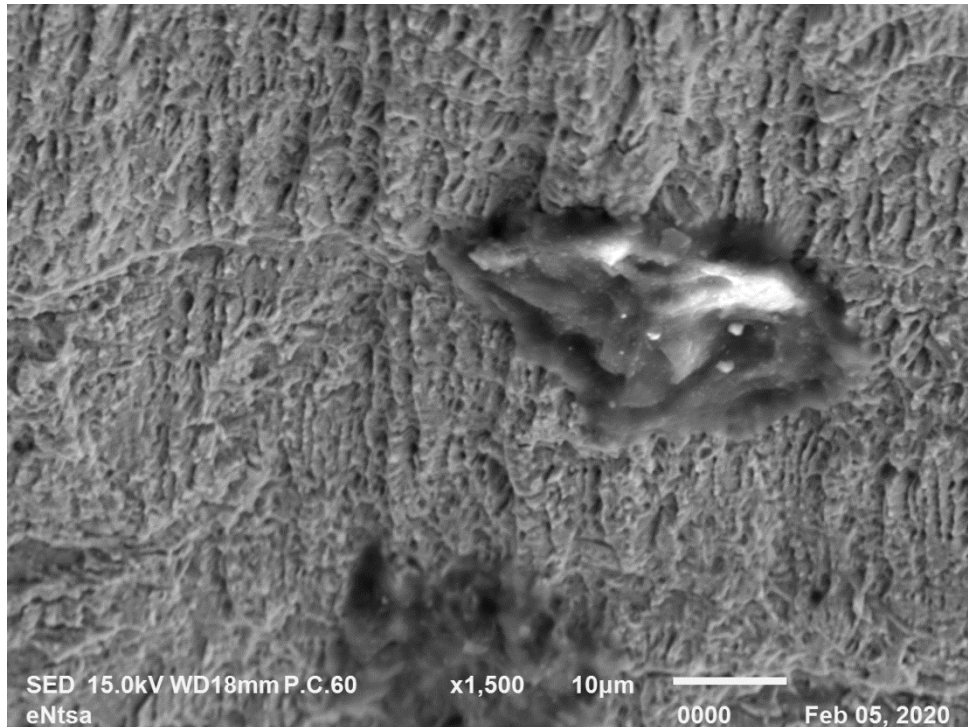
Figure 11 The mechanism of interdendritic fracture can be clearly seen in this image.

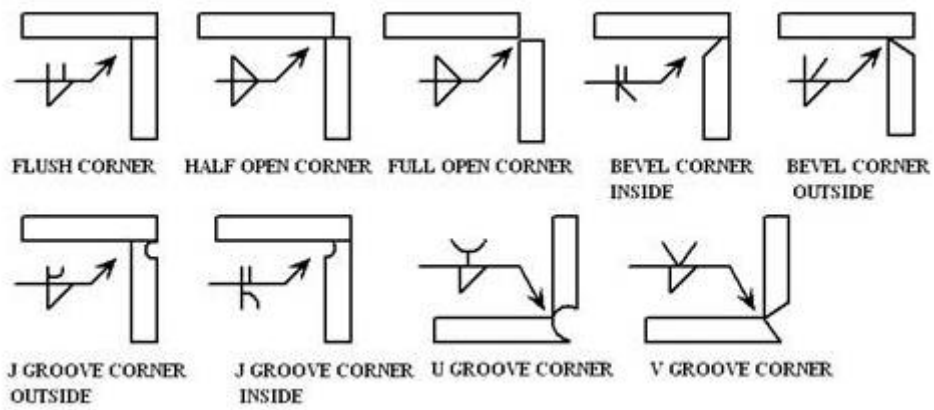
Guidance on GTAW of common welded joints is widely available on the internet, e.g. [15] and the full-open or half-open corner joint that was used for the failed seam weld (illustrated in Figure 12), although simple, requires some attention in terms of fit-up. According to the guide in reference [15] open corner joints demand precise fixturing because of the shallow joint depth and the ease with which the edge of the material melts. Stainless steel open corner joints are particularly susceptible to warping and tack welds may be required at a spacing ~50-75 mm in thin material to maintain a consistent joint. There was no evidence of such tack welds being used in the present case.

Figure 12 Types of corner joint edge preparation, illustrating the full-open or half-open corner joint that was used for the failed seam weld

A change in welding practice should resolve this problem, although a redesign of the tank could also be undertaken utilising, for example, rolled plate with a single butt weld joint and a flanged approach to attaching top and bottom pieces. These could then be either bolted or employ an edge weld on the flanged corner.
