Embrittlement failure of 51CrV4 leaf springs

<http://hdl.handle.net/10026.1/19406>

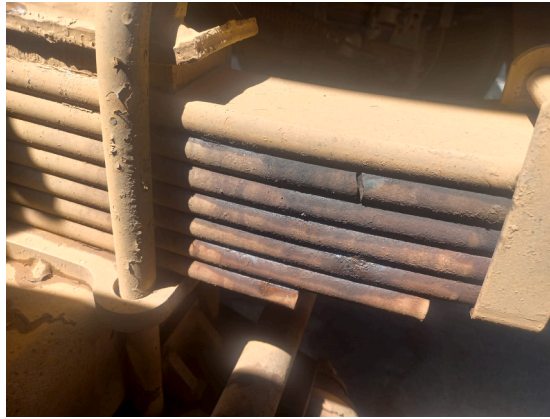
Fig. 1. The failures occurred in the second master leaf, equally distributed on either the left or right side leaf springs, with the fractures occurring either ahead of the axle (40%) or behind it (60%).

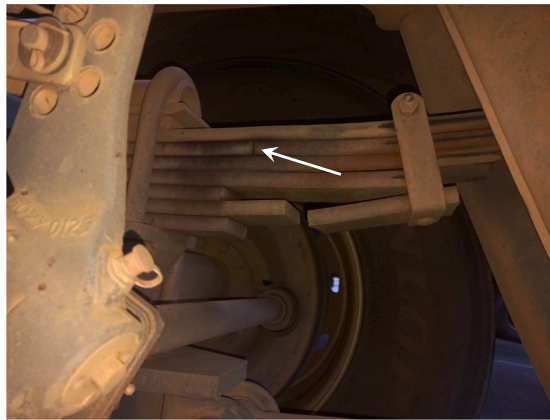
Fig. 2. In this spring assembly the first fracture in the second master leaf (arrow) has weakened the springs so that plastic deformation has occurred in the third and fourth leaves, and this has caused fracture in the fifth leaf.

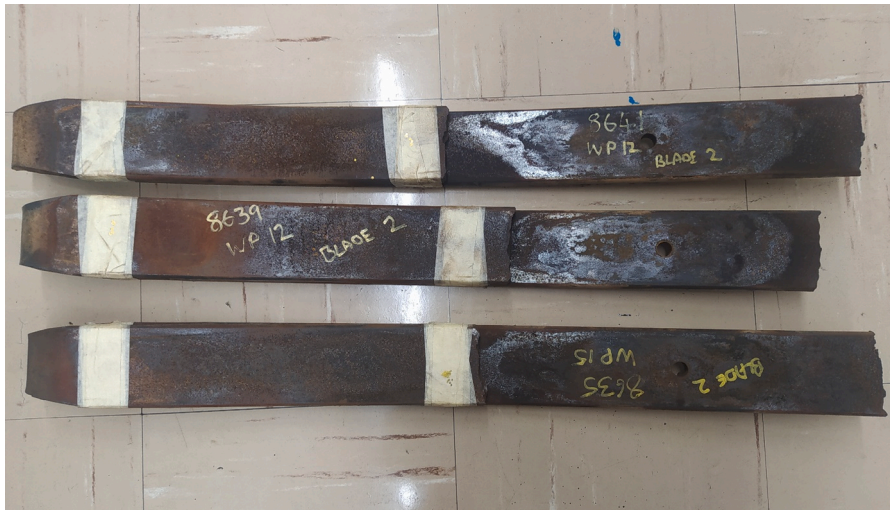
Fig. 3. The three fractured leaf springs delivered for investigation. The two halves are taped together in each case and are shown with the tension side up.

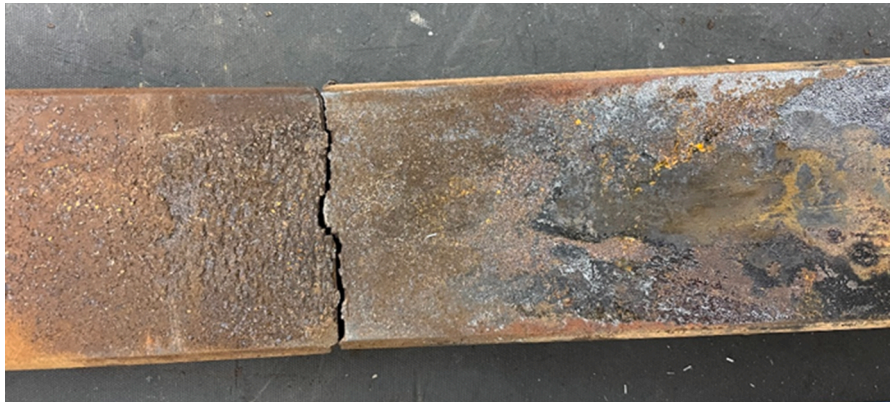
Fig. 4a. There is a significant amount of corrosion present on the tension surface of the fractured leaves, and the fracture surfaces are unusually jagged for a fatigue fracture.

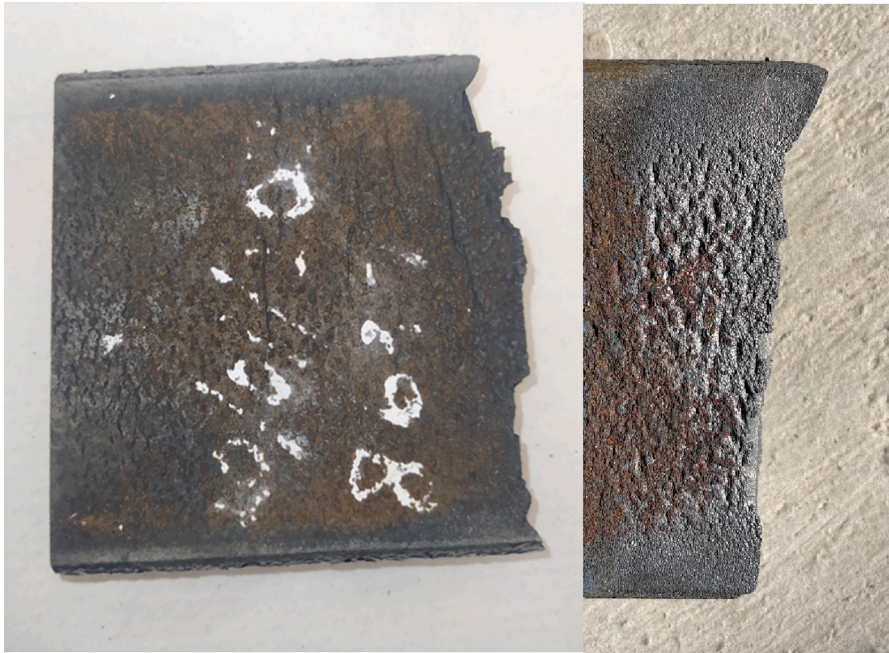
Fig. 4b. A colony of surface cracks can be seen on the tension surface, running parallel with the fracture surface. The image shows two different fracture surfaces and the one on the right has been derusted in dilute nitric acid.

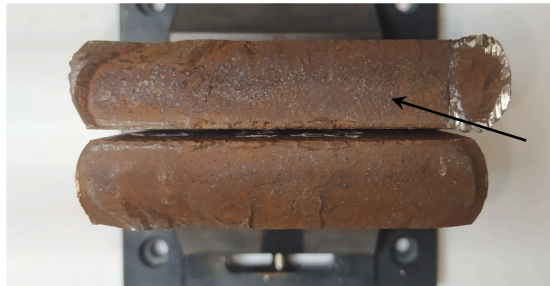
Fig. 5. As-received fracture surfaces from the fractured spring that was chosen for a detailed fractographic and metallographic investigation. The arrow indicates the surface that was chosen for detailed fractography.

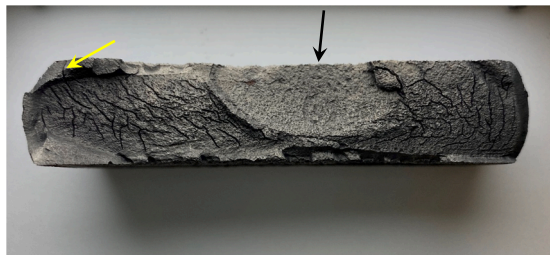
Fig. 6. After cleaning, a network of cracks can be seen on the fracture surface and these were proven to be cracks using scanning electron microscopy. The failure mechanism is clearly fatigue and there are several initiation sites, with the main one indicated with the black arrow.

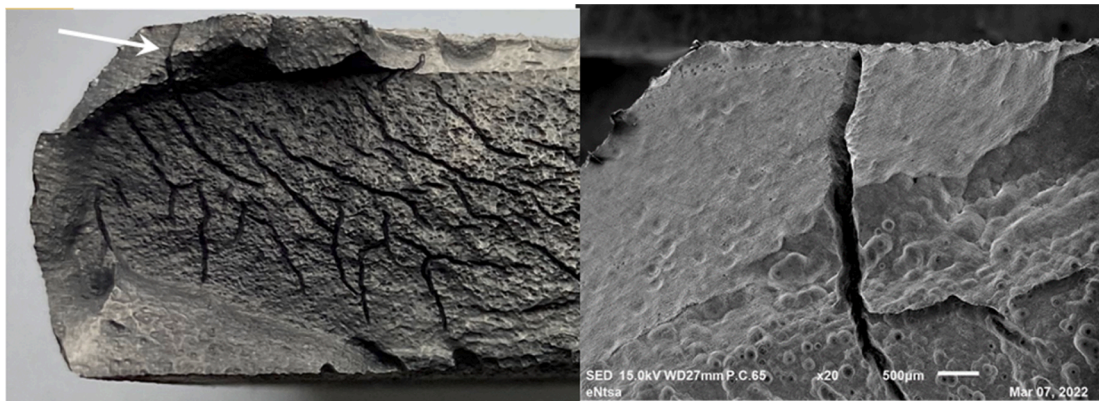
Fig. 7. This SEM image shows that the dark lines are, in fact, cracks and the crack shown is marked with the yellow arrow in Fig. 6. (For interpretation of the references to colour in this figure legend, the reader is referred to the web version of this article.)

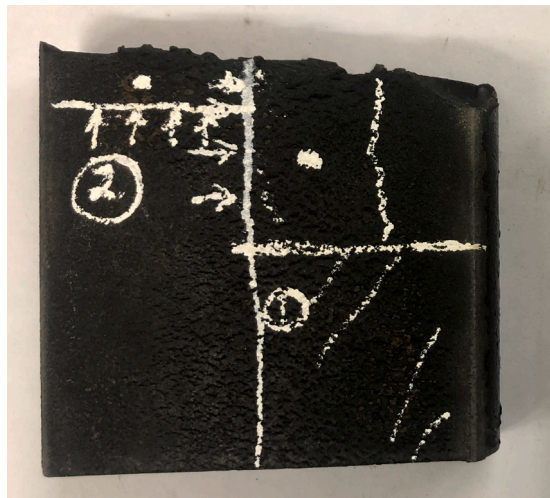
Fig. 8. Metallographic sections were cut perpendicular to the fracture surface (marked as 1), to sample the colony of surface cracks, and parallel with the fracture surface (marked as 2).

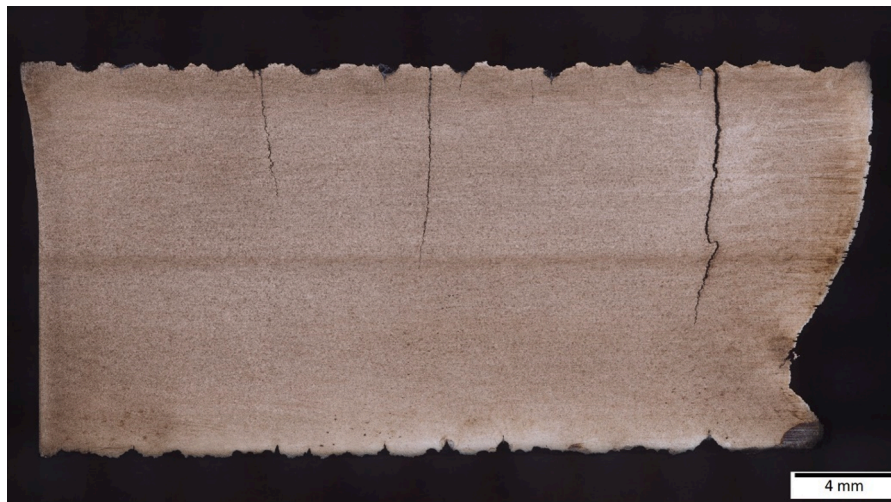
Fig. 9. This macro-etched section in the plane of specimen 1 shows the severe surface pitting corrosion in the region adjacent to the fracture, and a series of cracks which decline in size with distance from the fracture surface. Cracks have initiated at virtually every corrosion pit in this region.

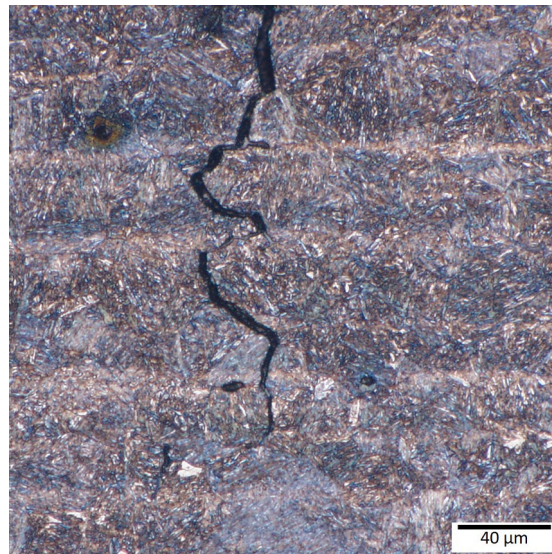
Fig. 10. Examination at higher magnification reveals the expected quenched and tempered martensitic microstructure, demonstrate that the cracks are intergranular and branched and may not extend to the surface, at least in this plane. 305x magnification.

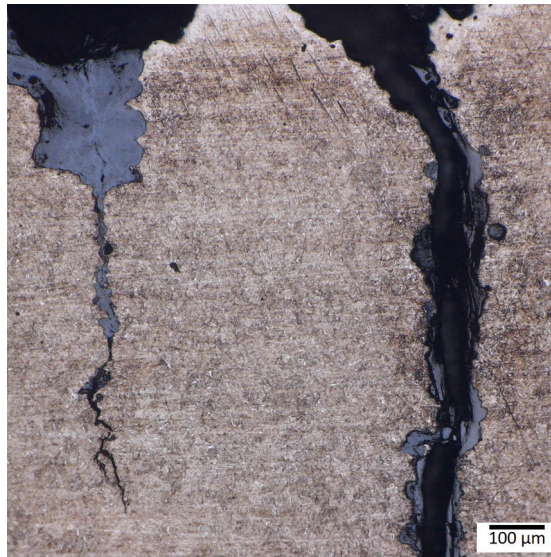
Fig. 11. Cracks have initiated from corrosion pits and have oxide extending significant distances down them. 277x magnification.

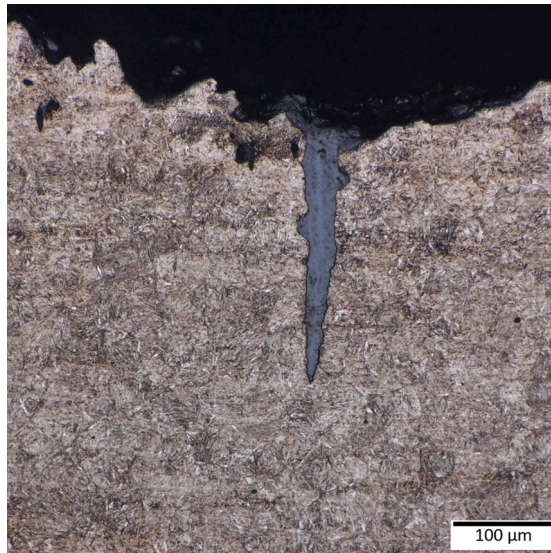
Fig. 12. No evidence of any surface decarburization was seen and the microstructure is clearly tempered martensite in this image at 500x magnification.

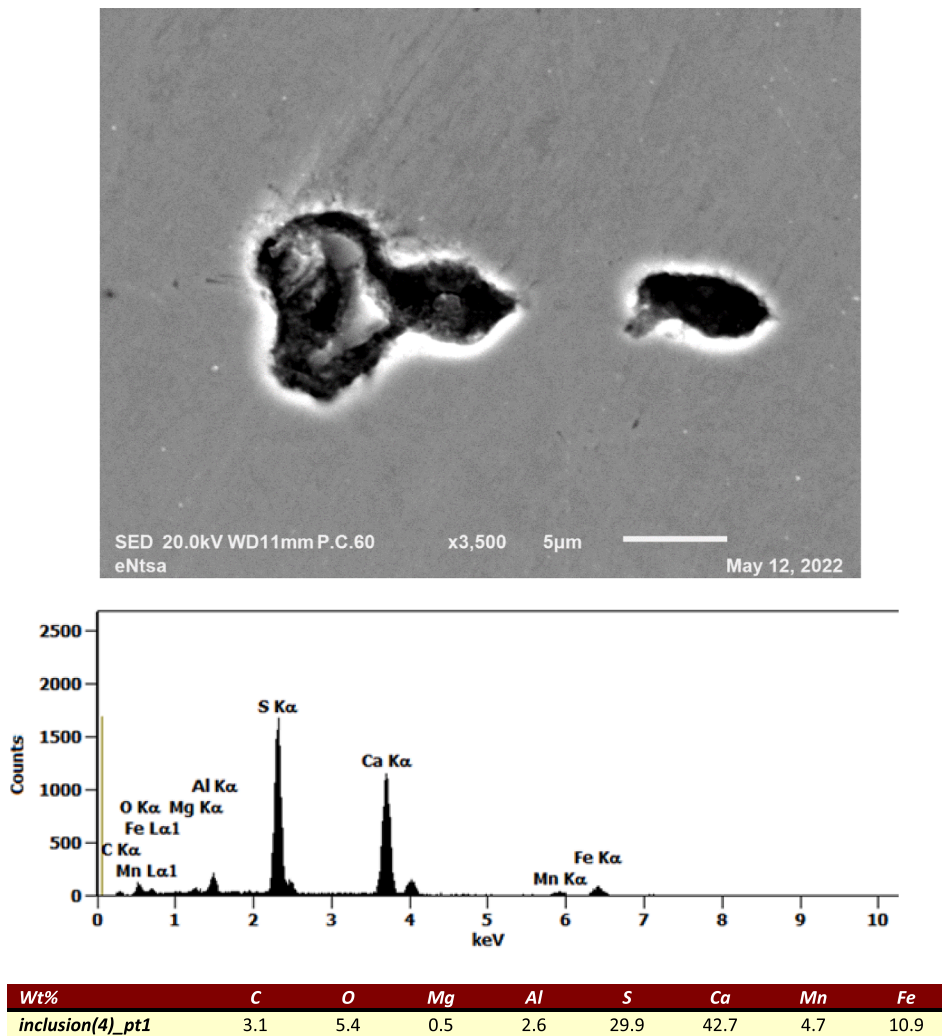
Fig. 13a. Typical high Ca and high S spectrum observed on a number of small inclusions in the 51CrV4 steel.

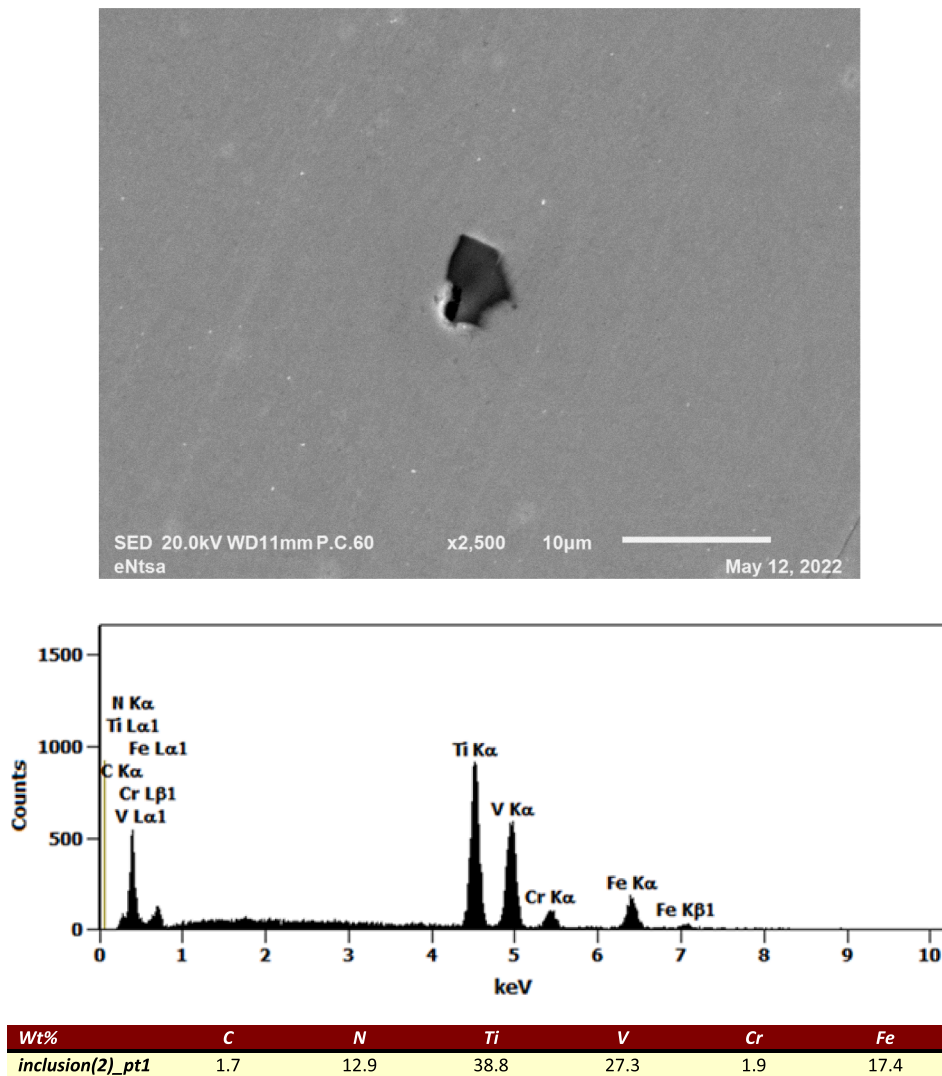
Fig. 13b. Typical high Ti and high V spectrum observed on some small inclusions in the 51CrV4 steel.
