# Damage assessment and refurbishment of steam turbine blade/rotor attachment holes

# Damage Assessment and Refurbishment of Steam Turbine Blade/Rotor Attachment Holes

D G Hattingh <sup>\*1</sup>, M N James <sup>\*1,2</sup>, M Newby <sup>3</sup>, R Scheepers <sup>3</sup> and P Doubell <sup>3</sup>

This paper presents a case study dealing with the assessment of cracking observed at steam turbine blade attachment holes, and subsequent use of an innovative repair solution based on a friction processing technique, friction hydro-pillar processing (FHPP). This was performed with a bespoke welding platform developed specifically for repair of radially cracked or incorrectly drilled blade attachment holes in LP turbine rotors. The paper initially outlines a fracture mechanics analysis of observed in-service cracking aimed at assessing critical defect sizes to support repair or replacement scenarios. It then briefly discusses development of the FHPP process before focusing on characterisation of the residual stresses resulting from the welding process and their amelioration by heat treatment; a necessary part of the procedure approval for turbine refurbishment.

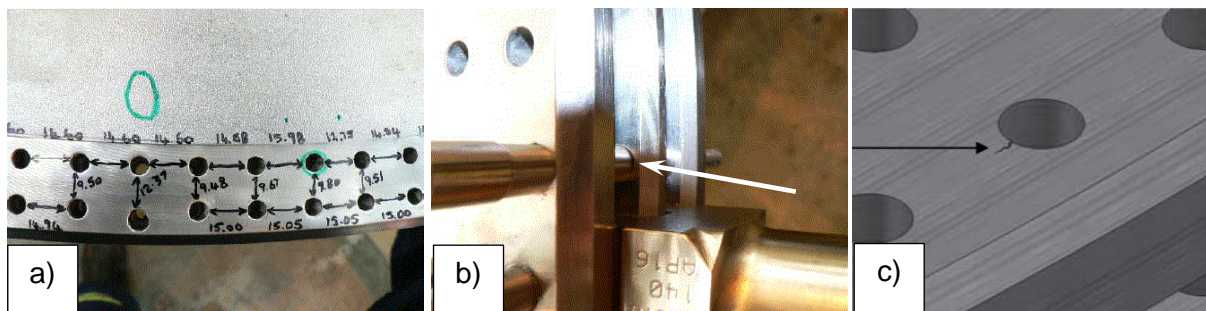
The South African power generation utility, Eskom, has experienced occasional instances of misaligned drilling, attachment hole ovality and fatigue or stress corrosion cracking at finger blade attachment holes on LP turbine rotors. The particular rotors under consideration have three attachment fingers and magnetic particle inspection is used to identify initial defect indications in-situ, with further investigation utilising ultrasonic or eddy current inspection with the blades removed. Condition monitoring of these rotors can be difficult if cracks exist at the hole in the central finger, even when the blade is removed. Where such defects have been detected, their influence on blade dynamic response and life is typically assessed using 3D finite element modelling to determine the stresses in each of the six attachment holes (two on each prong) seen in Figure 1. This can be combined with a fracture mechanics analysis to obtain values of stress intensity factor under various operating conditions as a function of crack size and position. This type of analysis allows the operator to decide whether immediate repair or replacement of the disc (or blades) is necessary, and to schedule remedial work and set inspection intervals if the rotor can continue in operation.

Figure 2 Exemplars of a) attachment hole misalignment; b) hole ovality (marked with the arrow which identifies a slight gap between pin and hole in the centre attachment finger of the blade); c) radial cracking.

In the case study presented here the decision was made to repair the attachment holes and Figure 2 shows the type of defects which can be repaired by welding and that are well suited to use of the friction hydro-pillar processing (FHPP) technique.

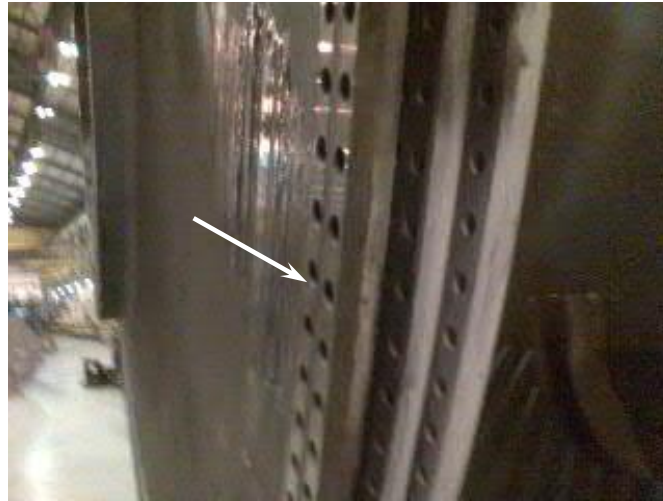
Figure 3 Typical stage 1 steam turbine shrunk-on disc showing pinned finger root design with three prongs and two rows of pinholes (lower row indicated by arrow).

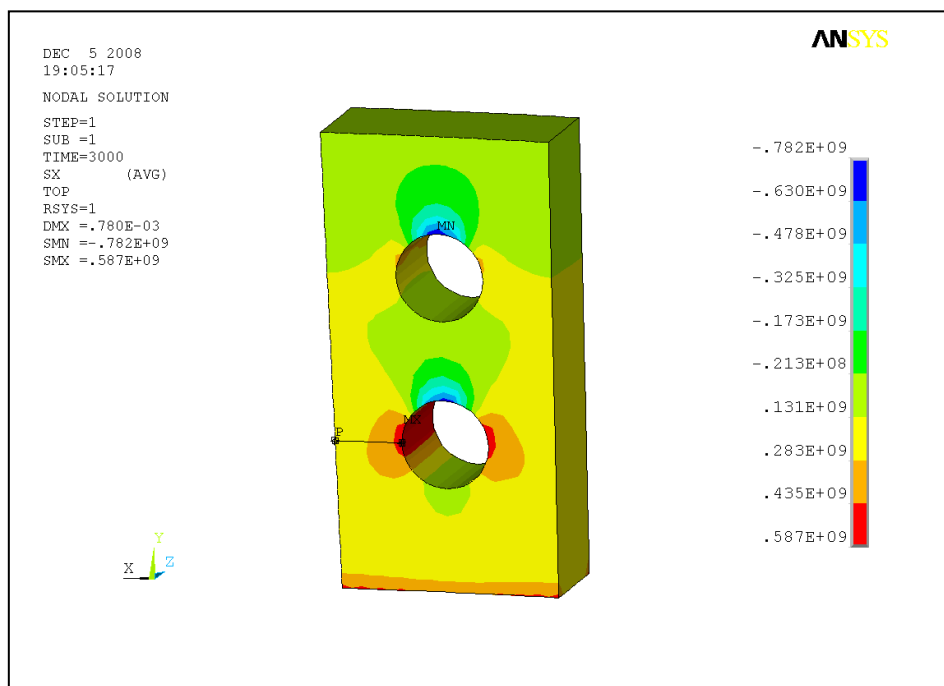
throughout. Finite element analysis (FEA) of the 'as-designed' case indicated that the 1<sup>st</sup> principal stress for the disc rim is in the radial direction with peaks at the 2 - 3 o'clock and 9 - 10 o'clock positions on the bottom pinhole on the central prong (Figure 4). This was in good agreement with the initiation position and propagation direction (circumferential) observed on the cracked disc from MT testing.

Figure 4 Radial stress distribution for the centre prong of a stage 1 steam turbine disc showing peak stress at the bottom pinhole.

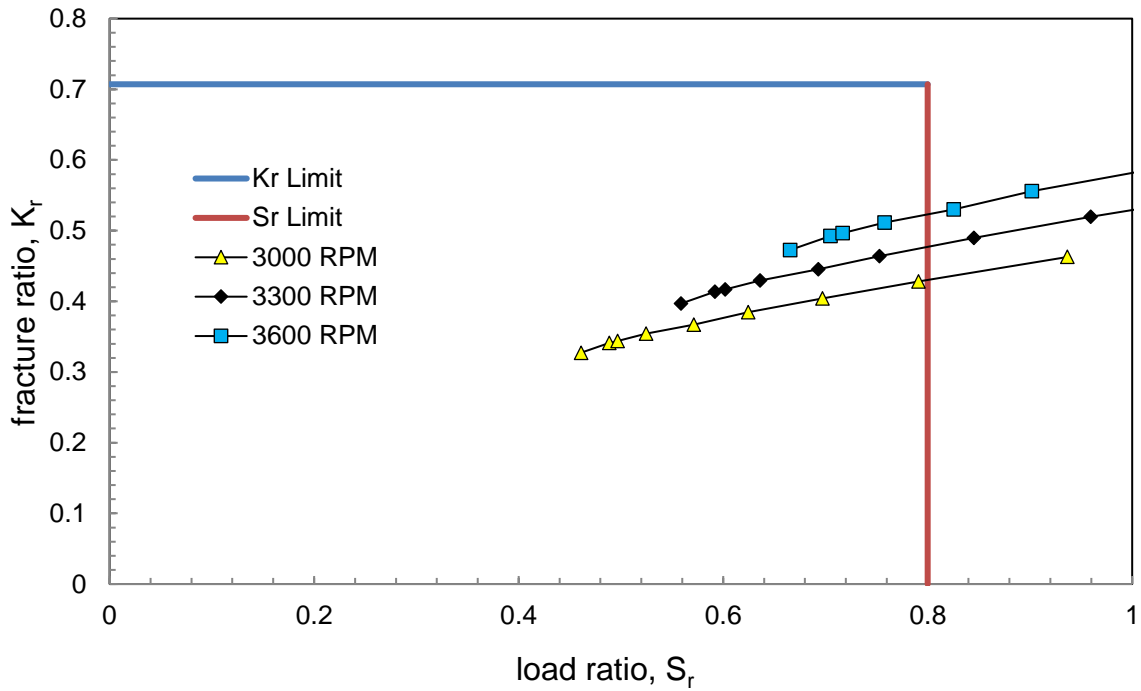
The fracture mechanics analysis has two stages, with the first involved in assessing the possibility of brittle fracture under the assumed defect size for several operating scenarios, while the second considers the possibility of continued crack growth and aims to determine the duration of further safe operation. For a through-prong SCC crack at the 2 o'clock position with a length from the hole edge of 8 mm, FEA calculations gave a value of the applied stress intensity factor for an operating speed of 3,000 rpm to be 38 MPa√m. The hypothetical worst case considered was an overspeed incident to 3,600 rpm at room temperature. Here the applied stress intensity will reach 54 MPa√m which is still well below the room temperature toughness of the material (expected to be in the order of 142 MPa√m) and hence the fracture toughness analysis demonstrated the required defect tolerance to cracks of the detected size.

Figure 5 Failure Assessment Diagram (FAD) for SCC crack propagating from a 36 mm initial length.

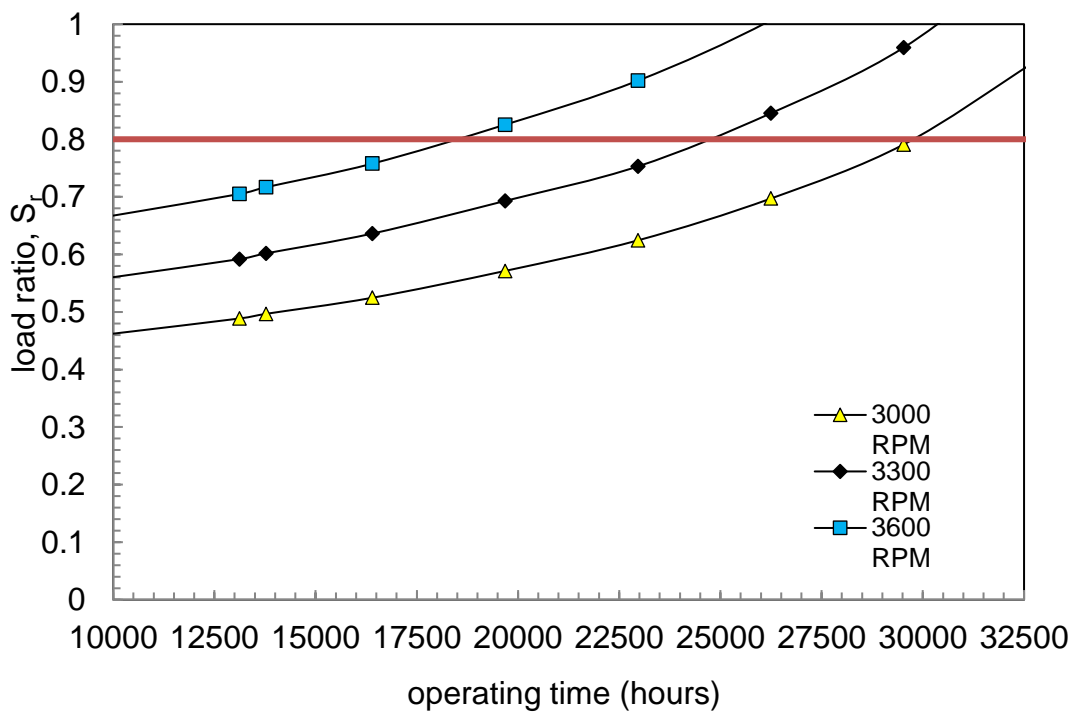
For continued operation, without addressing the SCC crack, the SCC propagation rate is expected to be in the order of 3mm/10,000 hours of operation. FEA was used to calculate the increase in the applied stress intensity factor and reference stress with time, for a conservatively assumed initial through-prong crack length of 36 mm, i.e. an initial crack spanning two pinholes and extending 3 mm on opposing sides of the two pinholes. Results were plotted on a Level 1 failure assessment diagram (FAD) in accordance with reference [15]. The FAD axes are load ratio  $S_r$ , defined as the value of the calculated reference stress divided by the flow strength, which is assumed to be the arithmetic mean of the yield strength and the tensile strength up to a maximum value of 1.2 times the yield strength, and the fracture ratio  $K_r$ , defined as the calculated value of applied stress intensity factor divided by the material toughness value. Figure 5 shows the FAD for the disc crack where crack growth has been plotted for three speeds from the normal

operating condition of 3,000 rpm to the worst case overspeed of 3,600 rpm. It shows that brittle fracture is not expected but that overload failure can occur in an overspeed situation after a further 18,500 hours (or just over two years) of operation (as shown in Figure 6).

Figure 6 Failure by overload expected after 18,500 hours of operation (3,600 rpm load case).

This assessment indicated that significant cracking is tolerable for a period of time from an operational point of view, providing some flexibility for postponing repair. However, if cracks are allowed to propagate they will reach sizes which are no longer repairable. Hence disc hole repair was scheduled for a suitable outage period.

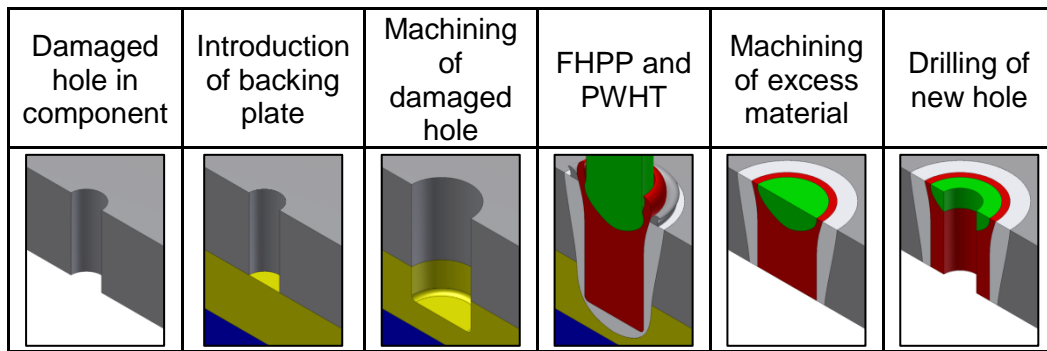
Figure 7 Stages in the FHPP repair of damaged blade attachment finger holes in a LP turbine rotor.

Friction hydro-pillar processing is a variant of the friction stir welding process developed at TWI in 1991. FHPP involves rotating a consumable tool concentrically in a hole whilst applying a downwards load, to continuously generate a localised plasticised layer. The plasticised material develops at a rate faster than the axial feed rate of the consumable tool, and hence the plasticised rubbing surface rises up around the length of the tool giving a dynamically recrystallised interface layer which forms the weld. There are only a few reports of the use of FHPP in the literature, although Xu et al [16] have provided a useful numerical simulation aimed at determining optimised hole/stud geometries. In the application of FHPP as a potential repair technique for cracks or incorrectly drilled holes in LP turbine rotors, the process consists of six stages that are illustrated in Figure 7:

1. A backing plate is introduced and used to support the blade attachment finger;
2. The damaged region around the hole is machined out using the specially designed FHPP platform;
3. FHPP is used to repair the hole, in a process integrated with the removal of the damaged region;
4. Post-weld heat treatment (PWHT) is used to relax residual stresses;
5. Excess weld metal is removed by machining;

6. The blade attachment hole is accurately re-drilled.
