# Photos of the Titan sub's wreckage support the theory that the carbon-fiber hull failed first, expert says

Guenot, M

Business Insider

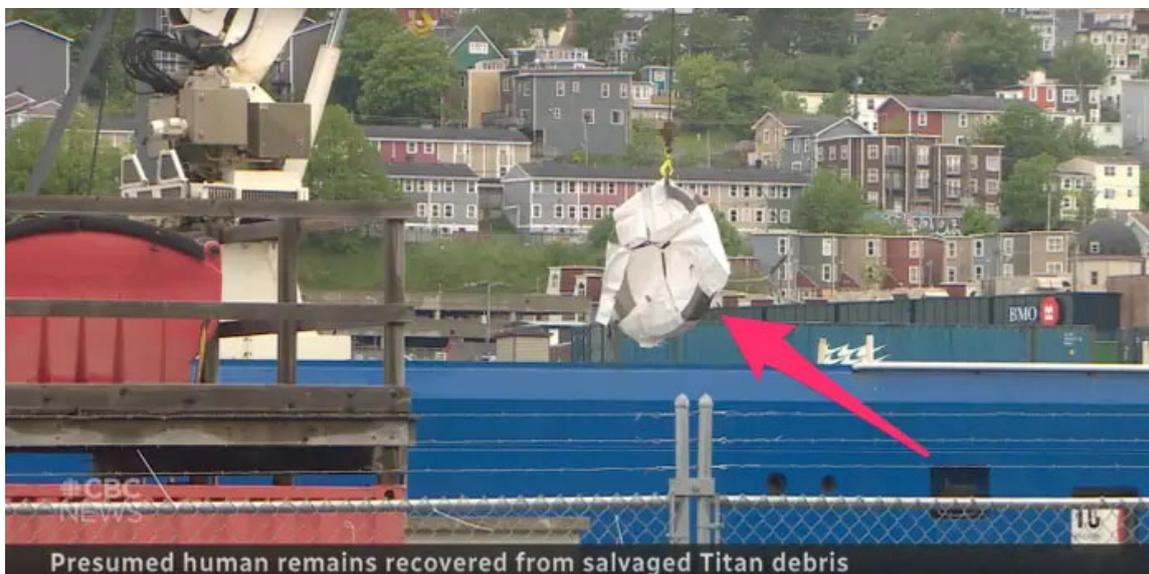
## 1. The titanium structural rings are intact

**An annotated picture of the titanium structural rings pulled from the wreckage of the Titan submersible.** CBC News/Insider

The picture above, taken by Canada's CBC News, shows structural titanium rings that supported the structure of the submersible. They are intact and, therefore, do not seem to have failed.

The Titan's design featured two titanium rings bound to the carbon-fiber hull. The rings seem to have held firm, Graham-Jones said.

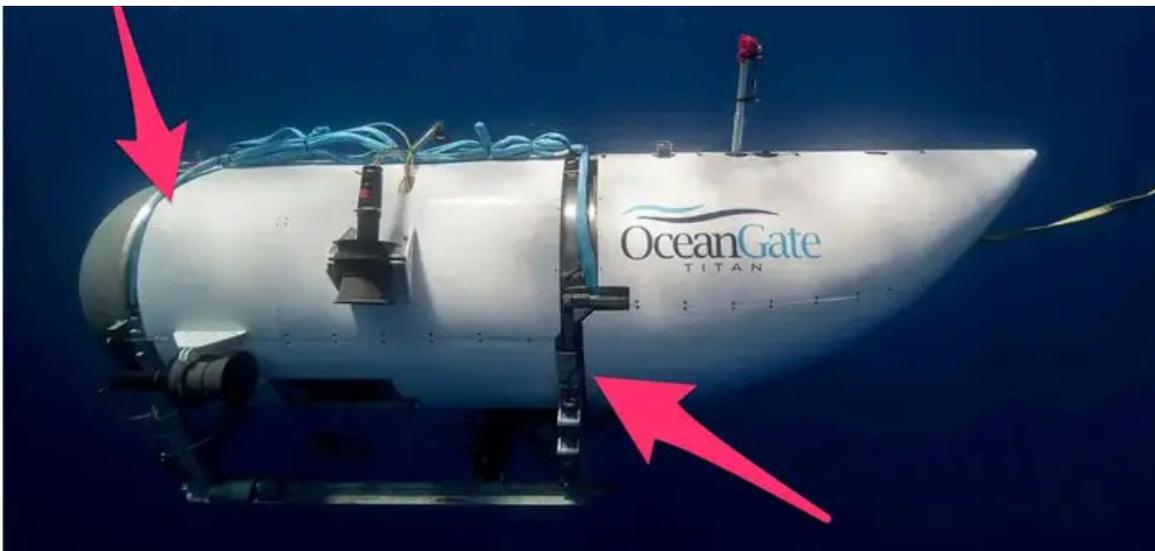
**An annotated picture points to the approximate location of the structural titanium rings.** OceanGate Expeditions/Reuters/Insider

"It shows that titanium was the right material to use, and linking with the composite was possibly the wrong material to use," he said.

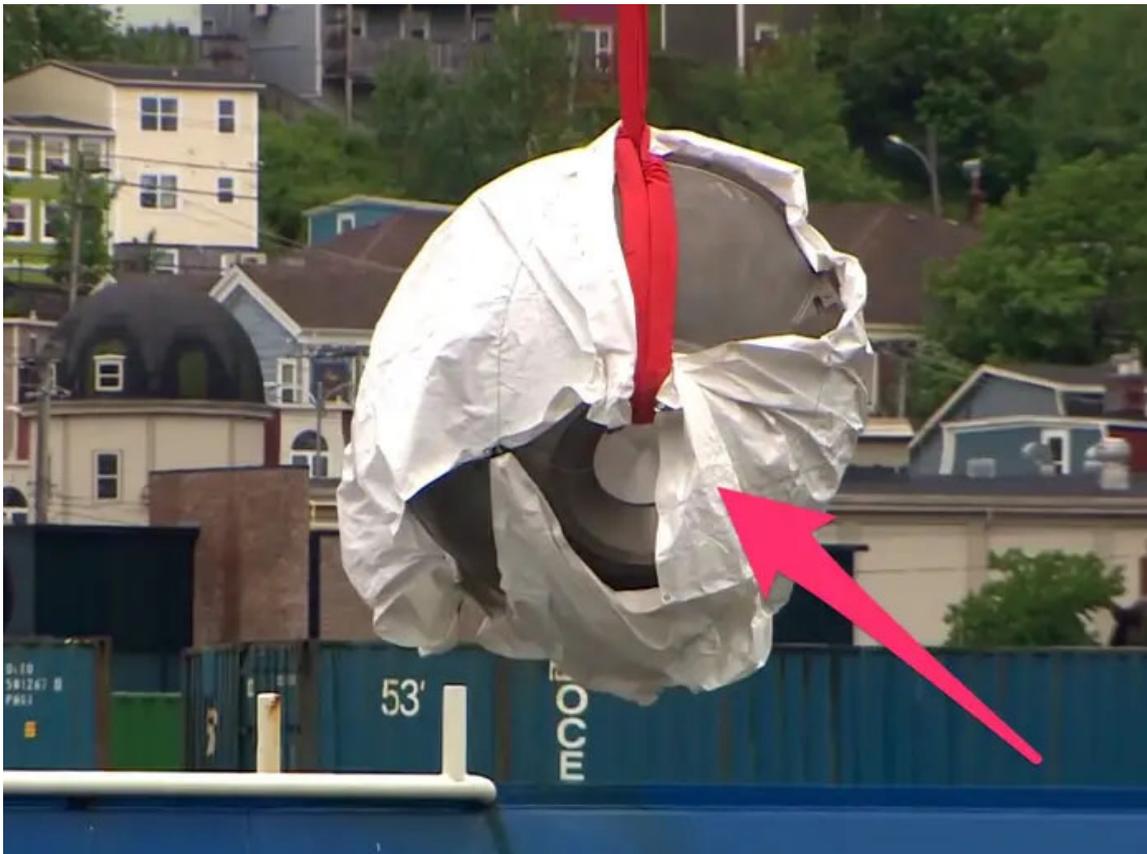
## **2. The front view port of the submersible seems to have failed**

**An annotated picture shows footage of the debris being winched off the rescue ship shows the partially covered front viewport.** CBC News/Reuters/Insider

The picture, captured by CBC News, shows debris that seems to belong to the front viewport of the ship. There is nothing in the porthole anymore other than the red cable lifting it.

While Graham-Jones said that it wasn't impossible that the salvage operation removed the acrylic viewport to make room for the red cable, he said it wasn't likely.

"It looks to me like it's failed, the window's gone," he said.

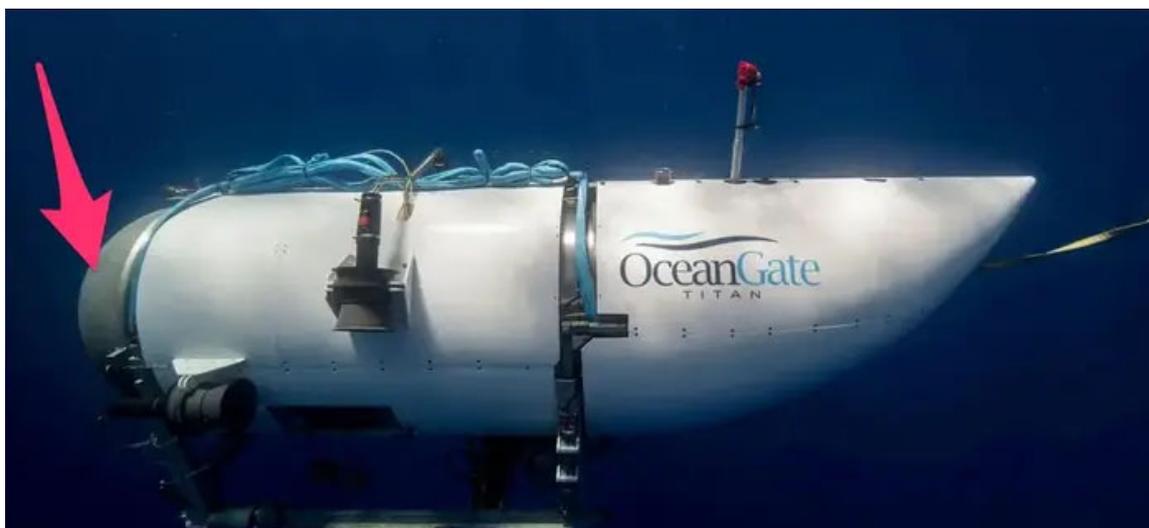
**An annotated picture points to the front viewport.** OceanGate  
Expeditions/Reuters/Insider

David Lochridge, OceanGate's former director of marine operations, alleged in August 2018 court filings that the company installed a front view port certified to a depth of only some 4,200 feet, or about 1,300 meters — far shallower than the Titanic wreckage it was built to visit.

An unresolved question, Graham-Jones said, is whether the window failed first, or if another part failed and the implosion blew out the view port.

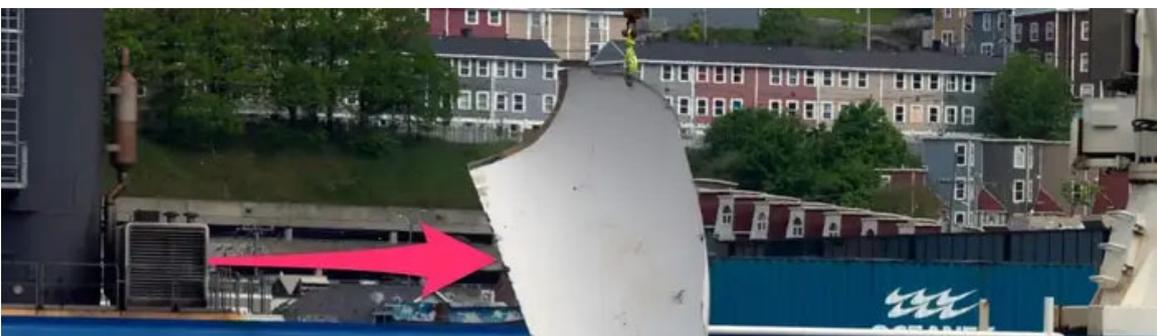
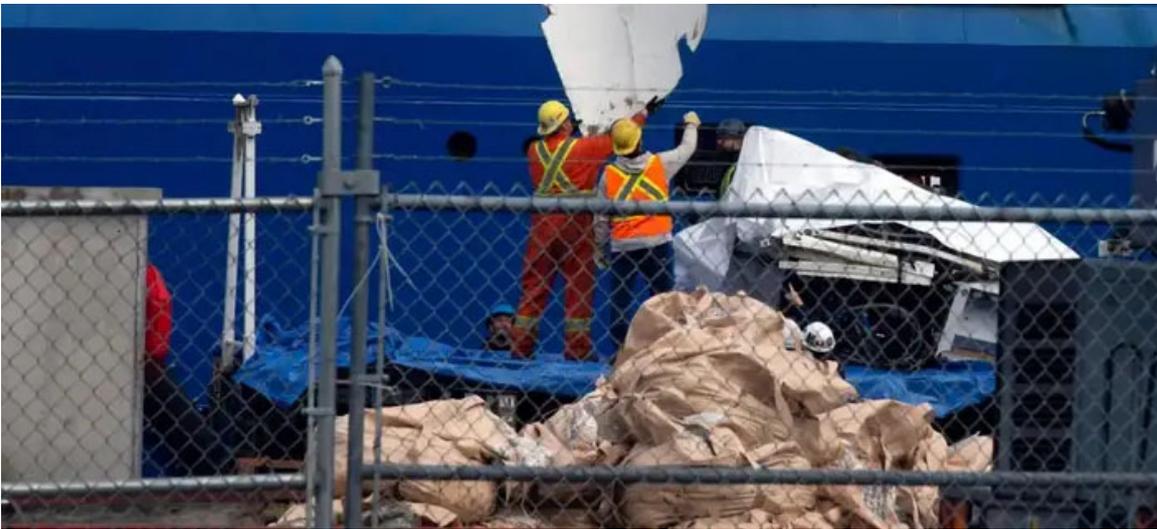
### **3. No large slabs of the hull seem to have been recovered**

**An annotated picture of recovered debris from the Titan submersible pulled up from the ocean floor.** Paul Daly/The Canadian Press via AP/Insider.

Graham-Jones said the most telling part of the footage was what you couldn't see: there were no big slabs of the carbon-fiber hull.

The investigators recovered large fragments of the covering of the submersible, a material that was placed above the carbon-fiber hull, pictured above. But they don't seem to have found much of the carbon-fiber hull itself.

But for Graham-Jones, it is a sign the composite-carbon-fiber hull likely failed first.

Graham-Jones said both the window failing and the hull failing would have led to the implosion of the ship. But if the front view port had gone first, the pressure would have been slightly less intense on the hull, so "would probably see bigger pieces of composite there."

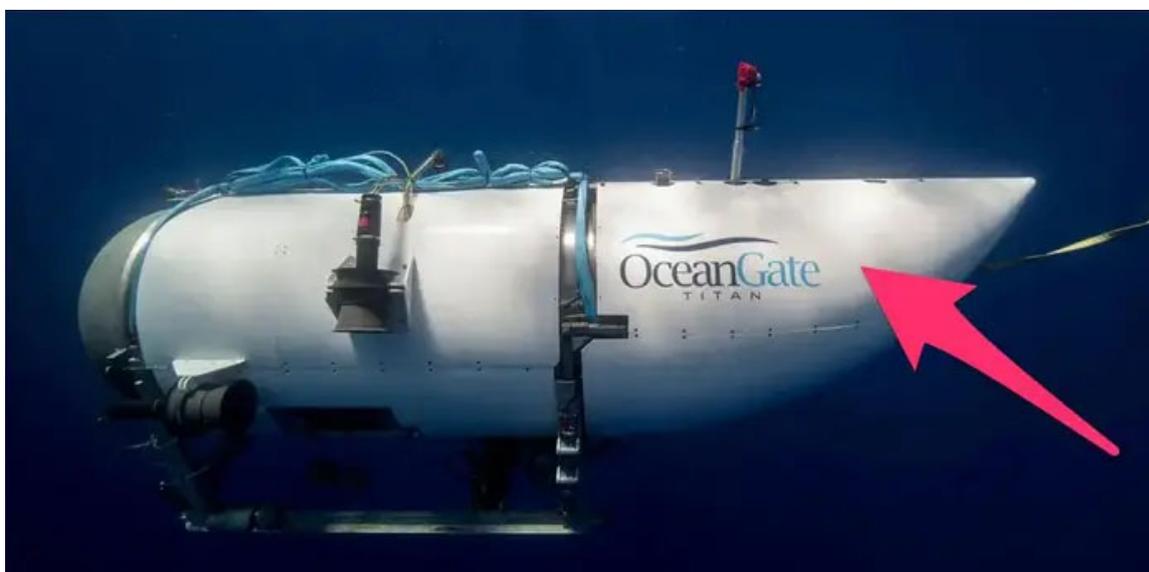
**An annotated picture of the OceanGate submersible points to the white covering placed above the carbon-fiber hull.** OceanGate/Reuters/Insider

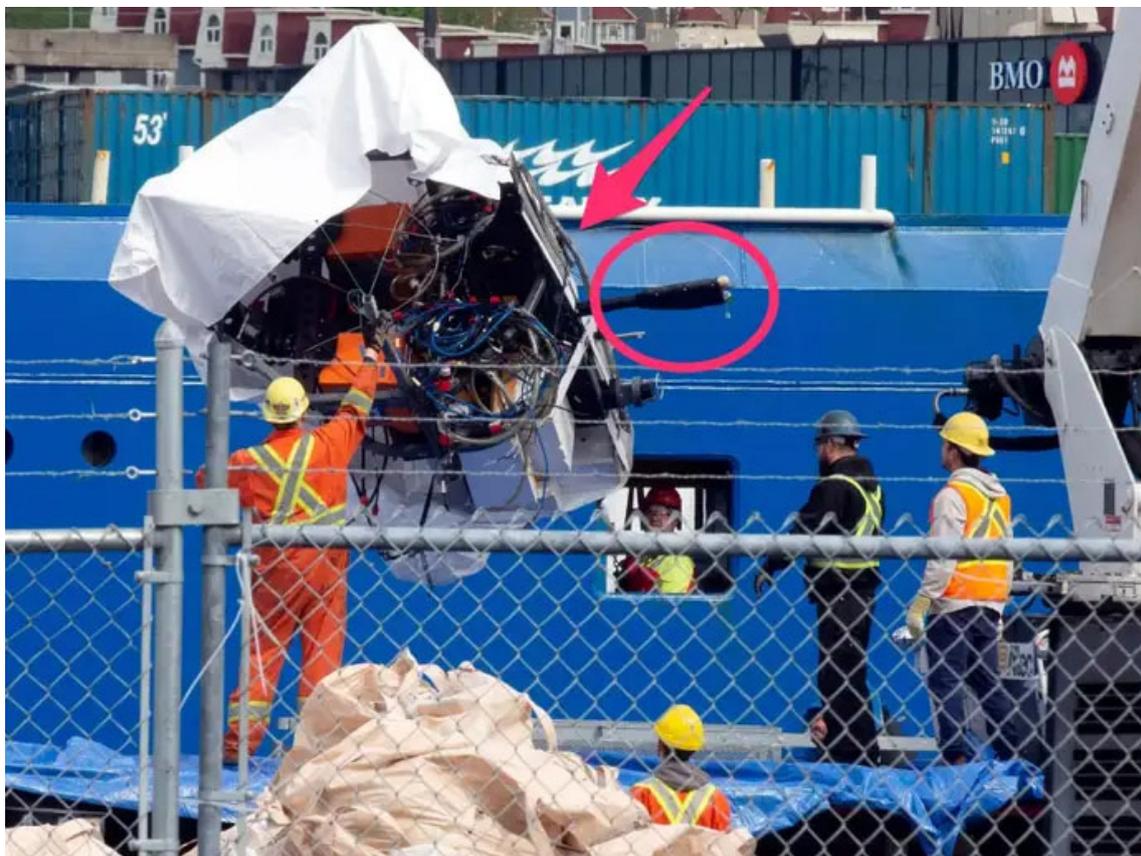
#### 4. Also no fragments of carbon fiber attached to other debris

**An annotated picture of debris of the Titan submersible. The circle points to an antenna, which is recognizable from a picture of OceanGate's submersible. An arrow points to the metal cage around the debris that would have connected to the hull.** Paul Daly/The Canadian Press via AP/Insider.

The picture above, Graham-Jones said, shows tubes and piping that would have been inside the ship. These were encased in a metal cage that would have been bound to the carbon-fiber hull.

"The joint should be strong enough that it goes into the carbon, and so you'd have carbon left on that piece," in many scenarios, Graham-Jones said.

But it doesn't seem like that happened. The absence of visible carbon fiber on the joints could mean one of two things.

Maybe the joint failed. Graham-Jones said the joining is generally done with epoxy glue, which needs to be applied in a dust-free environment — improper application could lead to problems.

But Graham-Jones said it is probably more proof that the carbon-fiber hull went first, breaking into such tiny pieces that you wouldn't see the remnants on the joints.

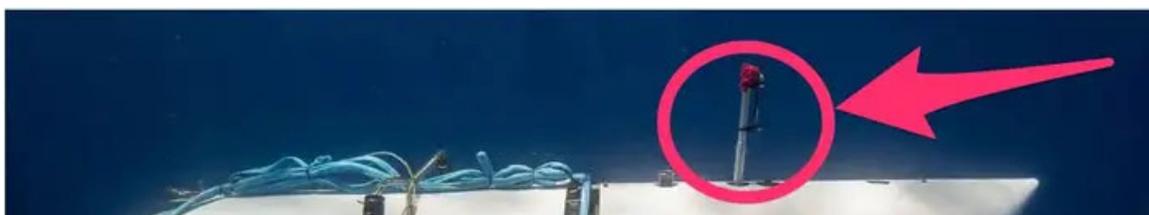
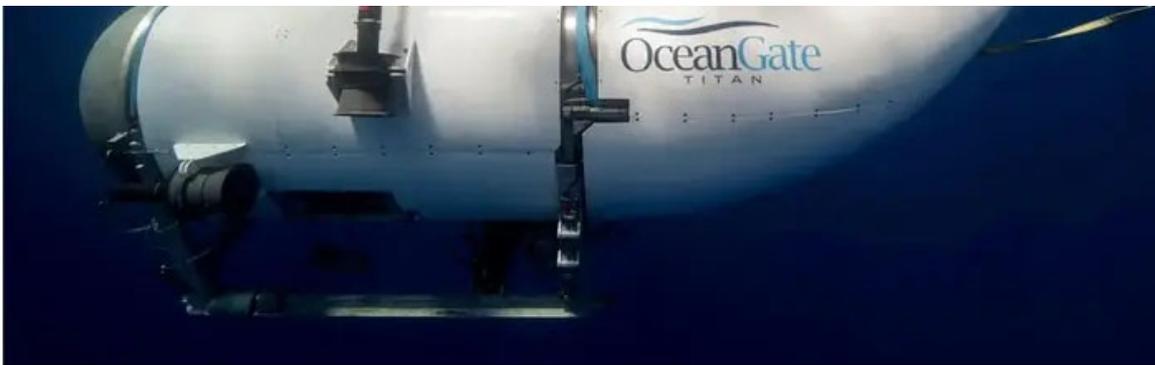
**An annotated picture shows the antenna that's recognizable on the debris.** OceanGate Expeditions/Reuters/Insider
