Photos of the Titan sub's wreckage support the theory that the carbon-fiber hull failed first, expert says

Guenot, M

Business Insider

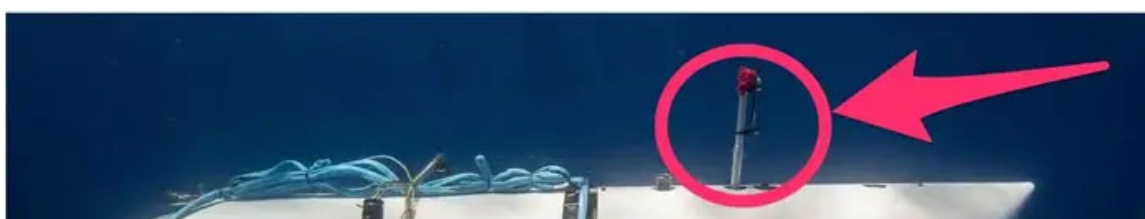
An annotated picture shows the antenna that's recognizable on the debris. OceanGate Expeditions/Reuters/Insider
