# Photos of the Titan sub's wreckage support the theory that the carbon-fiber hull failed first, expert says

Business Insider

Marianne Guenot Jun 30, 2023, 3:48 PM BST

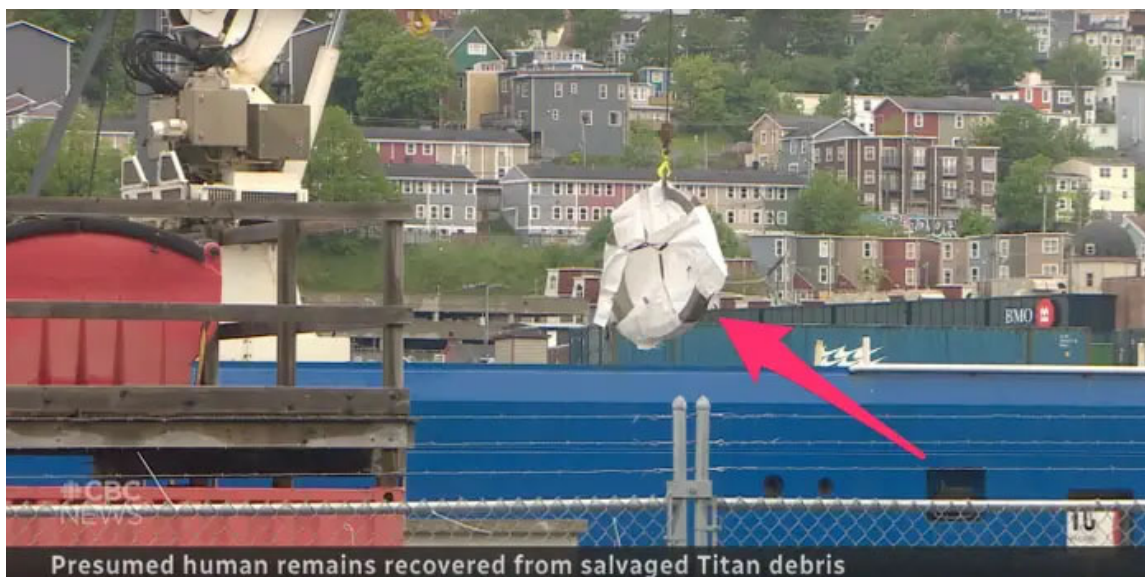
**An annotated picture of the titanium structural rings pulled from the wreckage of the Titan submersible.** CBC News/Insider

The picture above, taken by Canada's CBC News, shows structural titanium rings that supported the structure of the submersible. They are intact and, therefore, do not seem to have failed.

The Titan's design featured two titanium rings bound to the carbon-fiber hull. The rings seem to have held firm, Graham-Jones said.

"It shows that titanium was the right material to use, and linking with the composite was possibly the wrong material to use," he said.

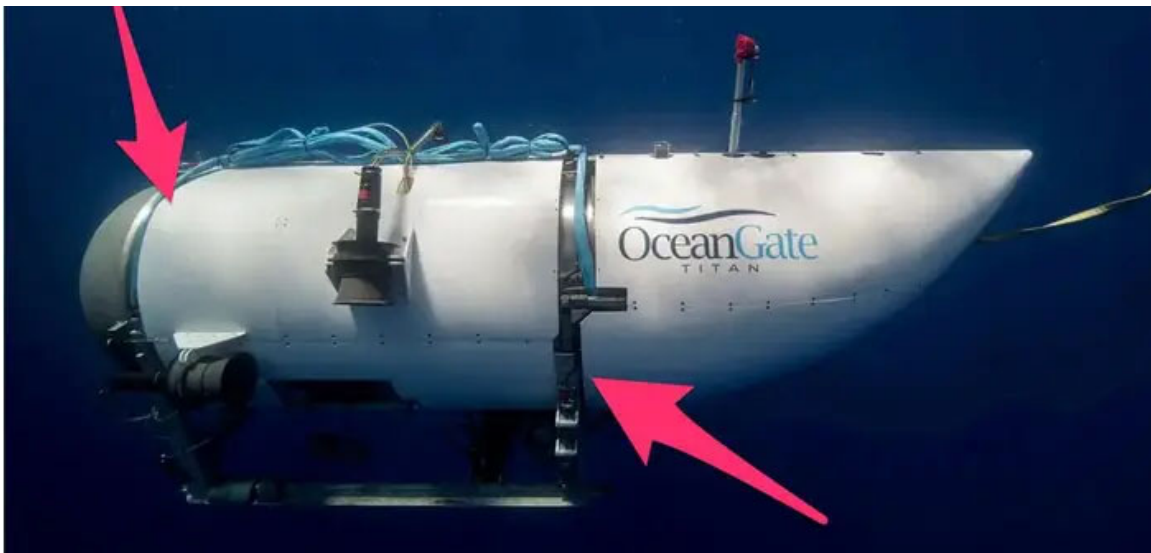
**An annotated picture points to the approximate location of the structural titanium rings.** OceanGate Expeditions/Reuters/Insider

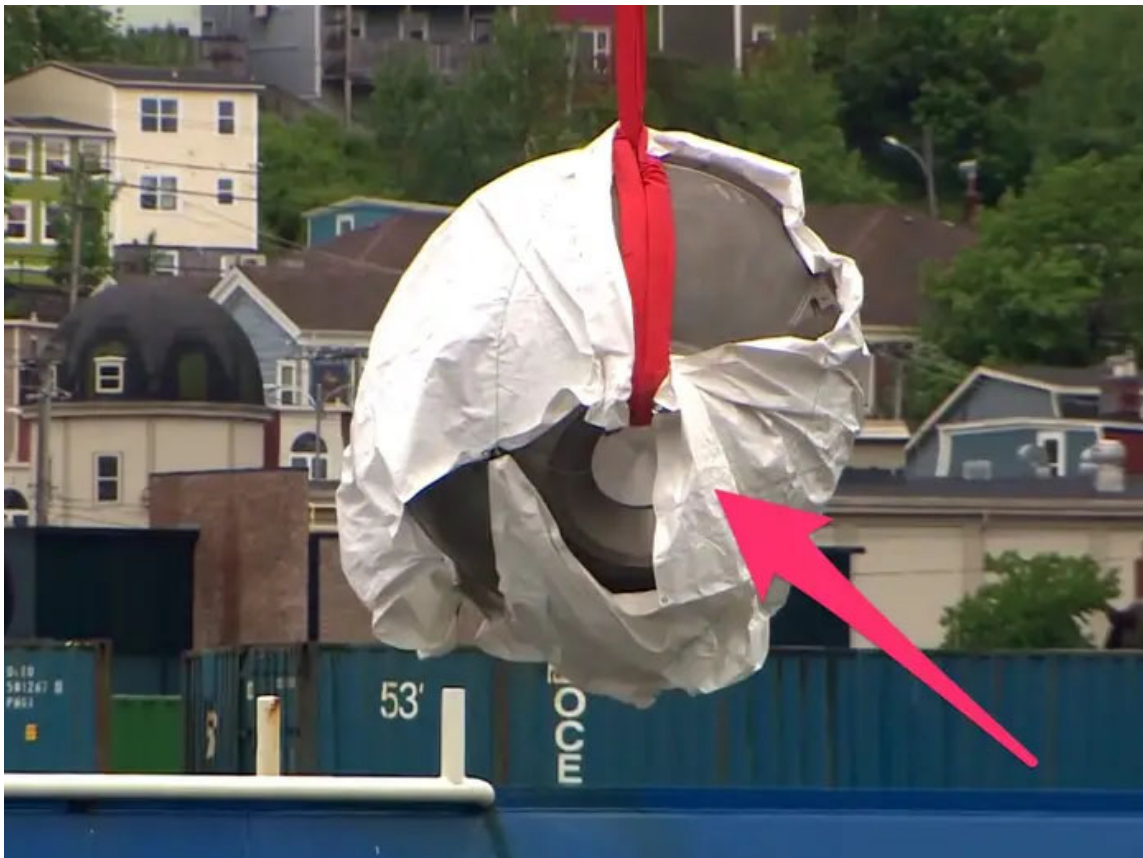
**An annotated picture shows footage of the debris being winched off the rescue ship shows the partially covered front viewport.** CBC News/Reuters/Insider

The picture, captured by CBC News, shows debris that seems to belong to the front viewport of the ship. There is nothing in the porthole anymore other than the red cable lifting it.

While Graham-Jones said that it wasn't impossible that the salvage operation removed the acrylic viewport to make room for the red cable, he said it wasn't likely.

"It looks to me like it's failed, the window's gone," he said.

An unresolved question, Graham-Jones said, is whether the window failed first, or if another part failed and the implosion blew out the view port.

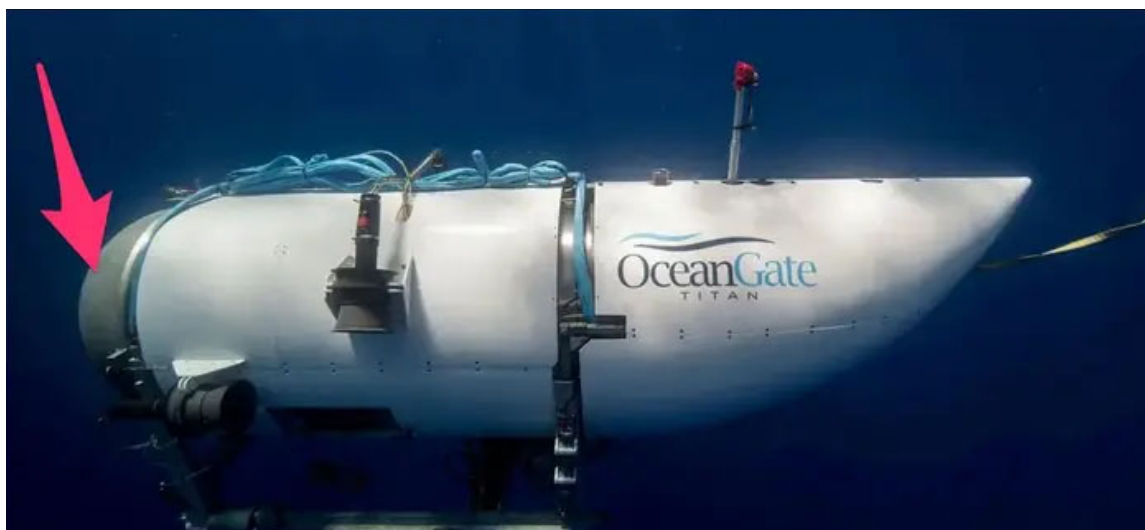
**An annotated picture points to the front viewport.** OceanGate  
Expeditions/Reuters/Insider

David Lochridge, OceanGate's former director of marine operations, alleged in August 2018 court filings that the company installed a front view port certified to a depth of only some 4,200 feet, or about 1,300 meters — far shallower than the Titanic wreckage it was built to visit.

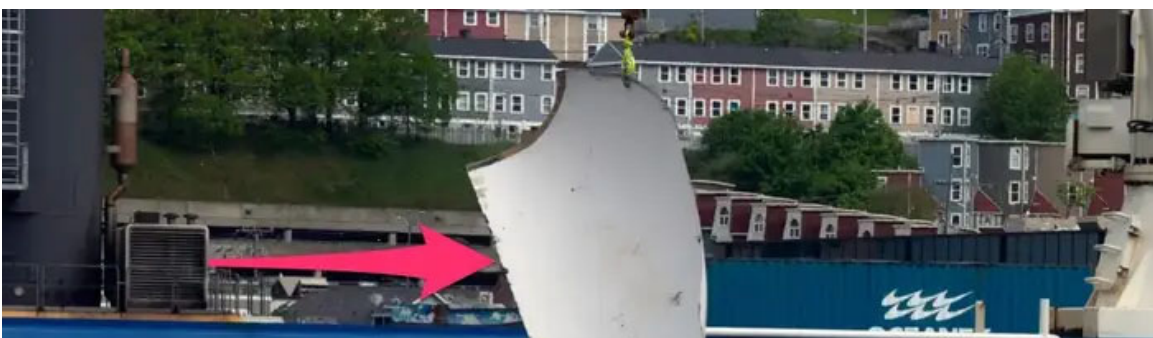
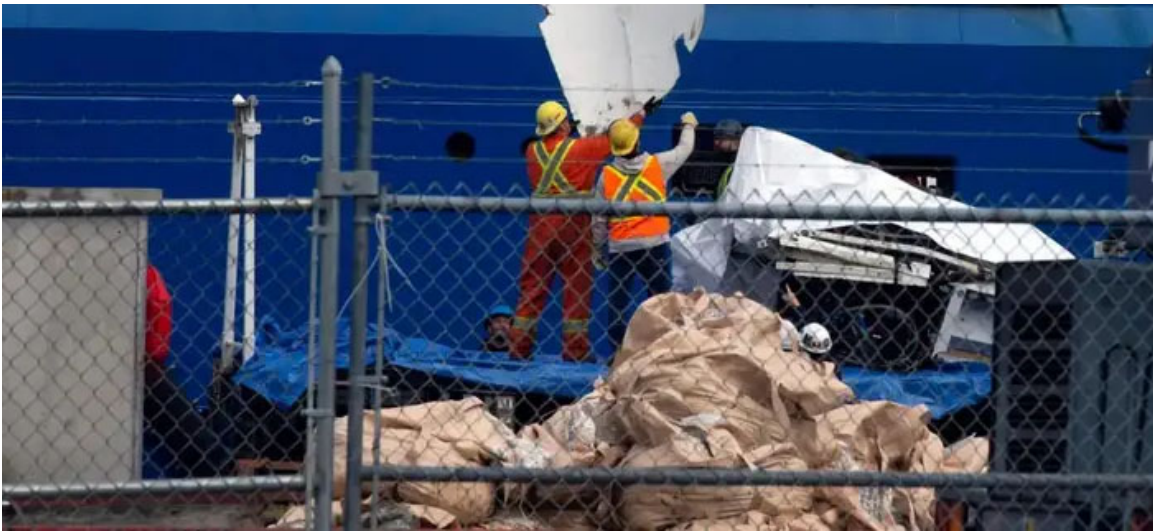
**An annotated picture of recovered debris from the Titan submersible pulled up from the ocean floor.** Paul Daly/The Canadian Press via AP/Insider.

Graham-Jones said the most telling part of the footage was what you couldn't see: there were no big slabs of the carbon-fiber hull.

The investigators recovered large fragments of the covering of the submersible, a material that was placed above the carbon-fiber hull, pictured above. But they don't seem to have found much of the carbon-fiber hull itself.

But for Graham-Jones, it is a sign the composite-carbon-fiber hull likely failed first.

Graham-Jones said both the window failing and the hull failing would have led to the implosion of the ship. But if the front view port had gone first, the pressure would have been slightly less intense on the hull, so "would probably see bigger pieces of composite there."

A possibility, he said, is that the carbon fiber failed because repeated trips had stressed the material, making small cracks that eventually gave way. This would also explain why the Titan had made trips before without incident.

If such a failure did take place, Graham-Jones said, you would expect "lots of small bits of composite carbon fiber," consistent with the absence of large chunks in the imagery.

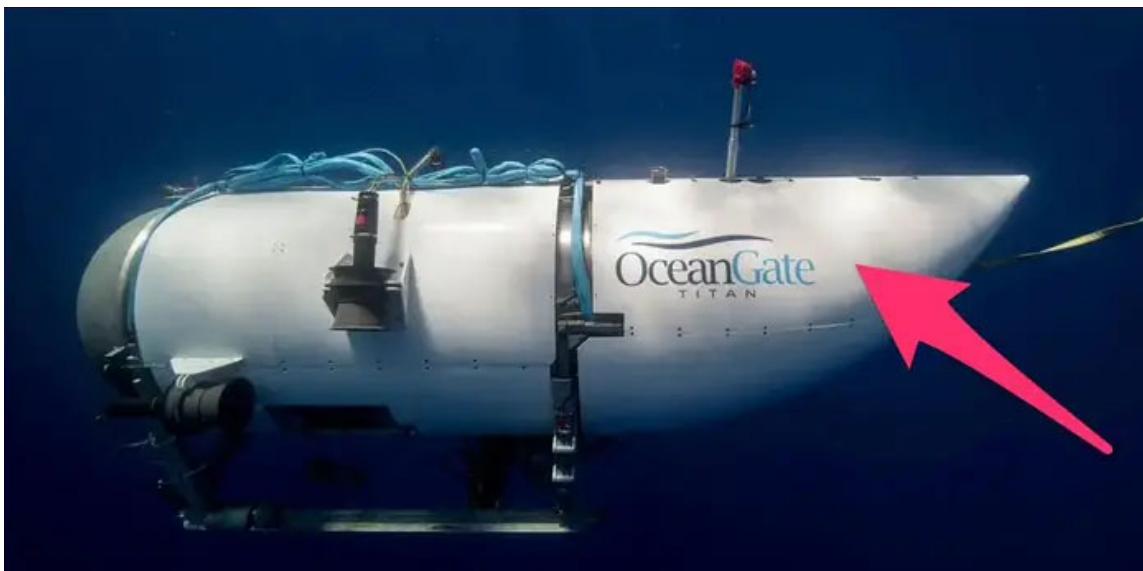
**An annotated picture of the OceanGate submersible points to the white covering placed above the carbon-fiber hull.** OceanGate/Reuters/Insider

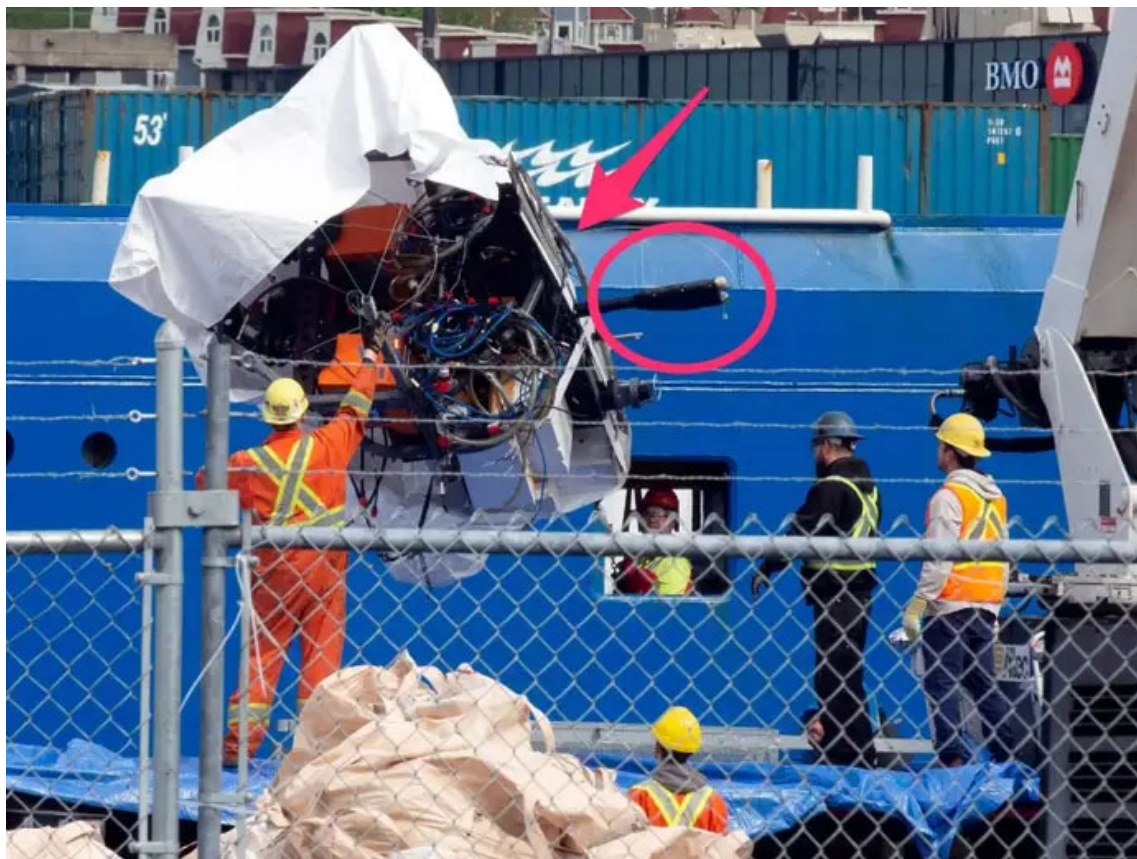
**An annotated picture of debris of the Titan submersible. The circle points to an antenna, which is recognizable from a picture of OceanGate's submersible. An arrow points to the metal cage around the debris that would have connected to the hull.** Paul Daly/The Canadian Press via AP/Insider.

The picture above, Graham-Jones said, shows tubes and piping that would have been inside the ship. These were encased in a metal cage that would have been bound to the carbon-fiber hull.

"The joint should be strong enough that it goes into the carbon, and so you'd have carbon left on that piece," in many scenarios, Graham-Jones said.

But it doesn't seem like that happened. The absence of visible carbon fiber on the joints could mean one of two things.

Maybe the joint failed. Graham-Jones said the joining is generally done with epoxy glue, which needs to be applied in a dust-free environment — improper application could lead to problems.

But Graham-Jones said it is probably more proof that the carbon-fiber hull went first, breaking into such tiny pieces that you wouldn't see the remnants on the joints.

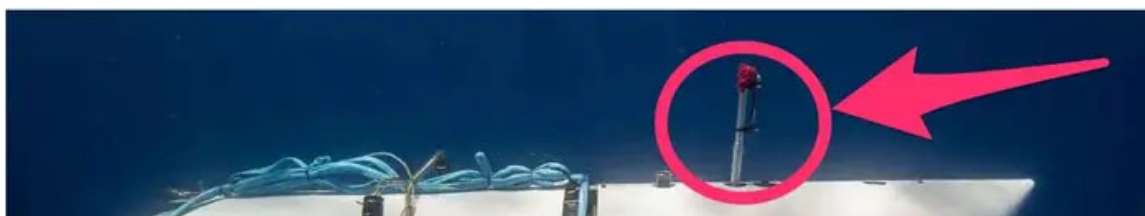
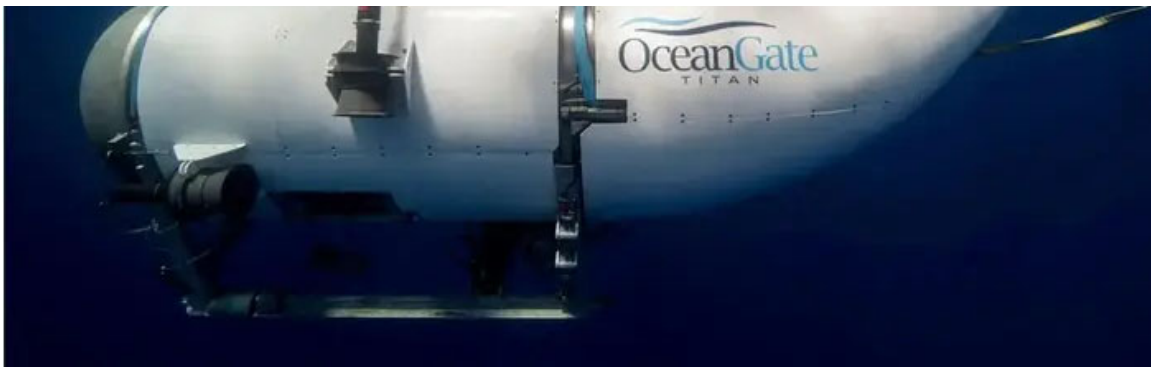
**An annotated picture shows the antenna that's recognizable on the debris.** OceanGate Expeditions/Reuters/Insider
