THE DEVELOPMENT OF A METHODOLOGY FOR CREATING AN EARTHEN BUILDING INVENTORY

MARGARET LYN FORD

DOCTOR OF PHILOSOPHY

The School of Architecture
Faculty of Technology

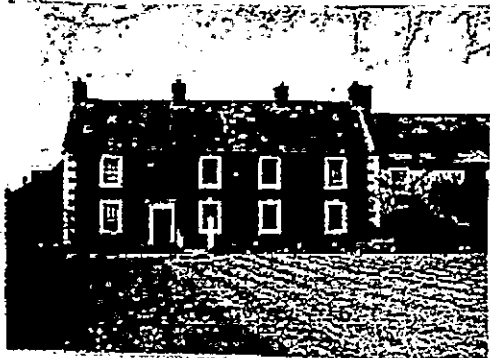
A completed record card. The coded description shows the house to have brick walling (A2), with a mixture of other materials (B2), a gabled roof (C3), of thick slate (D3), to have tall windows (E6), with vertically sliding sashes (F8), a doorway with a renaissance type surround (G5), be two-storey (H4), to have the two unit and cross-passage plan (J4) and to have a barn attached, laithe-house fashion (K7).

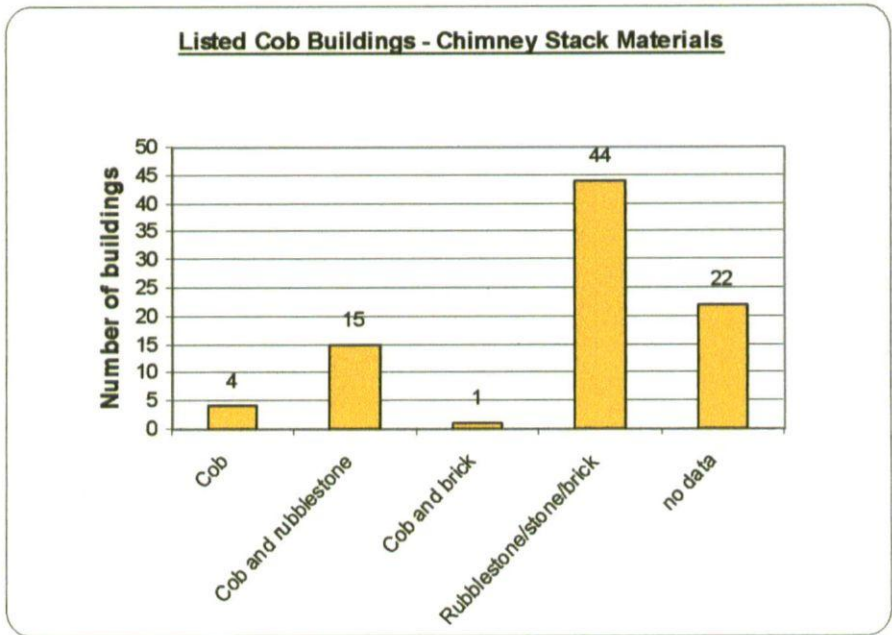
Histogram 5.7 illustrates the numbers of chimney stacks identified as being totally or partially constructed with cob in comparison to those constructed of other materials. From this histogram it is seen that a high proportion of the Listed cob buildings have the chimney stack material identified, but that very few of these have stacks made entirely of cob. Marshall (1796) referred to the use of cob for chimney stacks and Histogram 5.7 shows that a small number of stacks remain that are entirely of cob and that a larger

proportion of chimneys are partially built of the material. A seventeenth century cob fireplace and chimney is identified in a building, previously used as a blacksmiths, in the centre of Sandford and an eighteenth century cob stack has been confirmed on another former blacksmiths at Stones Hill (see case study on The Old Forge in Chapter Six).

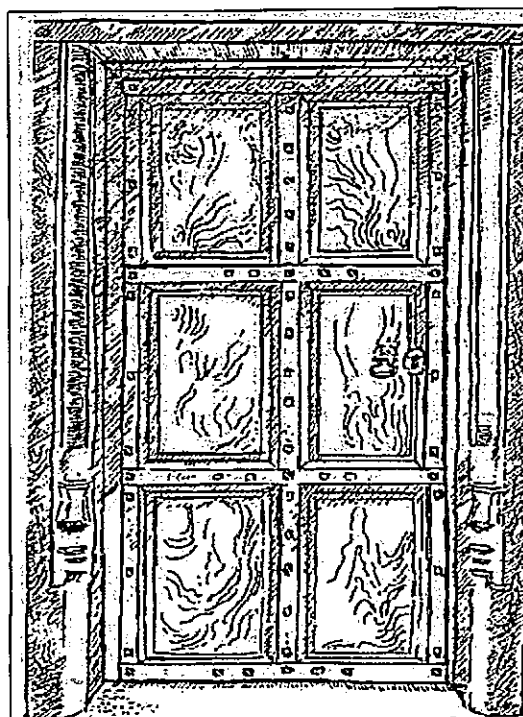
**Figure 5.3 shows decorative mouldings in two
sixteenth century cob buildings**

Bremridge - carved boss

Bremridge - chamfered, panelled door

Prowse - decorative panelled ceiling

Prowse - round headed doorway

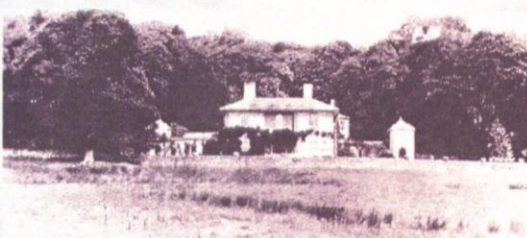
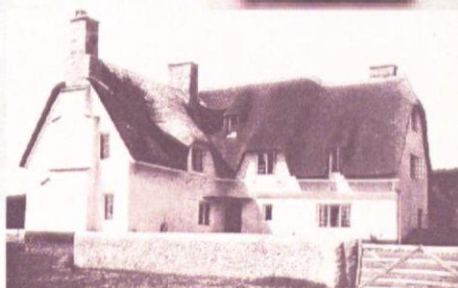
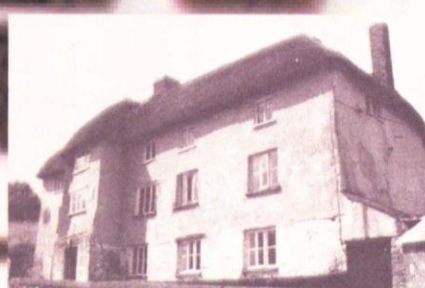
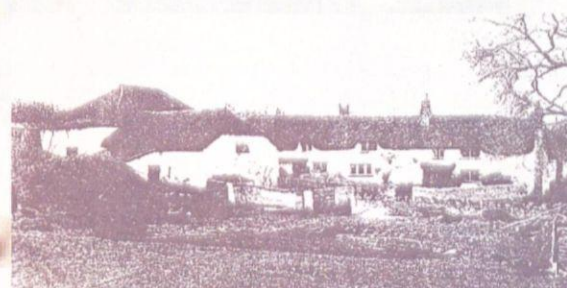
Pair of Cottages before and after reconstruction at a cost of \$750 each.
