An investigation into the survival of medieval plaster in Dorset churches

B. INDUNI

PhD 2006

A thesis submitted to the University of Plymouth
in partial fulfilment for the degree of

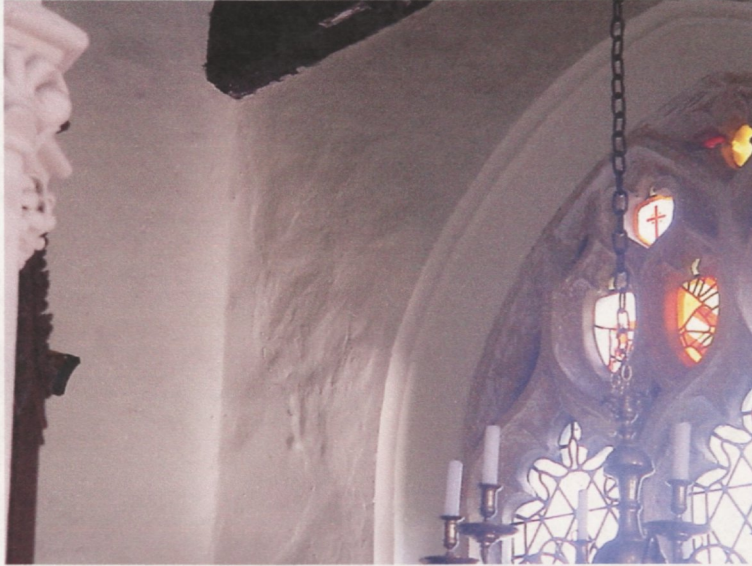
Figure 1

Abbotsbury.
East end of the north aisle.

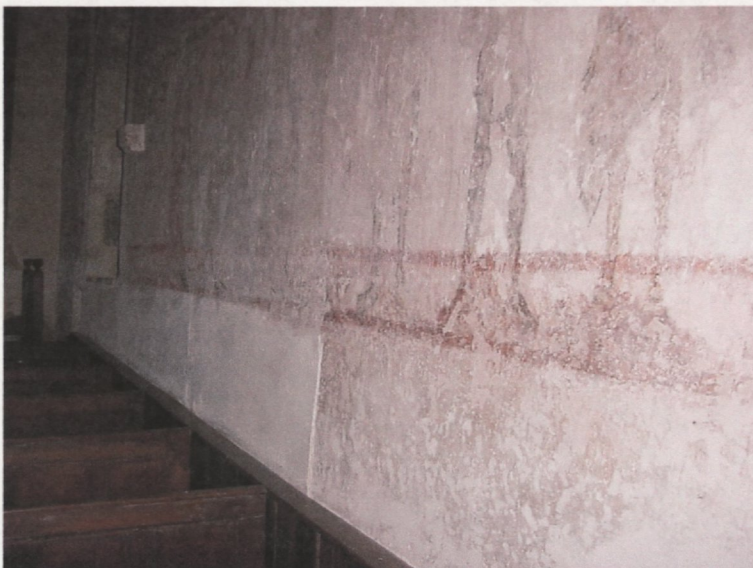
Figure 2

Tarrant Crawford.
Nave north wall.

Here a painted surface is smooth, as at Abbotsbury (above), and though much less wavy, is still not ruled flat in the way that is typical of nineteenth century plasters.

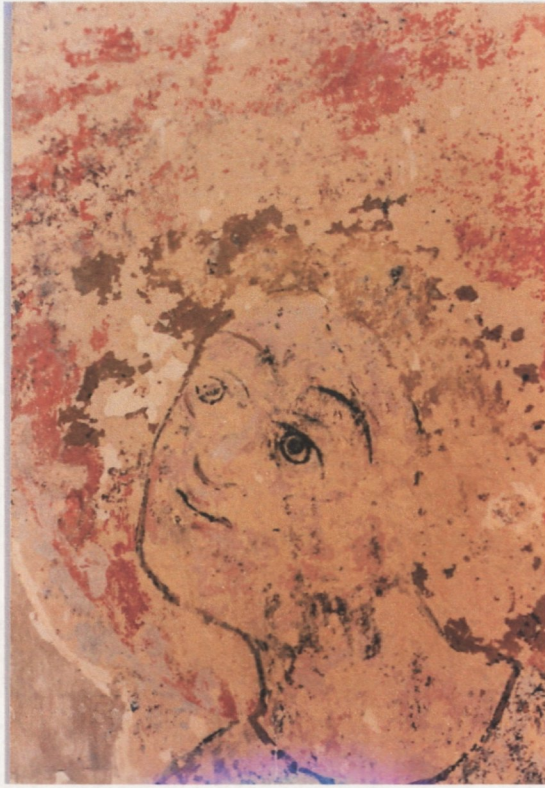
Figure 3
Inglesham, Wiltshire.
Flatter, less wavy, plaster was probably demanded by wall painters when they were drawing with very fine and delicate line, as here at Inglesham in Wiltshire.

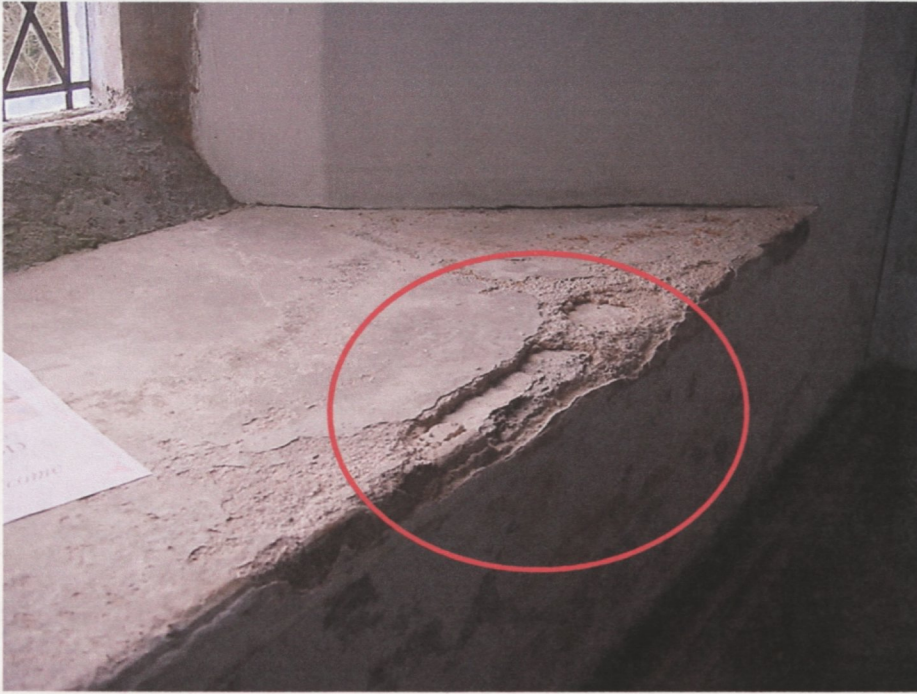
Figure 7

Litton Cheyney, north wall of the chancel.

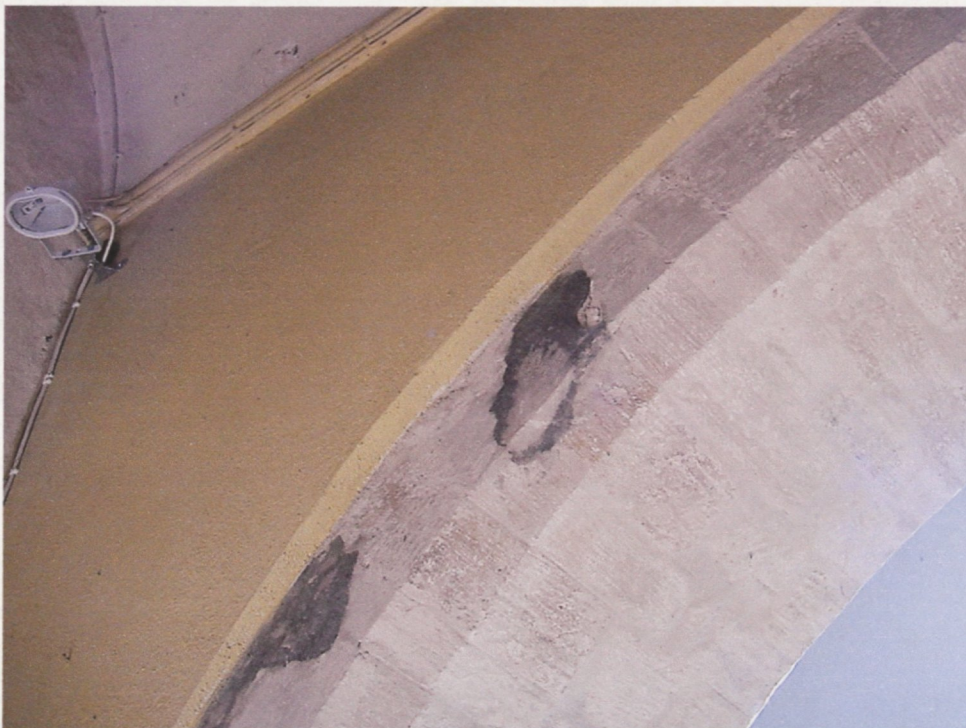
Puncknowle, east end of the north arcade.

The thick layer of yellow painted plaster is typical of the nineteenth century overskim plasters that are likely to be hiding considerable areas of early plaster.

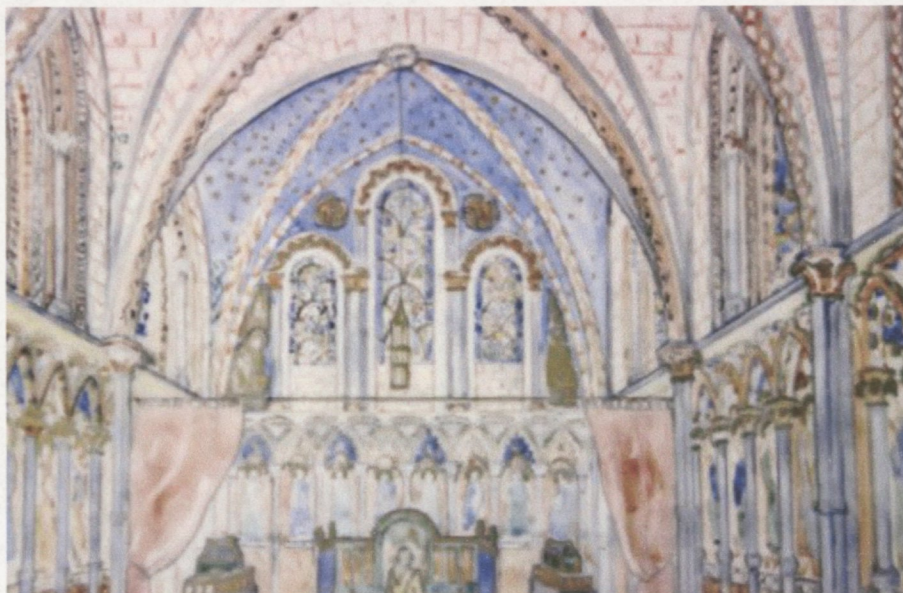
Figure 17 : Glastonbury Abbey Lady Chapel as it probably looked at the end of the fourteenth century, when fully plastered and painted. Evidence for the reconstruction is based on observation of paint traces on site, together with comparison with paint schemes at Wells and Exeter Cathedrals, by Warwick Rodwell, Jeremy Sampson and Eddie Sinclair. (From an original painting by Lizzie Induni.)

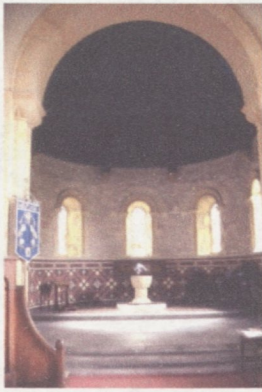
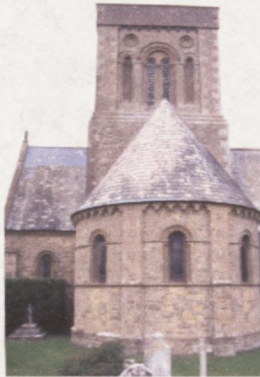
Figures 23 (above) and 24 (below) Melplash, Dorset. The furthest extreme of nineteenth century restoration, in Dorset. A giant creation by Benjamin Ferry in 1845-6 which completely obliterated the medieval church. No plaster of any sort now remains. The nave is now converted into a squash court. Perhaps a fitting indignity for such a pompous act of vandalism. Arguably, no other church in Dorset better illustrates how Victorian wealth, guilt and arrogance swept away medieval plaster in Dorset.

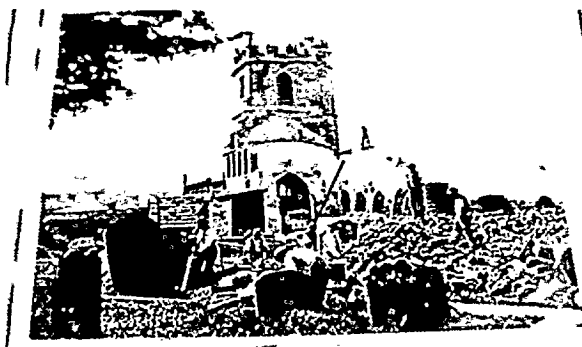
Broadwindsor Church
Figure 26
Broadwindsor, Dorset, showing the chaos of a nineteenth century restoration. Note the heaps of rubble in the foreground, and the apparently surviving areas of plaster wall above the nave arcade. This survey failed to find any evidence of surviving plaster. (*On display in the church, original photographer unknown.*)

A unique reason for plaster survival was found at Fordington church (Dorchester). Here a large fitted cupboard appears to have been too heavy to have been moved during restoration, and so preserved the plaster behind it. This may not be wholly atypical of restorers' efforts throughout the rest of the county. For example the rather beautiful, but certainly not Ecclesiologically pure tower stair at Stratton survived an otherwise comprehensive restoration. However, such survivals would seem to be truly random, and very uncommon. Restoration appears to have usually followed the model illustrated by the photograph of Broadwindsor church. (*See chapter 3.6.2, Figure 16*)

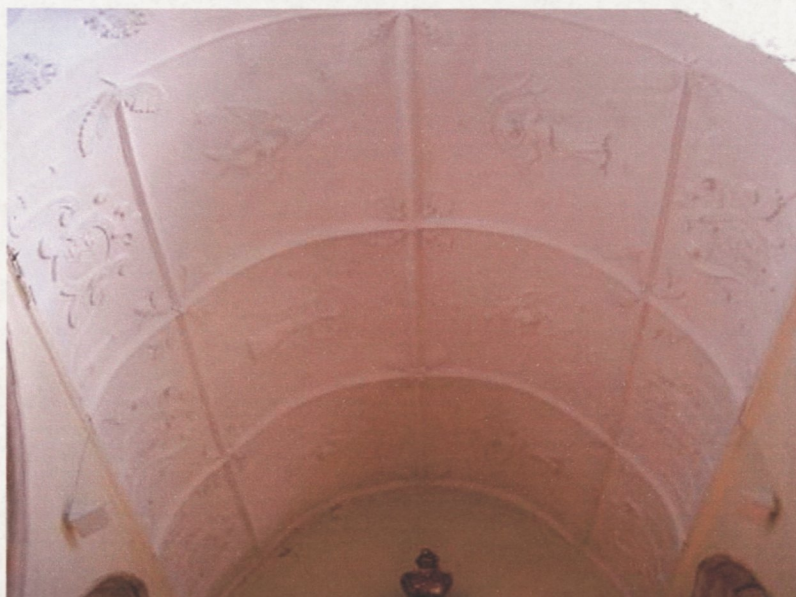
Figure 27
Abbotsbury, Dorset :
Hand modelled plaster
ceiling.

posed technical difficulties, which are discussed in detail below, but had one great advantage over modern plaster. Non-hydraulic lime based plasters set very slowly, often remaining workable for days, rather than hours. This slow set allowed extensive hand modelled shapes to be created.

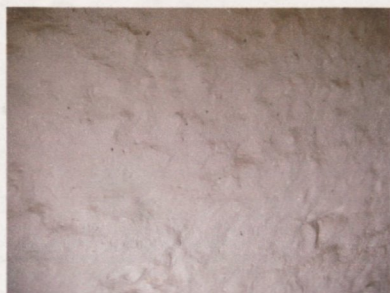
Figure 30
Whitcombe : very wavy plaster on north wall of nave, revealed but not measured by oblique light.

Given favourable light and an experienced guide, this waviness is easy to see :

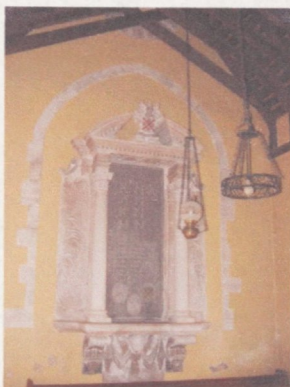
Figure 39 Puncknowle, monument and false window at the west end of the north aisle.

Date stones, cresset stones and flying angels have all contributed difficulties to task of identifying early plaster survival, but the most bizarre piece of misleading evidence was found at the east end of the north aisle at Puncknowle.

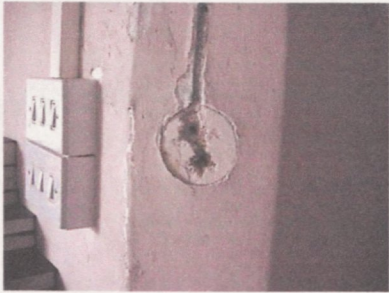
Figure 40 Warmwell, overskim plaster stopped at the edges of a relatively modern light fitting.

However, it was precisely this location that revealed the first definite evidence of early plaster below an overskim. At Warmwell, older plaster was revealed where a thin overskim has been brought up to, but not under a light fitting dating from the nineteen fifties. The exposed plaster appears to be late medieval, or possibly eighteenth century, from its composition (*See Chapter 5*).

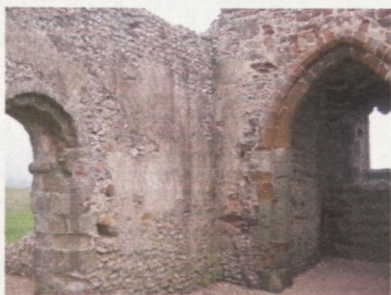
Figure 41 Knowlton. Plaster survival on the south wall of the nave and on the tower arch.

At Knowlton, the south west corner of the nave has plaster survival, but this is of uncertain date.

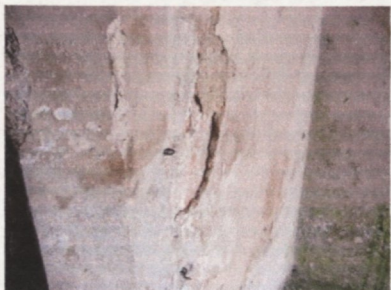
Figure 42 Litton Cheyney. Layers of plaster separated by salt damage. Are they significantly different in date?

Yet another example is the plaster in the porch at Litton Cheyney.

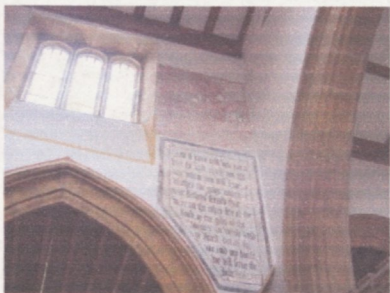
Figure 43 : Cerne Abbas. The upper area of exposed medieval painted plaster appears too neat an regular to represent the full extent of the survival.

- i Cerne Abbas is a large and complex church, with an unusual recent history, having had extensive structural modifications to the roof in the nineteen sixties. There is a substantial survival of medieval plaster in most parts of the church. This is likely to be much more extensive than the localised exposure of mural paintings suggests. These areas of exposure are altogether too orderly and neat, and are likely to have been deliberately limited to achieve this neatness. This is emphasised by comparison with the disorderly and random survival of painted plaster on the north nave wall at Winterbourne Steepleton.

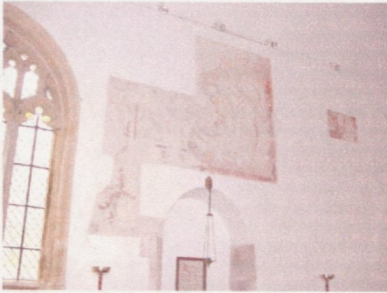
Figure 44 Winterbourne Steepleton. Neat but probably incomplete exposure of wall paintings.

It seems highly unlikely that the current exposure represents the full extent of the painting, since the texture of the underlying plaster does not change at the boundary of the paint exposure.

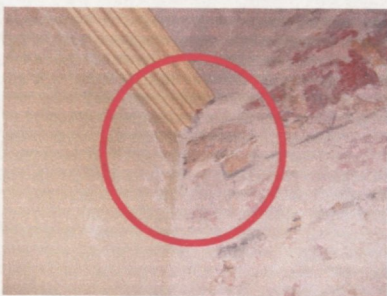
Figure 45 Puncknowle, junction of the north arcade wall with the chancel arch, showing the complex relationship of plaster fragments

Detailed examination of the junction of the north nave arcade wall and the north side of the chancel arch shows the difficulties in deciding the extent of plaster survival. (*See also photographs, chapter 15, on CD*) On the north nave arcade wall, immediately under the moulded plaster cornice, there appear to be fragments of plaster that match the painted plaster on the chancel arch. In other words, the area of

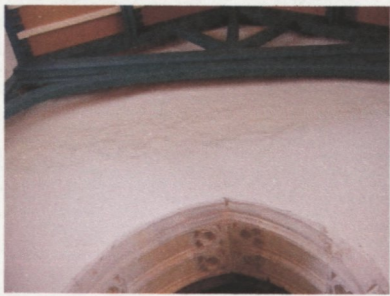
Figure 47 Upwey. Sudden change in the waviness of the plaster above the tower arch.

- i At Upwey (*See photographs, chapter 15, on CD*) there is a very marked contrast between the plaster immediately above the tower arch, and that on the upper parts of the same wall.

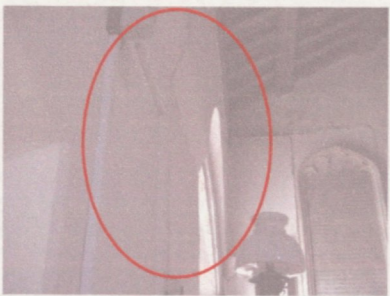
Figure 48 West Knighton. Upper areas of the south wall of the nave showing greatly thickened areas of plaster.

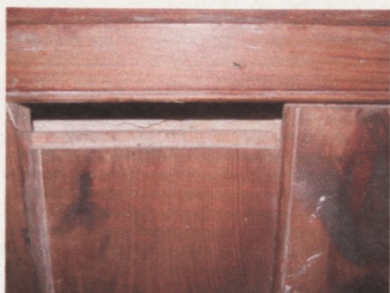
Figure 51 Warmwell. Medieval plaster protected behind wainscot.

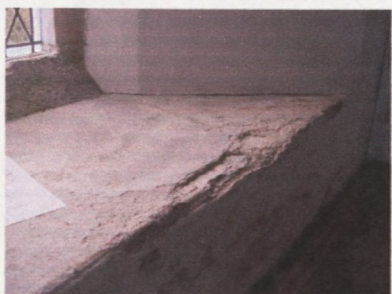
Figure 52 Litton Cheyney. How far do the overskimmed layers of plaster extend?

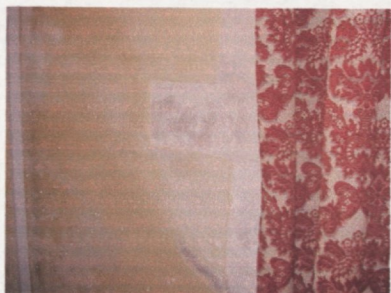
Figure 53 Puncknowle. Damp stains on flat plaster that were initially interpreted as waviness.

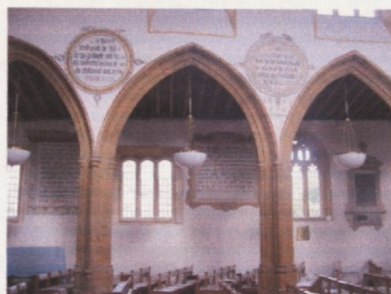
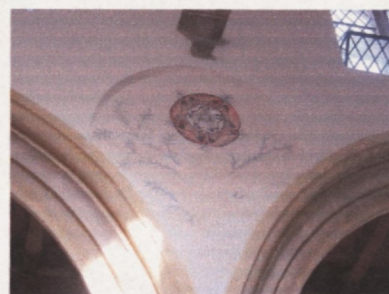
Figure 54
Cerne Abbas, left ,
and Upwey, right.
Both good examples of the
dating problems posed by
later retouching of early
painting...are they genuine?

In both cases these paintings would seem to have genuinely medieval origins, but to have been heavily retouched and modified by Victorian or later restorers. This project has not been able to explore this issue in depth, and it is possible that areas thought to be carrying medieval paint are not genuine. (*See also photographs, chapter 15, on CD*).

Since one of the most convincing proofs that plaster is medieval is for it to be carrying medieval wall paintings, the authenticity of medieval paintings is, in itself, an issue. The survey revealed two cases in which the authenticity was open to doubt. These are the roses painted on the south arcade spandrels at Upwey, and paintings on the north arcade spandrels at Cerne Abbas.

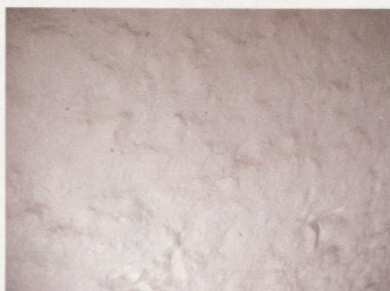
The survey revealed that wavy plaster was definable and observable and that large quantities exist in Dorset churches.

Figure 56
Whitcombe, wavy plaster.

The objectivity, accuracy and interpretation of this plaster survival is discussed in chapters 4.14, 5.8, 7.5. and in the other sections of this chapter. Individual examples of waviness are discussed in the photographic evidence section of chapter 15.

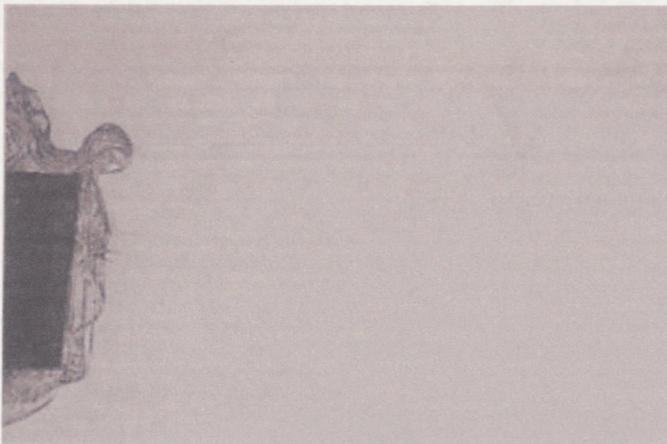
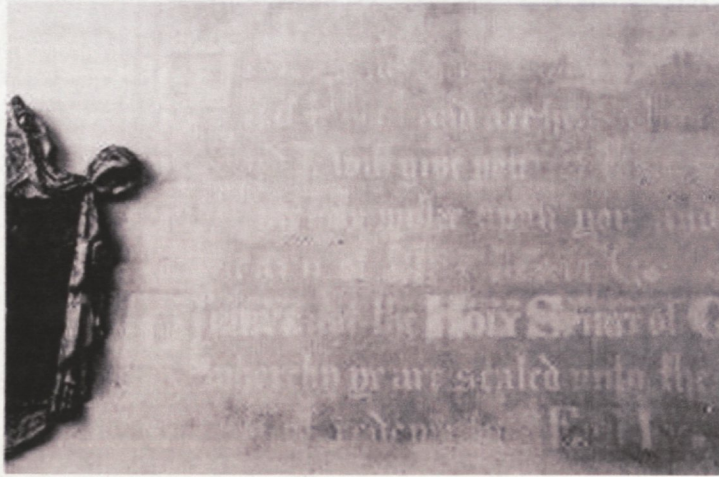
Figure 68

“Figure 10.2: Laxton (Nottinghamshire); south wall of the chancel prior to cleaning, as seen by the naked eye; faint traces of lettering are discernable (CJ Brooks)” (Wood, J., 1994, p.140.)

“Figure 10.3; Laxton (Nottinghamshire); south wall of the chancel as recorded by image enhancement photography, revealing the nature and extent of the painted decoration (C J Brooks)” (Source : Parsons, D ., and Brooks C., in Wood, J.,1994, p.140)

The original published quality of these photographs is so poor that it makes any conclusions very tentative.

However, there are clearly issues to be addressed. The upper image in *Figure 68* (10.2) is said to be “...prior to cleaning, as seen by the naked eye”. (Wood, J., 1994, p.140)

How far is the revelation of the lettering in the lower image in *Figure 68* due to cleaning and how much is due to computer image enhancement? There would seem to be a mysterious hazy quality around the area of visible lettering that could be explained as the remains of the limewash that had been cleaned from the lettering in the centre of the photograph. If this explanation is correct, it is not obvious what the role of computer enhancement may have been.

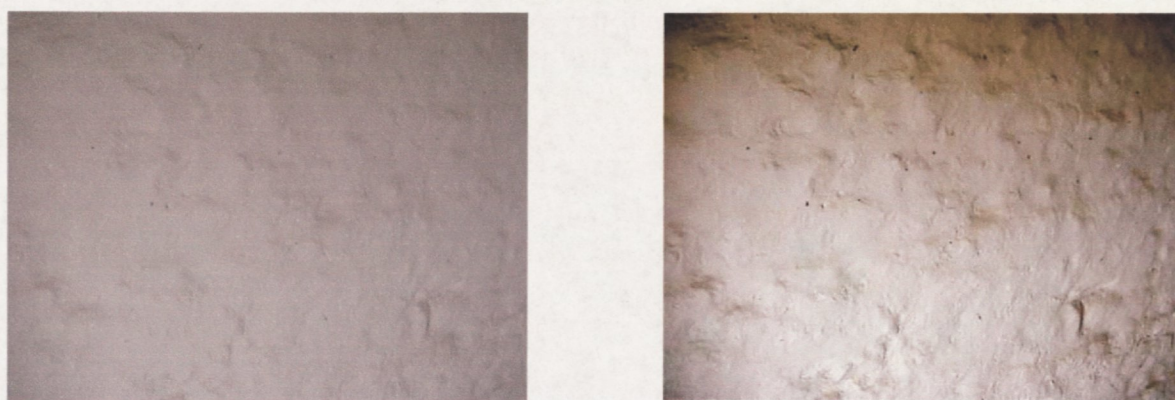
Figure 69

Whitcombe wavy plaster before (left) and after (right) adjustment of colour, brightness and saturation.

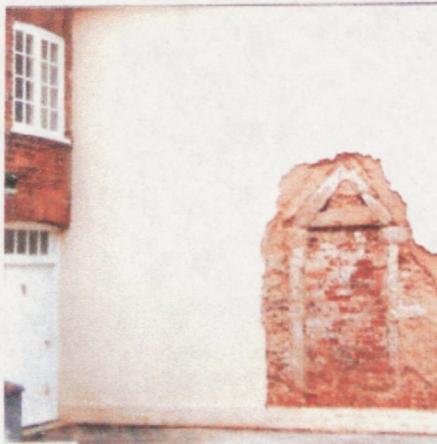
Figure 71

The same wall 'captured using infra-red thermography

The colours are 'false' and are used to represent temperature differences in the materials, and do not represent actual colours of the materials themselves
Darkest colours are the coldest areas
(Source : deMaus, as above)

The same wall after archaeological investigation
(Source : deMaus, as above)

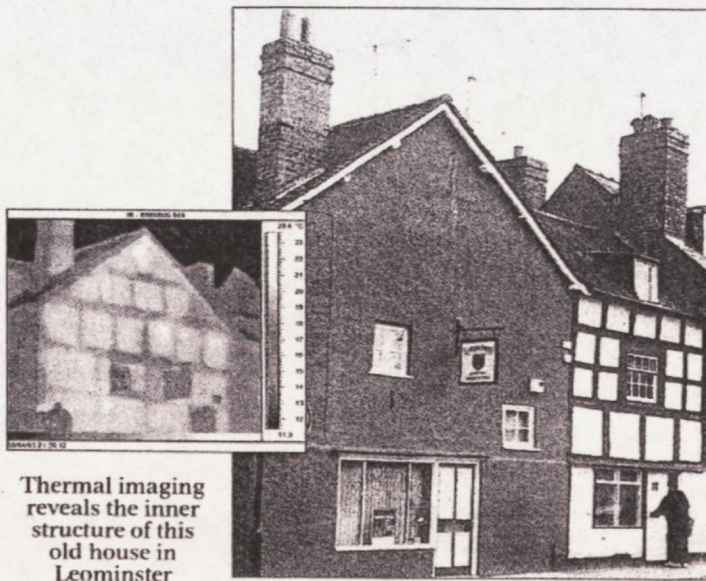
Interior structure (inset picture) of a rendered building revealed by infra-red thermography.

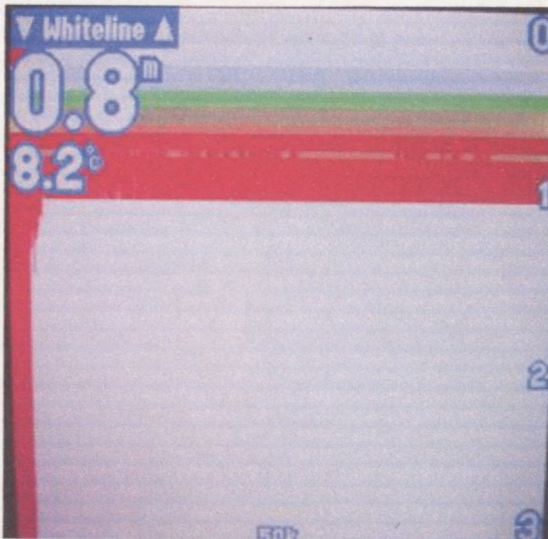
Figure 73:
Fishfinder tank trial results.

The large figure (0.8^m) represents the distance between the transducer and the bottom of the tank and is accurate to approximately 20 mm.

The graphic display produced was reasonably stable, and did produce banding that appeared to form an accurate, scaleable image of the thickness of the plaster samples.

However, adjustment of the controls to facilitate the best possible image, frequently introduced random effects into the display. These could not be analysed or explained within the structure of the trial, and thus introduced a level of uncertainty into all the data. It seems quite possible that the operating environment was introducing resonances and reflections of the ultra-sound impulses that could not be be correctly processed by the software.

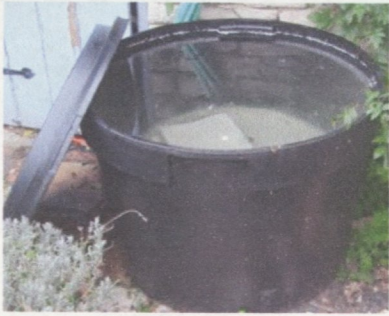
Figure 74
The test tank.

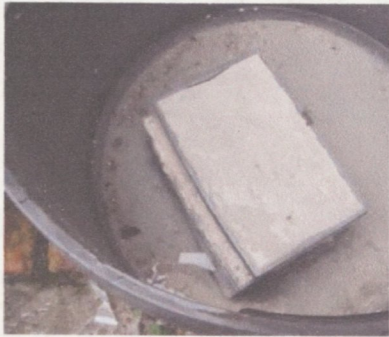
Figure 75
The test tank with three mortar samples installed. The white material at the bottom of the tank is a very thin layer of dust washed from the surface of the samples. It is not thought to have interfered with the trial results. The role played by the bottom of the tank, and the yard surface below it, is unclear and need further research.

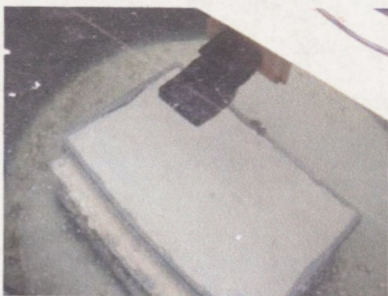
Figure 76
The transducer in place above the mortar samples. It is held by a simple wooded bridge above the water.

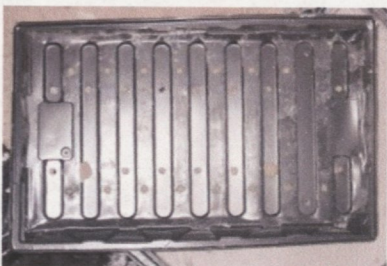
Figure 77
One of the seed trays used to cast the mortar samples.

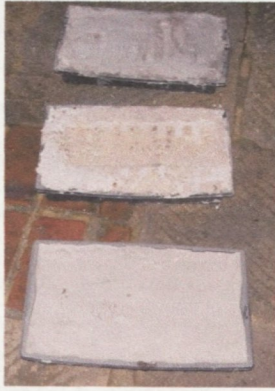
Figure 78

The three mortar samples :
top : OPC and sand (1:3)
middle : OPC, lime and Perlite (1:1:6)
bottom : Lime and sand (1:3)

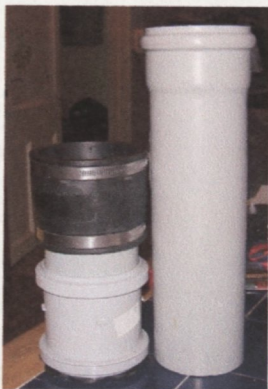
Figure 80

The test pipe was standard 100mm. extruded PVC soil pipe with standard fitting and connectors. The assembly had an overall length of 600mm. This allowed the transducer to be positioned 400mm. away from the surface of the sample.

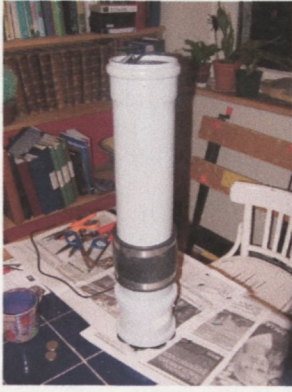
Figure 81

The lower part of the tube, containing the test sample, is connected to the upper part with a standard rubber drain connector. The purpose of the joint was to allow easy access to cast the sample.

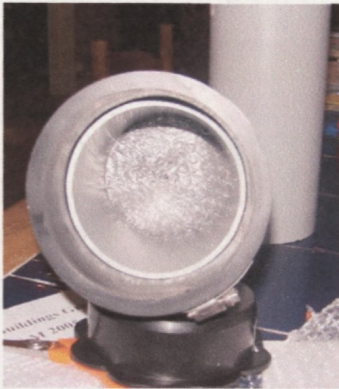
Figure 83

The bubble wrap installed prior to the placing of the lead and the mortar samples.

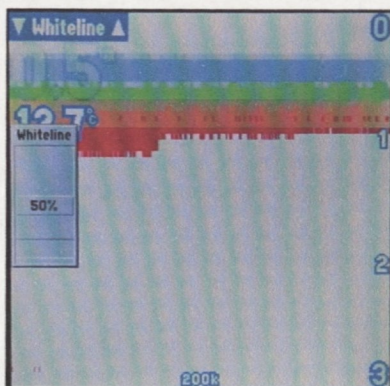
Figure 84

The pipe trial return results broadly in line with those of the tank trial. The following screen shot is typical :

In other words, the equipment appears to discriminate between the two samples (the blue and green layers), but the trial cannot be regarded as conclusive.

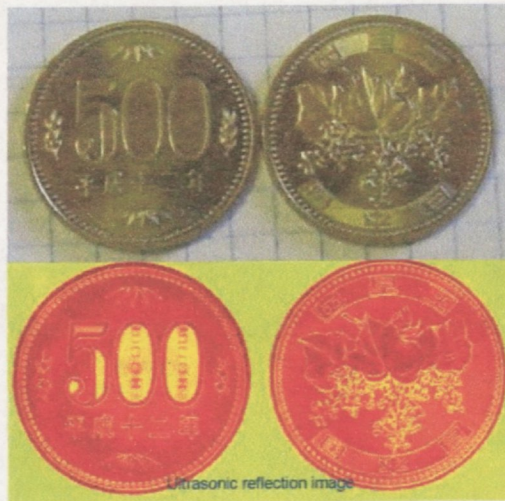
Single Transducer – Pulse-Echo
