Nasty, Brutish and Short? The life cycle of an Iron Age round house at Black Loch of Myrton, SW Scotland.

Journal of Wetland Archaeology

Nasty, Brutish and Short?; The Life Cycle of an Iron Age Roundhouse at Black Loch of Myrton, SW Scotland

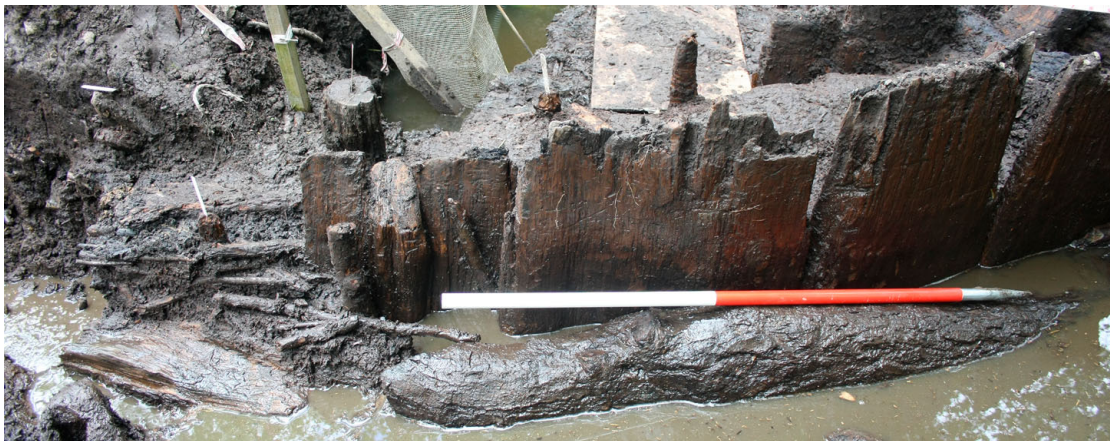
Figure 3. The oak plank façade to the left of the entrance. Courses of the wickerwork wall can be seen to the left, sitting just in front of the plank.

Oak planks had also been inserted into the outer wall and inner walls at the junction with the entrance. The planks sat tightly inside the outer stakeline, the wickerwork walling continuing around in front of the planks (Figure 3). They had been cleft from large, mature trees with estimated diameters of between 0.6 and 0.75 m, some of which would have been over 500 years of age when felled. Their felling, transportation and working must have represented a major investment in energy and resources. The line of planks would have strengthened what is usually the weakest structural section of a roundhouse, the junction between wall and entrance, while at the same time providing an impressive façade flanking the entrance into the house.

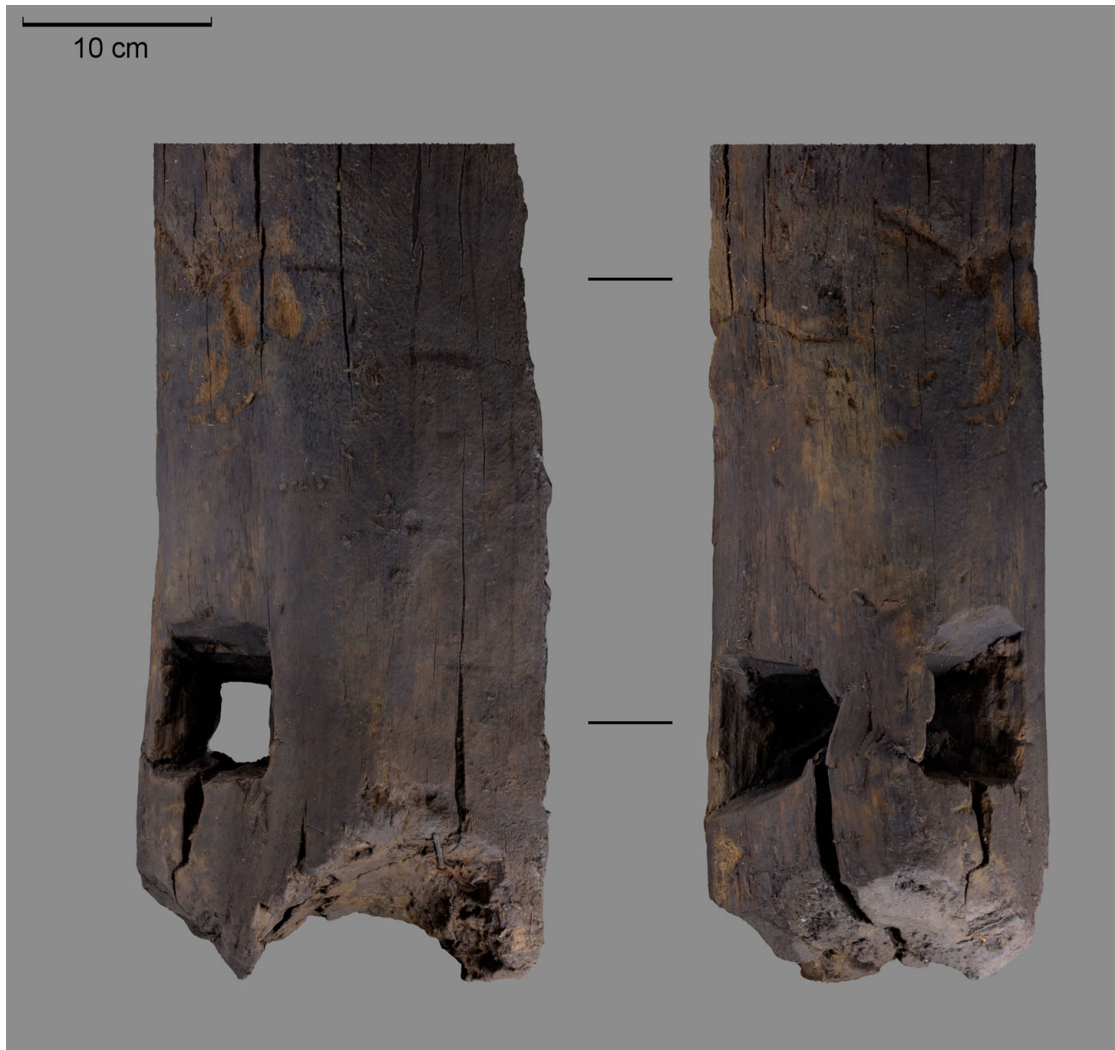
Figure 4. One of the oak posts of the outer post-ring displaying a concave base (orthographic view derived from photogrammetry). The roughly squared hole piercing one side of the post is a tow-hole which would have been used to drag the log from woodland to settlement. Many of the logs used in the settlement displayed these holes.

posts, of which six have been exposed. All the exposed posts have been fashioned from oak logs and all but one display concave bases which were presumably designed to fit over the radial logs of the sub-floor (Figure 4).

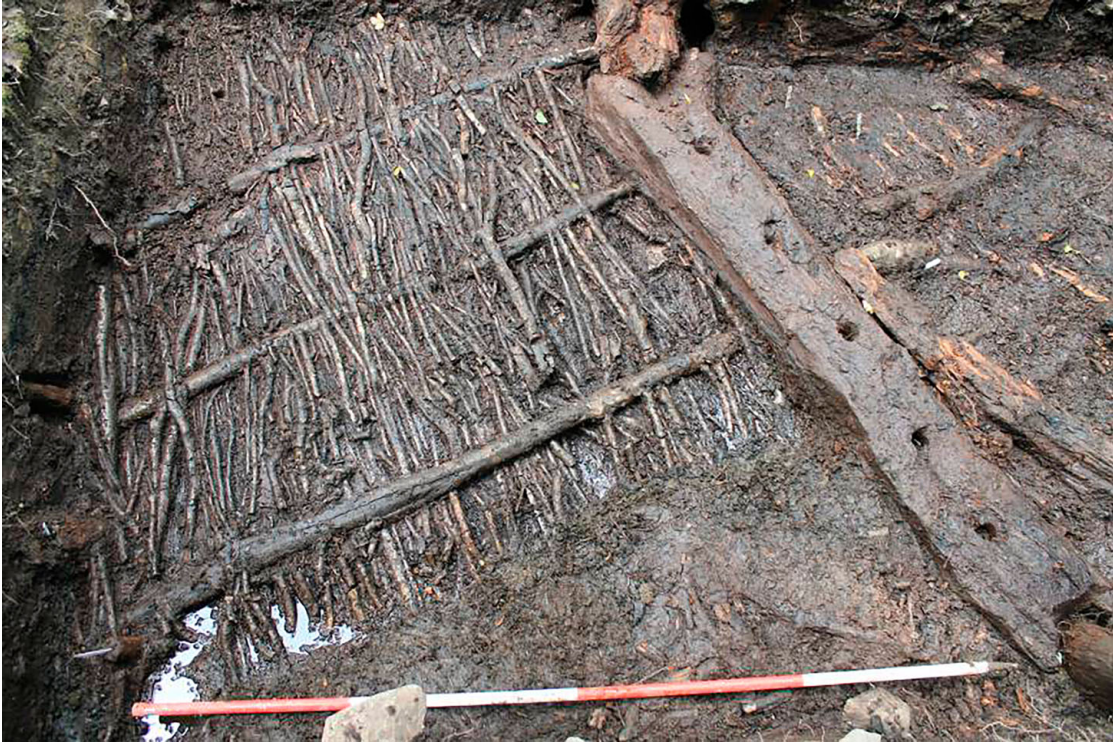
Figure 5. Sillbeam 223/1 *in situ* displaying stake holes and jointing around the posts. The stakes of the outer wall are visible to the left. The wickerwork screens formed the sub-floor of the Phase 1 building.

In between each post pair was a large alder sillbeam which had been laid directly over the wickerwork sub-floor. Most of these timbers were too decayed to preserve original carpentry details but the best-preserved example had been roughly squared, with five stake-holes cut along its length and shaped at either end to fit snugly around the upright posts, utilising a branch junction at one end to form this joint (Figure 5). These sillbeams would have created a major concentric division within the building (see below) but like the concave posts, they would have left no earthfast footprint.

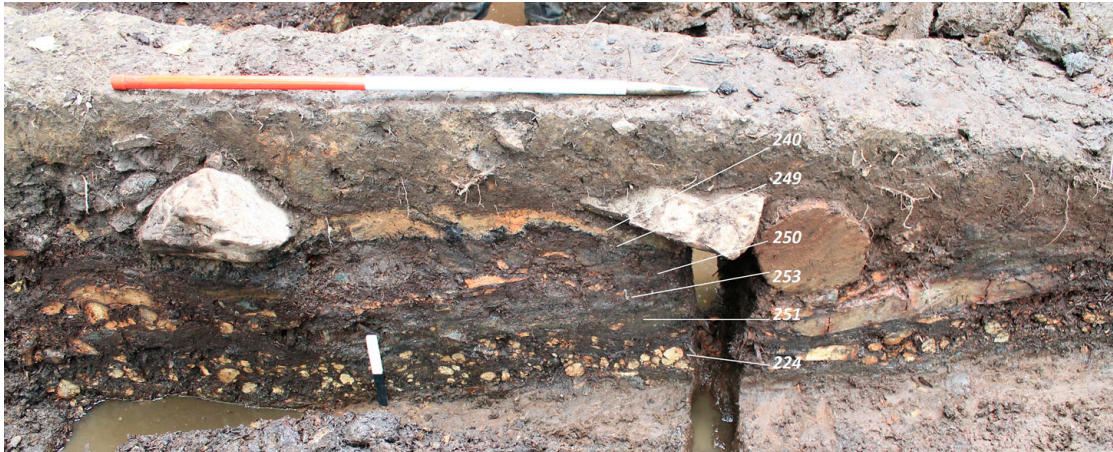
Figure 7. The full sequence of floor structures and surfaces is visible in this section. The Phase 1 wickerwork sub-floor lies at the base of the section, over the natural peat. Above this is [251], the plant litter floor surfaces, seen here as a grey-green layer. The Phase 2 brushwood sub-floor lies over this, followed by [250], the plant litter floors of this phase. The carbonised upper surface of this floor is visible, as is the orange clay laid immediately over it in Phase 3. The light brown peaty clay which covered the trench probably contains the mineralised remains of later organic floors belonging to this phase.

Immediately overlying [250] in large patches within the post-ring was a layer of carbonised plant litter between 0.03 and 0.04 m thick which is probably the burnt upper surface of [250] (Figure 7 – context 249). The survival of considerable quantities of charcoal, charred and reddened plant and fine mineral material suggests a relatively low temperature fire. It seems most likely that a spillage from the hearth caused the fire, which was prevented from spreading into the outer area beyond the post-ring by a screen of some sort. This conflagration probably brought this phase of activity in the house to an end.

In the final refurbishment of the house, the hearth was reduced to approximately half its original area from *circa* 7 m² in Phase 2–3.5 m² (Figure 7). A loosely constructed kerb of stones was laid just within and over the existing Phase 2 timber framework and a layer of clay, flecked with charcoal and burnt bone was spread over the surface area within the timber framework to form the foundation for Hearth 2. Within this outer kerb a line of four large oval boulders formed an inner kerb around the S edge which may have originally encircled the hearth and within this large greywacke slabs formed the working surface (Figures 7 and 10).

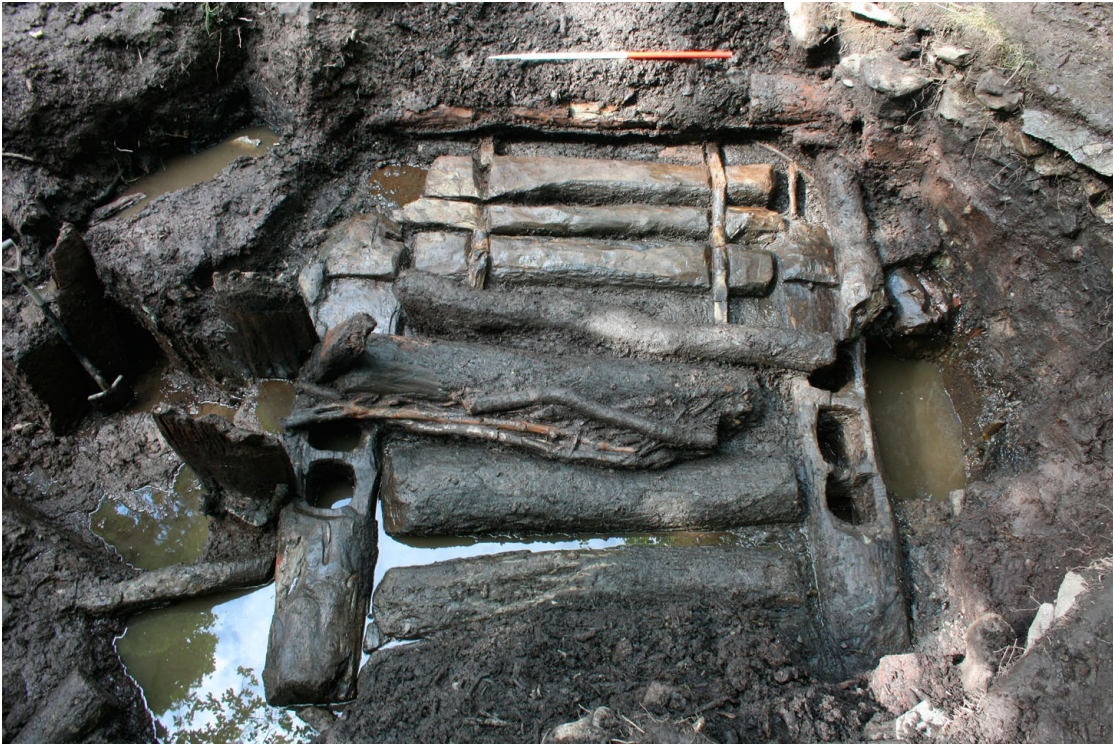
Figure 8. The Phase 1 entrance structure, looking into the building, with the oak planks of the outer wall still *in situ* where they abut the entrance.

The sides of the primary entrance structure were defined by two large radial logs 2.2 m long and set 1.70 m apart (Figures 2 and 8). A row of three closely-set mortices penetrated both logs, just at the point where the outer wallfaces met the entrance; these housed squared oak posts which would have formed the terminals of the outer wall and also lined the passage into the house. The inner ends of these radial sleeper beams had been dressed flat but the outer ends had not been worked, the bark still in place.

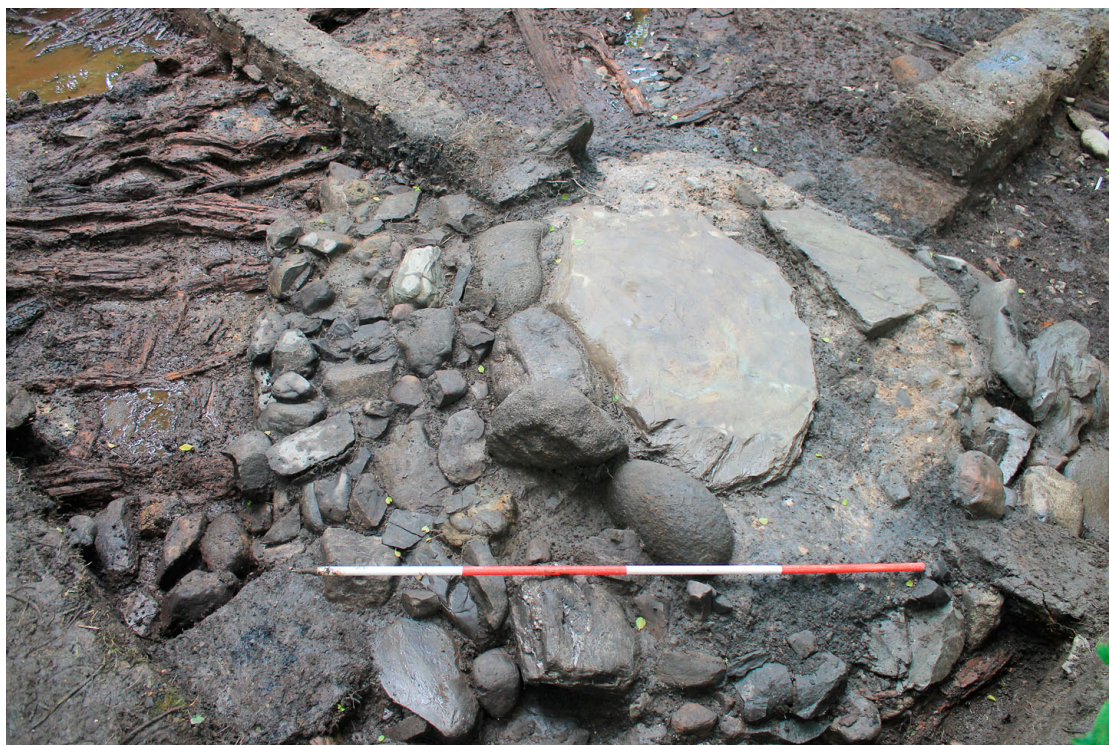
Figure 10. Hearth 2.

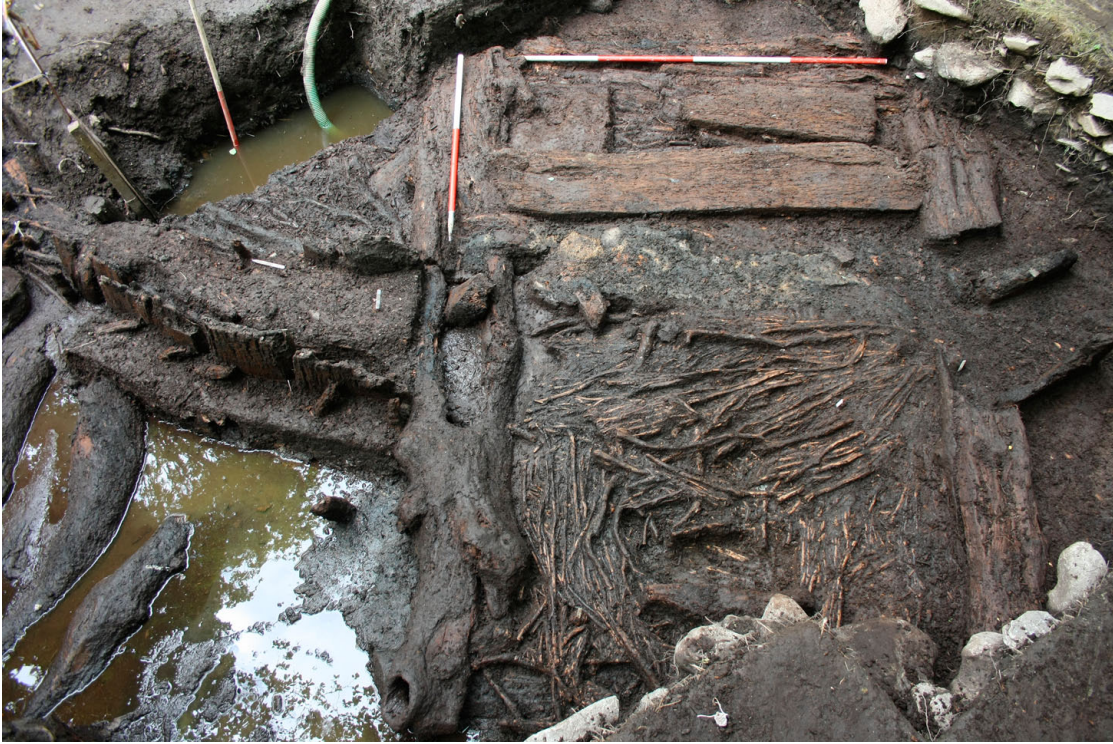
Figure 11. The Phase 2 entrance structure, looking into the building.

This framework was much more shoddily built than the Phase 1 entrance. New radial logs were laid directly over the Phase 1 logs (Figure 11). These radials were fashioned from undressed half-logs of alder, the curved surface of the log uppermost; it is possible that they are the two halves of the same log.

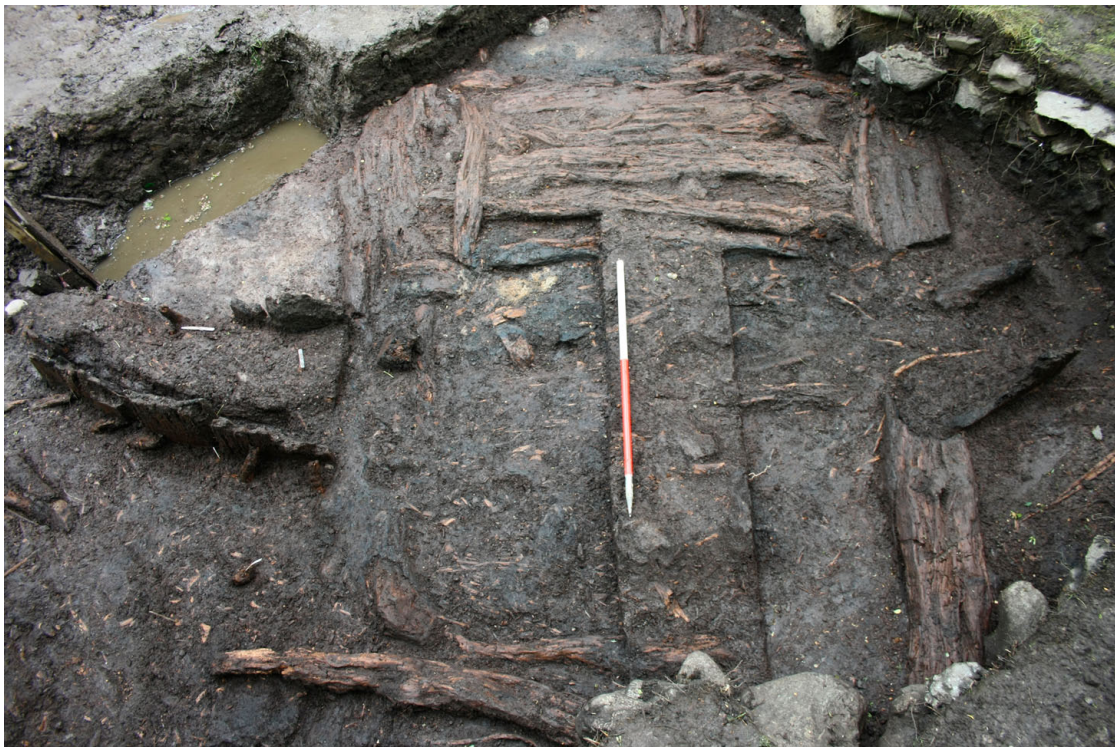
Figure 12. The Phase 3 entrance structure, looking into the building.

The final phase in the entrance area consisted of resurfacing rather than reconstruction and probably happened rapidly after Phase 2 because the new surfaces lay directly over the earlier ones with no evidence for any build-up of debris. The resurfacing consisted of a rectangular area of small alder logs, a 'welcome mat', which had been laid directly over the oak plank surface of the previous entrance (Figure 12). It was 2.2 m by 1.4 m, and was defined by two radial logs between which a continuous surface of tangential logs had been laid.

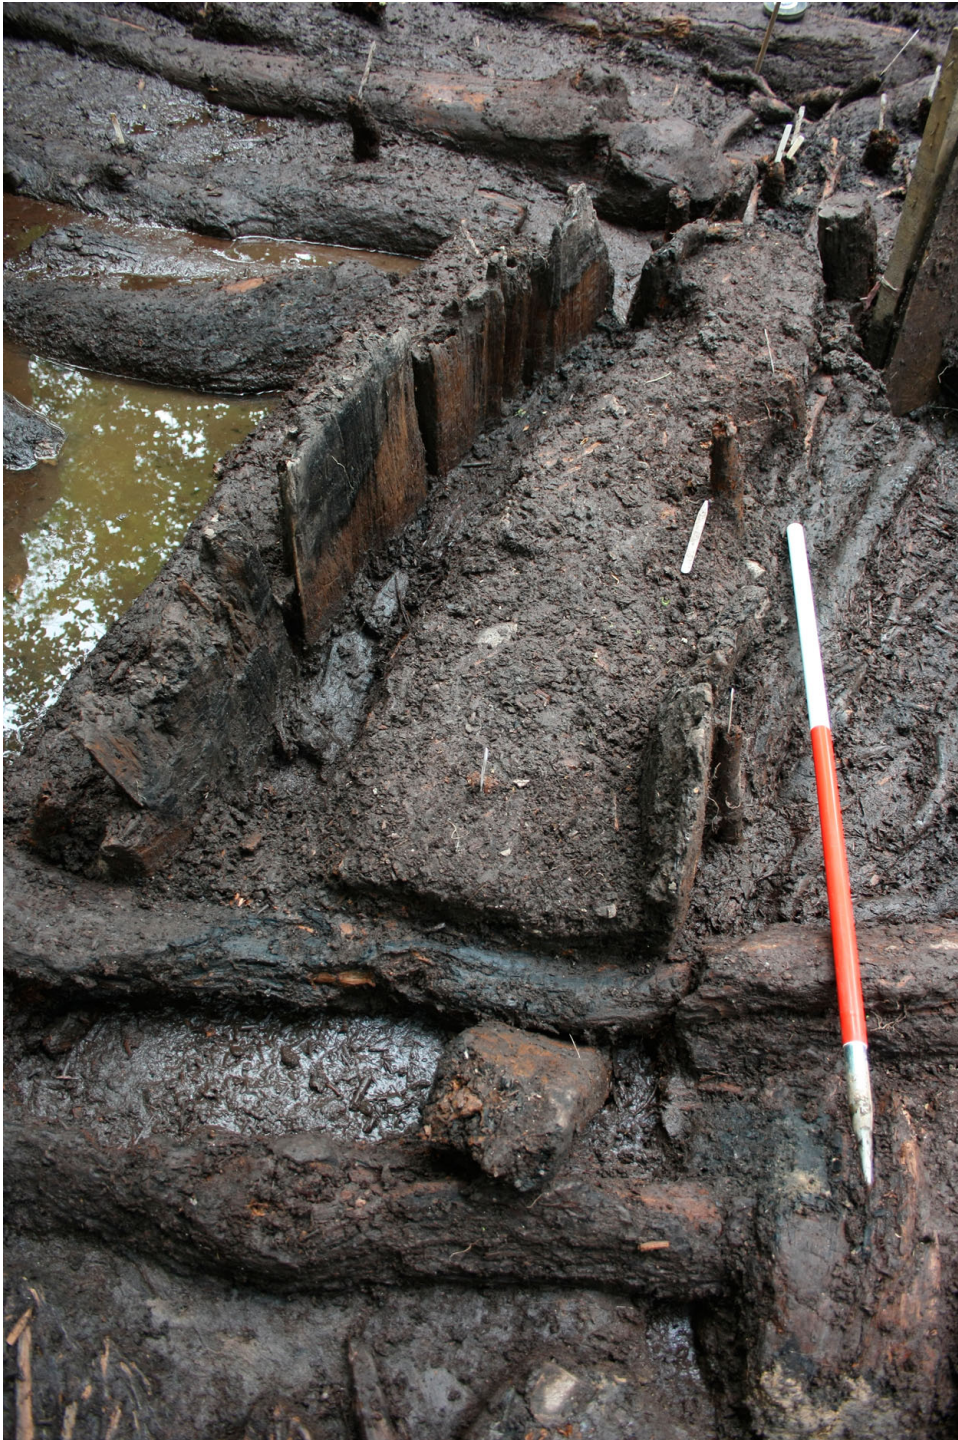
Figure 15. The plank walling of the outer wall at its junction with the entrance. Charring on the inner faces is visible. In the foreground the radial defining the lefthand side of the entrance is also clearly charred.

The bases of the posts and walls had obviously remained *in situ* so the structure was not entirely dismantled but there is evidence to suggest that a controlled burning event may have signalled the end of its life. The tops and inner faces of the planks on both sides of the entrance, as well as the tops of the posts in the eastern entrance terminal, were all charred, as was the radial log forming the eastern side of the Phase 2 entrance at its junction with the plank wallfaces (Figure 15). Within the cavity of the outer wall there were large quantities of carbonised withies, brushwood and plant remains. There is no evidence of burning within the interior or the entrance, apart from the charred tops of a few Phase 3 timbers and some of the trackway logs abutting the outer wall. This suggests that fires may have been set and contained within the outer wall. It also implies that, by the time the fire was started, the roof and the upper parts of the walls and posts had either been removed or had rotted down because there is no evidence, in the form of a charcoal horizon across the footprint of the house, to suggest that there had ever been a major conflagration. At one of the Iron Age farmsteads on the Assendelvers Polders in the Netherlands, some of the roof supports had been chopped off prior to abandonment, presumably to salvage usable timber (Therkorn et al. 1984, 365). The authors pointed out there that the roof would have had to have been dismantled before this could happen and this could also have occurred at Black Loch.
