Landsliding on the south east coast of the Isle of Wight: nature, characteristics and causes

Cole, G. (2013) 'Landsliding on the south east coast of the Isle of Wight: nature, characteristics and causes', *The Plymouth Student Scientist*, 6(2), p. 124-176.

Grant Cole

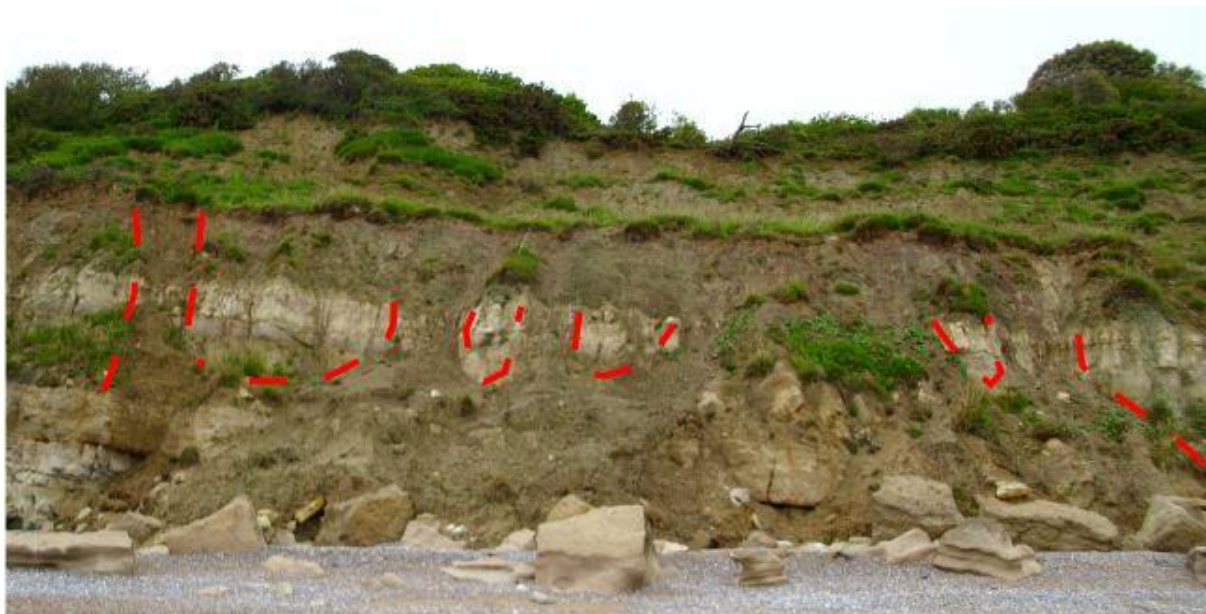
Figure 3.3 Complex landslide with main type of movement (25) being flow type (Whitecliff Bay).

The Fall type landslides seen at Culver Down (Whitecliff) (Figure 3.1 & photo 3, Figure 3.12) show an accumulation of rocks at the base of the cliff / slope, which can vary in size (see landslide inventory; appendix C). The flow type landslides in Whitecliff Bay have a typical channel shape to them which then expands at the front in a lobate structure (Figure 3.2). Complex landslides with flow as the main movement types are similar but due to there being many converging flows the lobate form is lost for this particular landslide (Figure 3.3).

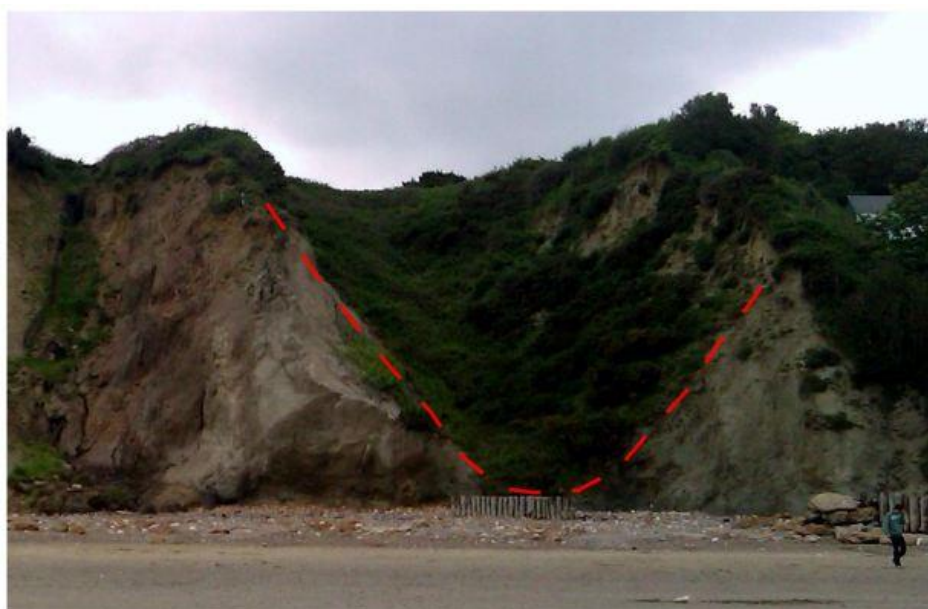
Figure 3.4 Cross-sectional shape of a Translational (planar) landslide (16) in Whitecliff Bay (south).

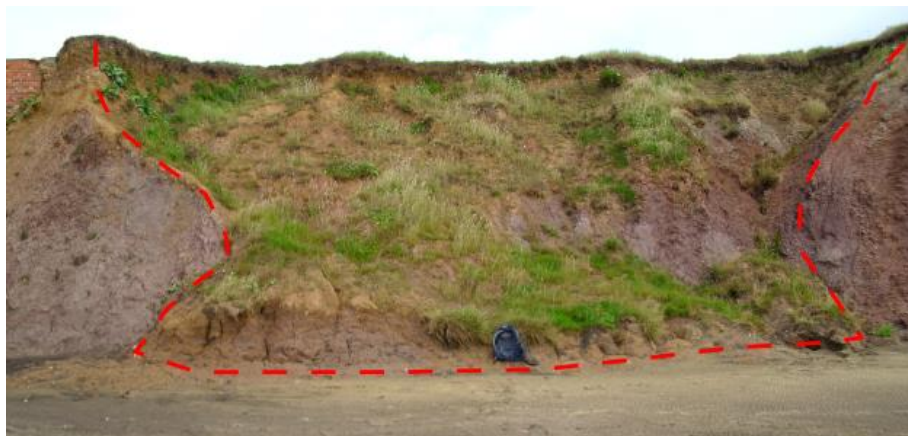
Figure 3.6 Shallow Translational (planar) landslide in Sandown Bay, failure occurring near top of cliff (2). 40L back pack for scale.

The translational (planar) slides in Sandown Bay are different to the ones in Whitecliff Bay (Figure 3.6); the U-shape form is lost, except possibly at the back of this landslide where the failure originated from, they also have a mass of material accumulating at the front of the landslide that has not rotated.

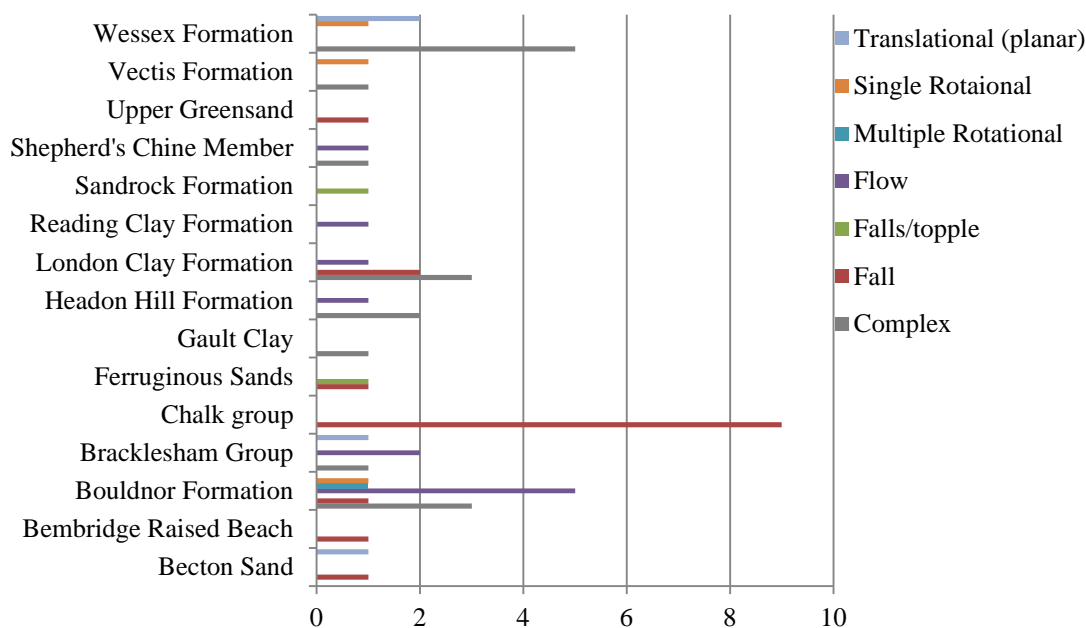
Figure 3.13 The relationship between chronostratigraphy and landslide type for landslides involving a single chronostratigraphic unit.

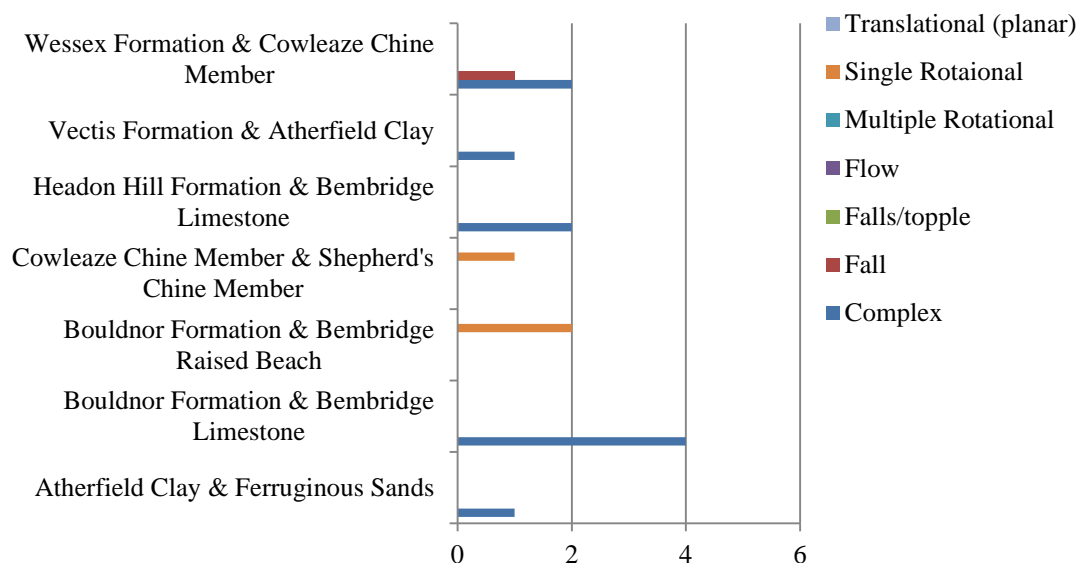
Figure 3.14 The relationship between movement type and chronostratigraphy for landslides involving two chronostratigraphic units.

Wessex formation and Cowleaze Chine member, which exhibit two types of failure (Figure 3.14).

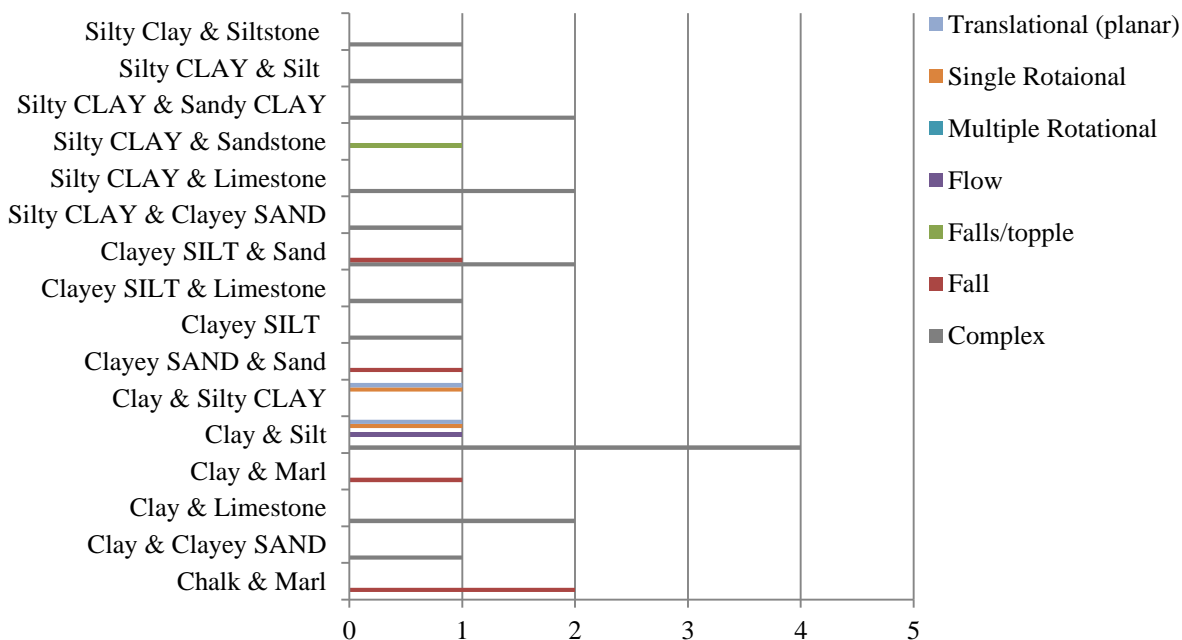
Figure 3.16 The relationship between movement type and lithology for landslides involving two lithologies.

landslide involved lithified material with Chalk being the most common (Figure 3.15-3.17).

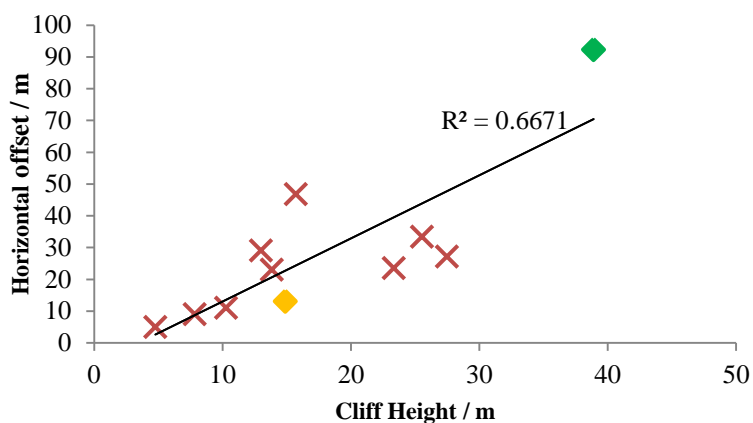
Figure 3.18 The relationship between cliff height and horizontal offset of rotational slides, also showing the front rotational slide of a multiple rotational landslide (green diamond) and a translational (planar) slide (orange diamond). Trend line calculated using linear regression.

There is a positive relationship between cliff height and horizontal displacement with rotational slides (Figure 3.18). The same trend can also be seen for vertical offset (Figure 3.19). The multiple rotational and translational (planar) also generally fit this trend (Figure 3.18 & 3.19). However, the multiple rotational landslide falls the furthest away from the regression line. The regression line for both does not pass through the origin, showing that offset will not occur until about 4/5 meter cliff height (Figure 3.18 & 3.19). The R^2 values show that there is a stronger relationship between cliff height and vertical offset than horizontal offset.

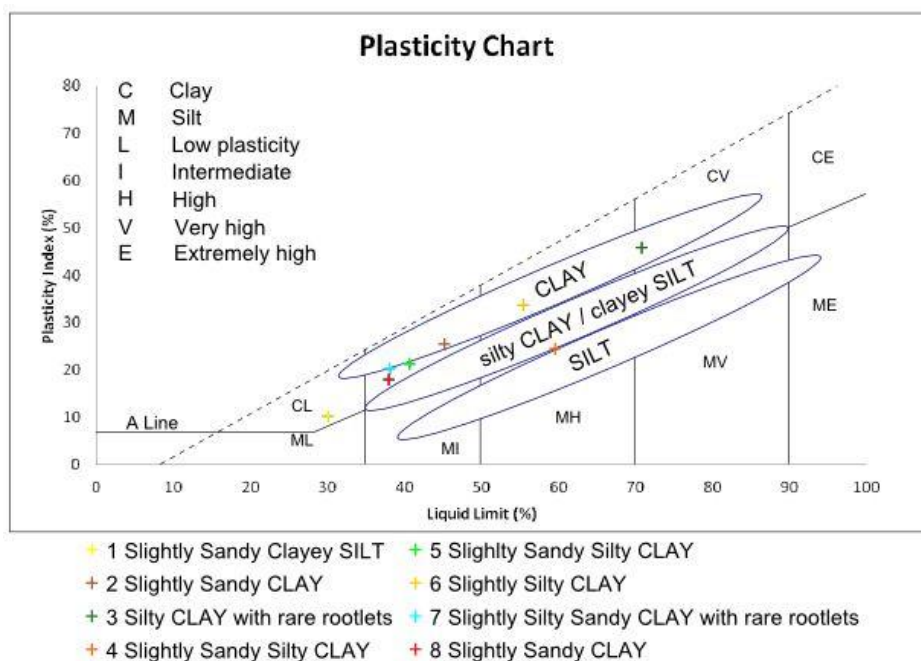
The plasticity chart (Figure 3.23) shows the soils have a wide range of plasticity from low to very high and all but one of the samples plot above the A line. It also shows that samples can generally be classified as Clays with the exception of sample 4.

Figure 3.23 Plasticity chart after Figure 4.17 Norbury (2010).

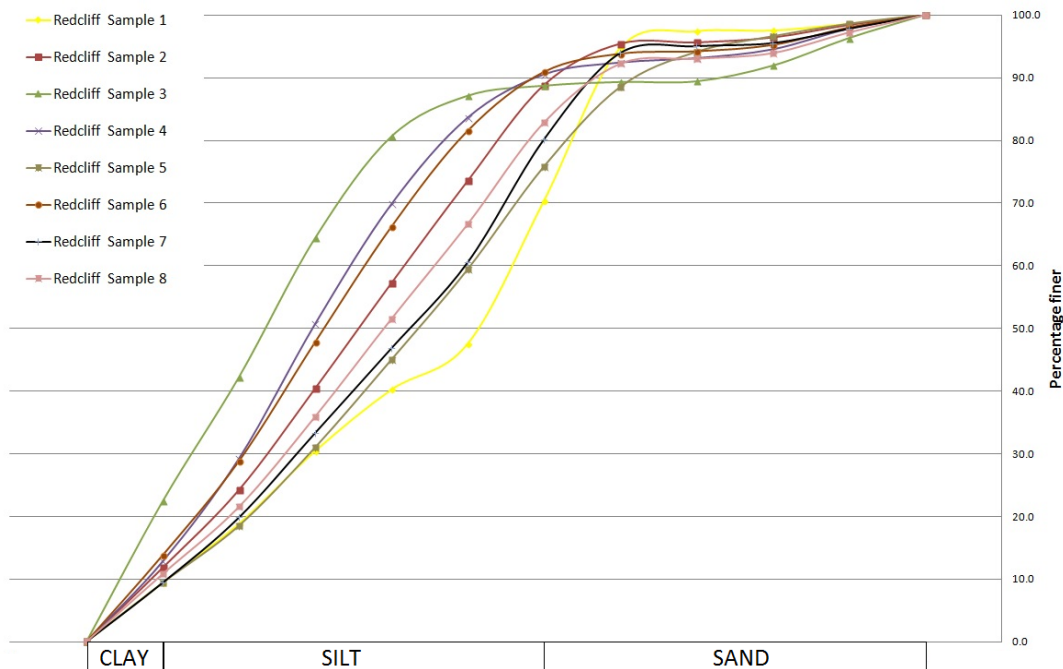
Figure 3.24 Particle size distribution plot (see appendix D for percentage break down) for the samples taken from the Complex landslide at Red cliff (Sandown Bay). Numbers correspond to locations samples were taken (see geomorphological map Figure).

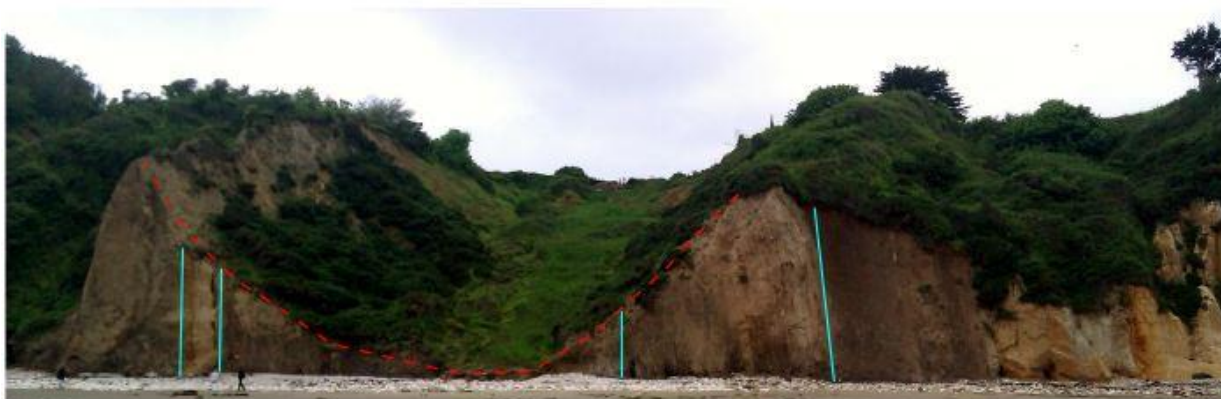
1982). However, landslides 11, 14, 15, 16 and 17 (Figure 3.12) are all occurring where bedding surfaces (contacts) occur and thus they could be making the slopes more susceptible to landsliding. Landslide 9 (Figure 3.12 & 4.4) shows that the deepest part of the landslide is in the centre implying that the failure occurred towards the centre of the landslide and thus away from the bedding surfaces, showing that they may have had little influence on this landslide.

Figure 4.4 Complex landslide (9, Figure 3.12) showing the relationship between bedding surfaces and the extent of the landslide.

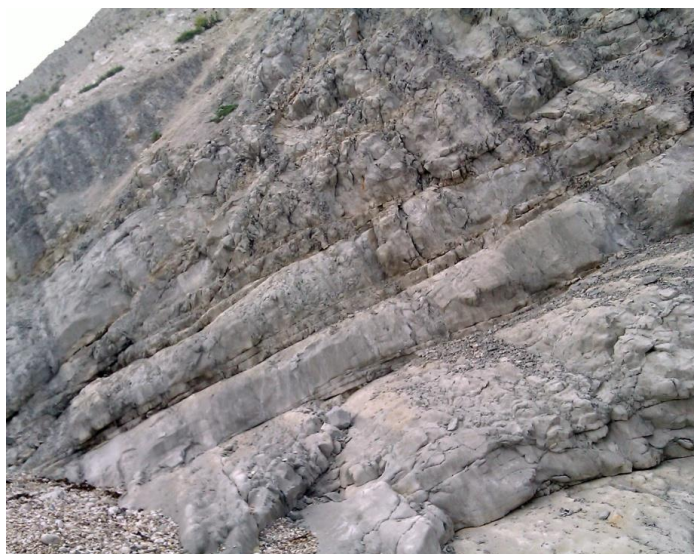
The effect that discontinuities can have on the susceptibility of a lithology to landsliding is highlighted by the chalk forming the cliffs at Culver cliff. Apart from the Limestone in Whitecliff the Chalk is the strongest material in the study area (Table 3.8) but rock falls are dominantly occurring along the cliffs (Figure 3.12). This is most likely due to the well developed discontinuities that run almost perpendicular to the bedding (Figure 4.5). Discontinuities influence the stability of a rock slope (Piteau and Peckover, 1978), acting as possible planes of failure (Foster, 2007), thus these discontinuities will then allow the chalk to detach with little or no shear which normally occurs with fall type landslides (Cruden and Varnes, 1996). It is then due to these discontinuities that the cliffs consisting of chalk and marl are highly susceptible to Fall type landslides and highlights how they can weaken a material.

Figure 4.5 Discontinuities developed in the interbedded chalk and marls at Culver cliff. Notice that the discontinuities are running at nearly right angles to the bedding. This was also seen in the whiter Chalk succession seen after this.

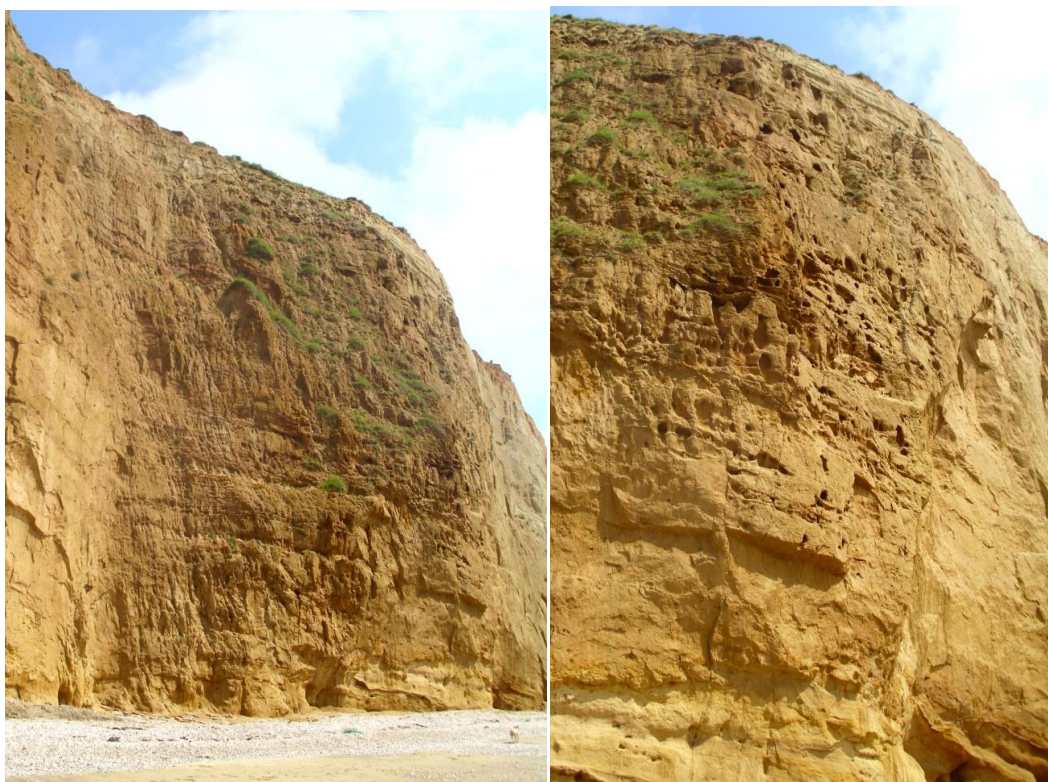
Even though the sea does not reach the base of the cliff at the Ferruginous Sands (Figure 3.9), there is still evidence of marine processes affecting the sands in the form of tafoni (Figure 4.8). The tafoni is most likely due to salt weathering (Huinink et al. 2004), due to it being a coastal setting, and is an example of cavernous weathering and results in the weakening of the cliff face (Mol and Viles, 2012). Thus, this can lead to the development of material falling from the cliff face and as tafoni structures can grow in size and coalesce to form larger forms (Sunamura and Aoki, 2011), this then could allow material to detach without shearing to produce falls.

Figure 4.8 Tafoni forming in the sand cliffs of the Ferruginous sands in Sandown Bay.
