Field and laboratory investigation into scour around breakwaters

The Plymouth Student Scientist

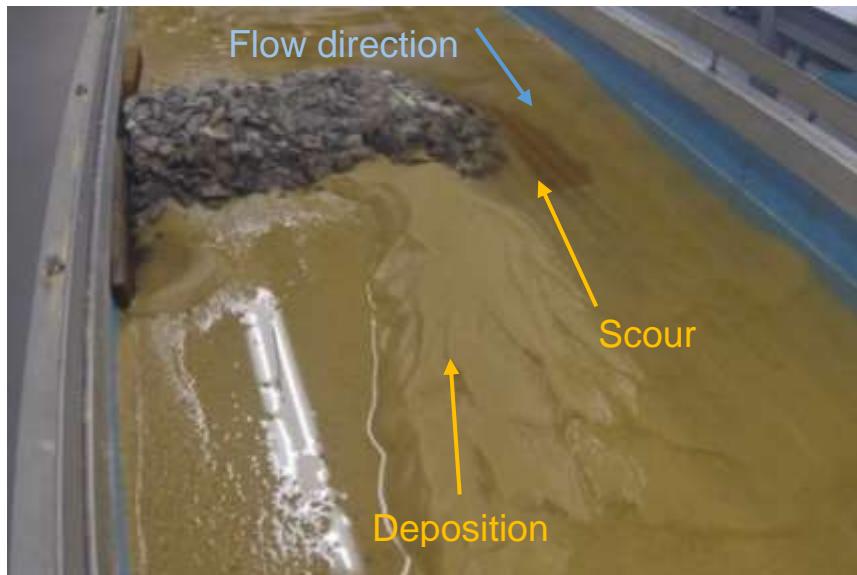
Figure 1: Scouring and deposition of bed material downstream of a structure.

This erosion of material is caused by the presence of the structure disturbing the flow of the water, this can narrow the channel of flow leading to an increase in the speed of the flow through the relationship of $Q = VA$ where Q is the flow rate, V is the velocity and A is the cross sectional area. This increase of velocity leads to an increase in turbulence which generates vortices which in turn lead to the removal of bed material close to the structure (Whitehouse, 1998).

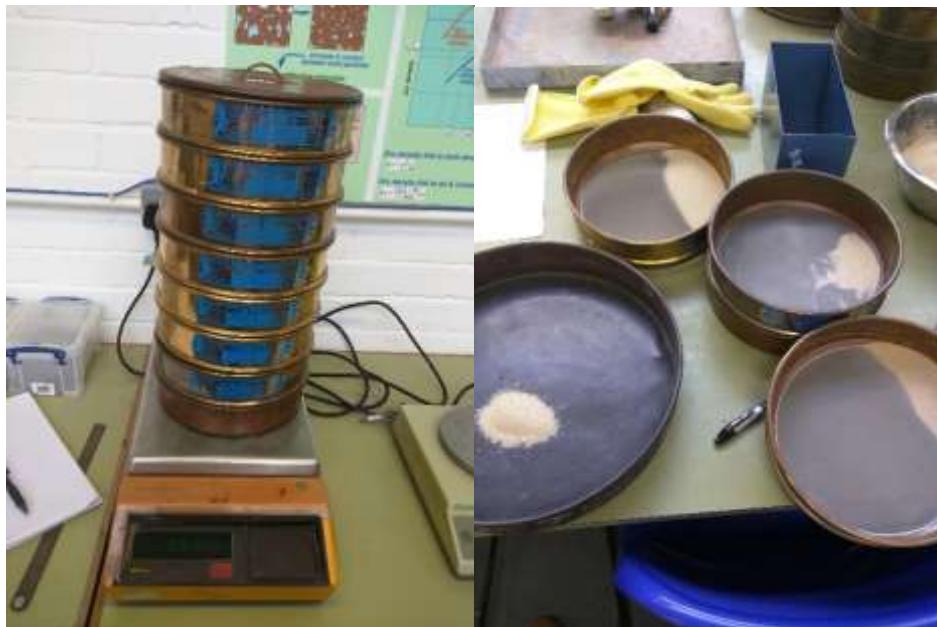
Figure 2: a) Sieve test apparatus b) Individual sieves showing collected bed material post-test.

In preparation for the preliminary experiments a sample of the sediment in the tank was taken, dried in an oven over night and sieved to examine the size of the sediment. The sediment in the tank was constant throughout the tank but the sample

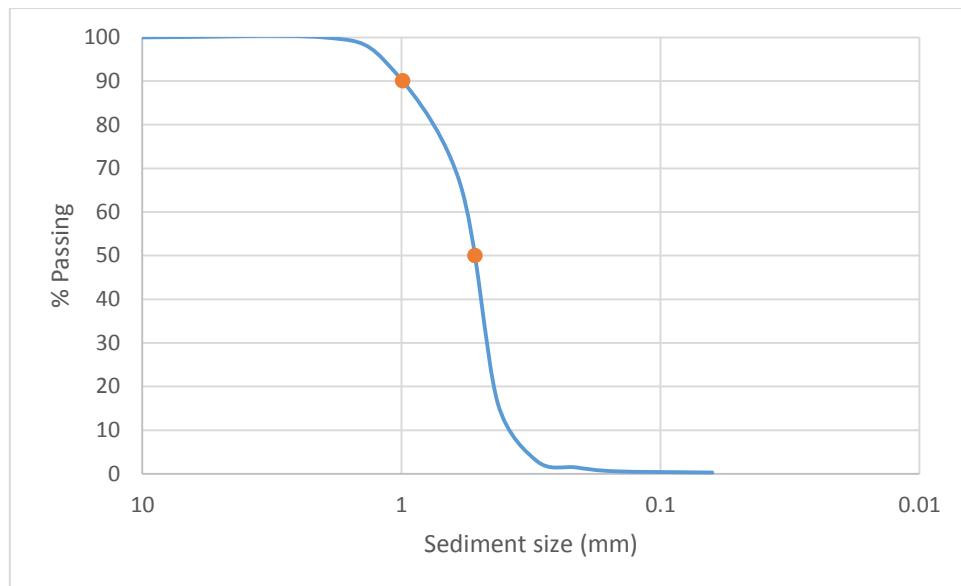
Figure 3: Percentage passing vs sediment size for bed material

The sieving of the sand concluded that the bed material was fine uniform sand based on the percentage passing for D₅₀ and D₉₀. D₅₀ was found to be equal to 0.52mm and D₉₀ was found to be equal to 0.99mm, this is shown in Figure 3. This sand was used as sediment in the tank to represent the sea bed material.

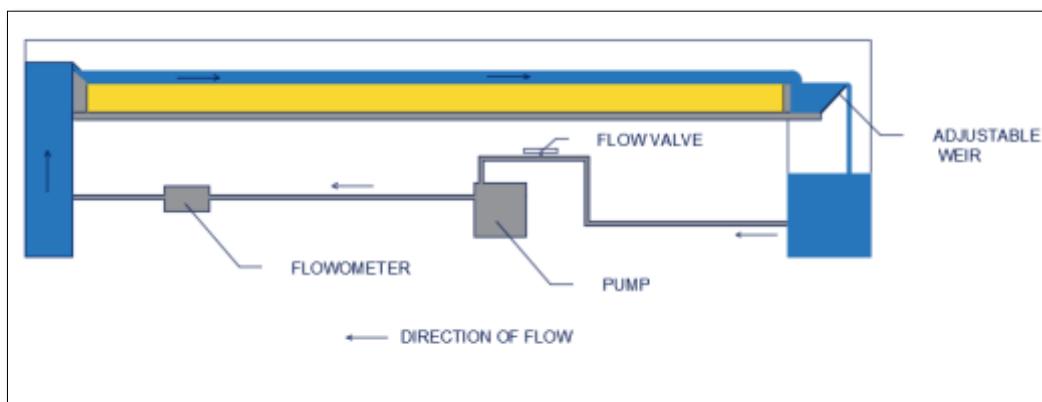
Figure 4: Diagram of Alborn Rig

Preliminary testing was conducted in an Alborn Rig to investigate the limitations of the apparatus and provide an insight into to the scour depths and patterns achievable using different parameters. This preliminary testing was conducted before the bathymetric survey in order to ensure that the relevant data was collected in the limited time available for that phase of the project. This reduced the likelihood of having to repeat the bathymetric survey at a time when there was significant risk of unsuitable weather conditions. Due to the physical limitations of the Alborn Rig a maximum length of breakwater section that can be used was 40cm and the maximum depth of water achievable was 5.5cm. These dimensions gave the most accurate representation of water, sediment and model interaction. Figure 4 shows the main elements of the Alborn Rig.

The Alborn rig consisted of a flume of dimensions 0.62m wide by 2.04m long with an overall depth of 0.2m which includes the 0.06m sediment bed depth. Figure 5 shows the relationship between structure, water and sediment inside the tank.

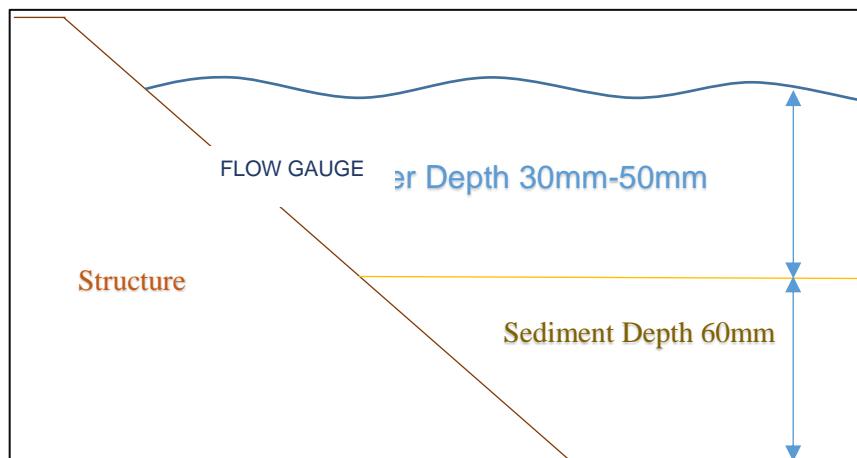
Figure 5: Cross section at end of structure showing sediment layer

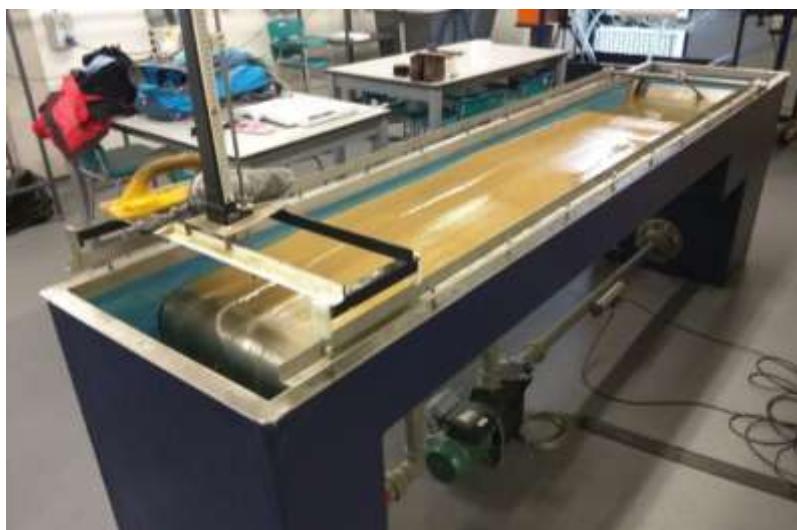
Figure 6: Alborn Rig

The Alborn rig shown in Figure 6 has a BomBa PSH Mini 80M 220-230 Volt pump that pumps fresh water through a 48.3mm diameter plastic pipe. An adjustable weir located at the downstream end of the flume acts as a sand trap as well as being used to control the water depth upstream. The level of the sand in the tank was measured using a point gauge and was levelled out to the same level for every test undertaken.

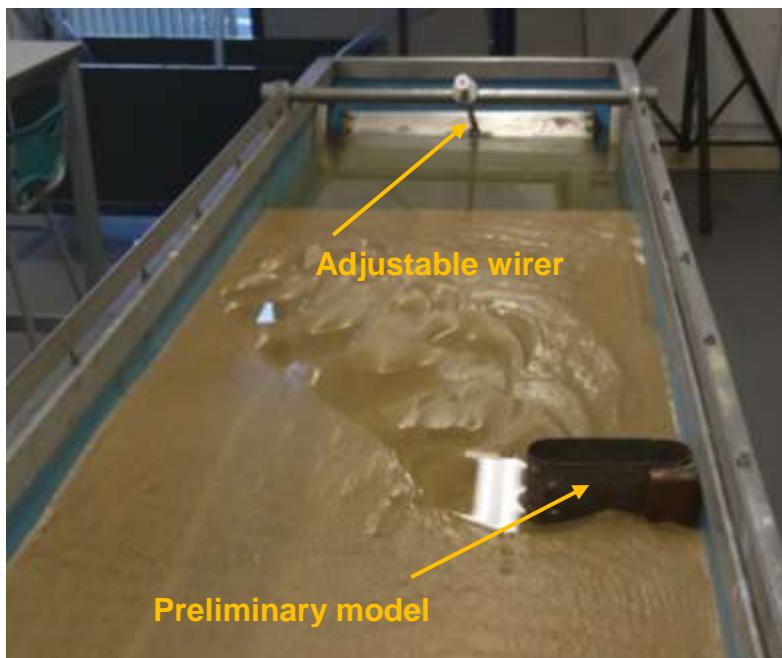
Figure 7: Preliminary model in Alborn tank post equipment limitation testing

The equipment was adjusted to explore the range of water depths achievable. Due to equipment design, an upper depth limit of 60mm was identified; while the lowest depth was set to 20mm as determined by the scaling effects. Similarly the adjustable weir was lowered to increase the flow in the tank and a max flow rate of 3.7 l/s was achieved at a water depth of 50mm. An initial rough model of 1:1000 scale was used to conduct preliminary testing in the laboratory as shown in Figure 7.

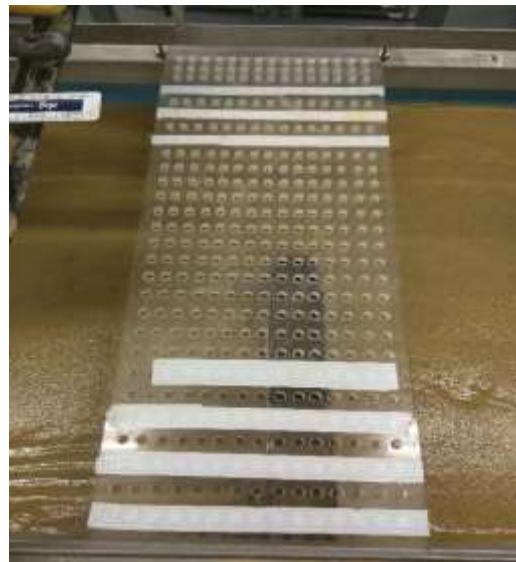
Figure 8: Grid used for measuring spot depths shown over preliminary model

depth was measured at specific locations using the grid shown in Figure 8. This process was repeated for all the subsequent tests.

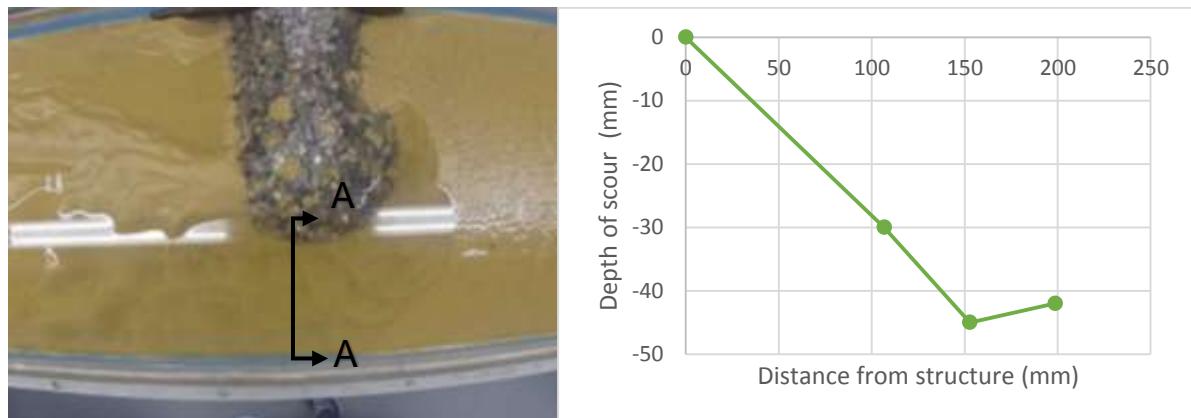
Figure 9: a) Falmouth model plan view of scour post-testing of 50mm water depth with a flow of 3.7 l/s b) transect A-A profile

Figure 9a shows the scour hole around the structure post-test and highlights the line of the scour hole which is represented in Figure 9b.

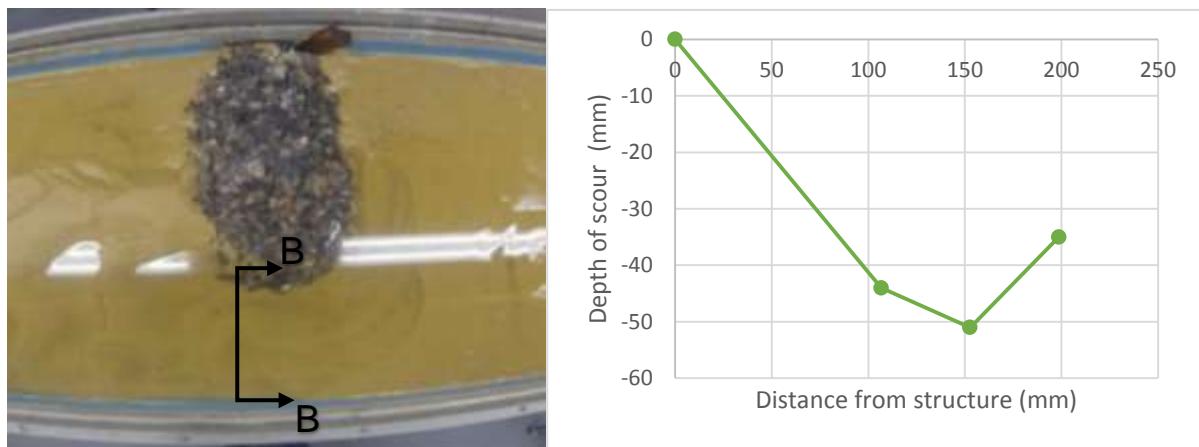
Figure 10: a) Mount Batten model plan view of scour post-testing of 40mm water depth with a flow of 3.7l/s b) transect B-B

Figure 10a shows the scour hole around the structure post-test and highlights the line of the scour hole which is represented in Figure 10b.

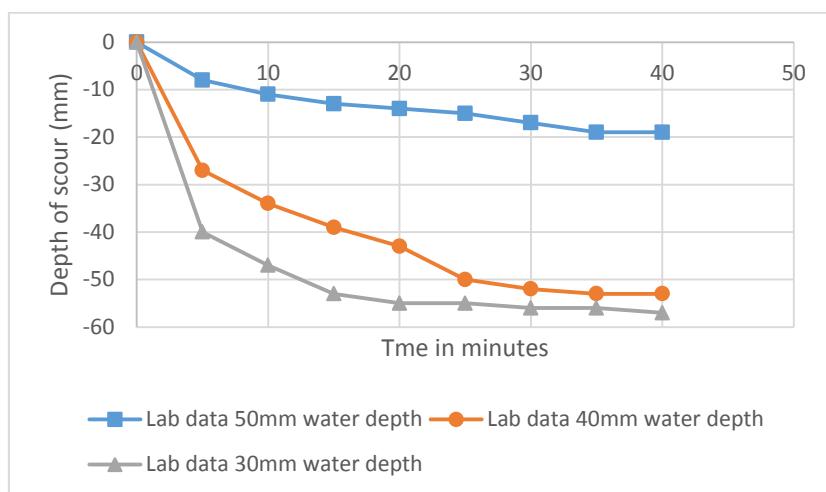
Figure 11: Preliminary scour depth vs time

Figure 11 shows the time taken for equilibrium to be reached during testing of three different water depths; 50mm, 40mm and 30mm. The depths represented in this graph are the maximum depths achieved and show that with a shallower water depth of 30mm the greatest depth of 57mm was obtained, whereas a maximum depth of 18mm was reached with a water depth of 50mm. This indicates a higher local velocity of flow past the structure with the shallower water depth. Both the 40mm and 30mm water depths follow the same trend and indicate that with this increased flow a greater scour representation is achievable. 30mm is the smallest water depth investigated in this experiment due to scaling effects discussed previously. 50mm water depth was the largest depth achievable while a sediment depth of 60mm was maintained across all tests.

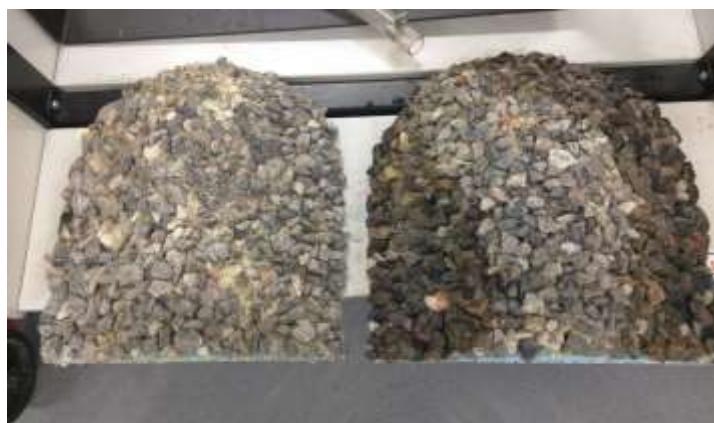
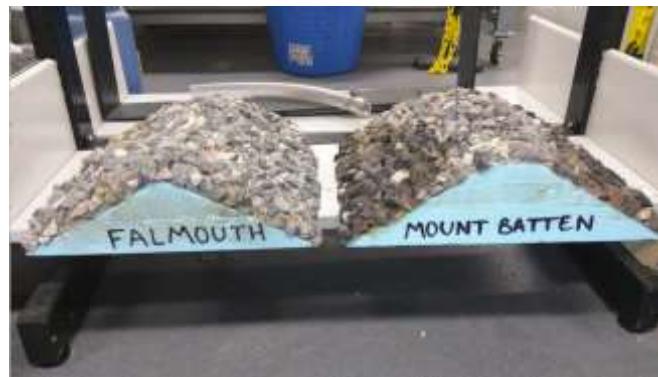
Figure 12: a) Plan view of Falmouth and Mount Batten models (L-R) b) Elevation view of Falmouth and Mount Batten models (L-R)

Froude scaling and symmetrical scaling were used to produce a model of the Mount Batten breakwater at a 1:80 scale and a model of the Falmouth breakwater at a 1:100 scale shown in Figure 12a and 12b.

Both the Falmouth and Mount Batten breakwater models made for this project were comprised of a dense foam core that geometrically represents the core layers of the breakwaters. Two layers of aggregate covered the foam core, one layer of 20mm and one layer of 10mm. The aggregate layers are attached to the foam cores using a silicone sealant which allows flow of water around the individual stones but provides a strong hold and prevents the stones being removed during testing.

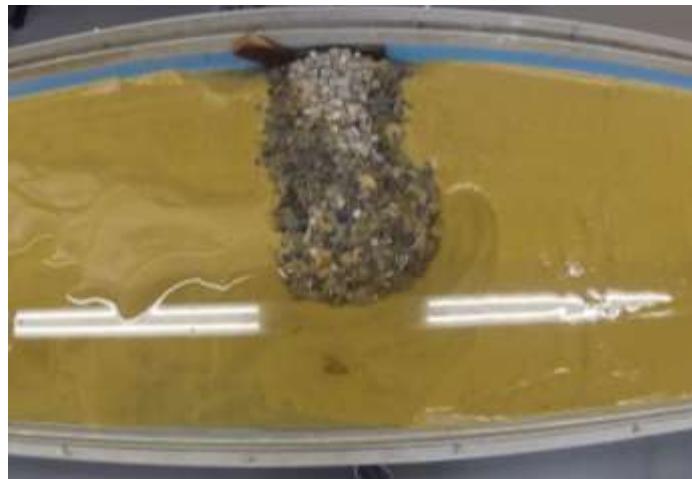
Figure 13: Image of Falmouth model post-test indicating smooth upstream bed material

The structures were placed in the flume at 102 cm which is half way along the length of the flume. This was to ensure that any turbulence experienced from the pumps did not affect the scouring process of the experiment. As shown in Figure 13 the

upstream half of the flume depicts smooth unsettled sediment which indicates little to no interference from the pumps. This was to ensure clearwater scour was observed.

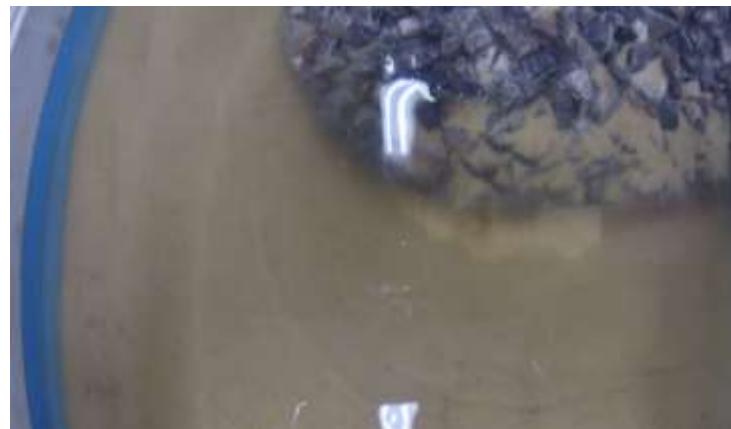
Figure 14: Falmouth model fail

Figure 14 shows the model has been lifted and exposed the wooden base underneath. The model itself weighs 6.58Kg and was subject to 40mm of water at a flow rate of 3.7l/s, the behaviour of the model was unexpected when considering the weight of the model compared to the water depth, however this problem was remedied by placing paving bricks on top of the model to weigh it down. This was an acceptable solution to the problem as in this case the point of interest is the scouring occurring around the structure and not the structure behaviour itself. The results from this particular test were omitted and the test was repeated.

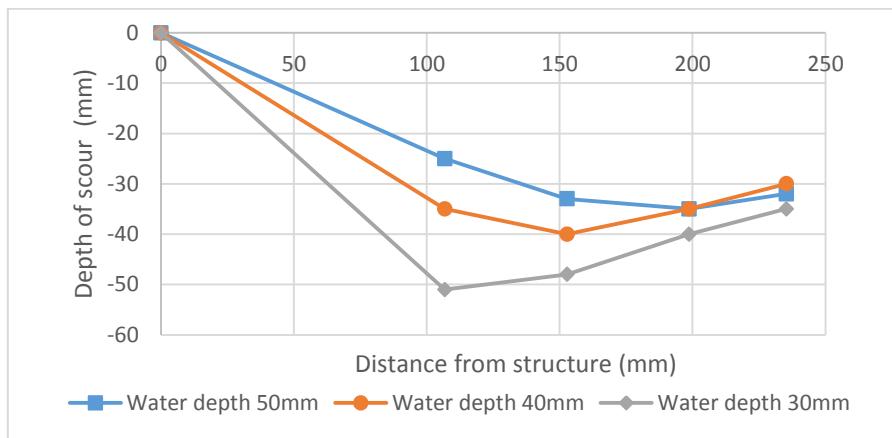
Figure 15: Graphical representation of scour depths from the end of the Falmouth model for varying water depths.

A graphical representation of the maximum recorded scour depths in a cross sectional tangent of the scoured area at the end of the structure is shown below in Figure 15.

The end of the structure is located at 0mm, all measurements are taken from the end of the structure. The maximum depth of scour that was recorded is achieved when a water depth of 30mm was used whereas the smallest scour depths achieved are that of the 50mm water depth, this implies that with a smaller water depth the scour depths occurring will be deeper, this is consistent with the idea that the lower the water depth the faster the water flow past the structure will be. This is due to the pump in the Alborn rig pumping at a continuous flow rate of 3.7l/s.

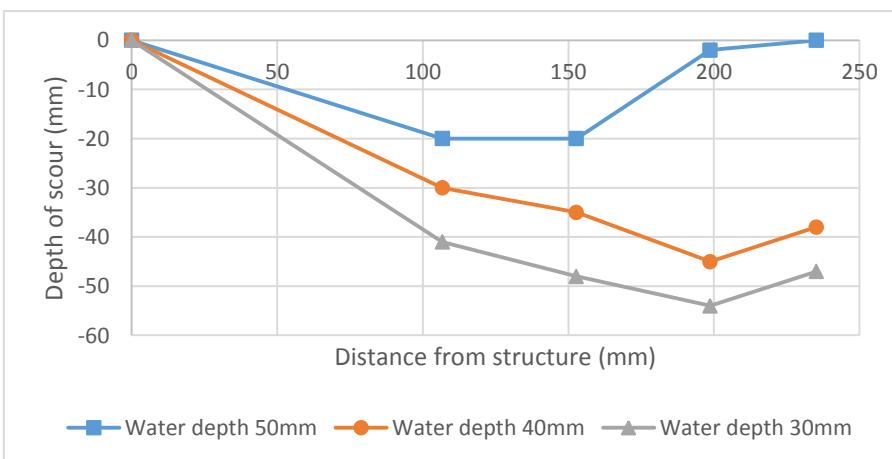
Figure 16: Graphical representation of scour depths from the end of the Mount Batten model for varying water depths.

A graphical representation of the maximum recorded scour depths in a cross sectional tangent of the scoured area at the end of the structure is shown below in Figure 16.

Similar to the results of the Falmouth model the maximum scour depth achieved was with a water depth of 30mm and the least scour was achieved with a water depth of 50mm implying an increase in scouring effect in shallower water.

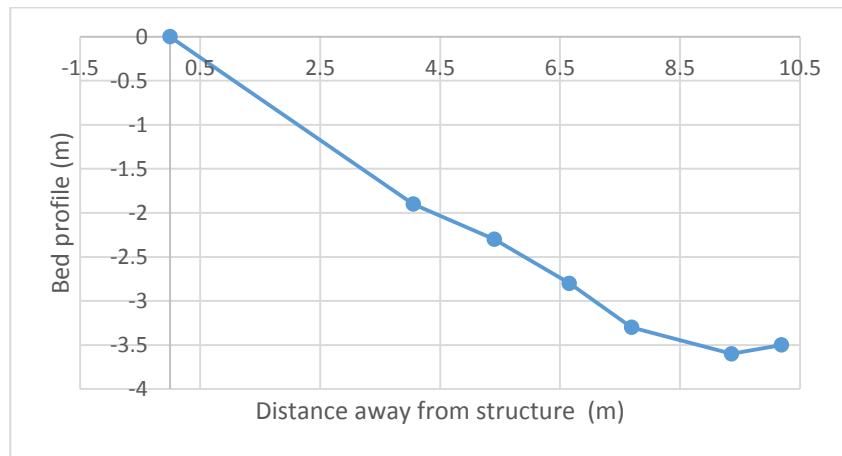
Figure 17: Graphical representation of the seabed depths at the end of the Falmouth Breakwater data taken from survey found in Appendix A

From the survey information collected a plot of the sea bed profile against the distance from the Falmouth breakwater in a north easterly direction could be created. Where 0 is chart datum.

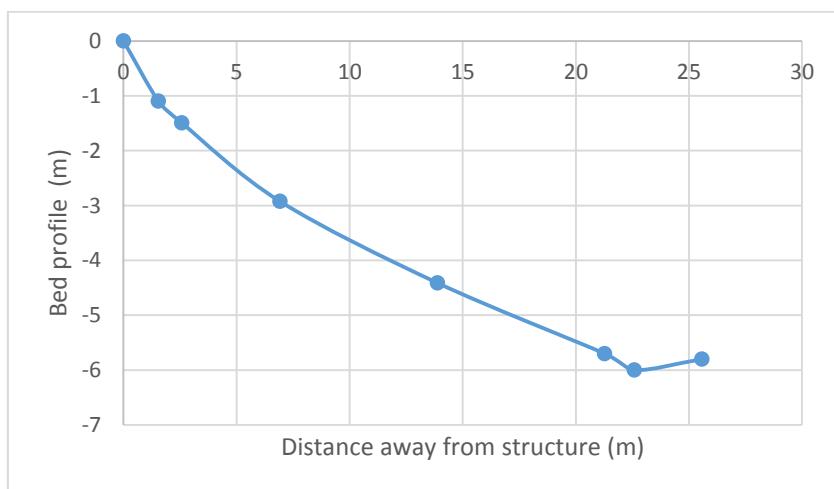
Figure 18: Graphical representation of the seabed profile at the end of the Mount Batten breakwater

Figure 18 shows the drop in seabed level at the end of the breakwater where 0 depths represent 4.1m below the waterline.

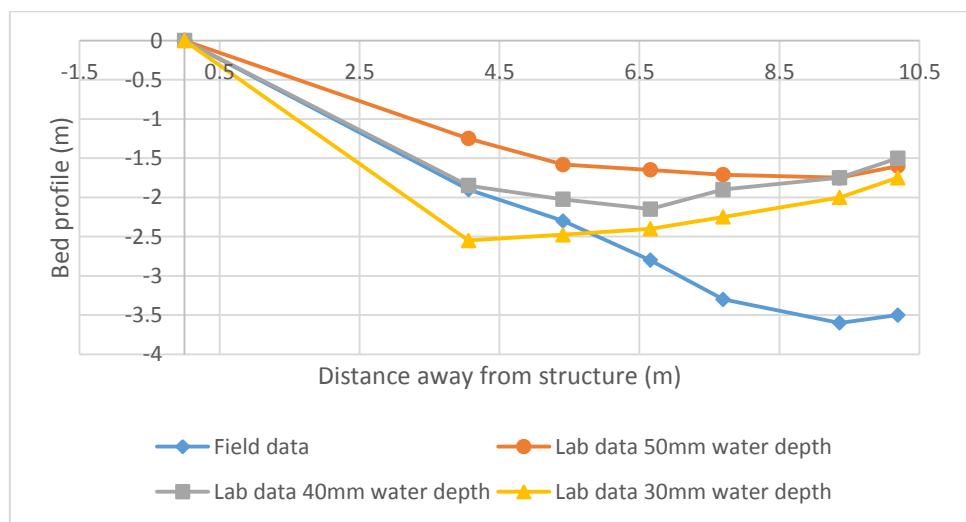
Figure 19: Falmouth field data and lab data comparison

Figure 19 shows a comparable trend between the laboratory experiments and the field data.

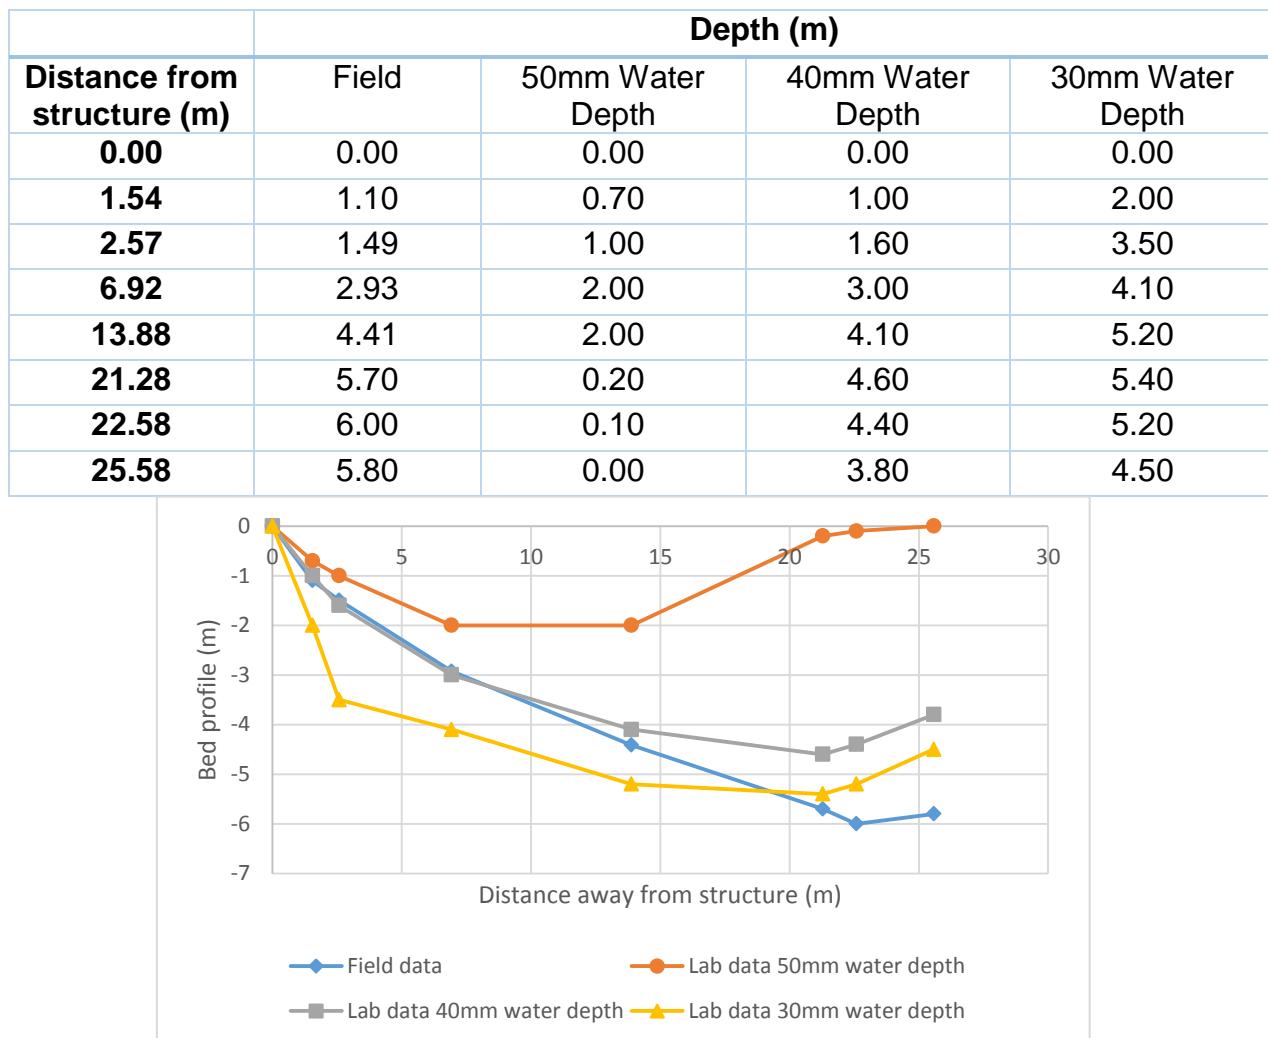
Figure 20: Mount Batten field and lab data comparison

Figure 20 sows a close similarity to the field data with a comparable trend between the results of water depth of 40mm and the field data. The 30mm water depth plot follows the trend but cannot be called a close representation and the 50mm water depth plot does not accurately represent the field sea bed profile, suggesting that a

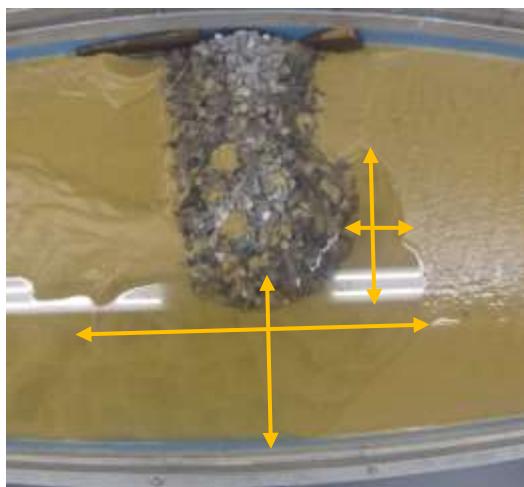
Figure 21: Location of where measurements were taken for area of scour

The parameter of flow velocity was investigated using the Mount Batten model using a fixed water depth of 40mm which was determined to be the most appropriate solution following the previous experimentations on water depth. The three different velocities investigated include 0.25m/s, 0.20m/s and 0.13m/s. The areas of scour were measured using the dimensions highlighted in Figure 21.

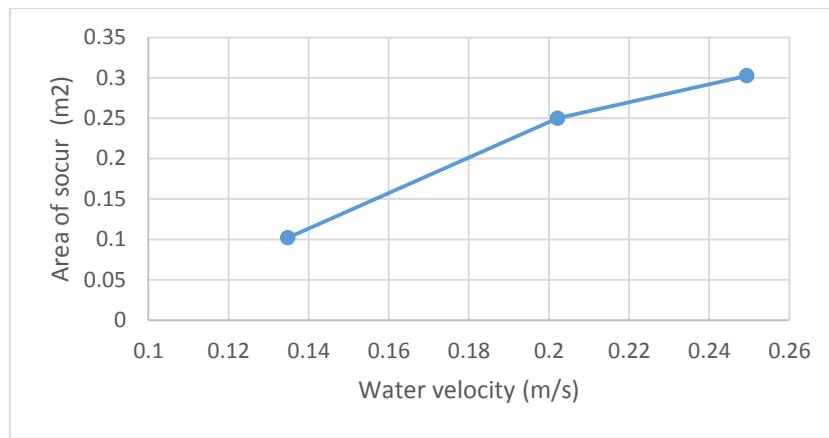
Figure 22: Mount Batten area of scour vs water velocity

The maximum areas of the scour holes were measured after 40 minutes and are displayed in Figure 22.

It is clear that there is a relationship between the depth of the scour area and the increase in water velocity. This is to be expected since increased turbulence usually follows increased velocity (Hamill, 2011).

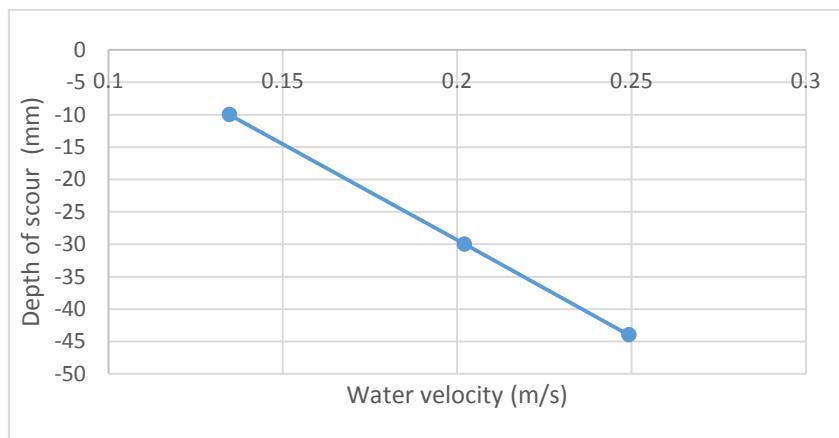
Figure 23: Mount Batten scour depth vs water velocity

Figure 23 presents the data collected about the relationship between depths of scour and water velocity.

As can be seen from the graph above there is a directly proportional relationship between scour depth and the velocity of the flow. The maximum scour depths recorded increase as the velocity of the flow increases meaning the deepest scour occurs as water velocity increases to 0.25 m/s.

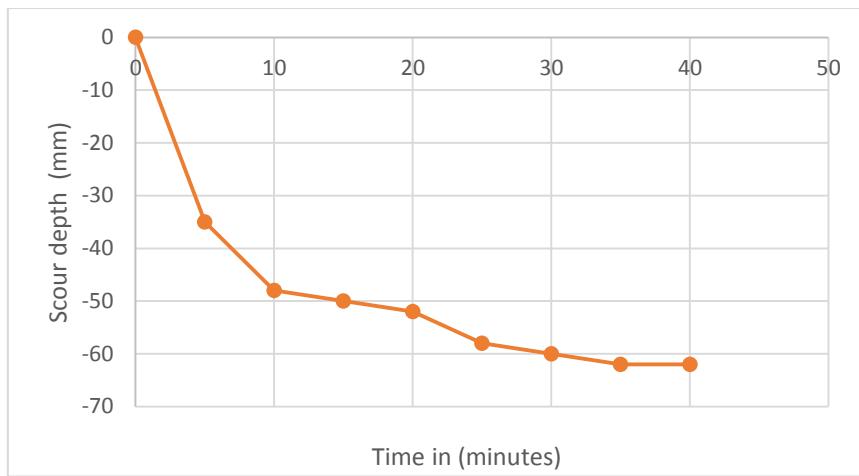
Figure 24: Mount Batten scour depth vs time

An experiment looking into the evolution of scour was undertaken on the Mount Batten model using a constant water depth of 40mm. The purpose of this experiment was to understand how scour develops over time and to investigate the point at which equilibrium is achieved if at all. Figure 24 presents the findings of this experiment.

The scour depth was measured at the edge of the structure where the deepest scour had been observed in previous test. The profile of this plot indicates that rapid scouring of the sediment occurs between 0-10 minutes and slowly evens out until it tends to an equilibrium state at 40 minutes. This is in keeping with the equilibrium theory discussed in Chapter 2. The time taken for this model to reach equilibrium equates to approximately 6 hours in the field applying a Froude scaling factor of $\sqrt{80}$, which is in keeping with a study undertaken by (Irie & Nadaoka, 1984).
