Investigation into the process of cured-in-place pipe sewer rehabilitation

The Plymouth Student Scientist
University of Plymouth

Caitlin Mitchell

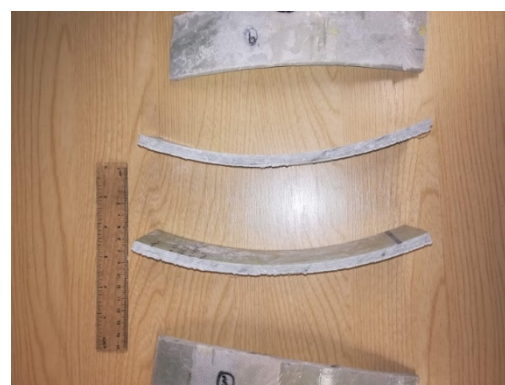
Figure 2: Batch C samples prior to testing. Plan

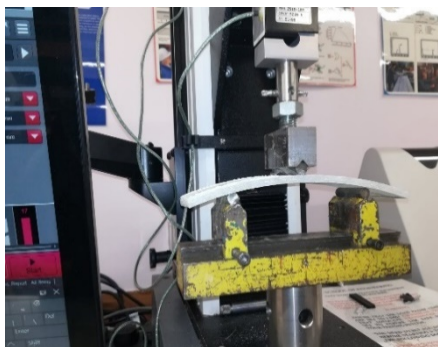
Figure 3: Flexural strength, 3-point bending test set-up.

- 1) The 3-point bending test machine was calibrated, and a span set based on the length of the sample. Sample span can be found in table 5.
- 2) Samples can be inputted into the machine, as shown in figures 3 and 4.
- 3) The applied force load cell was lowered to sit on the sample.
- 4) A load of 10mm/min was set, following guidance from ISO 178:2010+A1:2013.
- 5) All appropriate data regarding the sample sizes etc., was inputted into the testing machine.
- 6) The machine was the balanced, calibrated to 0 throughout.
- 7) Load was applied at the set load, strain (%) and displacement (mm) were recorded and a Young's Modulus was calculated.

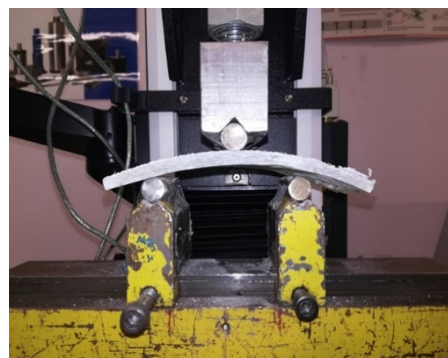
Figure 4: Flexural strength, 3-point bending test set-up.

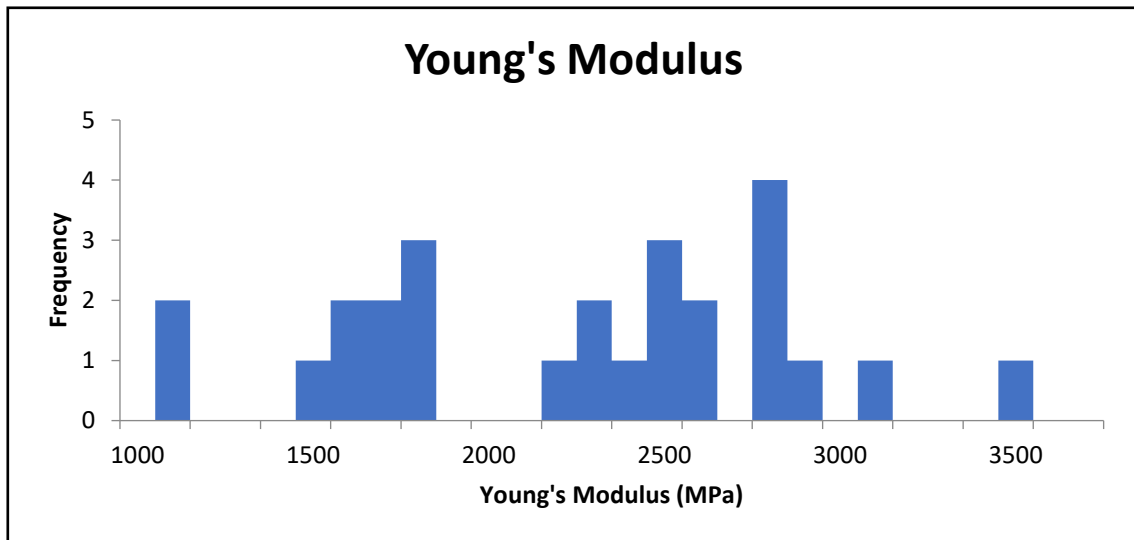
Figure 5 shows the frequency of Young's Modulus values across all samples. Full batch breakdowns of the Young's Modulus can be found in appendix 2.

Figure 5: Young's Modulus Histogram

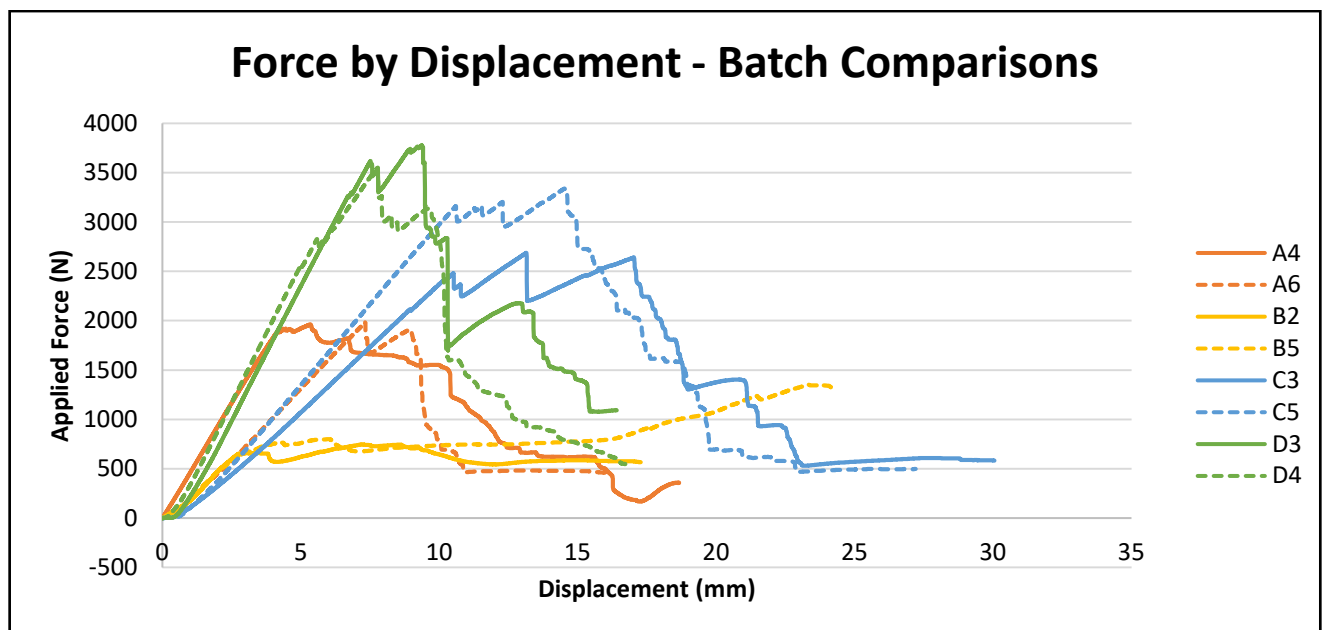
Figure 6 shows a range of 2 samples from each batch of testing completed and the associated displacement displayed. This has been created to quickly compare different batches of testing without cluttering the graph. Full graphs for each batch can be found in appendix 3.

Figure 6: Force by displacement - batch comparison

model which would be expected in a composite matrix, carrier material (shown in figure 6). Whereas it is difficult to see the actual failure point of batch B due to the ductility of the failure (see figure 6 and appendix figure 3B). The maximum displacement also ranged dramatically throughout the varying samples, appearing to level out at roughly 12, 20, 25 and 16mm for batches A, B, C and D respectively. Which shows a considerable range, once again batch B showed variation from the other samples and even at 20mm deflection the sample hadn't reached its maximum, showing it could potentially keep deflecting under heavier loading.

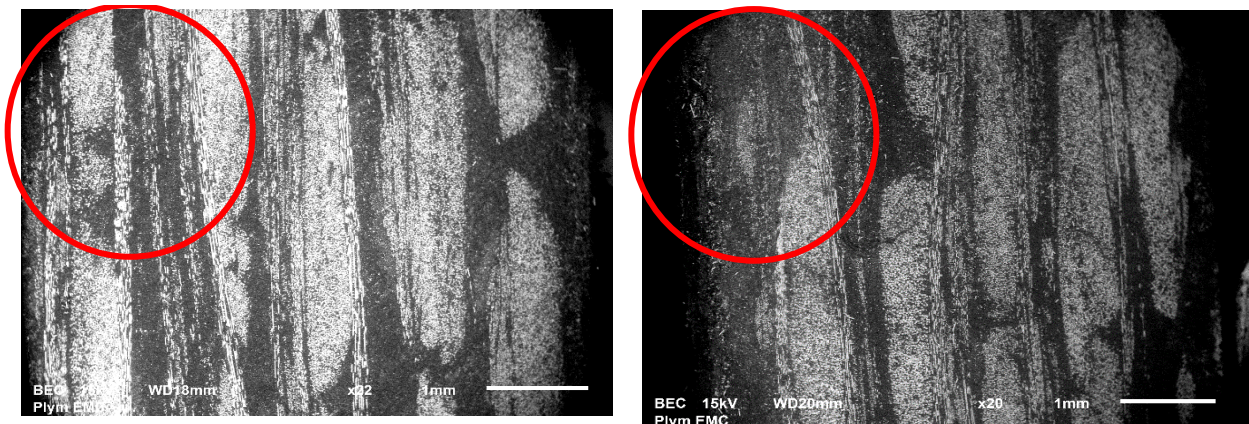
Figure 12 & 13: Sample C - whole thickness (L), Sample D – whole thickness (R)

some voids present throughout sample C, but overall the sample indicated a good spread of fibres, reaching to the edges of the sample. Sample D, shown in figure 13
