# Investigation into the process of cured-in-place pipe sewer rehabilitation

Caitlin Mitchell

*Project Advisor: [Tony Tapp](#), School of Engineering, Computing and Mathematics, University of Plymouth, Drake Circus, Plymouth, PL4 8AA*

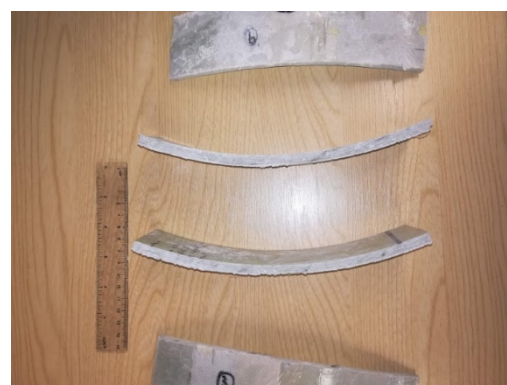
**Figure 2:** Batch C samples prior to testing. Plan

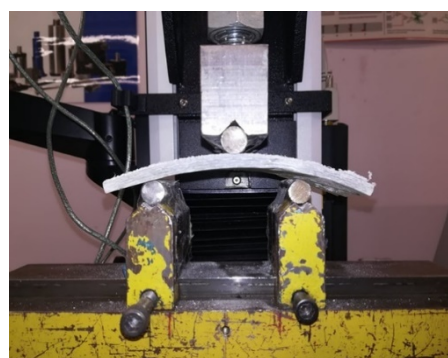
**Figure 4:** Flexural strength, 3-point bending test set-up.

- 1) The 3-point bending test machine was calibrated, and a span set based on the length of the sample. Sample span can be found in table 5.
- 2) Samples can be inputted into the machine, as shown in figures 3 and 4.
- 3) The applied force load cell was lowered to sit on the sample.
- 4) A load of 10mm/min was set, following guidance from ISO 178:2010+A1:2013.
- 5) All appropriate data regarding the sample sizes etc., was inputted into the testing machine.
- 6) The machine was the balanced, calibrated to 0 throughout.
- 7) Load was applied at the set load, strain (%) and displacement (mm) were recorded and a Young's Modulus was calculated.
