CAPE VERDE BEACH HAZARDS

Report provided by: Coastal Marine Applied Research,
University of Plymouth Enterprise Ltd.

Project code: 1710

Document code/version: 1710_v1

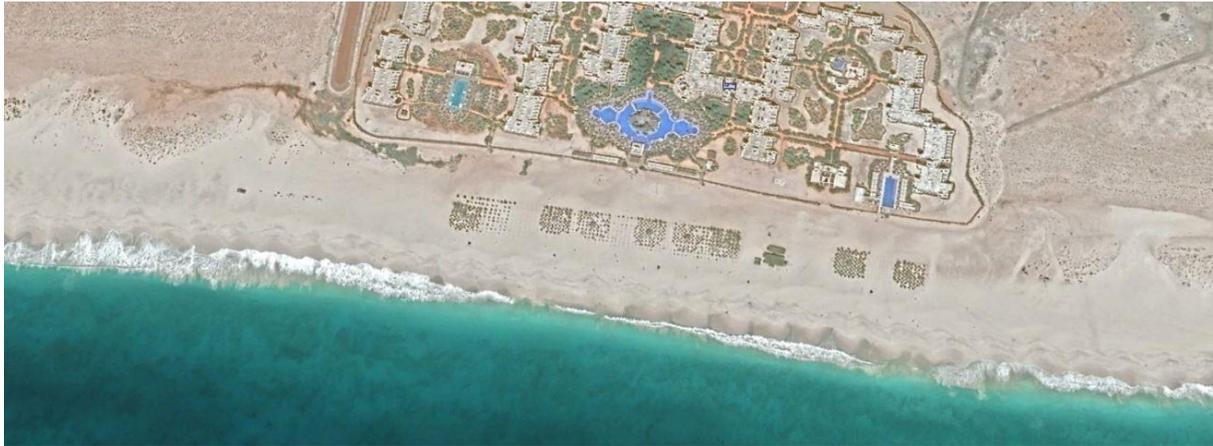
Figure 6. Aerial imagery of Praia de Lacacao, showing beach cusp formations at the shoreline.

- Active beach cusps are always visible in the 15 available Google Earth aerial images between March 2005 and October 2019 (Figure 6), and are features that are exclusively found on steep beaches in the upper intermediate to reflective morphology range (i.e. panels e-f, Figure 4).

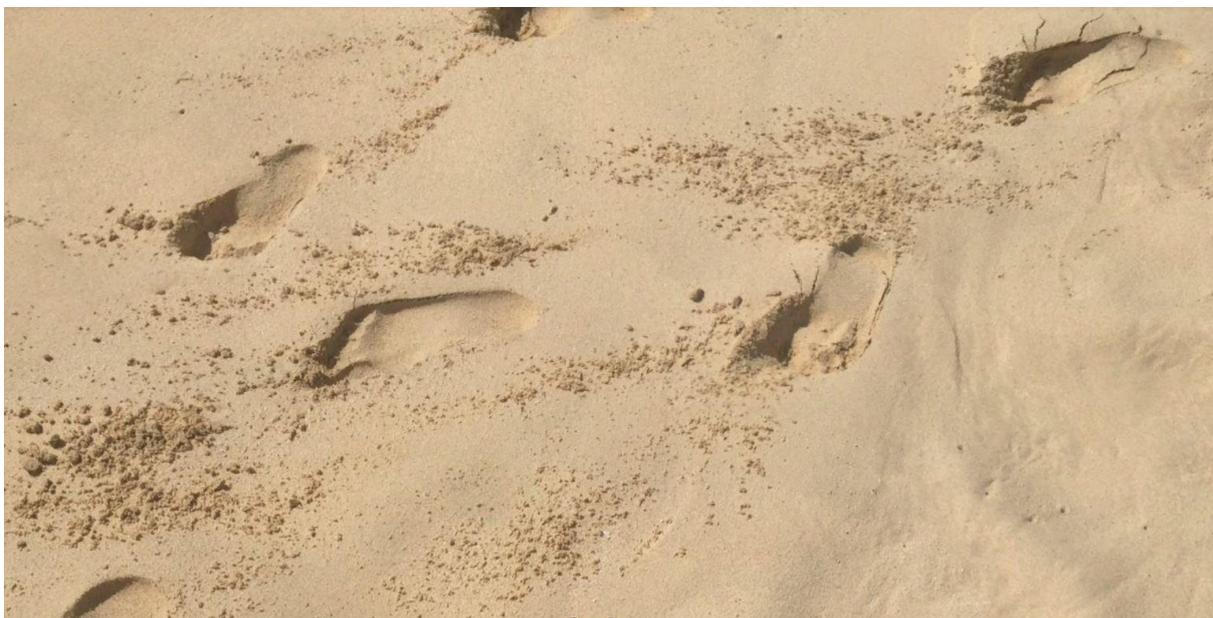
Figure 7. Photograph of beach sediment at Praia de Lacacao, extracted from a tourist photograph posted on Google Maps.

- Tourist photographs of the beach indicate the sediment is likely to consist of ‘medium sand’ (for example, Figure 7) with a grain size on the order of 0.25 – 0.5 mm diameter.

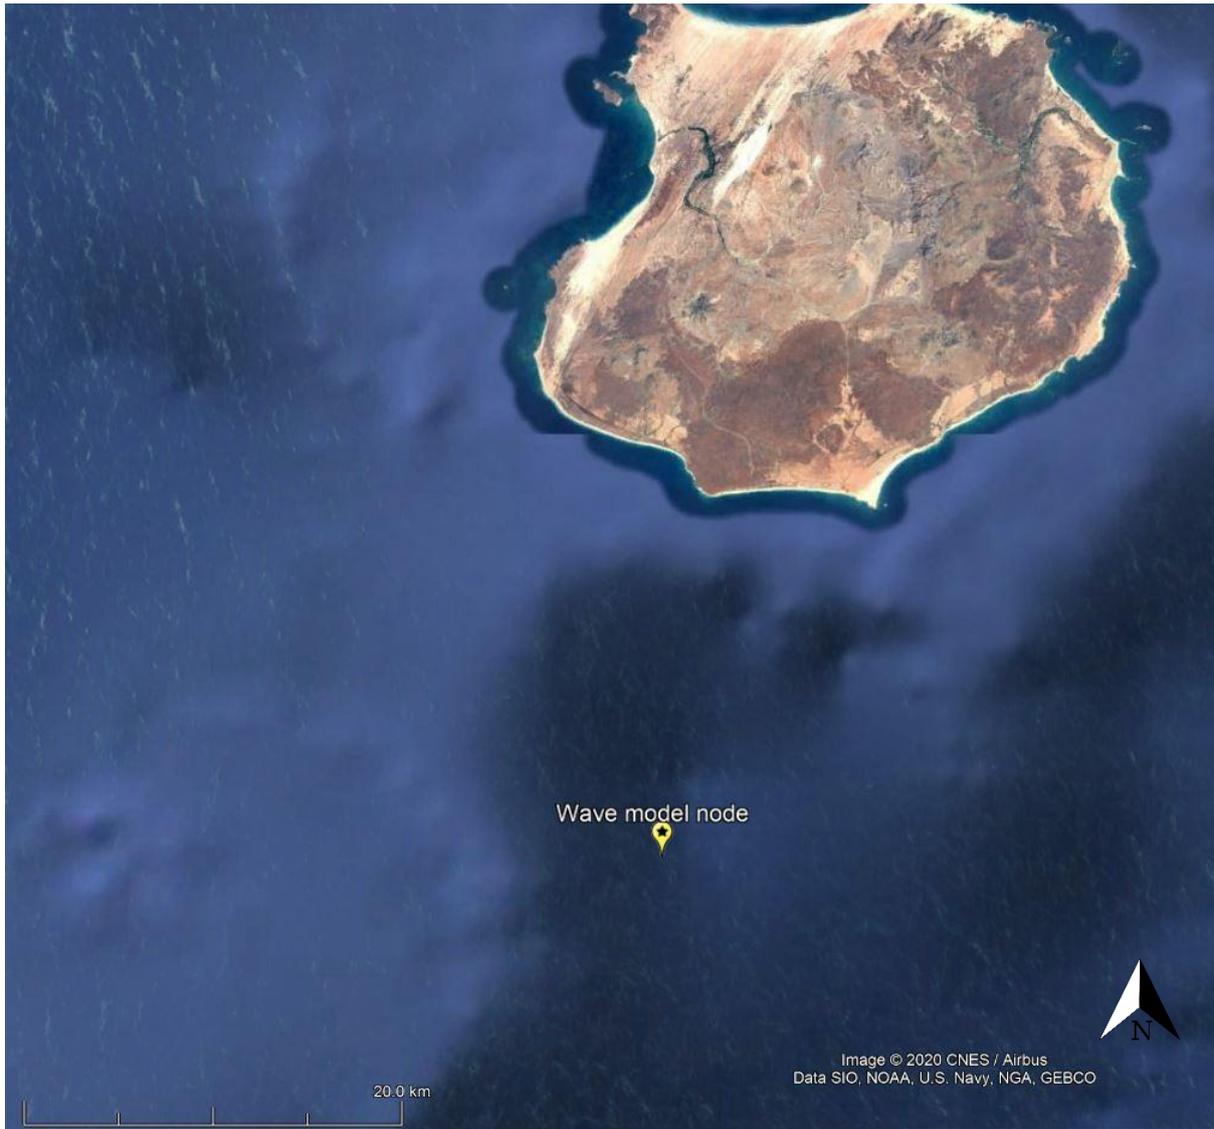
Figure 8. Upper panel: Wave model output location at 15.9° latitude, -22.9° longitude, approximately 21.5 km directly offshore of Praia de Lacacao, in deep water (>1000 m depth). Lower panels: wave roses showing proportion of wave heights (lower left) and wave periods (lower right) from different directional sectors at the wave model output location.

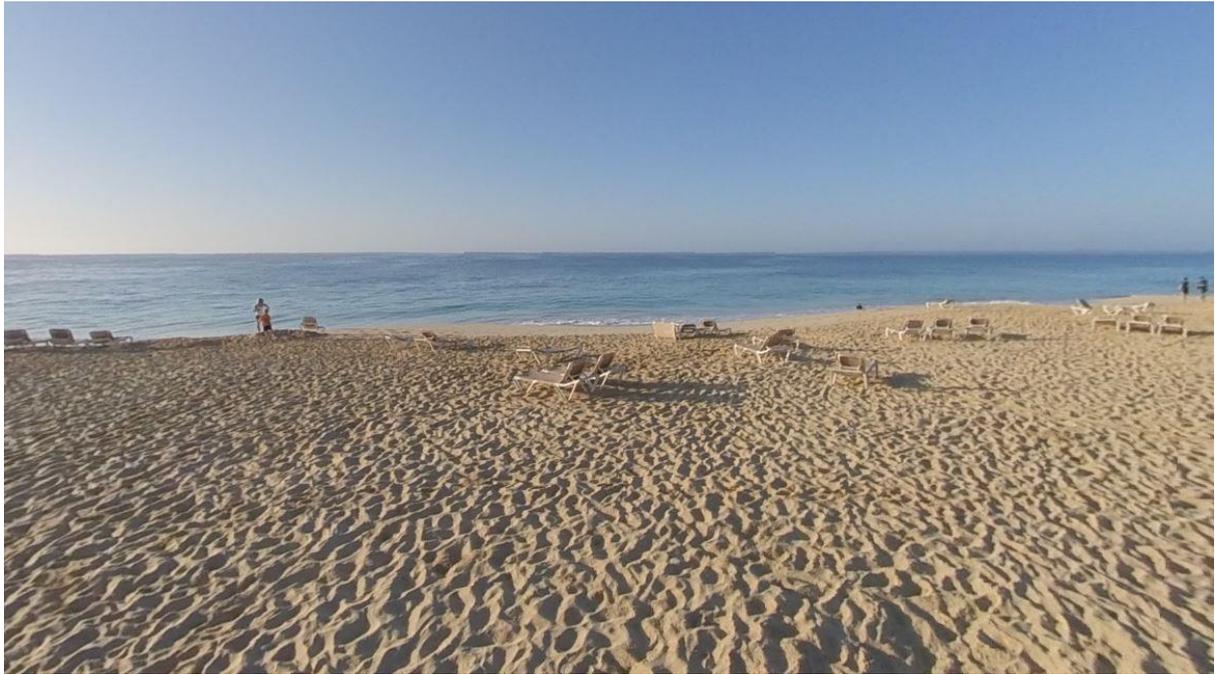
Figure 12. Examples of wave breaking at Praia de Lacacao under 'low wave energy' conditions (estimated as $0 < H_b < 0.5$ m).

In-situ photographs of waves breaking at Praia de Lacacao at different levels of wave energy were sourced from Google Maps to verify the wave breaker types that occur at the beach. Example images are presented in Figure 12, Figure 13, and Figure 14, showing low energy (estimated as $H_b < 0.5$ m) to high energy (estimated as $H_b > 1$ m) breaking waves. These images confirm that **waves typically break very close to the beach, and under larger waves ($H_b > 1$ m) break as plunging breakers with considerable breaking intensity and power at the shoreline.**

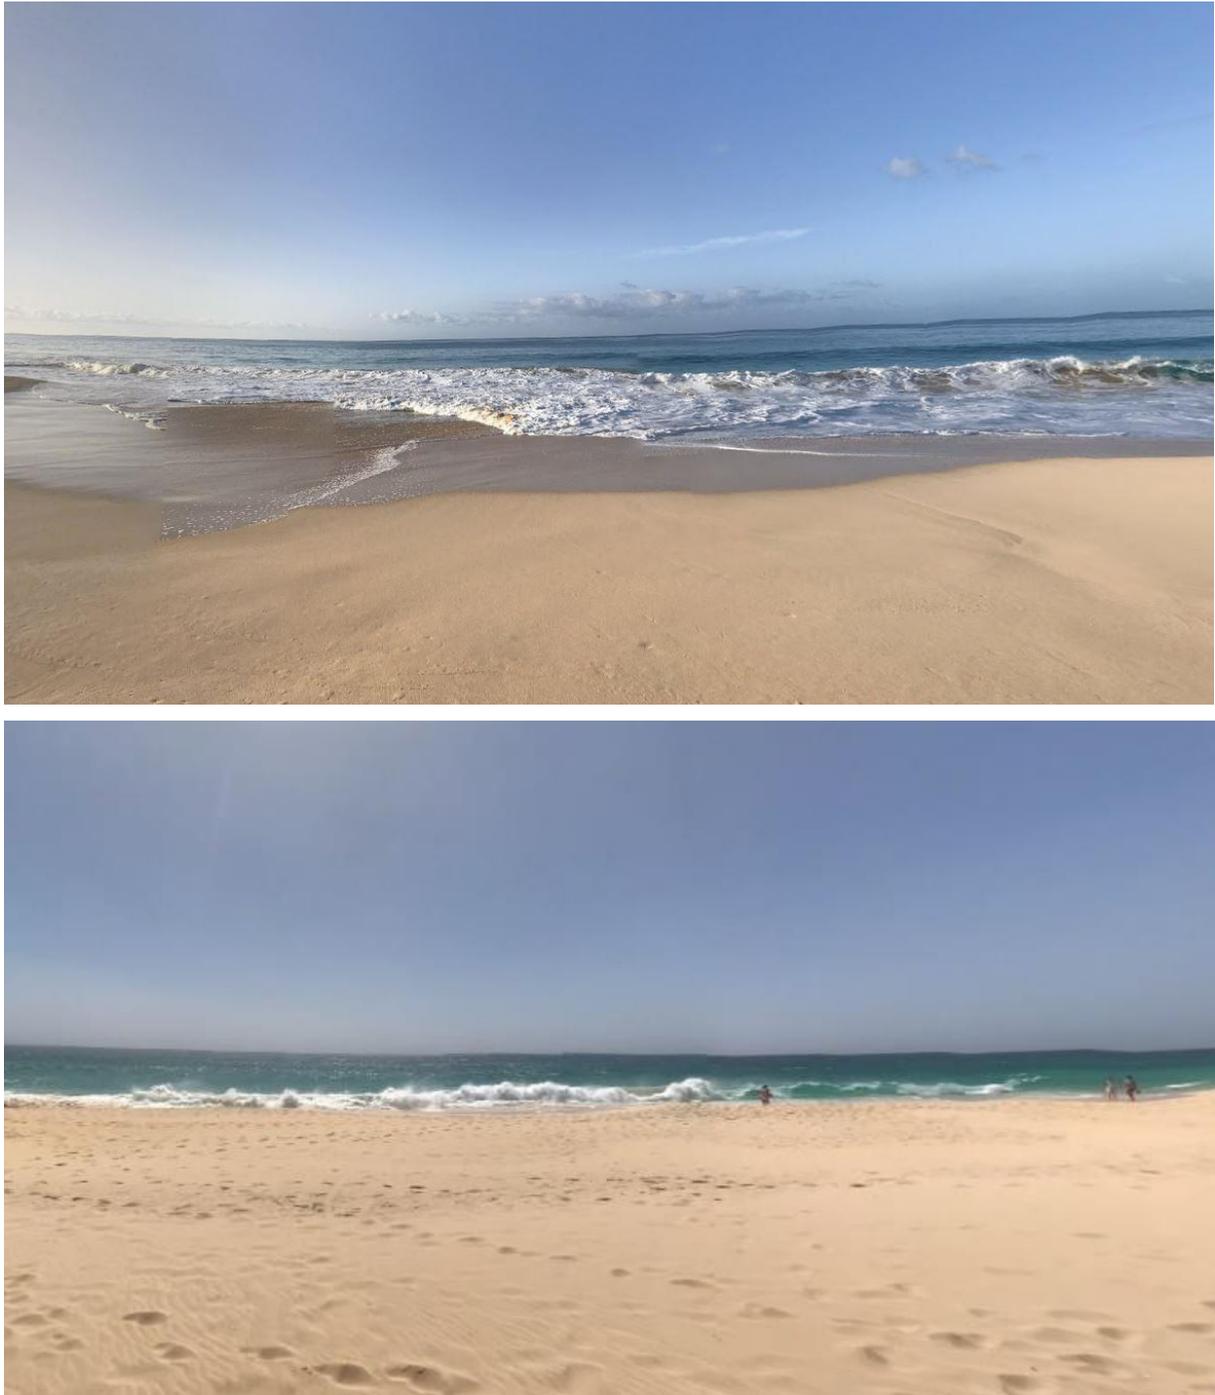
Figure 13. Examples of wave breaking at Praia de Lacacao under ‘medium wave energy’ conditions (estimated as $0.5 < H_b < 1$ m).

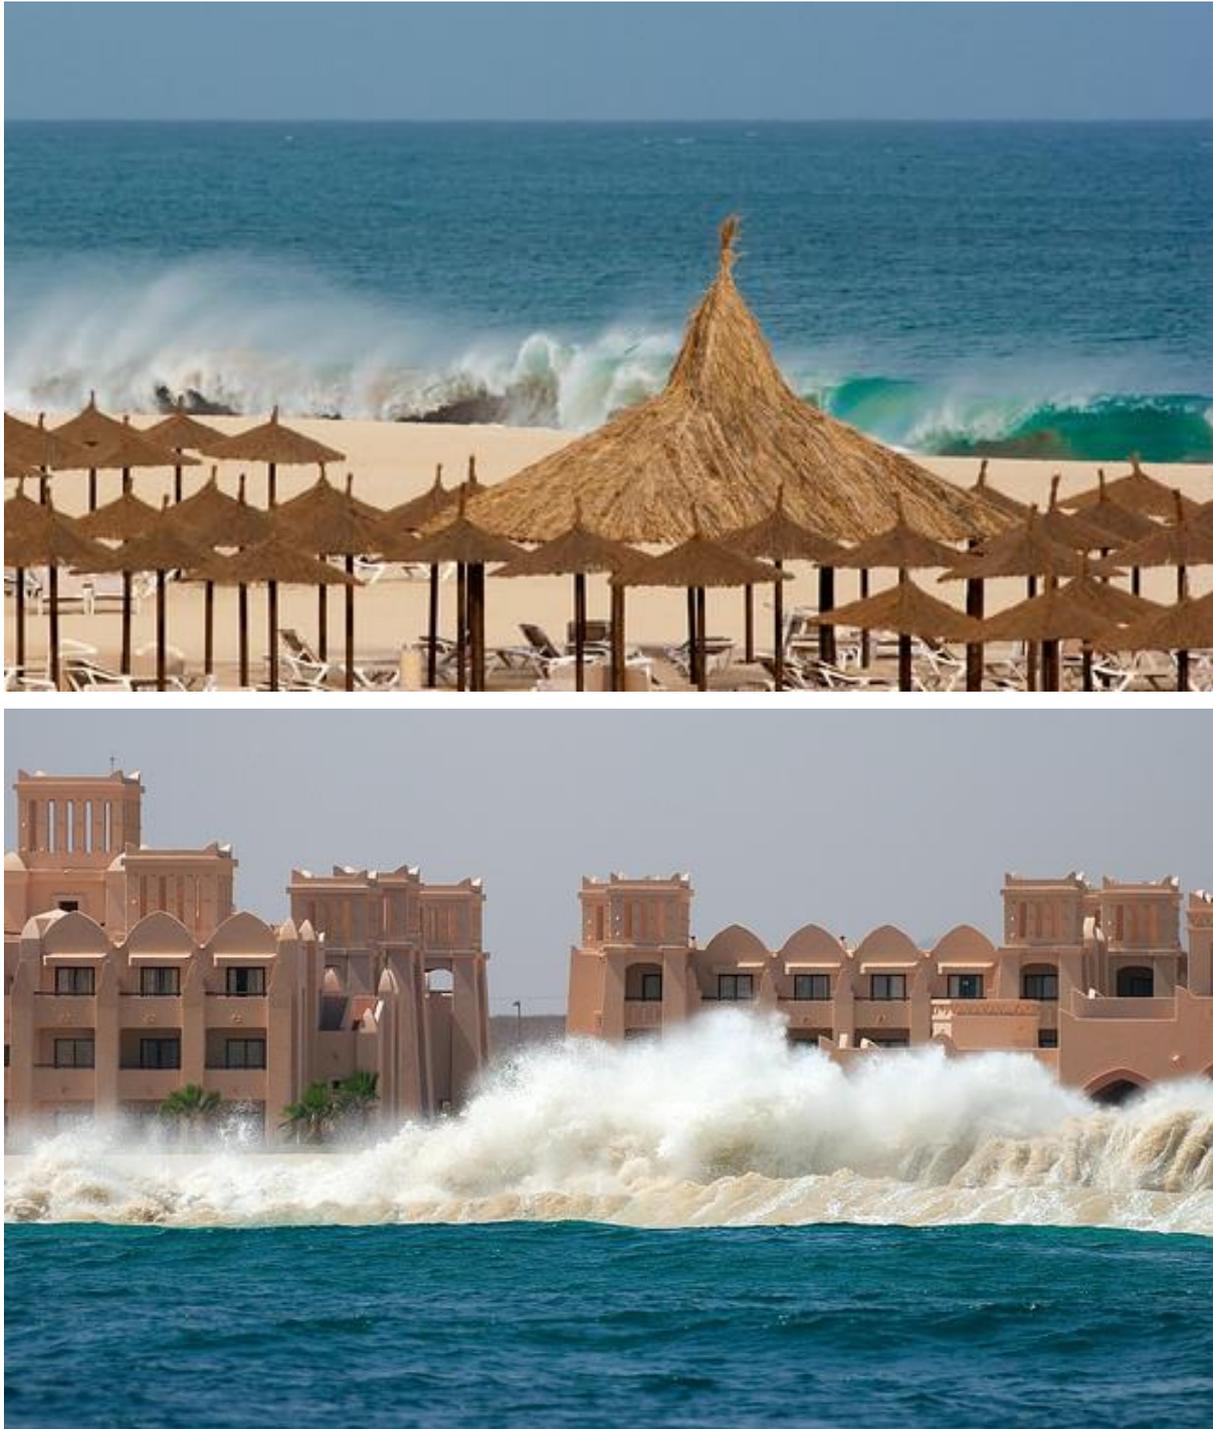
Figure 14. Examples of wave breaking at Praia de Lacacao under 'upper wave energy' conditions (estimated as $H_b > 1$ m).
