BEACH HAZARDS: RIU FUNANA, CAPE VERDE

Report provided by: Coastal Marine Applied Research,
University of Plymouth Enterprise Ltd.

Project code: 2109

Document code/version: 2109_v3b

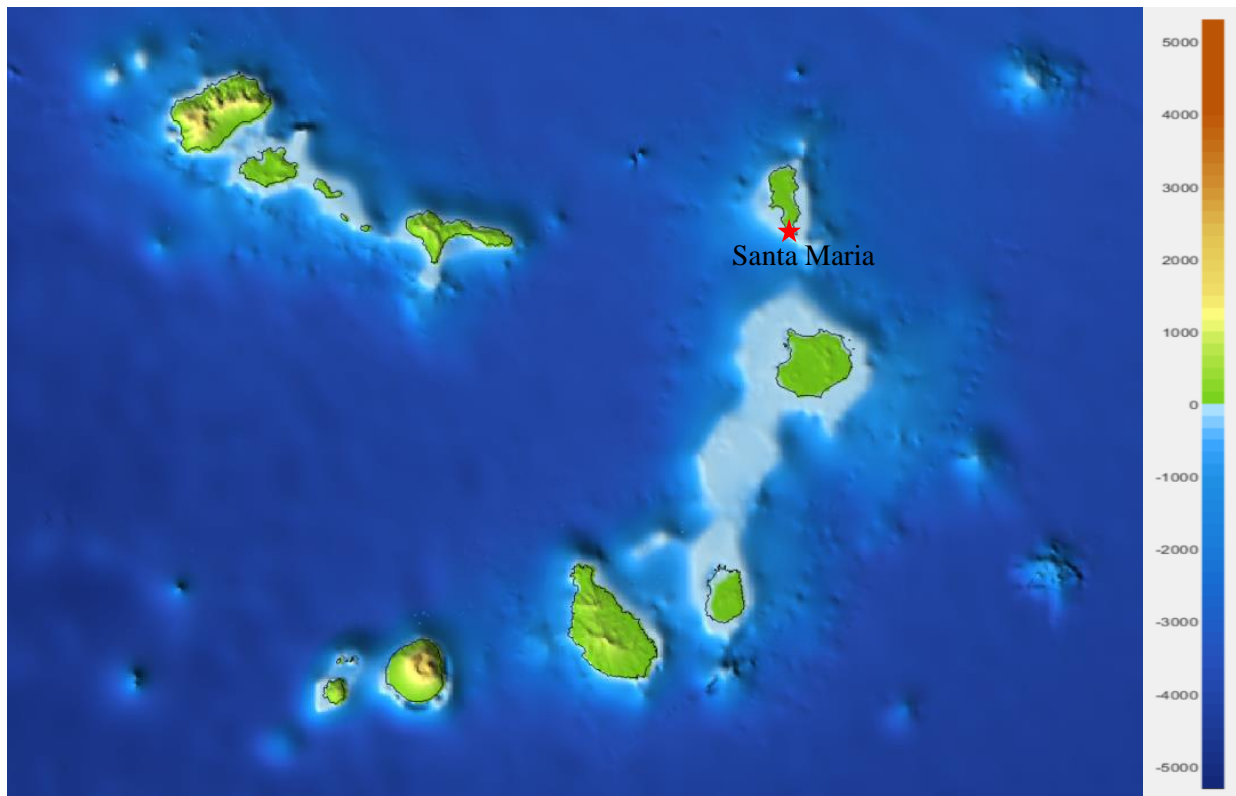
Figure 1-3. Chart of bathymetric depth in the Cape Verde island chain, from the General Bathymetric Chart of the Oceans (GEBCO) database (<https://www.gebco.net/>). Santa Maria on the island of Sal is demarked with a red star. Note that the coastal shelf visible around Sal Island is less than 100 m depth.

The beach has a small ‘microtidal’ tide range of 0.8 m during an average spring tide (From Admiralty Total Tide data at the secondary harmonic tidal port of Ilha Do Sal Bahia De Palmeira). There is a relatively shallow coastal shelf (< 100 m depth) surrounding the island of Sal (Figure 1-3).

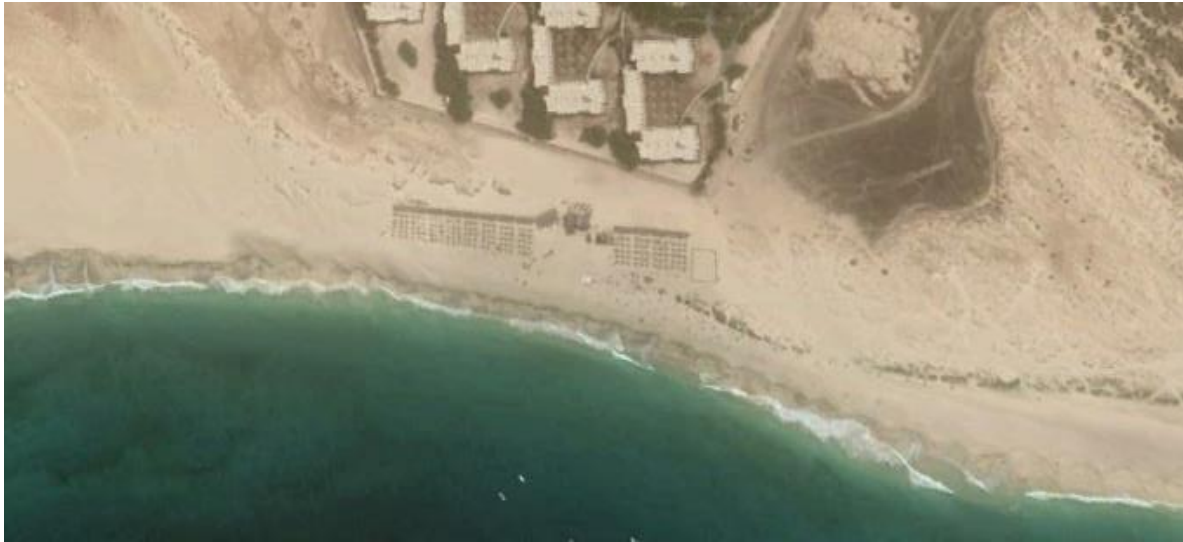
Figure 2-3. Aerial imagery of Riu Funana beach showing beach cusp formations at the shoreline.

- Active beach cusps are visible in 7 out of 10 available Google Earth aerial images between October 2003 and September 2019 (Figure 2-3), and are features that are typically found on steep beaches in the upper intermediate to reflective morphology range (i.e. panels e-f, Figure 2-1).

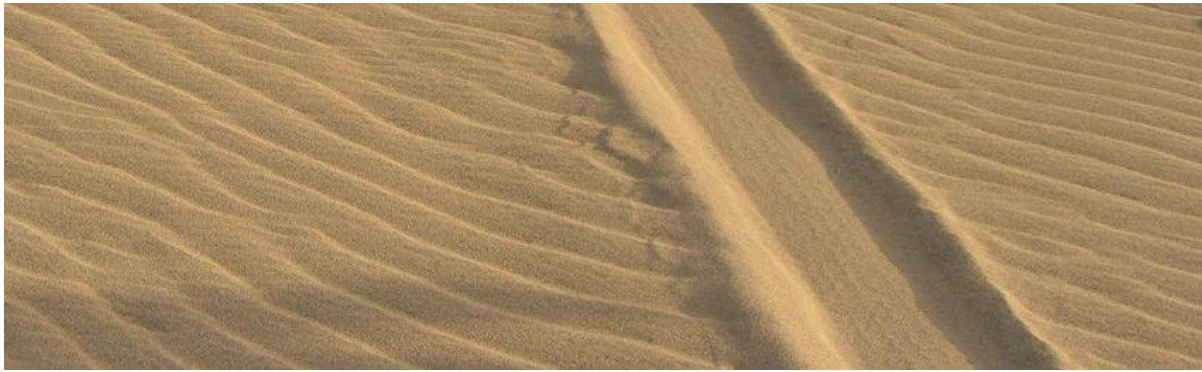
Figure 2-4. Photograph of beach sediment at Riu Funana beach, extracted from a tourist photograph posted on Google Maps.

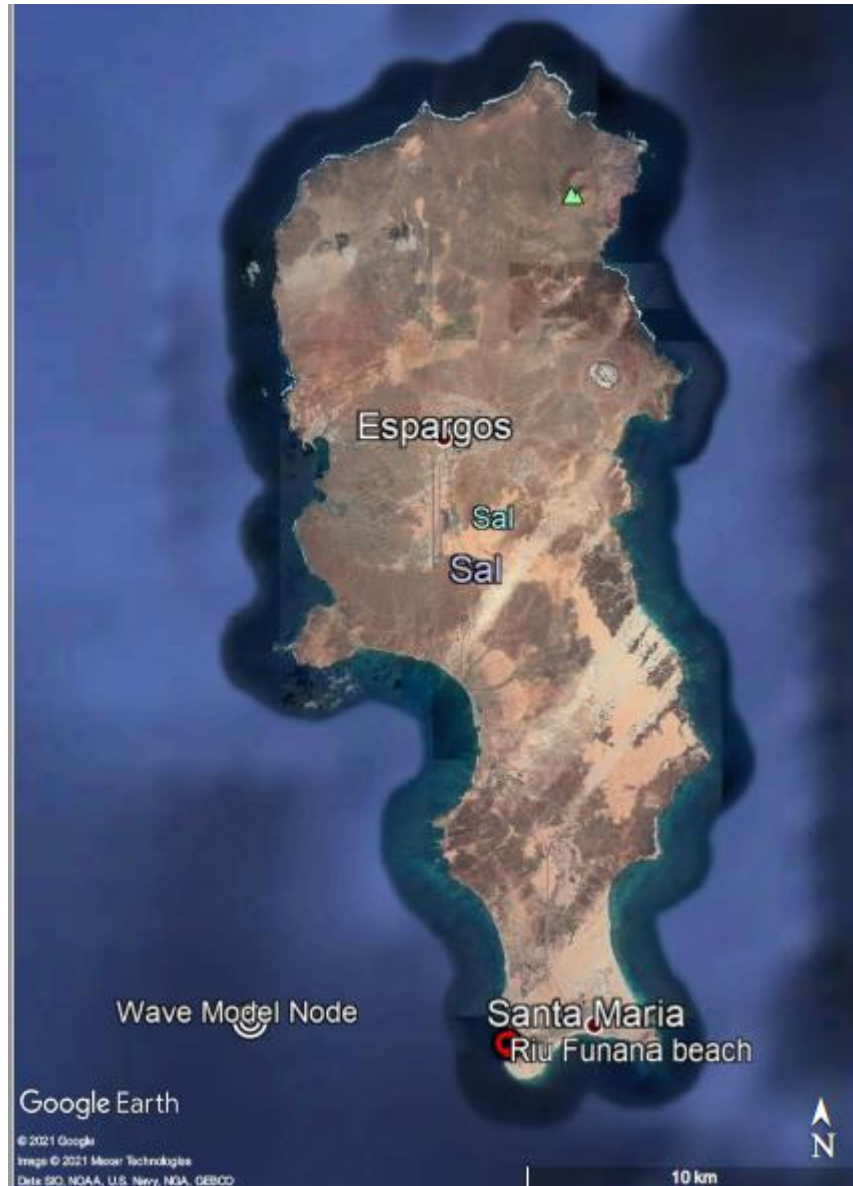
Figure 3-1. Wave model output location at 16.6° latitude, -23° longitude, approximately 7.5 km directly offshore of Riu Funana beach, in deep water (>1000 m depth).

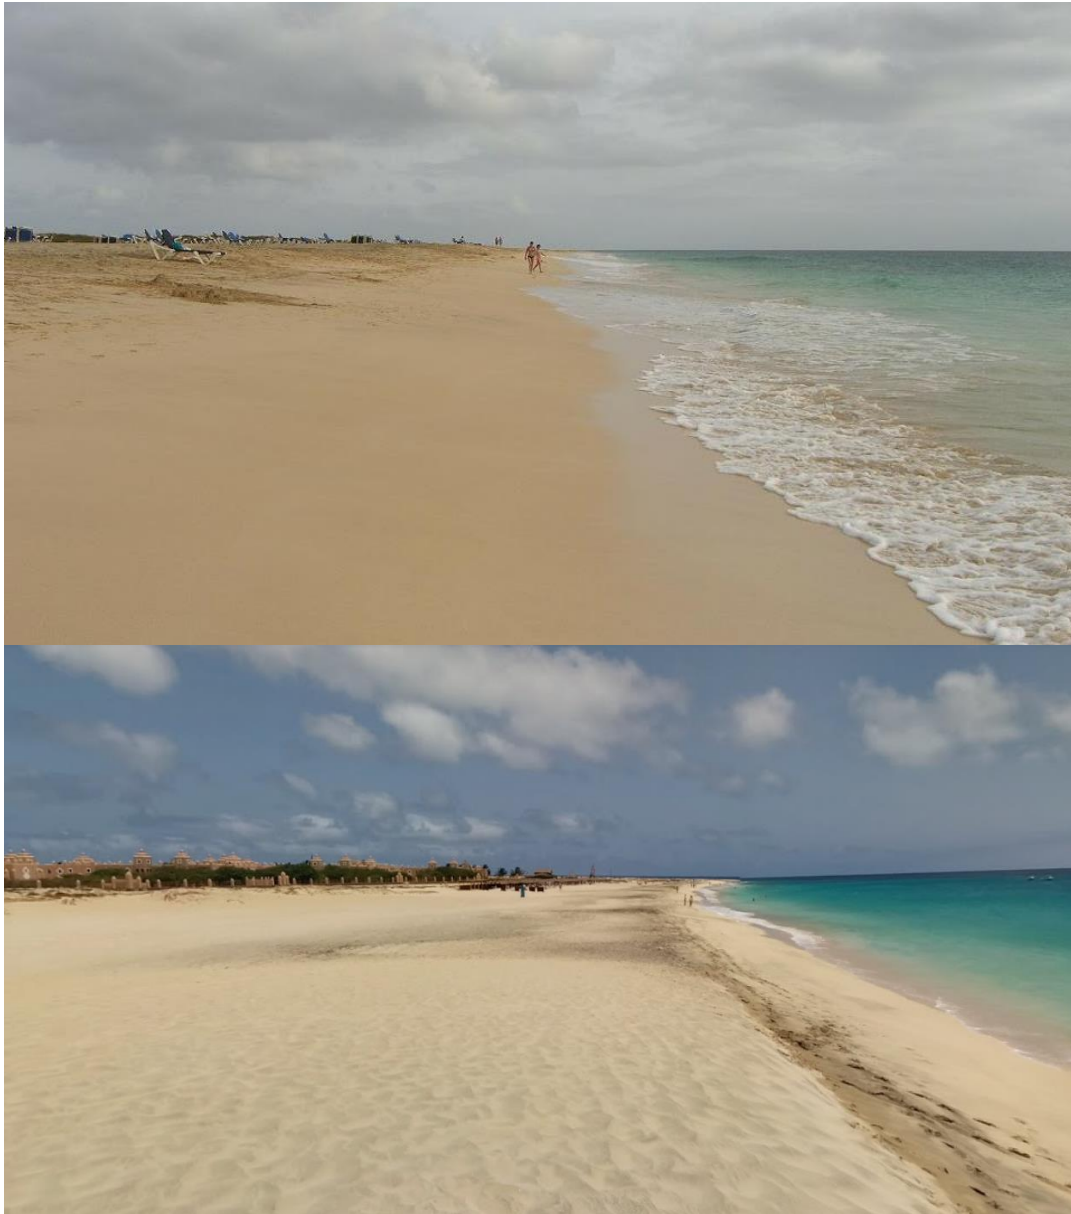
Figure 3-5 Examples of wave breaking at Praia de Lacacao under ‘low wave energy’ conditions (estimated as $0 < H_b < 0.5$ m).

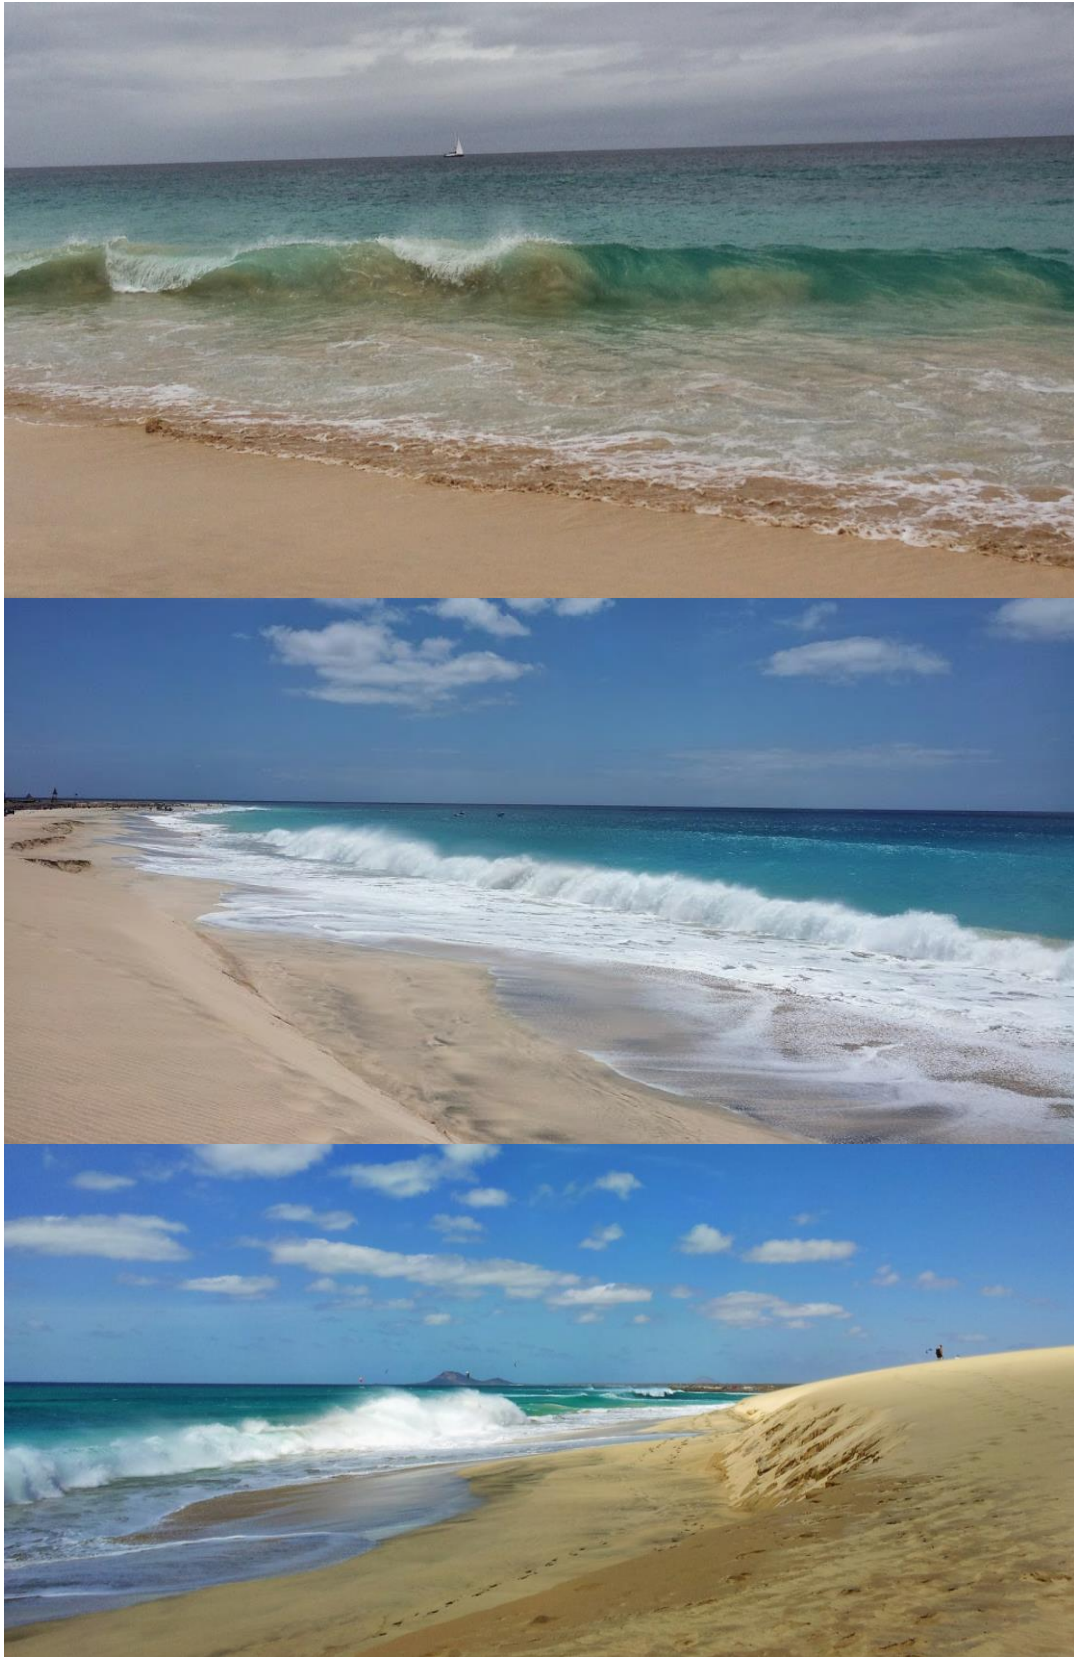
Figure 3-6. Examples of wave breaking at Riu Funana beach under 'medium wave energy' conditions (estimated as $0.5 < H_b < 1$ m).

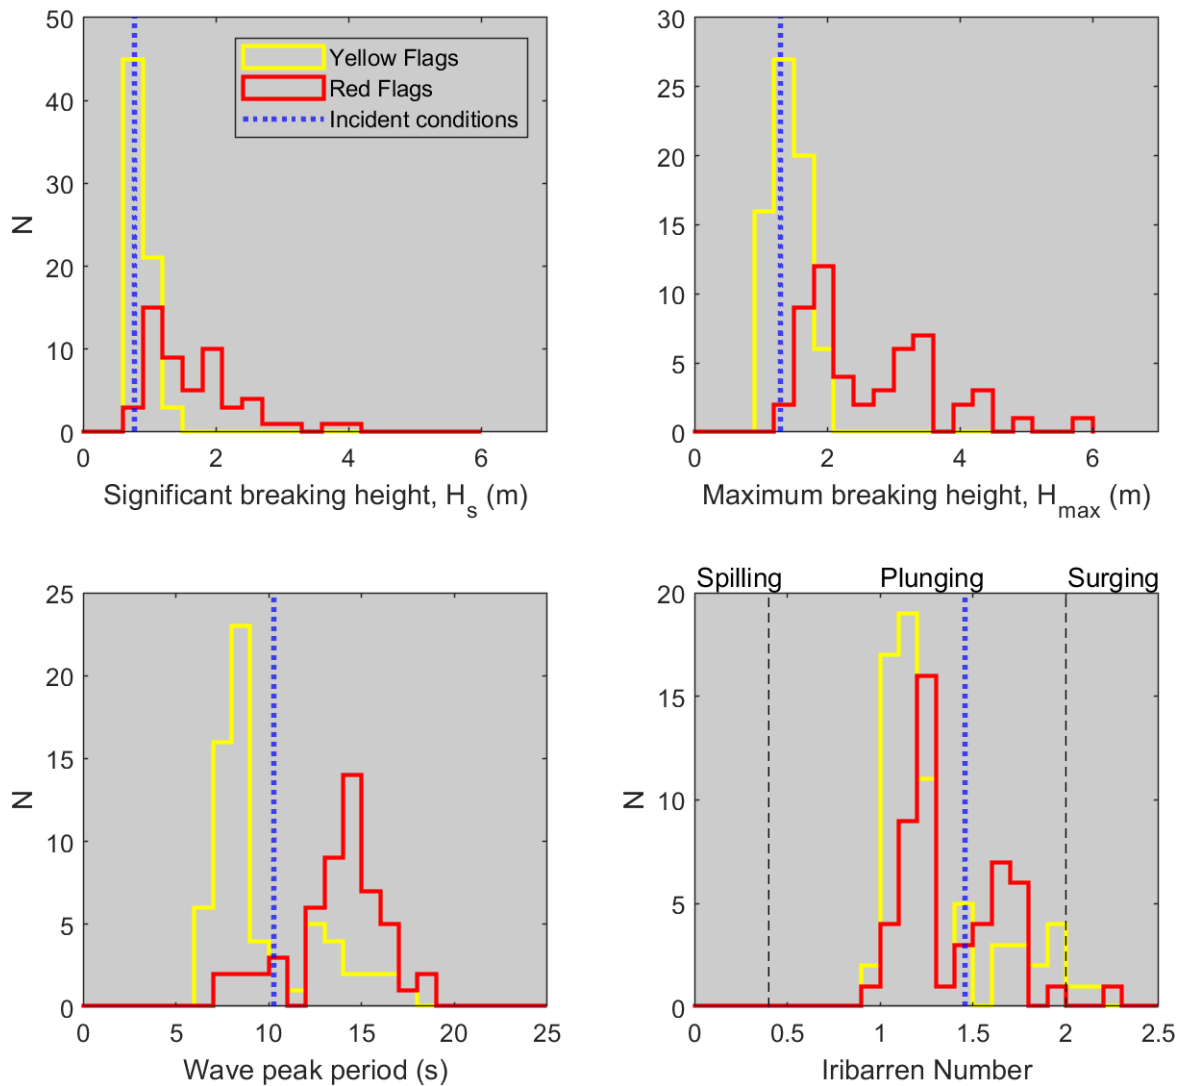
Figure 5-2. Histograms showing the distribution of wave conditions associated with each lifeguard hazard flag in March and April of 2018. The red and yellow lines in each panel show the distribution of wave conditions associated with the red and yellow flags in March and April of 2018, respectively. The red and yellow dashed lines show the average (median) condition associated with the red and yellow flags in March and April of 2018, respectively. The blue dotted line in each panel shows the wave conditions at the time of the bathing incident on 31st of March 2018. The y axis ('N') shows the number of half-day periods where each flag was flown during the
