Remote sensing of boat abandonment using Google Earth

Environmental Science and Pollution Research

2 **Remote sensing of boat abandonment using Google Earth**

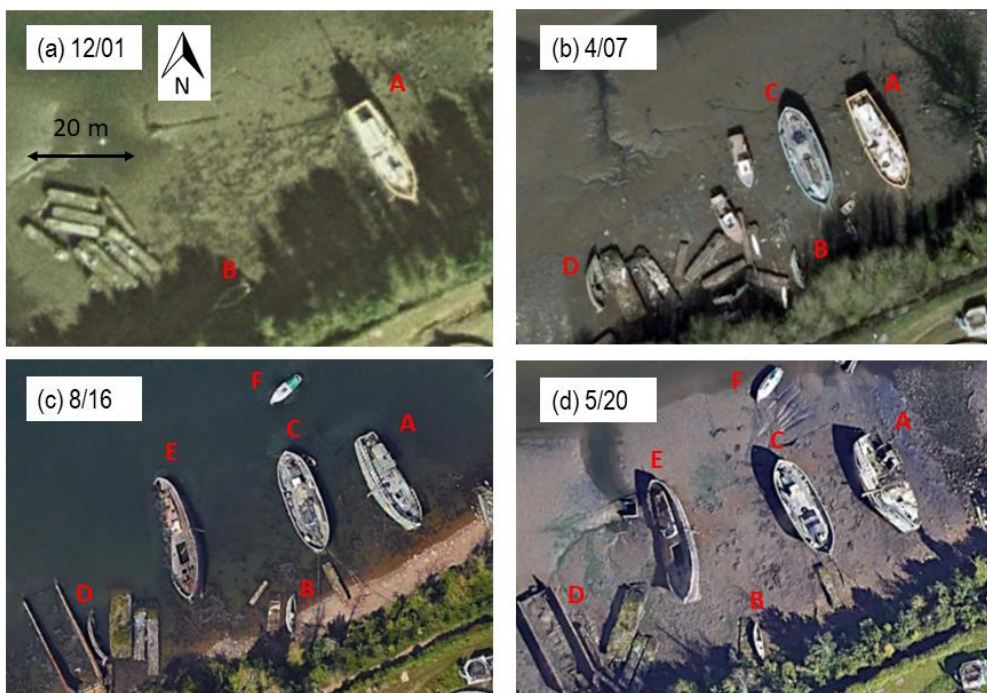
140 Figure 2: GE imagery of a region of Hooe Lake, Plymouth (50°21'22"N, 4°06'28"W), where boat
141 abandonment has been increasing over the past twenty years. Selected dates are shown as
142 month/year and boats labelled in each image are described in the text.

105 In many cases, identification of abandoned boats was straightforward in that a vessel would remain
106 at a specific location and undergo decay. Boats could first appear on imagery at a particular date or
107 be present throughout the whole time series recorded. In other cases, identification and
108 characterisation was more complex. This is exemplified by the GE imagery of the intertidal zone of
109 Hooe Lake, Plymouth, captured on four selected dates that illustrate the evolution in the number
110 and condition of several boats (Figure 2). Thus, boats A and B, of 20.4 m and 9.8 m in length,
111 respectively, are evident on the earliest imagery (December 2002). Boat A remains in the same
112 position throughout the time series to May 2020, but has begun to list by August 2016 and exhibits
113 considerable damage, including by fire, in the most recent image. In contrast, boat B has shifted its

114 precise location, either because of tidal currents or intervention during the mooring or
115 abandonment of other boats and structures, but is nevertheless classed as abandoned. Boats C and
116 D, of lengths of 20.7 m and 17.8 m, respectively, appear in imagery dated April 2007, and while the
117 latter is clearly abandoned and decaying, the former remains moored and appears to have
118 undergone recent modification. A subsequent visit to the location revealed that the boat is

119 undergoing restoration on an intermittent basis and is, not, therefore, classified as abandoned.
120 Boats E (32.0 m) and F (8.0 m) appeared between 2007 and 2010 and in 2016, respectively, and
121 while the former is in poor condition and taking in water, the latter appears to be securely moored
122 and in relatively good condition. Since boat F had been at the same location for only four years, the
123 principal criterion for abandonment was not, therefore, met.

197 Scattered clustering occurs when there is a growth of abandoned boats at a particular locality that
198 are not moored together. This type of clustering is evident in Hooe Lake, Plymouth (Figure 2), and at
199 Lytchett Bay in Poole Harbour (Figure 5) and has been reported in studies of the east coast of
200 England (Turner and Rees, 2016) and the Pacific and Caribbean territories of the US (Lord-Boring, et
201 al., 2004). Such locations are perceived to be convenient and acceptable because they evade any
202 punishment or other repercussions; consequently, they attract successive abandonments by the
