# **Remote sensing of boat abandonment using Google Earth**

**Millicent R. Payne and Andrew Turner\***

## **Abstract**

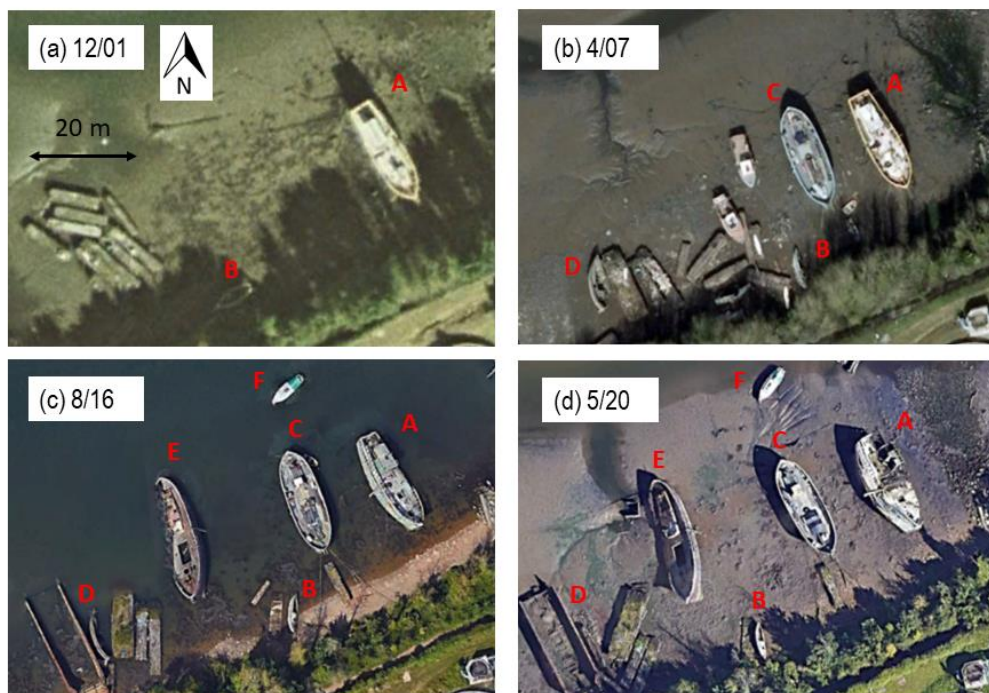
Figure 2: GE imagery of a region of Hooe Lake, Plymouth (50°21'22"N, 4°06'28"W), where boat abandonment has been increasing over the past twenty years. Selected dates are shown as month/year and boats labelled in each image are described in the text.

objects or details that could be observed and including distinctive boat parts whose precise dimensions were established from a site visit to Hooe Lake (Figure 2), ranged from about 0.3 to 2 m. Because of constraints on positional accuracy resulting from the use of images from different satellites that are not orthorectified, coordinates are reported with a suitable precision (and to the nearest whole second). Where available, imagery from Google Street View, an additional feature of GE that provides interactive panoramas from positions along public streets, was inspected to gain further details about specific boats.

In many cases, identification of abandoned boats was straightforward in that a vessel would remain at a specific location and undergo decay. Boats could first appear on imagery at a particular date or be present throughout the whole time series recorded. In other cases, identification and characterisation was more complex. This is exemplified by the GE imagery of the intertidal zone of Hooe Lake, Plymouth, captured on four selected dates that illustrate the evolution in the number and condition of several boats (Figure 2). Thus, boats A and B, of 20.4 m and 9.8 m in length, respectively, are evident on the earliest imagery (December 2002). Boat A remains in the same position throughout the time series to May 2020, but has begun to list by August 2016 and exhibits considerable damage, including by fire, in the most recent image. In contrast, boat B has shifted its precise location, either because of tidal currents or intervention during the mooring or abandonment of other boats and structures, but is nevertheless classed as abandoned. Boats C and D, of lengths of 20.7 m and 17.8 m, respectively, appear in imagery dated April 2007, and while the latter is clearly abandoned and decaying, the former remains moored and appears to have undergone recent modification. A subsequent visit to the location revealed that the boat is

undergoing restoration on an intermittent basis and is, not, therefore, classified as abandoned. Boats E (32.0 m) and F (8.0 m) appeared between 2007 and 2010 and in 2016, respectively, and while the former is in poor condition and taking in water, the latter appears to be securely moored and in relatively good condition. Since boat F had been at the same location for only four years, the principal criterion for abandonment was not, therefore, met.

Scattered clustering occurs when there is a growth of abandoned boats at a particular locality that are not moored together. This type of clustering is evident in Hooe Lake, Plymouth (Figure 2), and at Lytchett Bay in Poole Harbour (Figure 5) and has been reported in studies of the east coast of England (Turner and Rees, 2016) and the Pacific and Caribbean territories of the US (Lord-Boring, et al., 2004). Such locations are perceived to be convenient and acceptable because they evade any punishment or other repercussions; consequently, they attract successive abandonments by the

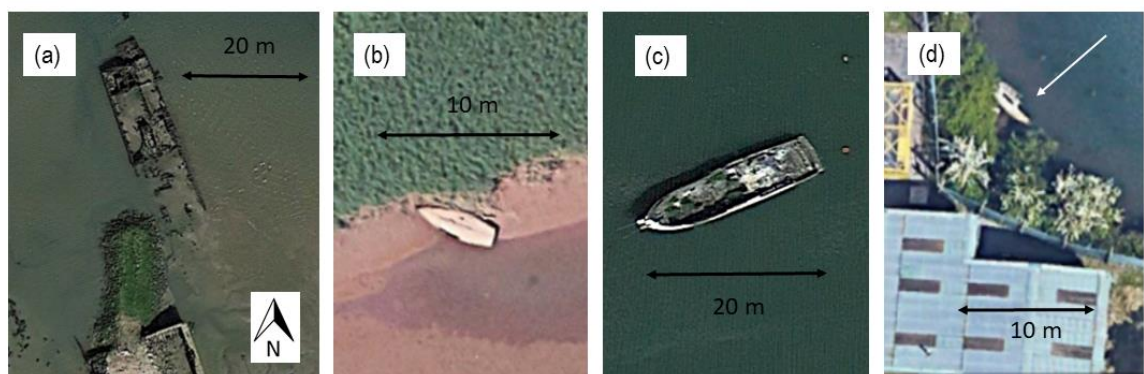
Figure 3: GE images of (a) A broken down boat in Tipner Lake, Portsmouth ( $50^{\circ}49'38.29''\text{N}$ ,  $1^{\circ}05'18.86''\text{W}$ ), (b) an abandoned boat, hull facing upwards, in reasonable condition (intact) on the Exe Estuary ( $50^{\circ}40'53.81''\text{N}$ ,  $3^{\circ}28'03.65''\text{W}$ ), (c) a damaged but floating boat on the Itchen Estuary

(50°55'08.46"N, 1°23'05.17"W), and (d) a partially submerged and concealed boat in a creek off Southampton Water (50°53'39.19"N, 1°25'35.00"W).

The condition of each abandoned boat identified in the most recent imagery of the coastline was categorised according to the criteria shown in Table 1, and examples of each category are illustrated in Figure 3.

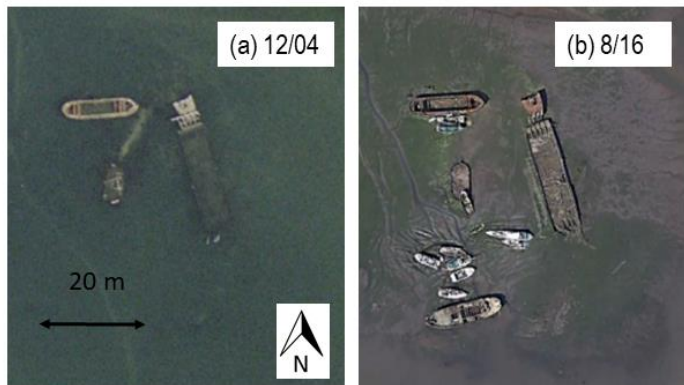
Figure 4: GE imagery showing the evolution of a cluster of abandoned boats on the Itchen Estuary ( $50^{\circ}54'57''\text{N}$ ,  $1^{\circ}22'55''\text{W}$ ) between (a) 2004 and (b) 2016.

Many of the boats on intertidal flats were also encountered in distinct clusters of up to twelve boats (with clusters defined as at least two boats within 100 m of each other). The majority of clusters were observed in the sheltered intertidal flats of estuaries and embayments around Portsmouth, Southampton, Poole and Plymouth (Figure 1). In some cases, clusters appeared to develop over a period of time through mooring aggregation, and as exemplified in Figure 4. Here, boats abandoned before 1999 in the Itchen Estuary (and illustrated in 2004) were subsequently used for the mooring and abandonment of newer vessels, resulting in the development of a dense cluster (and illustrated in 2016).

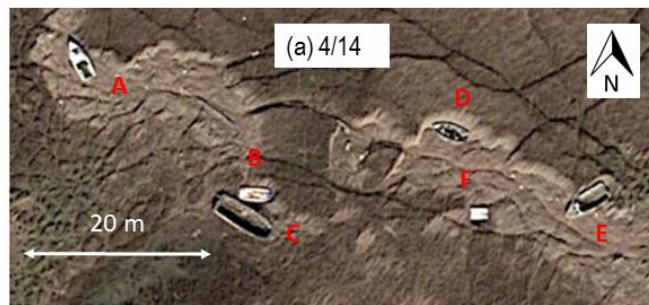
Figure 5: GE image of a cluster of abandoned boats (A to E) in Lytchett Bay (50°43'53"N, 2°02'10"W).  
Note the presence of an additional, rectangular structure (F) that has been dumped at the location.

same or different owners over a period of time. These locations often attract the dumping of other structures that may or may not be related to boating activities (and as exemplified in Figure 5).

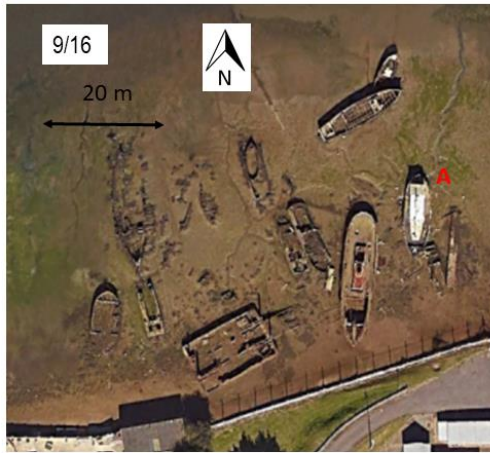
Figure 6: GE image of a cluster of abandoned boats in Forton Lake, Portsmouth Harbour (50°48'11"N, 1°07'57"W). Most boats, including those partly submerged in the sediment, were abandoned following the closure of a boatyard in 1959, but boat A appeared in 2015.

Event clustering is the sudden, mass abandonment of multiple boats at the same time resulting from an incident. Mass abandonment has been reported in US territories because of extreme weather events (Lord-Boring et al., 2004) but this is unlikely in the UK. More important here might be closures of boating facilities or the withdrawal or replacement of a particular type of vessel. As an example, a cluster of abandoned boats observed in Forton Lake, Portsmouth Harbour (Figure 6), was attributed to an event that pre-dated GE imagery. Specifically, multiple boats were left when a boatyard closed down in 1959, with additional boats being abandoned within the cluster since (Karmy, 2009).

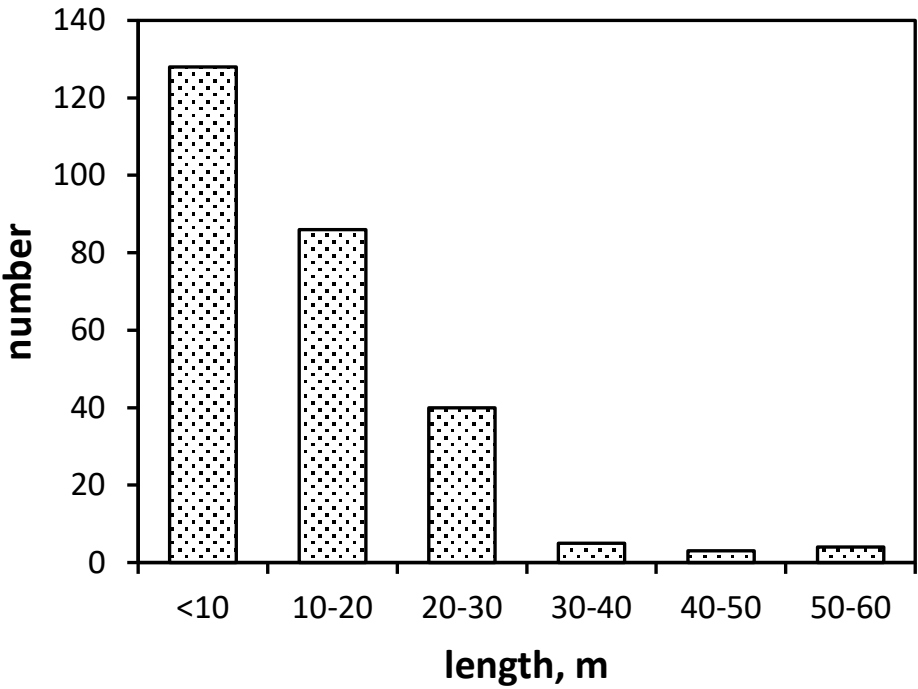
276 Figure 7: Size distribution of the abandoned boats identified along the south coast of England.

The size distribution of the abandoned boats identified in the present study is shown in Figure 7. Length ranged from 2.6 m to 60 m, with mean and median values of 13.4 m and 10.5 m, respectively, and frequency exhibited a reduction with increasing length. Regarding boat condition, and according to our criteria, 190 were broken down, 43 were damaged, 31 were partly submerged and two were intact. Amongst the abandoned boats, 95 could be defined in terms of their material of construction. Thus, based on colour, texture, panelling and decay, and, where available, imagery generated by Google Street View, 90 were identified as being of timber construction and five were identified as being of steel construction.

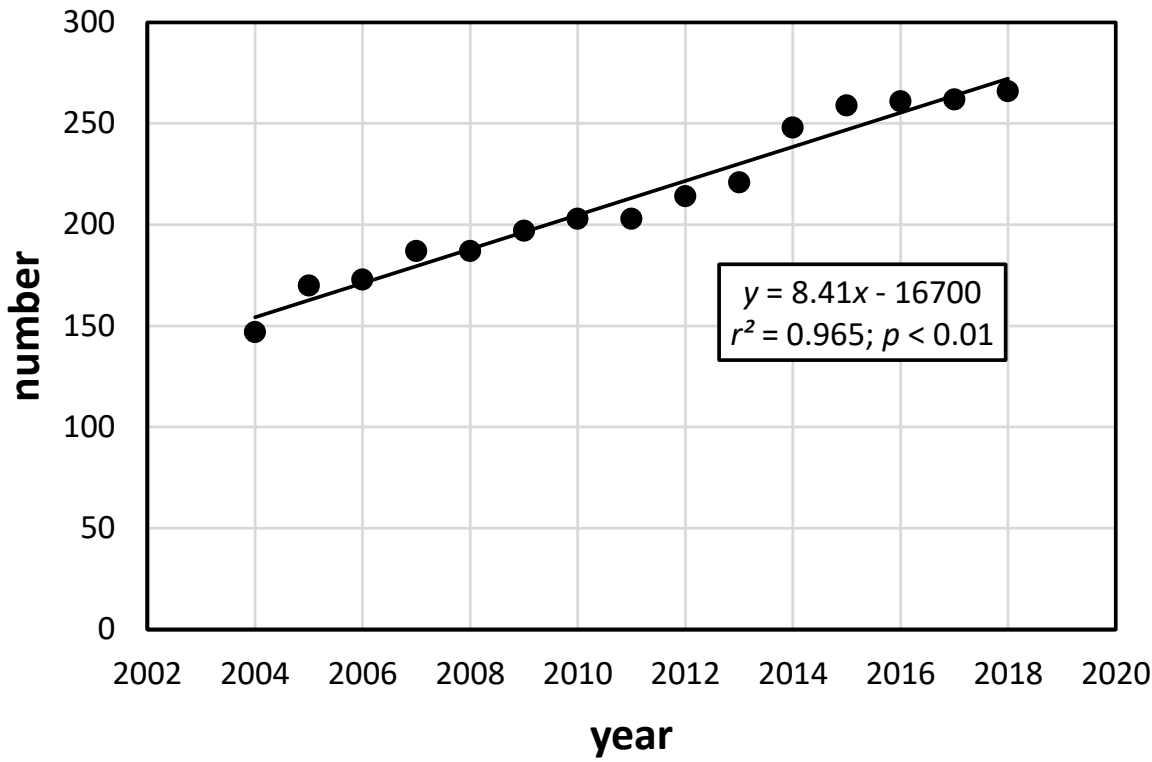
Figure 8: Cumulative frequency distribution of date of boat abandonment along the south coast of England. The regression (solid line) is defined by the parameters annotated.

Local databases and historical accounts of shipwrecks and other underwater structures mention a few of the larger foreshore boats identified in the present study with abandonment dating back to 1945 (Langley and Small, 1988; The SHIPS Project, 2021). However, and despite GE imagery available since 1999 in some areas, the earliest date of recording across the entire coastal region surveyed was 2004. The year of abandonment since this date is shown in terms of cumulative frequency in Figure 8 and reveals a steady increase in the number of boats that averages 8.4 per year and a

269 relationship between cumulative frequency and year of abandonment that is defined by linear  
270 regression with statistical significance. Note that this figure is not offset by boat recovery as none of  
271 the abandoned vessels identified were removed from their locations during the time period  
272 surveyed.
