**LANDSLIDE INVESTIGATION IN THE RÍO AGUAS
CATCHMENT, SOUTHEAST SPAIN**

A thesis submitted to the University of Plymouth in partial fulfilment for the degree of

Doctor of Philosophy

University of Plymouth

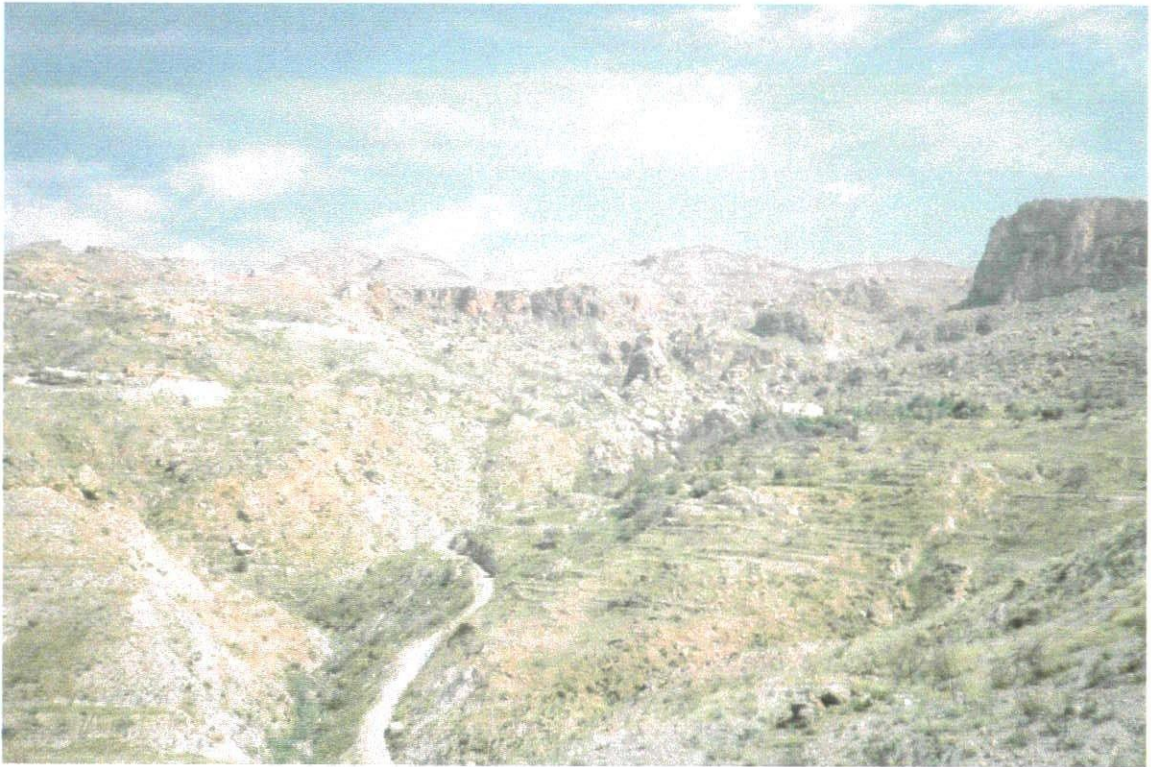
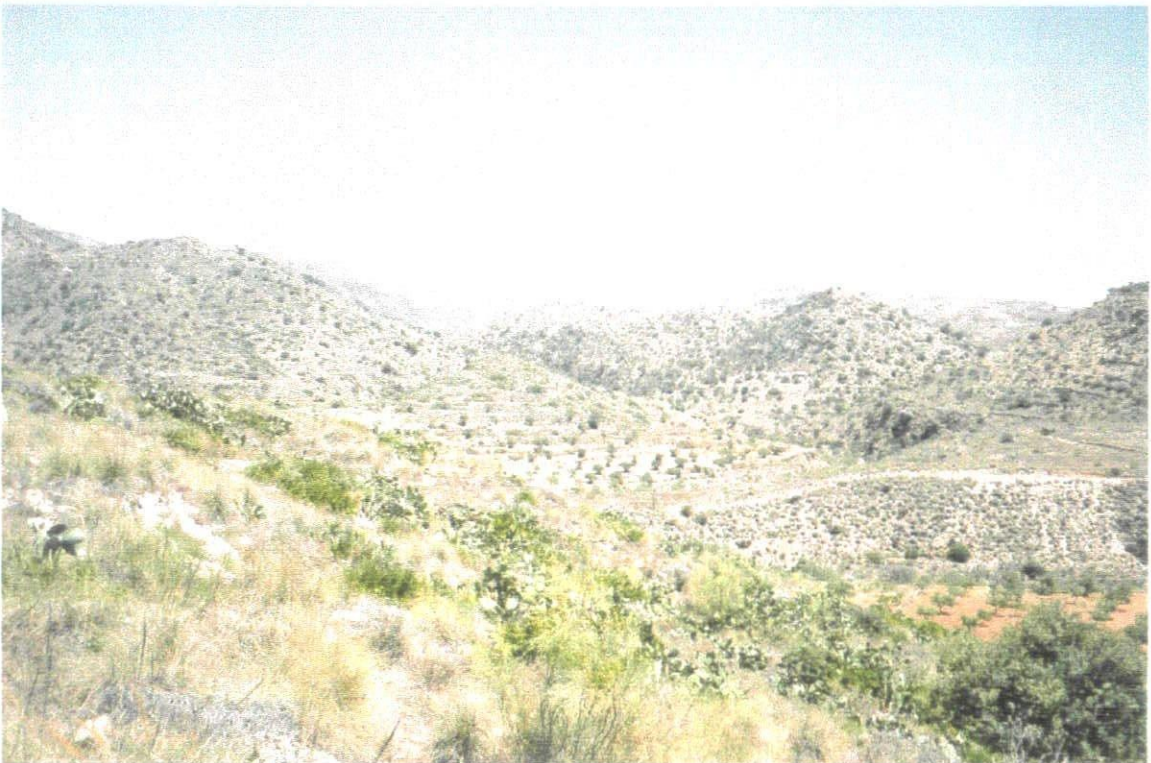
Figure 3.3 – “Mountain slopes with incised drainage” Land System.

A. The incised Rambla del Aguarón (Grid Reference: 0579041074 / Facing northeast from Alto de Zorreras / the incision is approximately 30-40m at this point).

B. A view along the incised section of the Río Aguas at Los Perales (Grid Reference: 0583041056 / Facing east). The scarp slope indicated above is approximately 70m high.

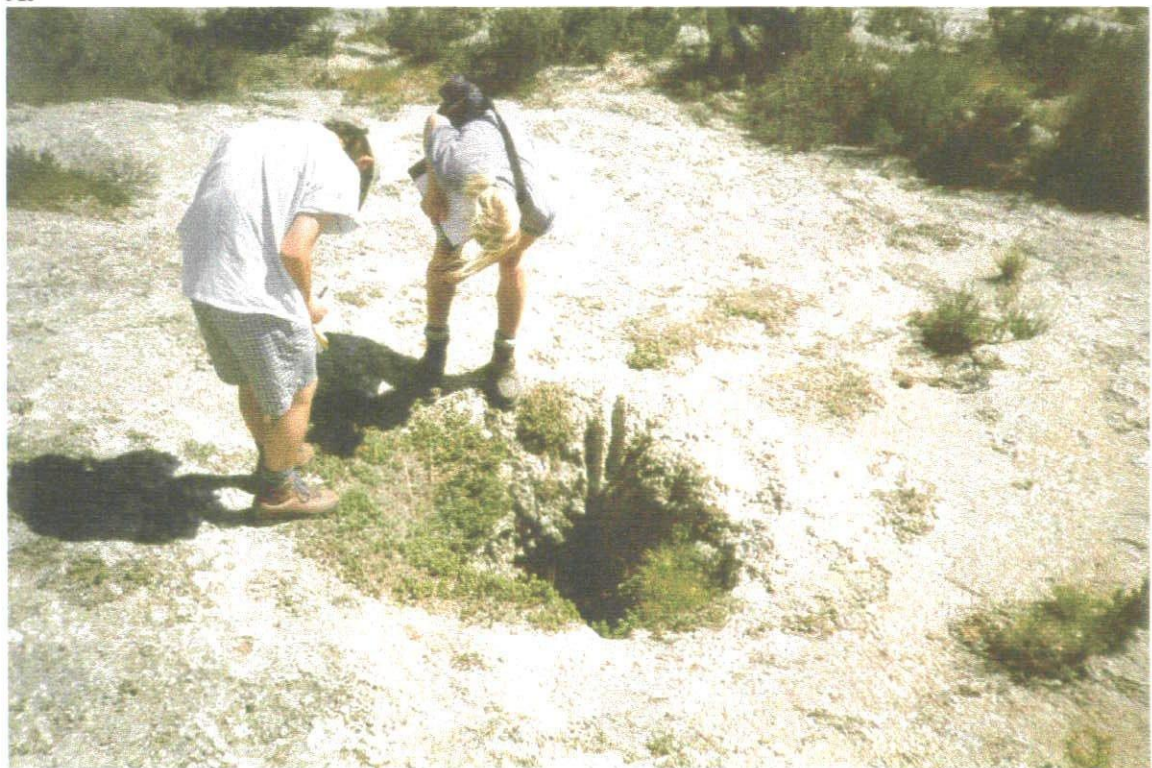
B.

Figure 3.7 – “Gypsum plateau and karst” Land System.

Gypsum Plateau and Karst	Central part of the study area	Large area of level terrain. Very thin or no soil cover. Sparse vegetation cover. Characterised by dissolution features such as sinkholes, and cave systems, as well as other karstic features. The eastern edge of the plateau is marked by a distinctive escarpment.	Yesares Member – gypsum interbedded with calcareous mudstone	3.7
Badlands	1. Between the Gypsum Plateau Land System and the Río Aguas 2. Mocatán area	Typical “Badland” landscapes. Areas of high rates of erosion and dissection.	Zorreras and Góchar Formations	3.8
Level Terrain	NE and SW parts of the study area, as well as areas below the Sierra Filabres	Relatively level terrain. Some parts of this area (i.e. central parts of Sorbas Basin) will relate to the Góchar erosion surface	Neogene and Quaternary sediments	3.9

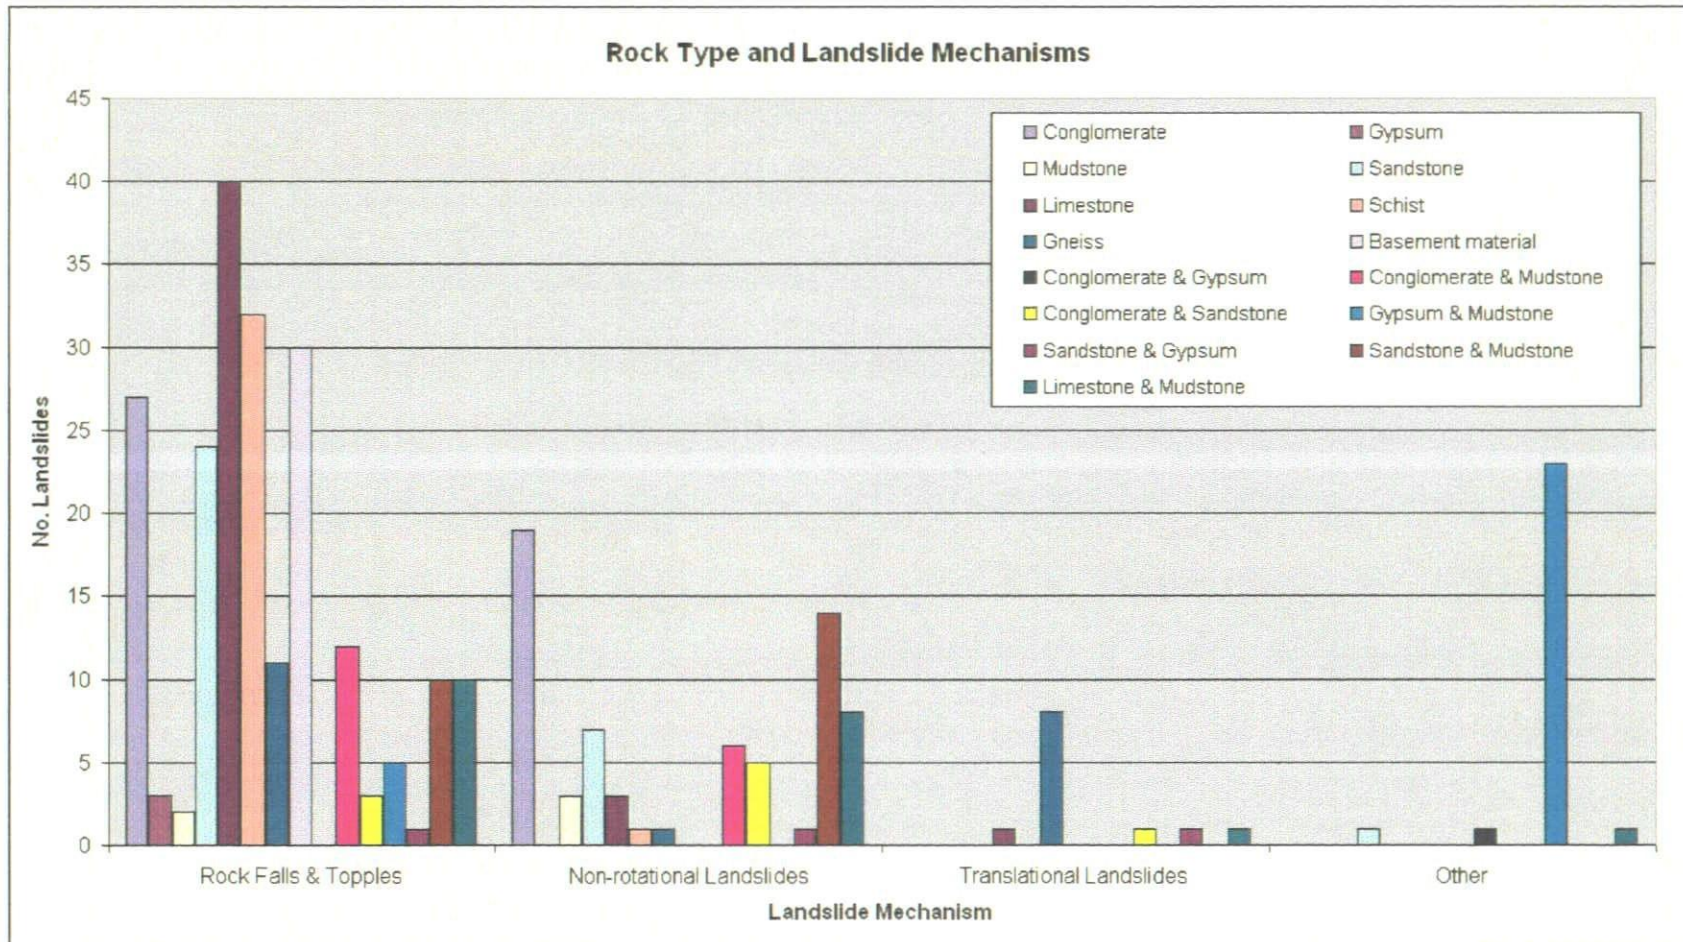
Figure 4.20 – Graph showing the breakdown of landslide mechanisms compared with the lithological units involved with the mapped landslide activity of the study area.

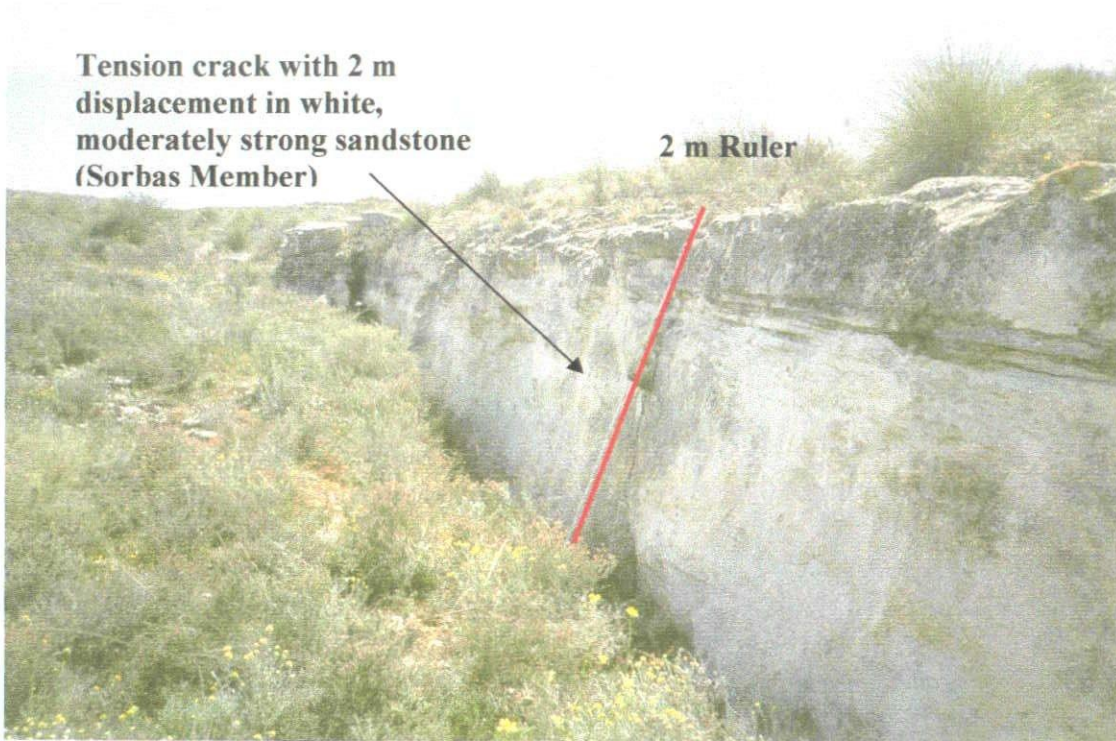
Figure 5.9 – Photograph of the tension crack and backscar associated with the displaced block shown in Figure 5.8 (Grid Reference: 0578041056).

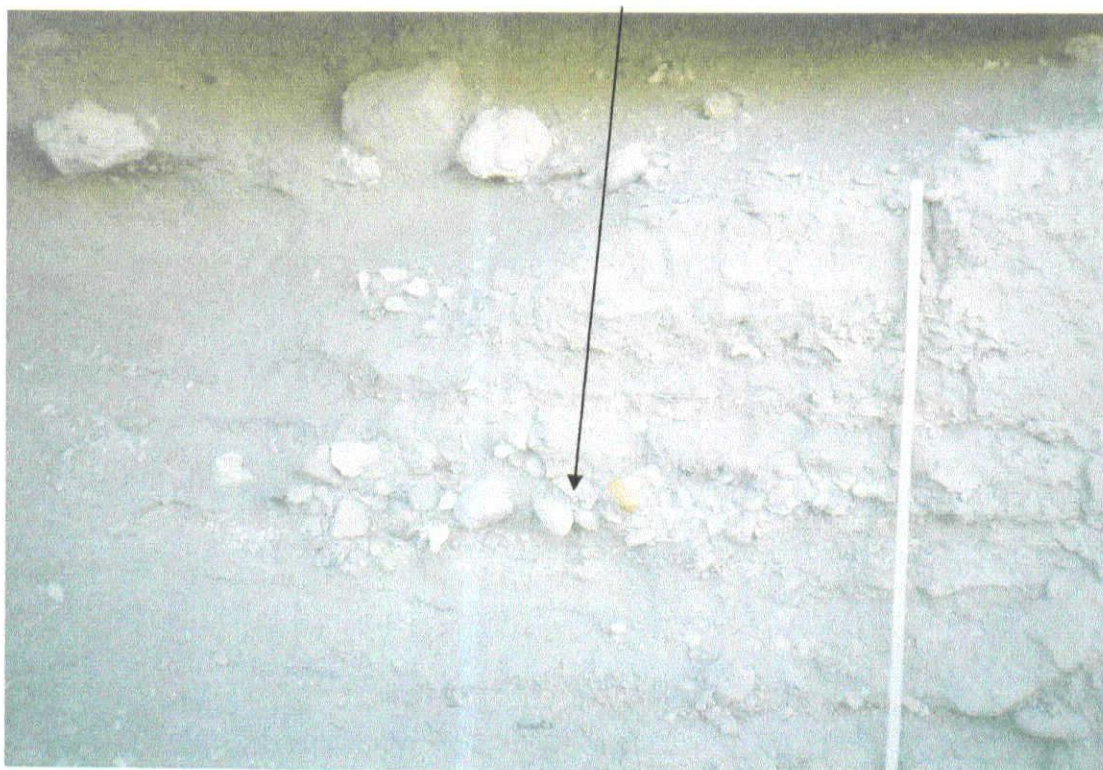
Chaotic distribution of gravels and pebbles & possible imbrication in places.

Figure 5.32b – Photographs of the second section (Scale is 1 m ruler) showing the chaotic nature and possible imbrication of the sediments (Grid Reference: 0583241053).

- A weathering hollow on the northern side of the outcrop (Figure 5.32a);
- A three-roomed man-made cave accessed through a hole in the front of the outcrop (this may have been used for cold storage by the owners of the abandoned farmhouse, but is now home to a swarm of African Bees – Figure 5.32b); and
- A weathering hollow at the eastern end of the outcrop.

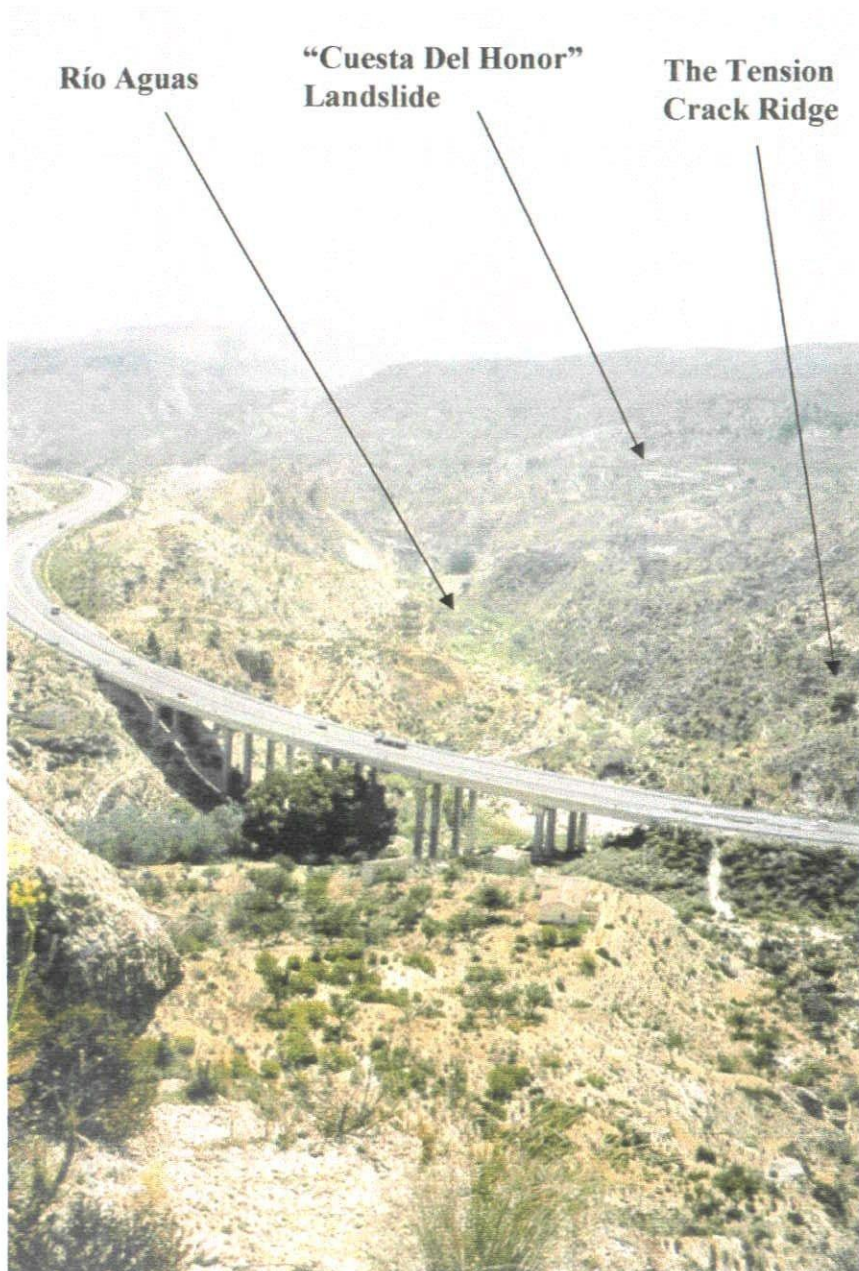
Figure 5.41 – Photograph of the elevated section of the E-15 Motorway above the Río Aguas (Grid Reference: 0583041055 / Facing east).

If the ridge were to collapse towards the north and/or east, it would block the Río Aguas, particularly as the river is within a very narrow canyon in this area. This could result in the formation of a lake, although this would not take place very quickly considering the climate of the area and the amount of water in the river. The sizeable boulder field and rock talus slopes in this area suggests that this side of the ridge is very active. The extremely large size of some of the boulders in this area would also suggest that any failure in this area could have devastating effects on any infrastructure located in this area. However, the only infrastructure in the area, at this time, is the E-15 motorway. The motorway is on an elevated bridge section above the valley and the river (Figure 5.41).

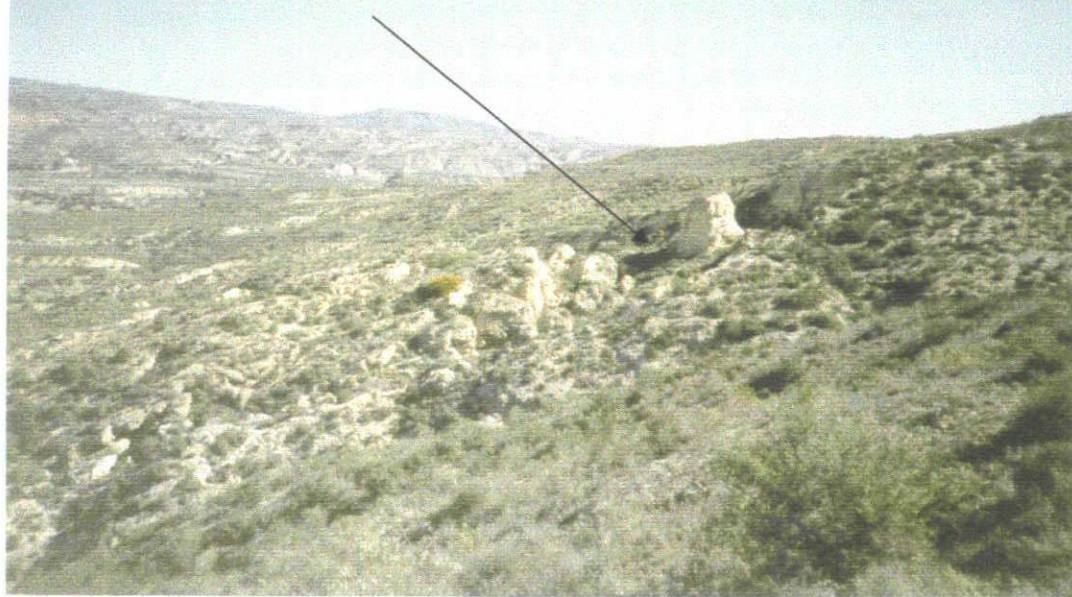
Translation landslide involving fine grained sediment sliding along the contact with underlying gypsum of the Yesares Member. Slope angle c. 30°.

Figure 6.7 – A translational landslide within the “Hill areas with valley side slopes” Land System. This landslide is located at “La Clauda” near to Cortijo Urra (Grid Reference: 0579541050 / Facing northeast from near to the farm “La Clauda”).
