Biodeterioration and bioprotection of concrete assets in the coastal environment

International Biodeterioration & Biodegradation

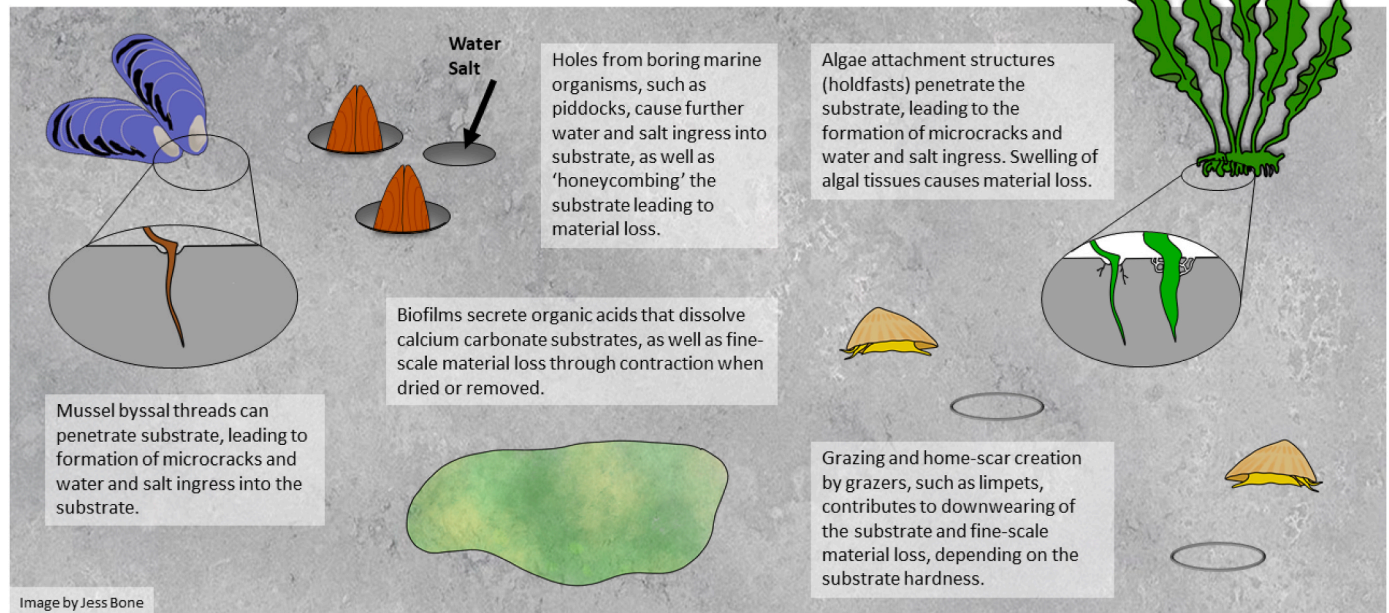
The biodeteriorative mechanisms caused by marine organisms will act in tandem with erosion and weathering agents, such as wave action, salt cracking, and chemical attack from sulphate and chloride in seawater.

Fig. 1. The biodeteriorative action of rocky intertidal organisms. Note that while substrate is indicative of concrete, the magnitude of biodeteriorative action is dependent on the substrate material and spatiotemporal variations in population size of the organism. Not to scale. See also 'Shore Shapers' (Naylor et al., 2014).

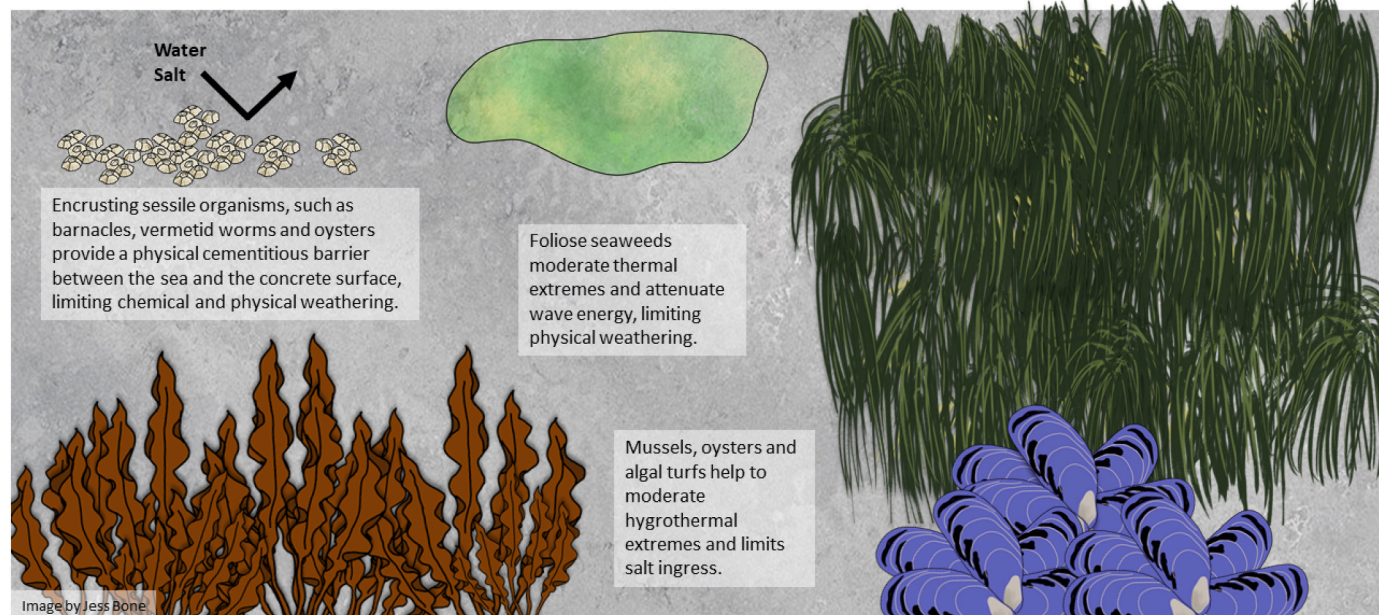
Biofilms provide a protective patina that provides minor protection against salt ingress, and can promote the precipitation of insoluble materials that prevent further water penetration.

Algal turfs and honeycomb worm reefs trap sand and particulate matter, limiting scour and stabilising sediments.

Fig. 2. The bioprotective effects of rocky intertidal organisms. Note that while substrate is indicative of concrete, the magnitude of bioprotective benefits is dependent on substrate material, whether the organism is live, and the spatiotemporal variations in population size and density. See also ‘Shore Shapers’ (Naylor et al., 2014).

Bioprotection can be achieved via three main mechanisms: stabilisation of the substrate, microclimate mediation, and attenuating weathering and other deteriorative effects (Fig. 2). Substrate stabilisation can involve the aggregation of particulate matter within biofilms, the secretion of insoluble precipitates on the substrate surface, such as oxalates, and the retention of sediment in algae. Buffering hygrothermal regimes and reducing the frequency of extreme temperature events can be achieved through the colonisation of sessile and epilithic biota, which

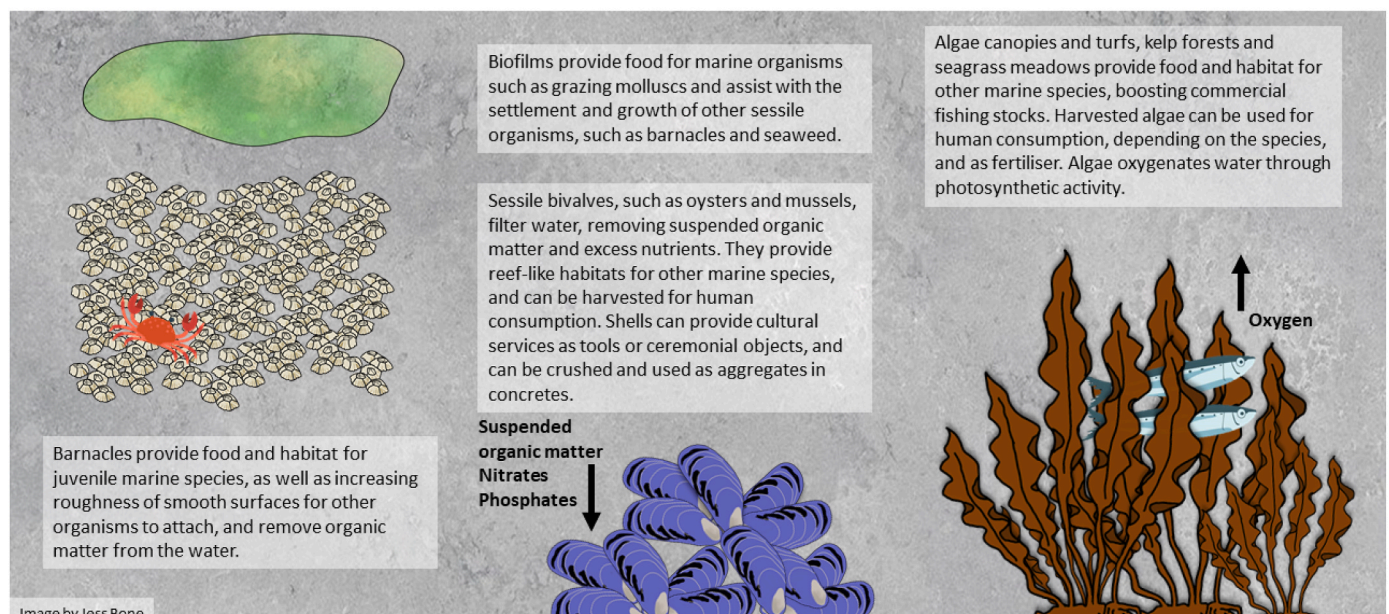
In addition to benefits provided by individual morphologies and taxonomic groups below, communities of marine organisms contribute to a 'natural aesthetic' and improve human health and wellbeing by 'greening the grey'. Where eco-engineering is used, there is potential for education, recreation and tourism benefits if the artificial coastal structure is appropriately accessible and signage and interpretation is used.

Fig. 3. Examples of some of the beneficial ecosystem services and processes provided by the rocky intertidal organisms mentioned in this review.

When attempting to determine if a species or assemblage offers a net bioprotective gain or biodeteriorative loss, acknowledgement of the additional ecosystem services offered by it should be considered (Fig. 3). For example, carbon dioxide sequestration and water filtration (Layman et al., 2014), habitat and food provision (Vaughn 2018), contribution to 'natural' aesthetic (Fairchild et al., 2022), and cultural and socio-economic benefits (education, tourism, recreation, fisheries industry) may be provided (Naylor et al. 2014, 2017) and could tip the scales in favour of encouraging or retaining existing colonisation (Coombes and Viles 2021). Ultimately, a bioprotective assemblage is not guaranteed as colonisation of a substrate is dependent on spatiotemporally variable factors, such as latitude, climate, orientation, aspect, substrate material, larval supply, predator-prey dynamics, competition, and habitat and food availability. As noted by Gadd and Dyer (2017) there is no guarantee that target species will colonise or perform in the expected and desired manner. However, promoting a diverse
