Biodeterioration and bioprotection of concrete assets in the coastal environment

International Biodeterioration & Biodegradation

Jessica R. Bone^{a,*}, Rick Stafford^a, Alice E. Hall^{a,b}, Roger J.H. Herbert^a

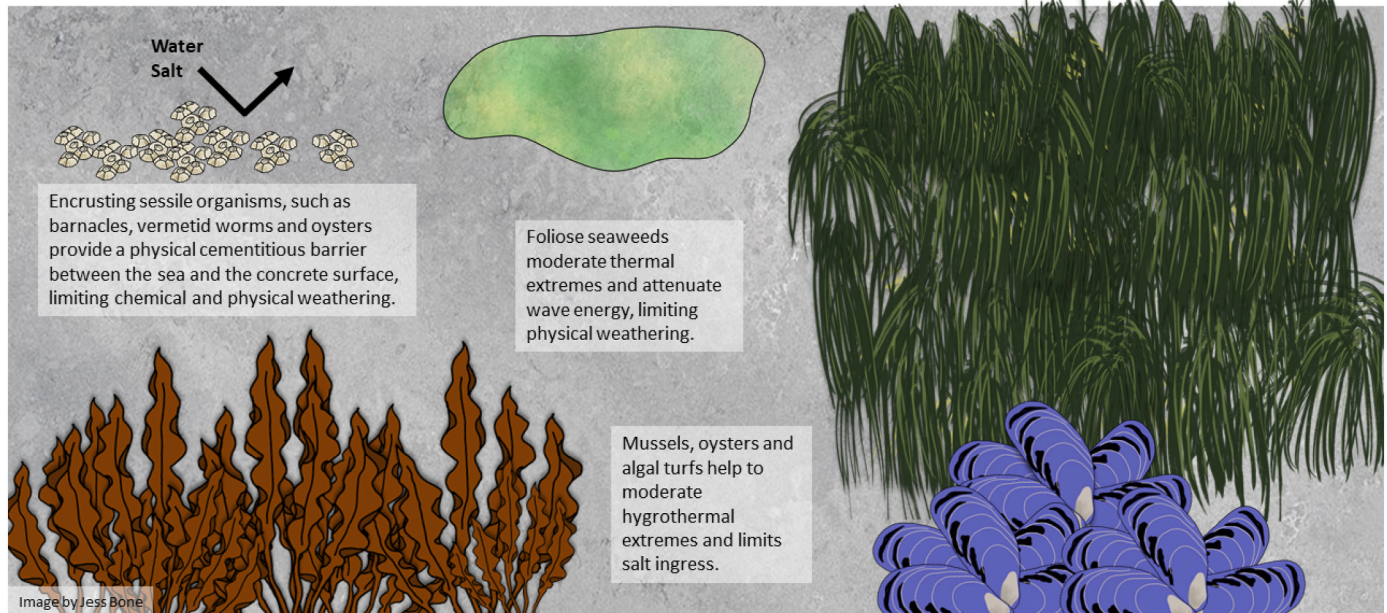
Biofilms provide a protective patina that provides minor protection against salt ingress, and can promote the precipitation of insoluble materials that prevent further water penetration.

Algal turfs and honeycomb worm reefs trap sand and particulate matter, limiting scour and stabilising sediments.

Fig. 2. The bioprotective effects of rocky intertidal organisms. Note that while substrate is indicative of concrete, the magnitude of bioprotective benefits is dependent on substrate material, whether the organism is live, and the spatiotemporal variations in population size and density. See also 'Shore Shapers' (Naylor et al., 2014).

Bioprotection can be achieved via three main mechanisms: stabilisation of the substrate, microclimate mediation, and attenuating weathering and other deteriorative effects (Fig. 2). Substrate stabilisation can involve the aggregation of particulate matter within biofilms, the secretion of insoluble precipitates on the substrate surface, such as oxalates, and the retention of sediment in algae. Buffering hydrothermal regimes and reducing the frequency of extreme temperature events can be achieved through the colonisation of sessile and epilithic biota, which

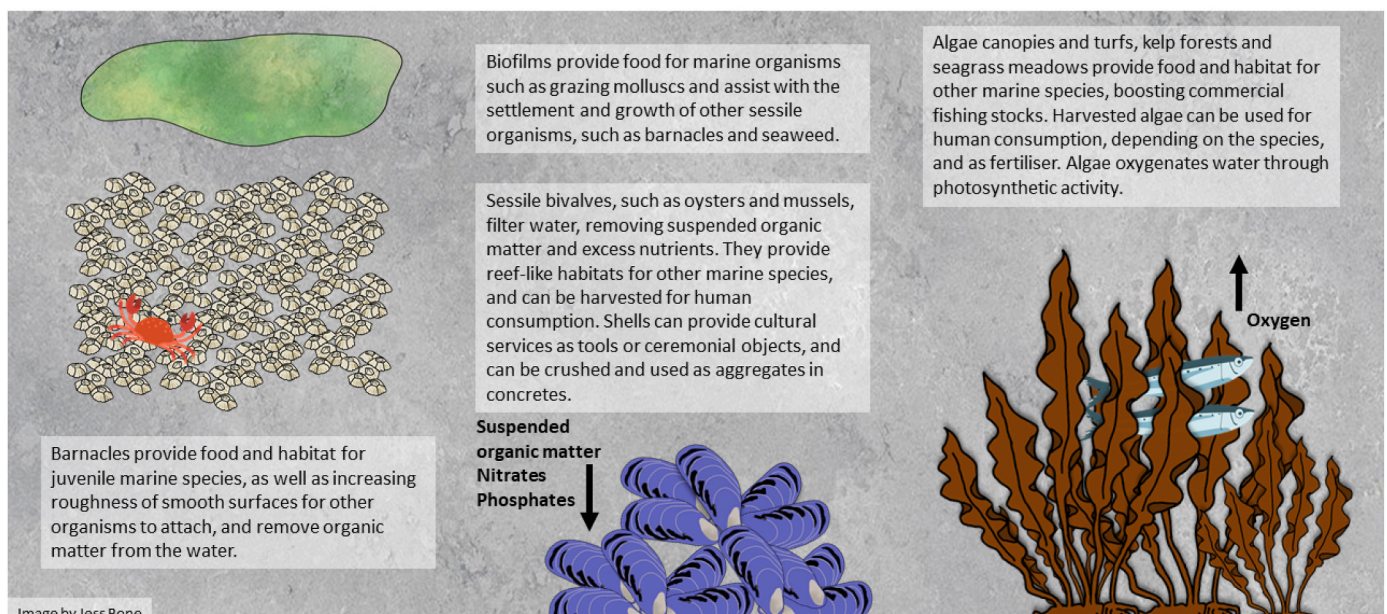
EXAMPLES OF BENEFICIAL ECOSYSTEM SERVICES AND PROCESSES PROVIDED BY ROCKY INTERTIDAL ORGANISMS

In addition to benefits provided by individual morphologies and taxonomic groups below, communities of marine organisms contribute to a 'natural aesthetic' and improve human health and wellbeing by 'greening the grey'. Where eco-engineering is used, there is potential for education, recreation and tourism benefits if the artificial coastal structure is appropriately accessible and signage and interpretation is used.

Fig. 3. Examples of some of the beneficial ecosystem services and processes provided by the rocky intertidal organisms mentioned in this review.

When attempting to determine if a species or assemblage offers a net bioprotective gain or biodeteriorative loss, acknowledgement of the additional ecosystem services offered by it should be considered (Fig. 3). For example, carbon dioxide sequestration and water filtration (Layman et al., 2014), habitat and food provision (Vaughn 2018), contribution to 'natural' aesthetic (Fairchild et al., 2022), and cultural and socio-economic benefits (education, tourism, recreation, fisheries industry) may be provided (Naylor et al. 2014, 2017) and could tip the scales in favour of encouraging or retaining existing colonisation (Coombes and Viles 2021). Ultimately, a bioprotective assemblage is not guaranteed as colonisation of a substrate is dependent on spatiotemporally variable factors, such as latitude, climate, orientation, aspect, substrate material, larval supply, predator-prey dynamics, competition, and habitat and food availability. As noted by Gadd and Dyer (2017) there is no guarantee that target species will colonise or perform in the expected and desired manner. However, promoting a diverse
