THERMOGRAPHY APPROACHES FOR BUILDING DEFECT DETECTION

A thesis submitted to Plymouth University

DOCTOR OF PHILOSOPHY

Environmental Building Group

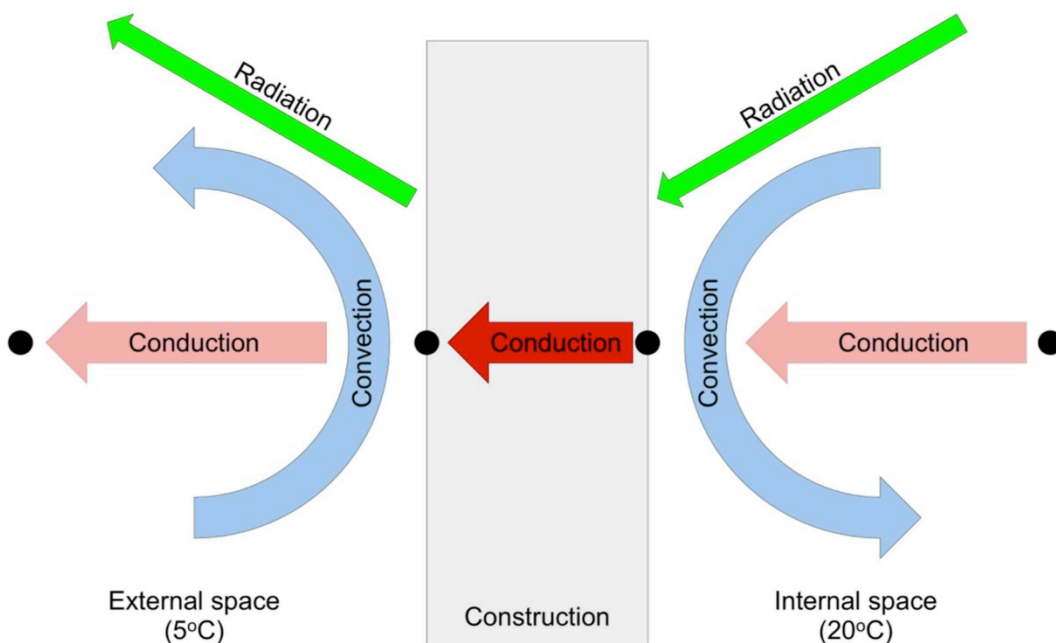
Figure 4. The three heat transfer mechanisms subject to an unspecified structure. Adapted from De Wilde (2009).

It is also important to consider the physics behind thermally significant building defects. Referring back to Walker's list of key overall areas of heat loss, all three defect types will be subject to conduction, convection and radiation. Figure 4. illustrates the key heat transfer mechanisms subject to an unspecified target (with indicative internal and external air temperatures). Although this relates to a steady state/dry target, adding moisture or air movement to the construction will have the effect of altering the material properties of the structure by increasing conduction (evaporative cooling and forced convection for example). It is therefore important to not treat conduction heat losses in isolation from the other heat transfer mechanisms.

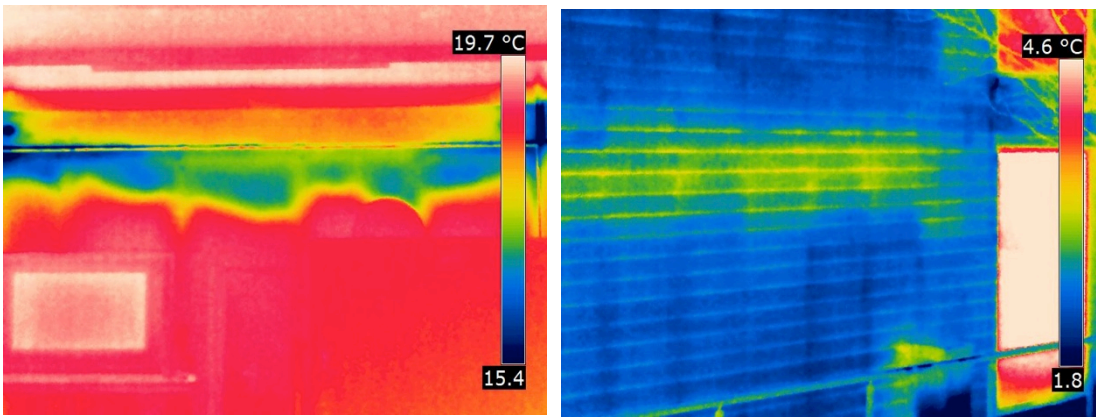
Figure 14. Two thermal images of the same wall area viewed from either side.

Building thermography can be undertaken both externally and internally. External thermography is more susceptible to transient environmental conditions than internal thermography, which provides a much more controlled environment that has slower and less significant climatic fluctuations (Balaras & Argiriou, 2002). When viewing defects, Pearson (2011) suggests that any areas of heat loss observed in external thermography will almost always present themselves more clearly on internal thermography at the same time. This is illustrated in figure 14, which shows external wall with slumped cellulose insulation. The location of this (appearing cool) defect internally corresponds to a hot region found on the same wall when viewed externally. As reported by Williamson (2014), it is not uncommon to find defects internally, though not externally.

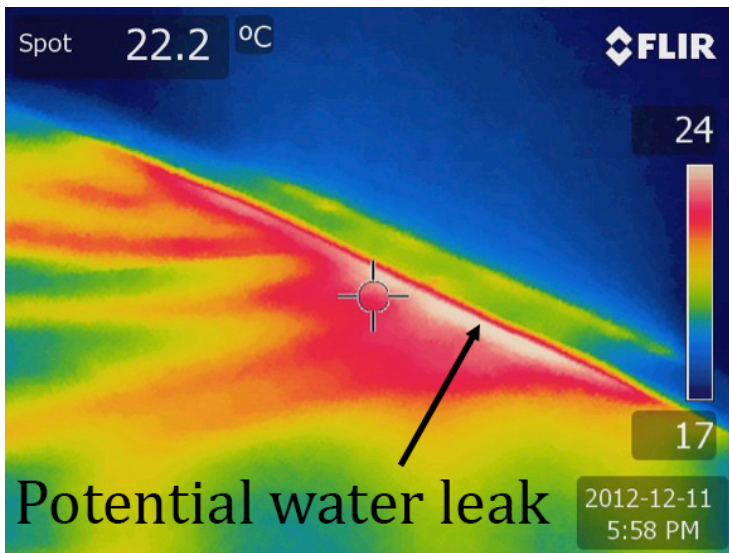
Figure 19. Potential defect with under floor heating system.

Titman (2001) discussed this application, describing the usefulness of building thermography for detecting buried/hidden and or defective services within old buildings, particularly where little or no record is kept. One such example is the identification of under-floor heating installations (Nowicki, 2004), where thermography could help to determine the quality of workmanship or whether there were any leaks in the service piping (Figure 19) (Snell & Spring, 2008).

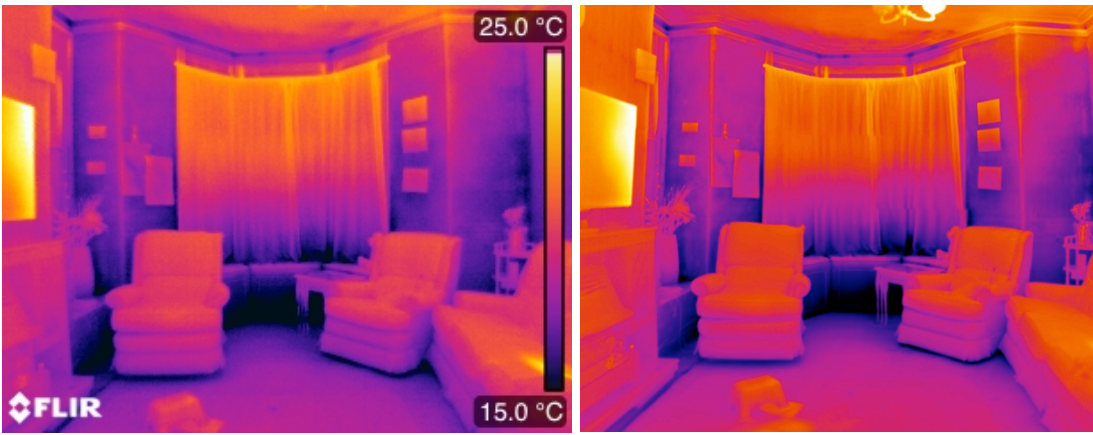
Figure 48. Single, wide-angle thermal image (Left). 16 individual thermal images pieced into one panoramic view (Right).

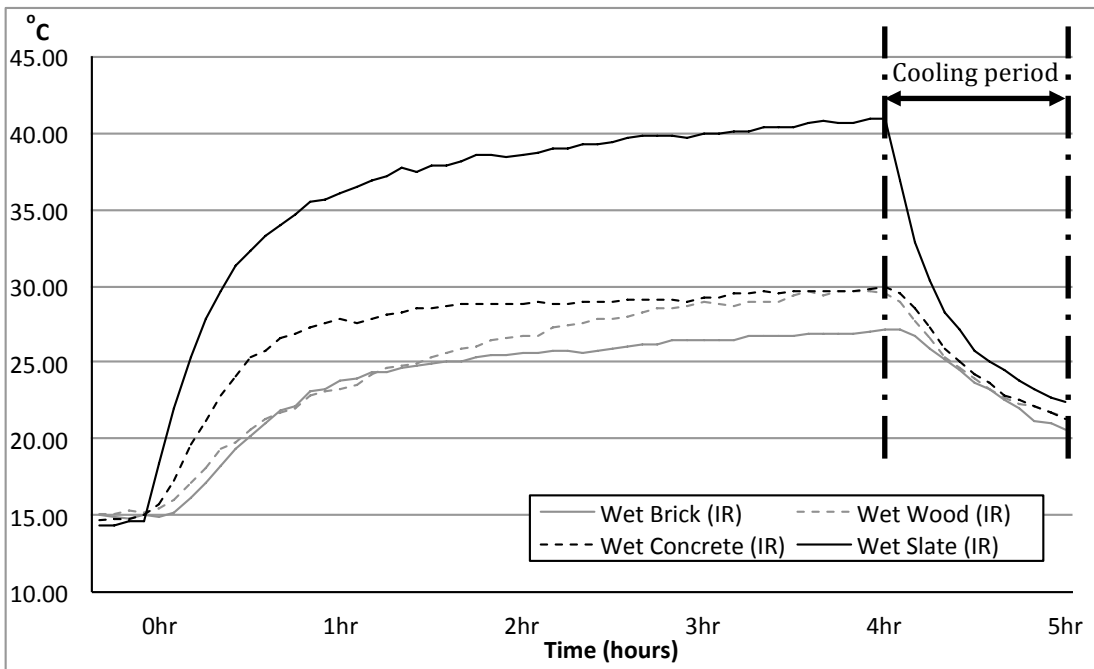
Figure 57. Experiment 2. Wetted samples. Showing apparent surface temperatures obtained from the thermal camera (IR).

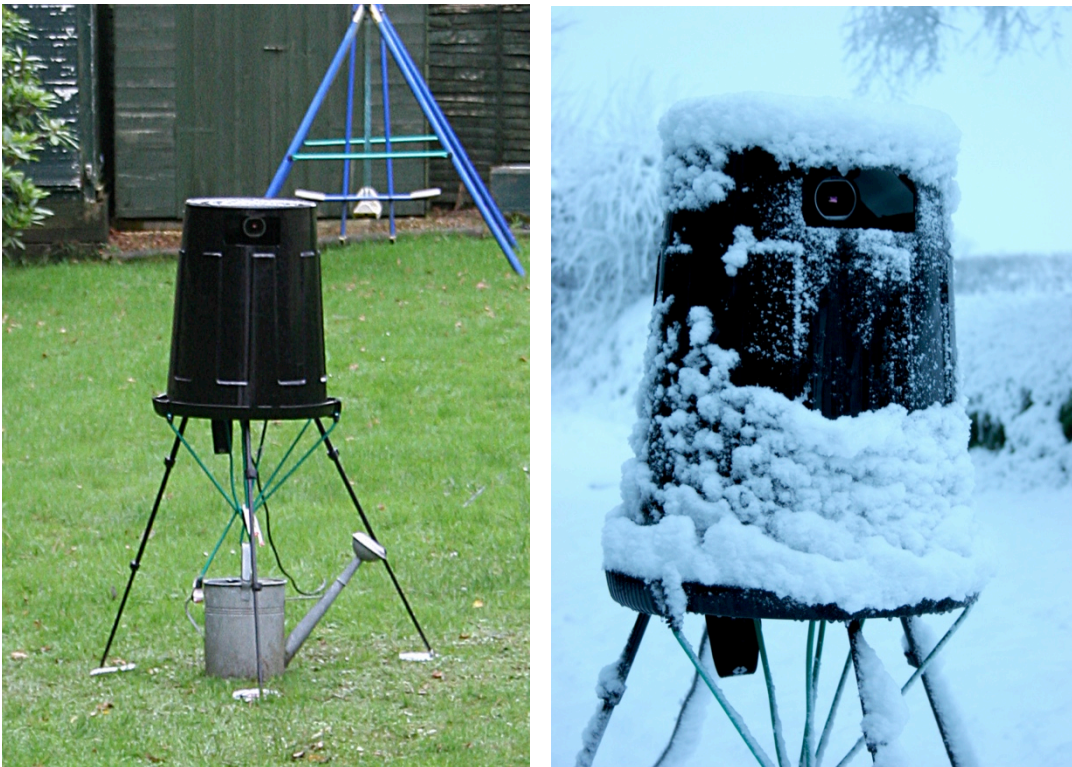
Figure 65. Tripod mounted thermal camera housed within a simple plastic shelter. (left). Snow covered experimental set-up (right).

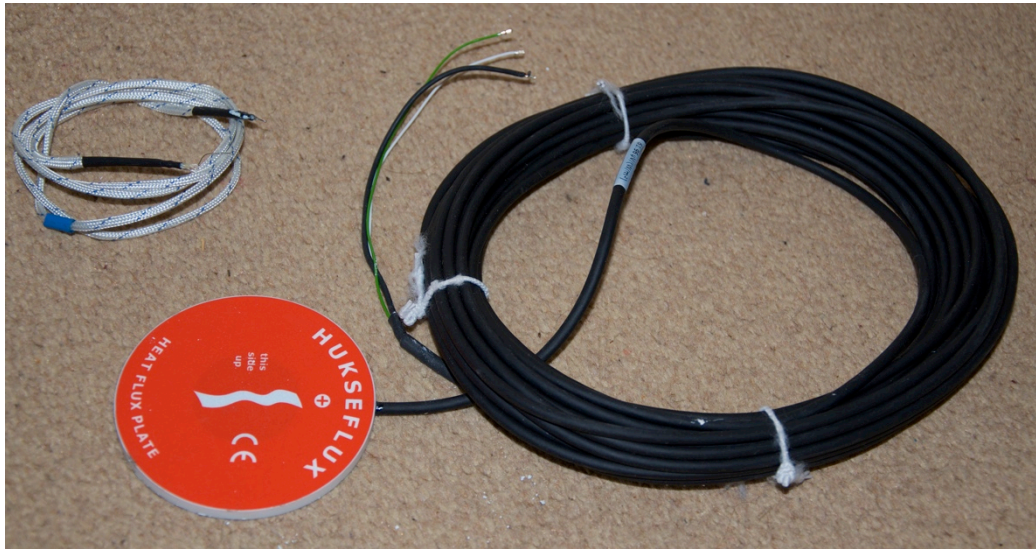
Figure 77. Hukseflux Heat flux sensor and K-type thermocouple.

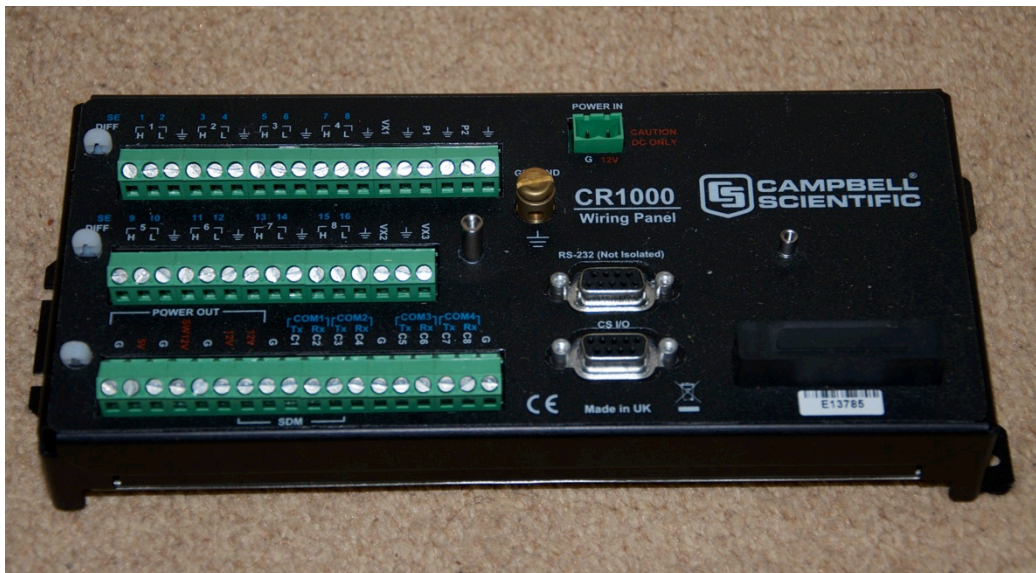
Figure 78. Campbell Scientific CR1000 data logger.

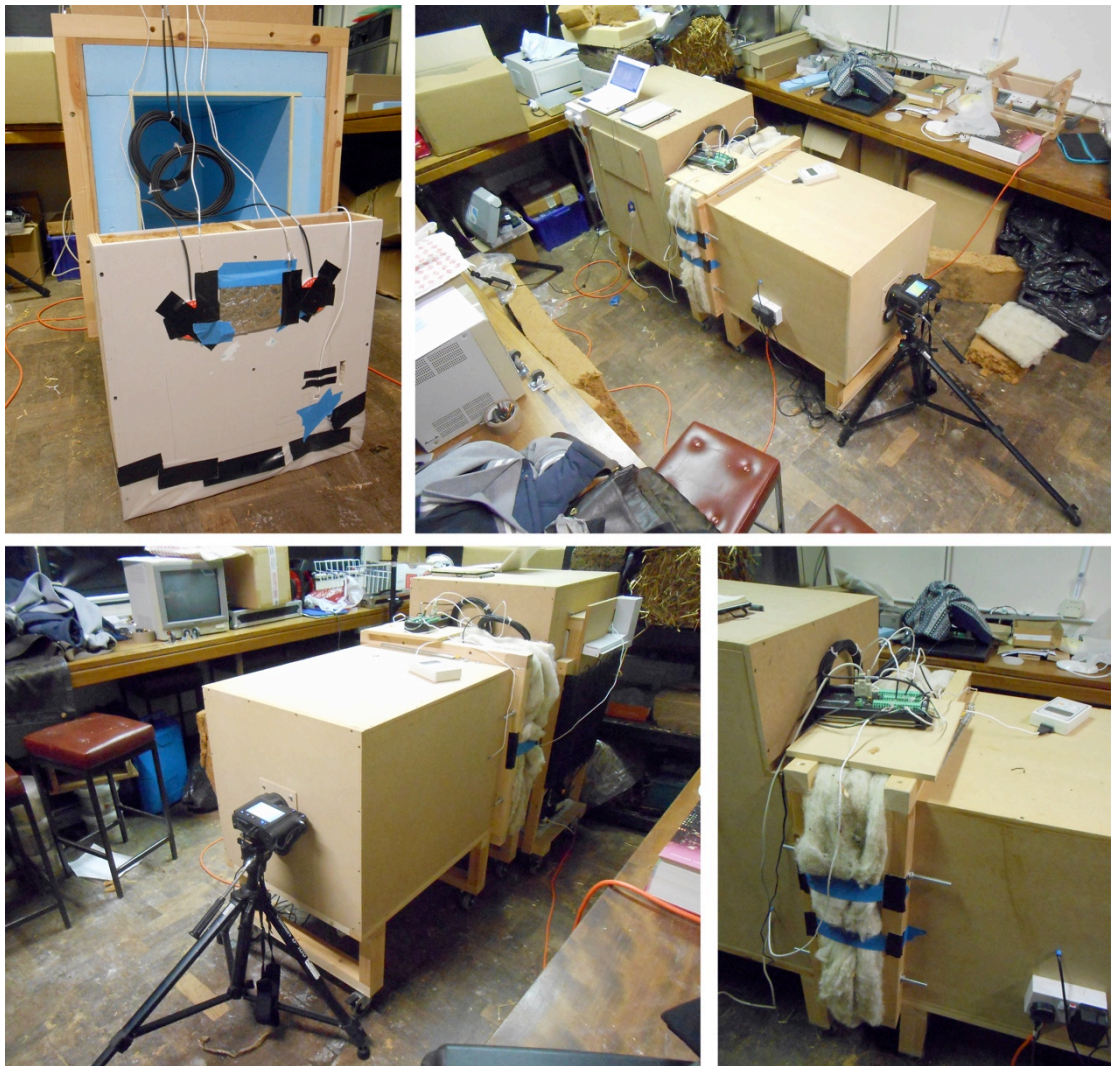
Figure 127. Four photos showing the sample, hot box, cold box and connected sensors.
