# The environmental impacts and health hazards of abandoned boats in estuaries

# **The environmental impacts and health hazards of abandoned boats in estuaries**

**Andrew Turner\* & Aldous Rees**

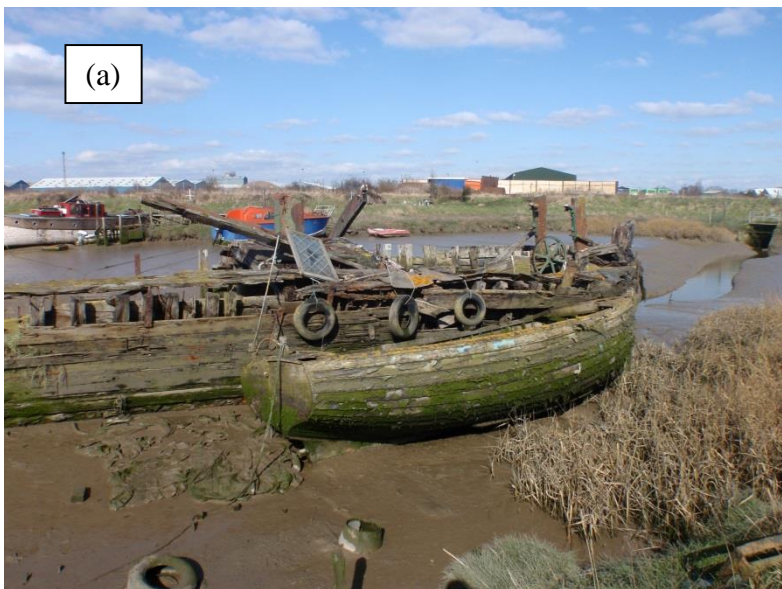
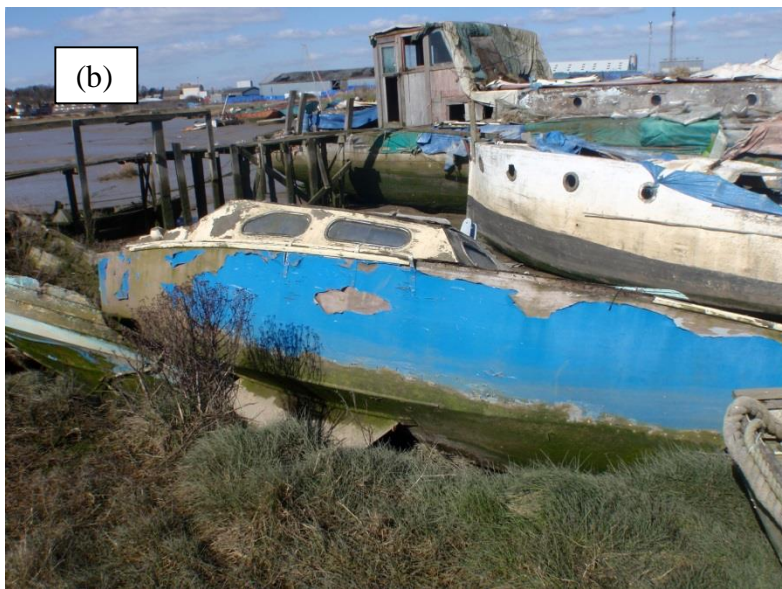
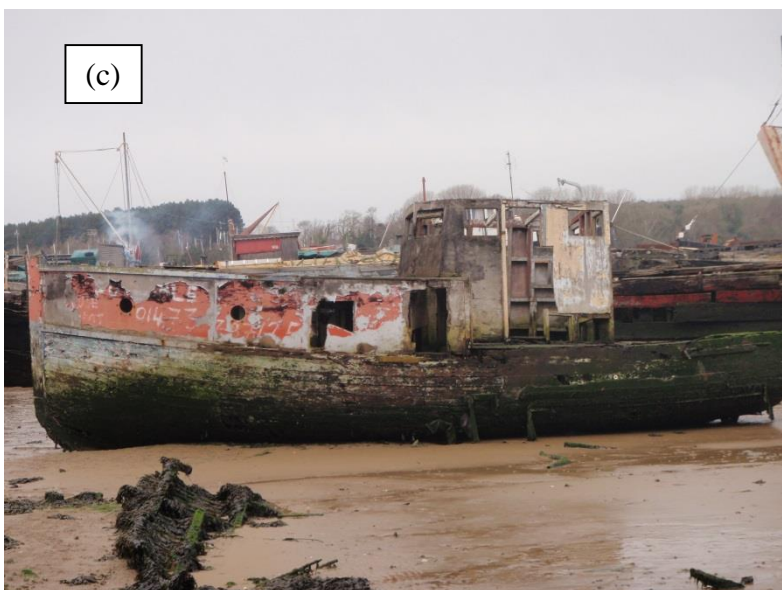
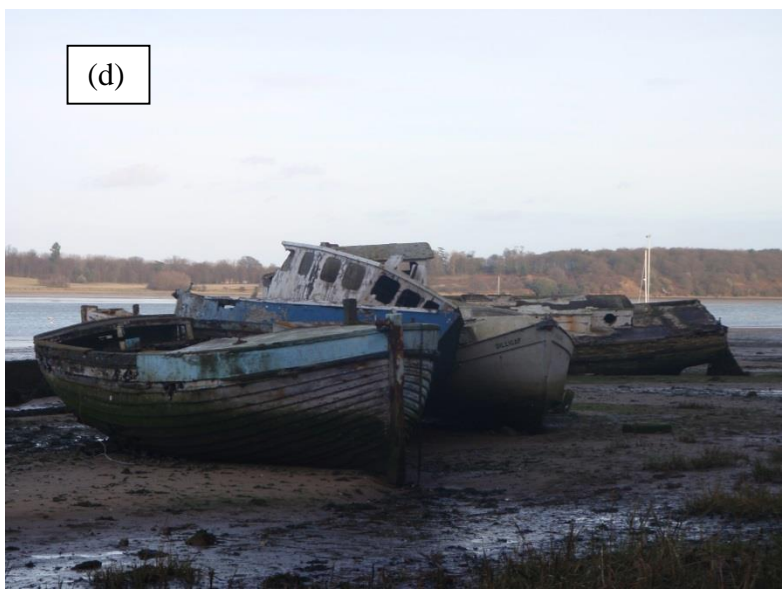
12 Figure 2: Photographs of a selection of the boats and debris inspected on the Blackwater and Orwell estuaries. (a) Boat 2 lying on the mudflats of the Blackwater estuary and adjacent to a  
13 decaying jetty; (b) boats 4, 5, 6 and 7 clustered together on the Blackwater estuary and partially covered in tarpauling ; (c) boat 49 on the Orwell estuary at Pin Mill and with various decaying  
14 boats visible behind; (d) boats 50, 51 and 52 clustered together on the foreshore at Pin Mill.
