**THE MOISTURE PERFORMANCE OF
STRAW BALE CONSTRUCTION
IN A TEMPERATE MARITIME CLIMATE**

A thesis submitted to the University of Plymouth
in partial fulfilment for the degree of

Environmental Building Group
School of Architecture
Faculty of Arts

June 2011

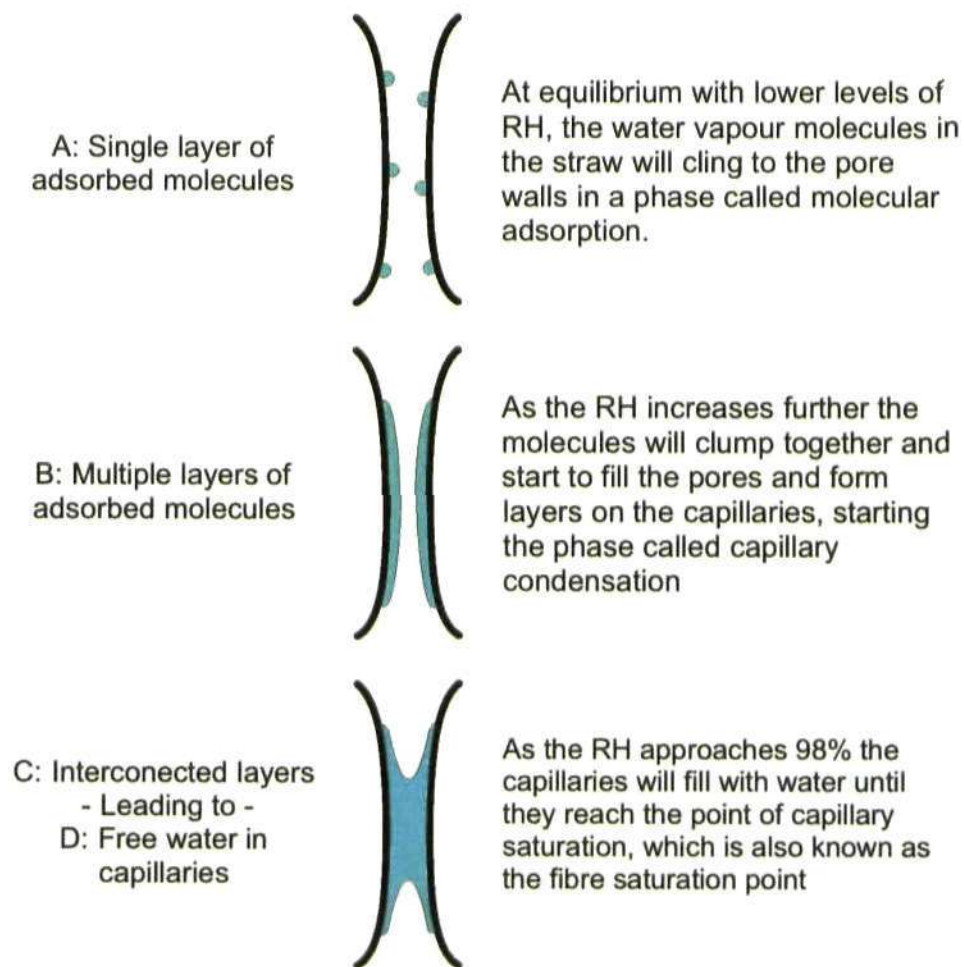
Fig.15 Phases of water sorption in a hygroscopic material, such as straw. Redrawn from Hens (2007).

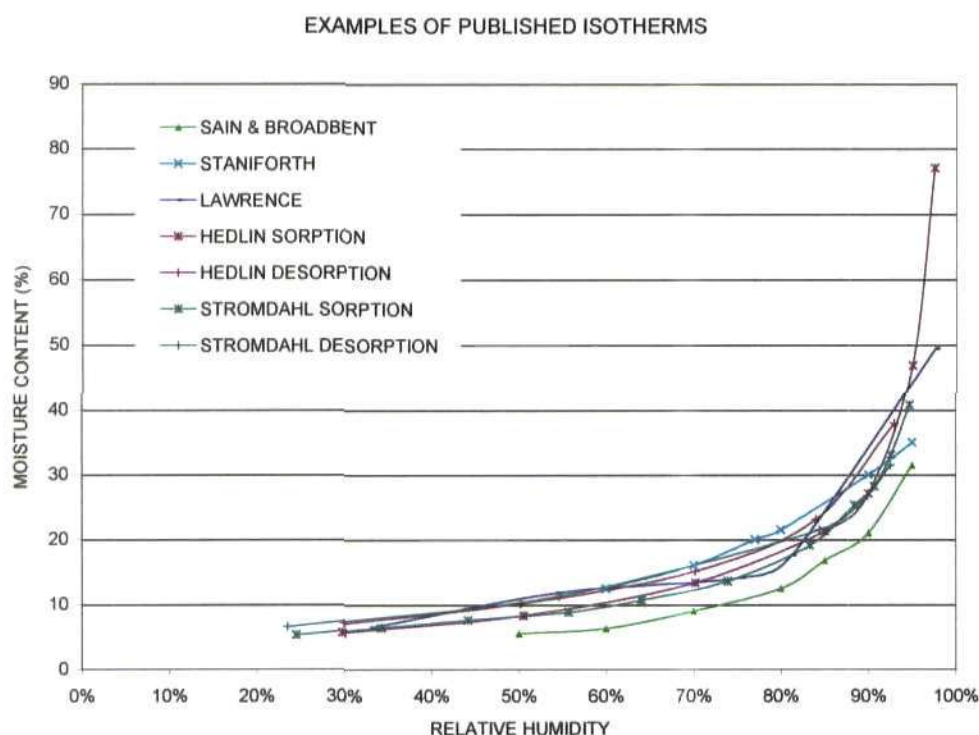
Sain and Broadbent (1975) created an adsorption isotherm for rice straw using a method that involved grinding the samples to pass through a 2mm sieve, then using vacuum desiccators containing sulphuric acid to provide the required relative humidities, a method that is no longer supported by the current standards. Their isotherm shows a consistently lower level of moisture content than the other published isotherms shown in Fig.17, below. However, this may be because the isotherm is for rice, not wheat, straw.

Fig.17 Published isotherms for straw

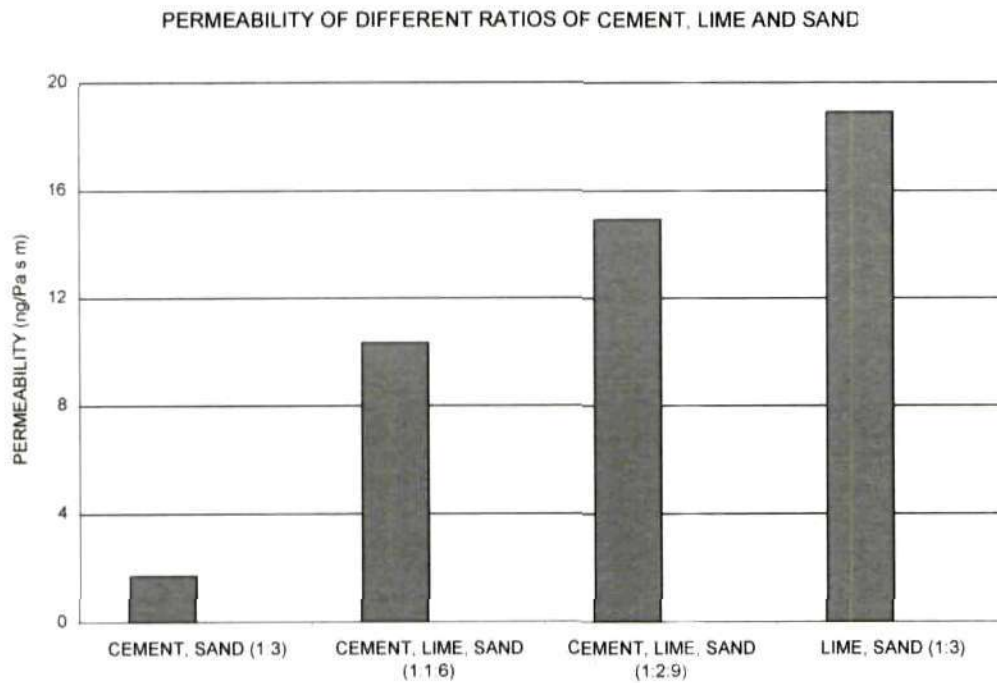
In straw bale building this vapour permeability is created by the use of lime based renders. Research by John Straube (2000a) has shown that lime based renders can have a significantly higher permeability than cement based renders. As shown in Fig.18, his tests renders made with pure slaked lime and sand had 12 times the permeability of a render made with cement and sand in the same ratio, with different mixes of cement and lime falling between the two.

Fig.18 Graph showing the considerable difference in the permeability of renders using varied combinations and ratios of cement, slaked lime, and sand (Straube 2000a).

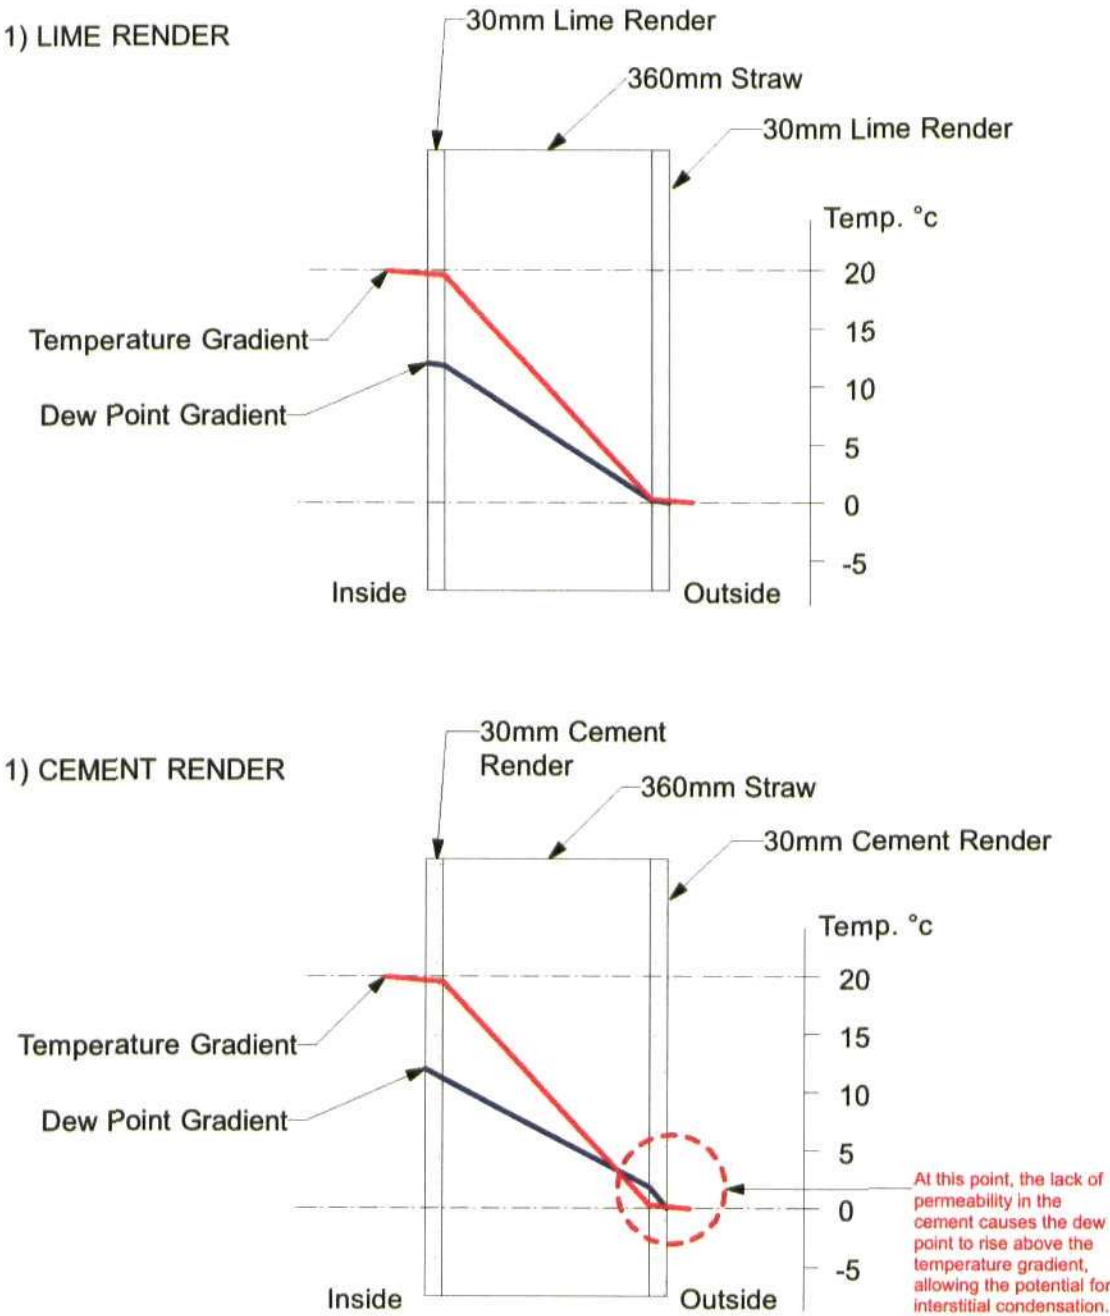
COMPARISON OF LIME AND CEMENT RENDER.
Difference in Dew Point Gradient for Lime:Sand Render compared to
Cement:Sand Render on a Straw Bale Wall

Fig.19 The effects of permeability on the dew point gradient and the potential for interstitial condensation

If the render used was less permeable than the lime, then the dew point gradient would cross the temperature gradient at the outer edge of the wall (as shown in Fig.19 in section 3.2.1). If this was the case, then the moisture levels in the straw close to the exterior render could be expected to be significantly higher.

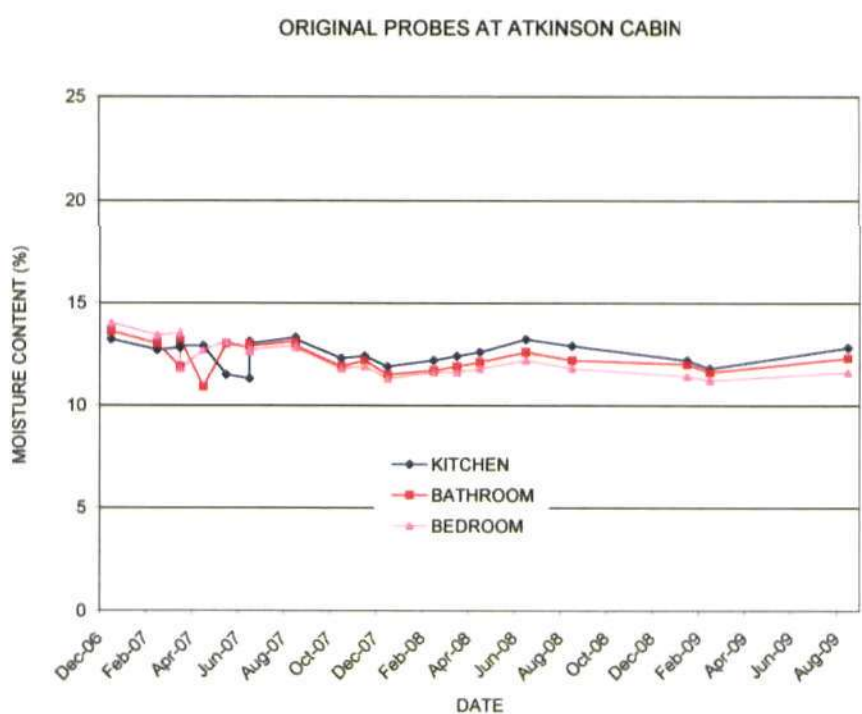
Similar examples of the Goodhew probes had also been installed in a straw bale cabin constructed by Carol Atkinson in West Yorkshire (UK). Single probes at 350 mm long were embedded in the walls of each of the three rooms in the cabin, to read the moisture levels towards the outside edge of each wall.

Fig.21 Readings from Goodhew probes in straw bale cabin.

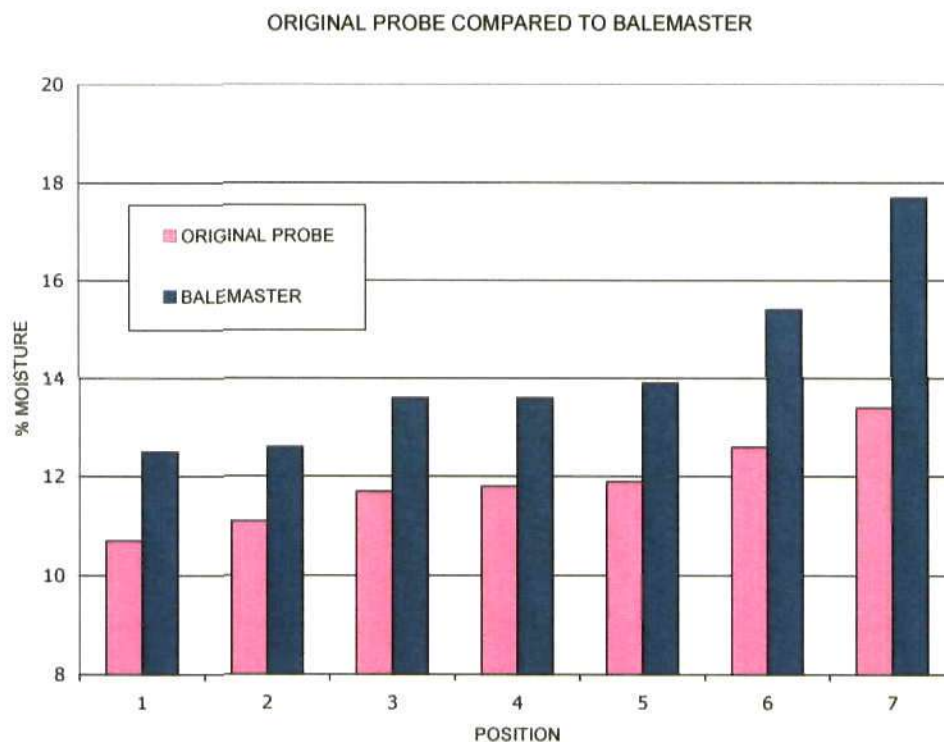
Fig.22 Comparing the original probes with the “Balemaster”

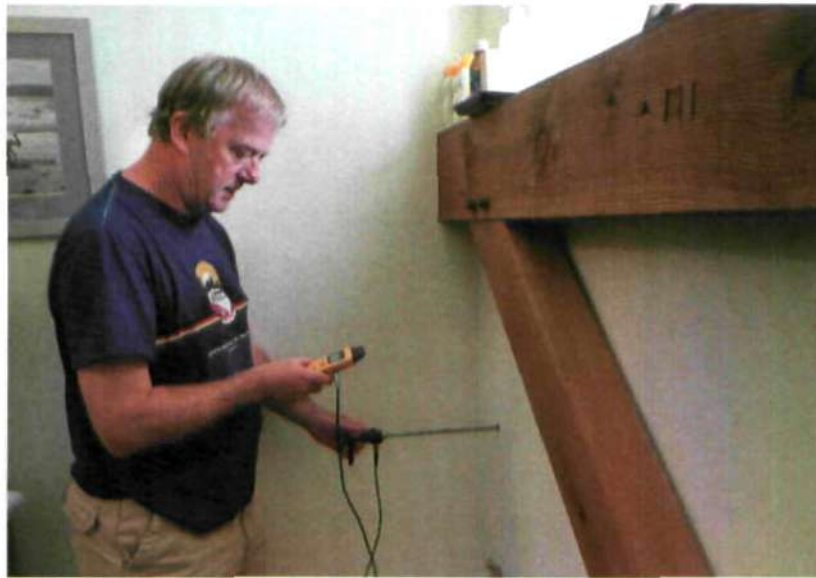
In practice it proved hard to get consistent measurements at 100 mm, possibly because the straw this close to the inside of the wall had too low a moisture content to be read accurately. Therefore measuring started at 150 mm (120 mm into the straw) and continued at 50 mm intervals until the probe reached the far side of the straw in the wall at 350 mm, as shown in Fig.24 below.

Fig.24 Diagram and photograph of 'Balemaster' in use

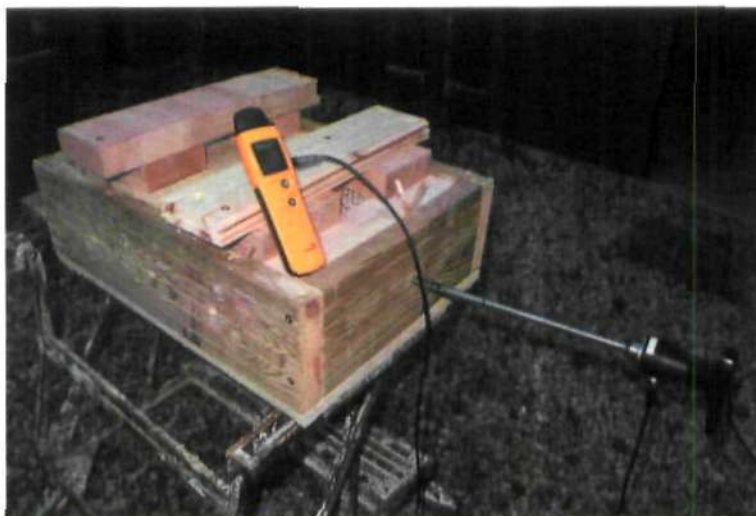
The sample bale was inserted into the box and the lid positioned ready for compression as shown in Fig.25. Some small voids between the bale and the interior of the box were unavoidable, so these were recorded and the final volume measurements adjusted accordingly. The lid was compressed into the box at measured intervals, and a series of readings taken with the 'Balemaster' at each stage.

Fig.26 Box with straw fully compressed showing 'Balemaster' inserted

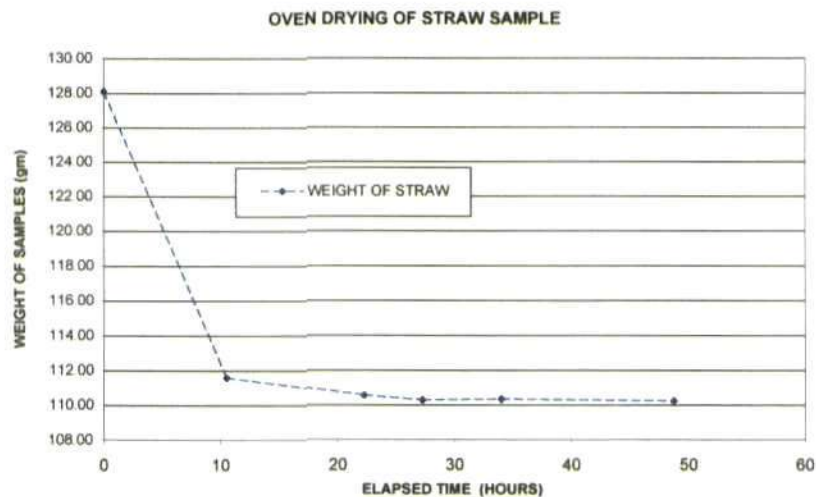
On completion of the readings the mini bale was taken apart and three smaller samples of straw were teased out and placed in aluminium trays to be weighed and then oven dried at 105°C for gravimetric analysis. After a series of weighings over 48 hours the straw had reached an oven dried equilibrium of +/- 0.1% of total mass as defined in EN ISO 12570 (2000b). The rate of drying demonstrated by the straw is shown in Fig.27 below.

Fig.27 Time taken for straw to dry in an oven

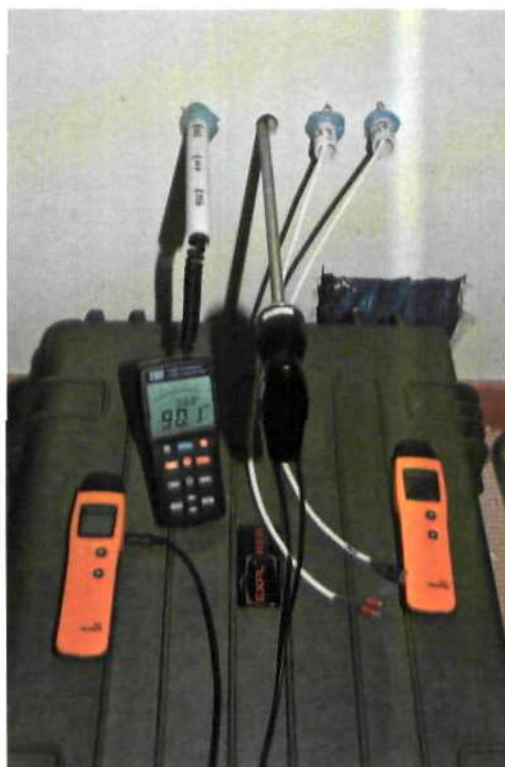
When inserted from the inside into the wall, the construction of which consisted of 360mm of straw finished with 30mm of lime render on each side, the length of the uPVC tube would place the timber in the outside 50mm of the straw wall. The probes were inserted at a height of 50mm from the bottom of the wall, which was known to be the area with the highest RH following monitoring with a TES 1365 temperature and RH meter. The test set up is shown in Fig.31 below.

*Fig.31 Setup for initial tests of the new probes
The devices inserted in the wall are as follows (L to R):
TES 1365 RH and Temperature meter, 'Balemaster' probe and
the two wood block probes. In the foreground is the 'Balemaster'
meter, and the Timbermaster meter for reading the moisture
content of the timber bullets on the probes.*

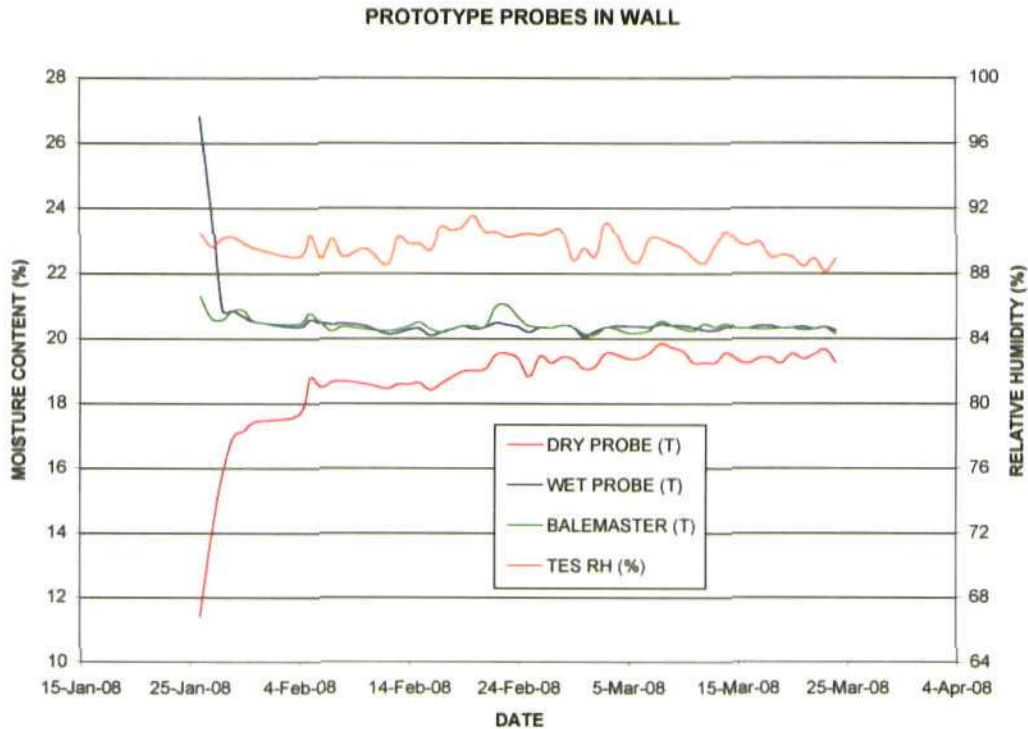
give an expected moisture content of between 20% and 22% on the desorption curve, and between 18% and 20% on the sorption curve. Looking at the readings from the two probes in the wall, the previously wetted one is reading between 20% and 20.5%, and previously dried one is reading between 18.8% and 19.8% (taken from the beginning of March, allowing a period of a month for them to stabilise). This resulted in readings from the probes that are almost exactly within the expected range, but they don't follow the variations in RH as closely as expected.

Fig.32 Two new probes compared to the 'Balemaster'

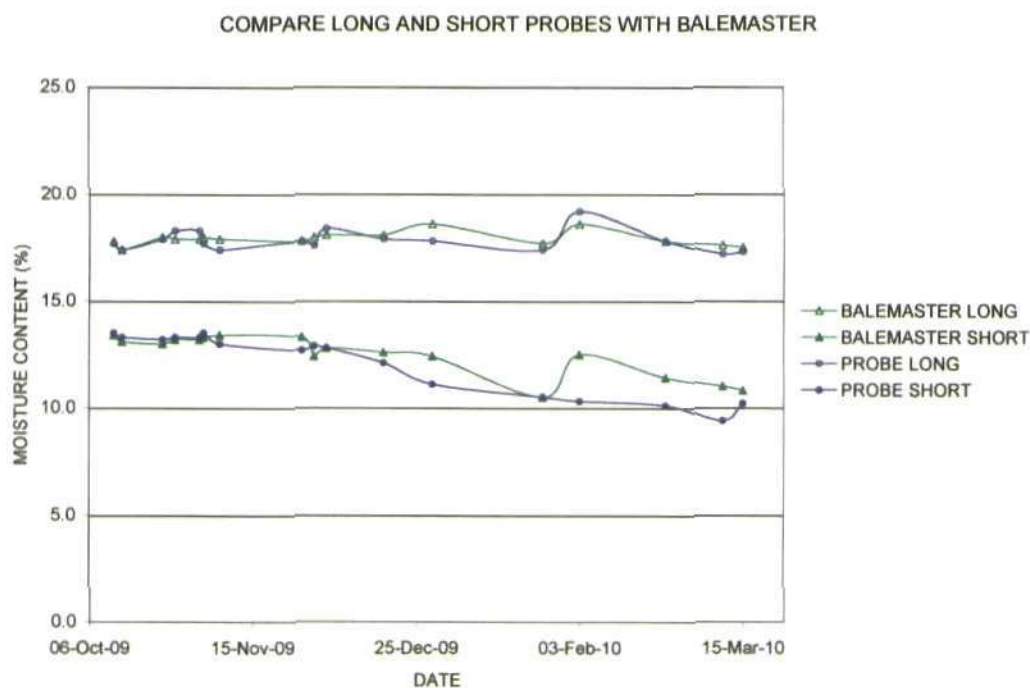
Fig.34 Long and short probes compared to 'Balemaster' in the wall of the master bedroom

Fig.34 above shows the results of readings taken at intervals between 12th October 2009 and 15th March 2010. At this point the probes had already been in the wall for four months and had time to settle into their environment. The results of the long probe compared to the 'Balemaster' show a similar level of accuracy to the earlier tests shown in Fig.33, with a deviation of plus 0.8, minus 0.6%. The shorter probe readings were not as close to the 'Balemaster' with a deviation of plus 2.2, minus 0.6%, but it was harder to get a consistent readings this close to the inside of the wall, possibly due to the lower moisture levels.

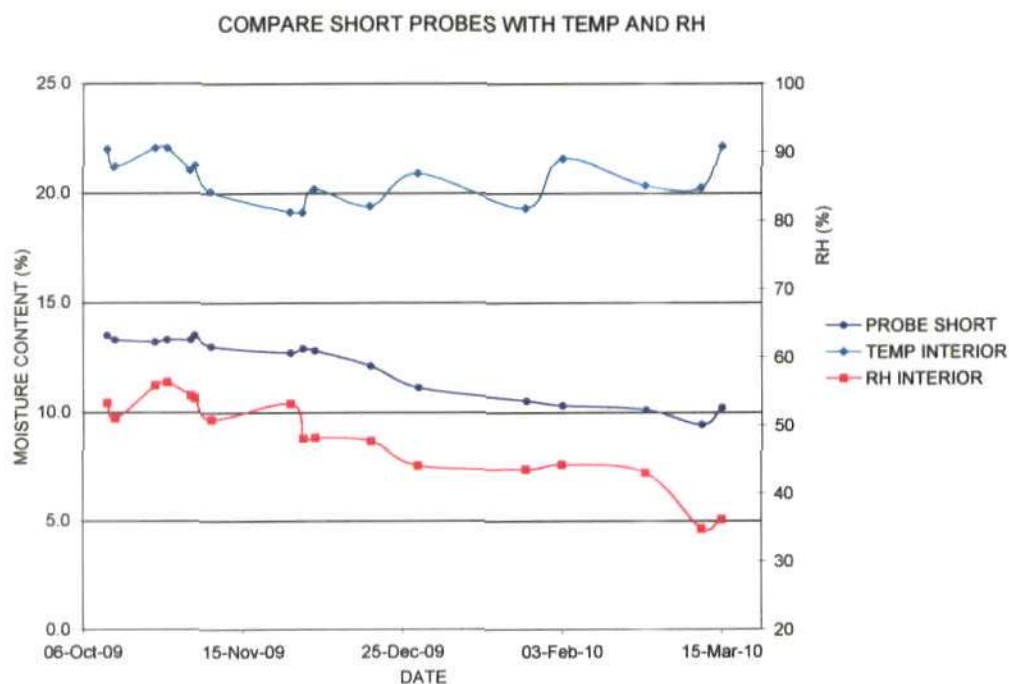
Fig.35 Short probe compared to RH and Temperature readings taken inside the house

The moisture shown by the probe is gradually decreasing, from 13.5% to 9.4%, roughly in line with the interior RH, which descends from 55% to around 35%. The temperature in the house is not descending, thus it is the RH that appears to be the driver for the changes in moisture content.

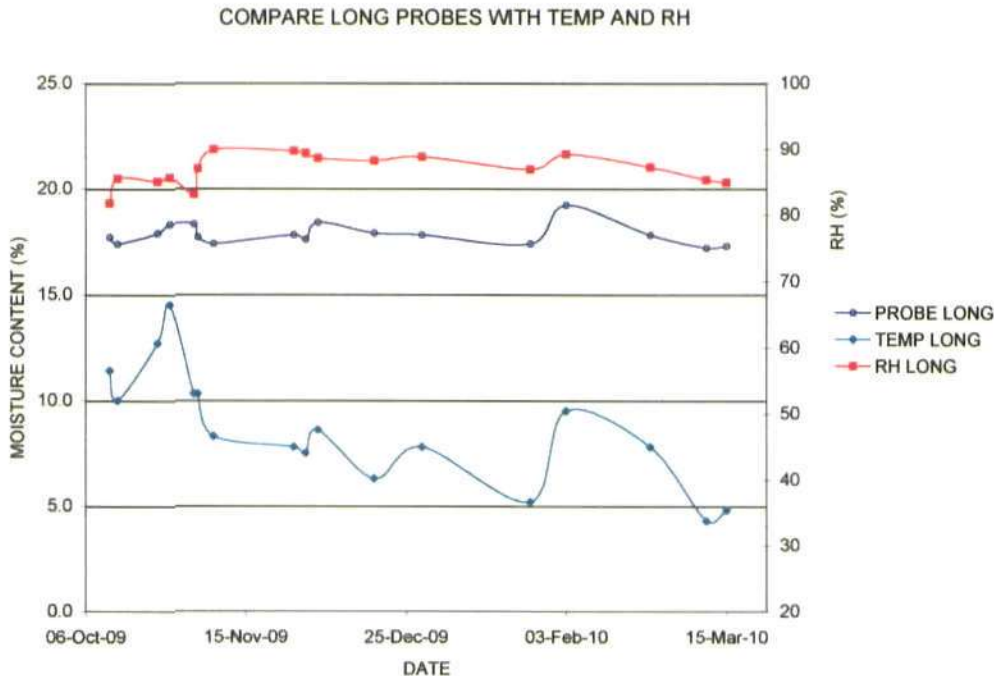
Fig.36 Long probe compared to RH and Temperature readings taken at the same depth

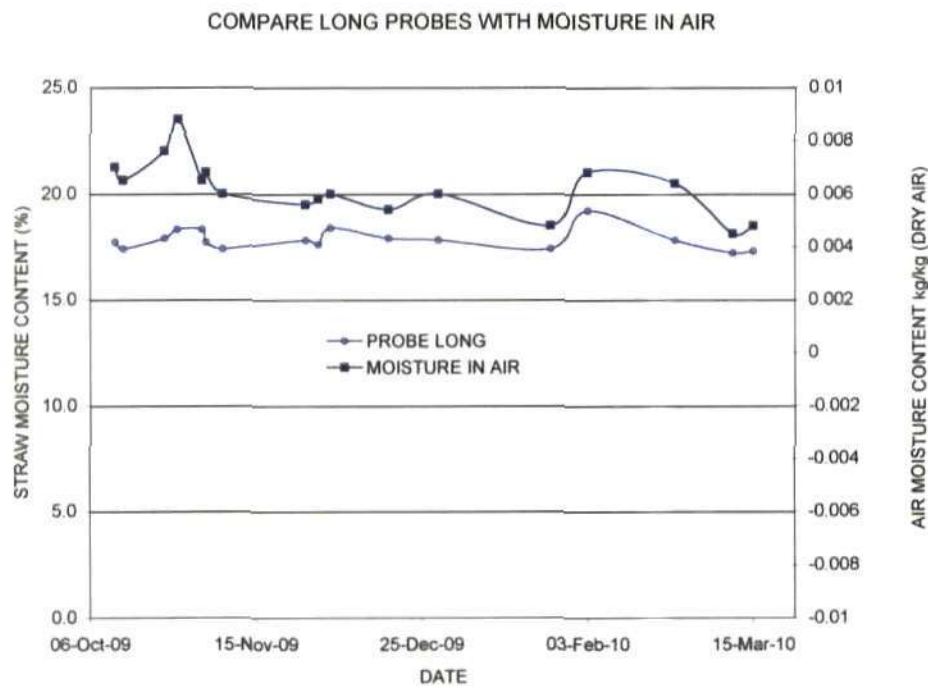
graph in Fig.37, below, shows this quantity of water plotted against the moisture content of the long probe.

Fig.37 Readings from the long probe compared to the mass of water in the air at the same point.

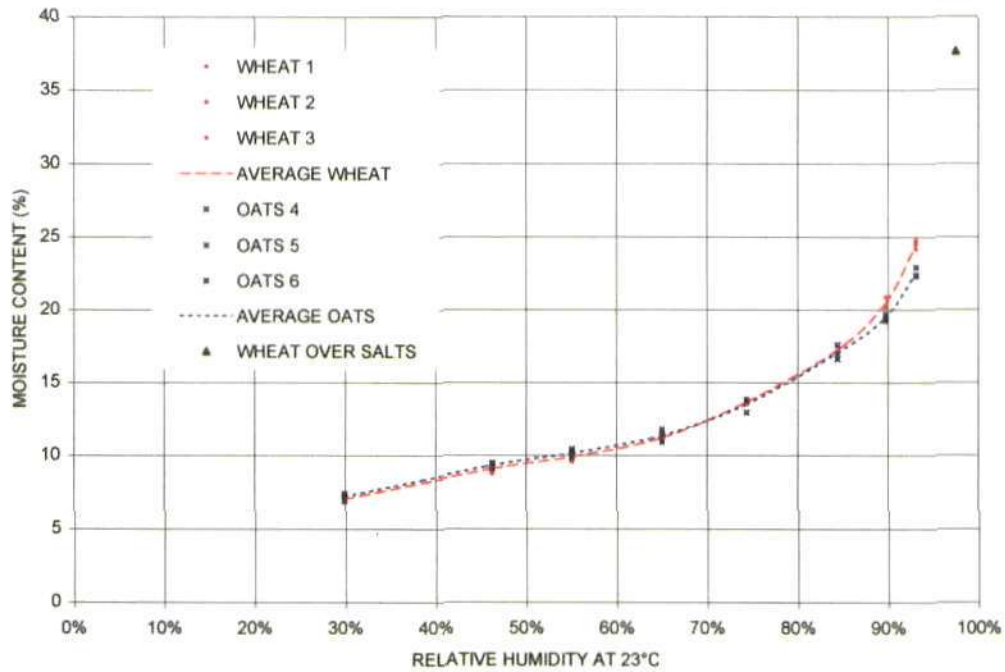
Fig.40 Sorption isotherms for all six samples of wheat and oat straw

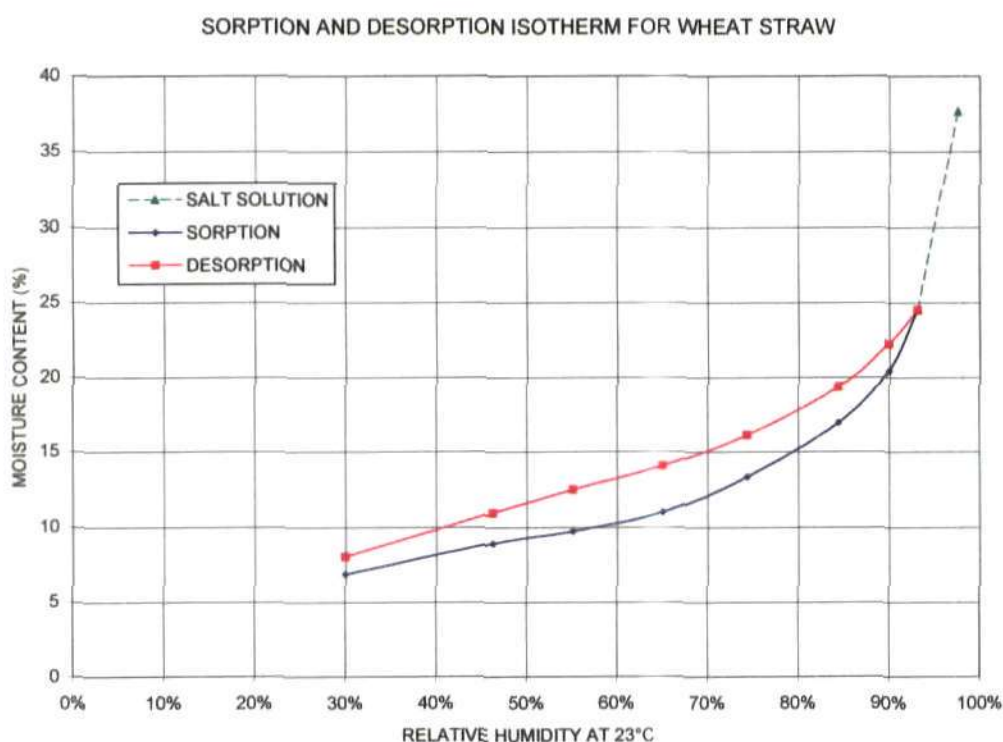
The complete process of sorption and desorption took five months to complete. The isotherms for wheat straw from the chamber can be combined with the result from the sample of wheat straw kept over a saturated salt solution of K_2SO_4 , which achieved a moisture content of 37.6% after nearly four months in the desiccator, to give the sorption and desorption isotherm shown below in Fig.42 . This gives a more complete view of the relationship between moisture content and RH, up to the theoretical fibre saturation point.

Fig.42 Complete sorption and desorption isotherm for wheat straw

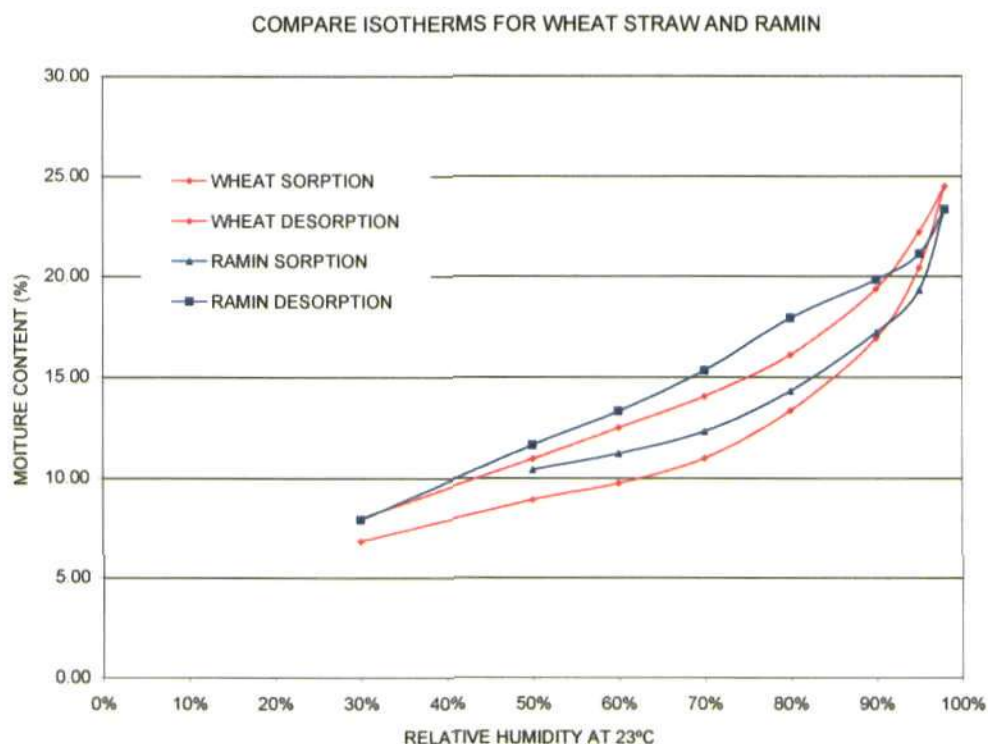
By comparing the performance of the different timber species with the wheat straw it can be seen that none of the species has the same development as the straw, but because this research is more interested in the behaviour of the straw at RH values higher than 80%, it can be seen that ramin is the closest to the wheat. This is especially the case at the highest RH where the difference is 1.1% at 93.2%

Fig.44 Adsorption and desorption isotherms for wheat straw and ramin

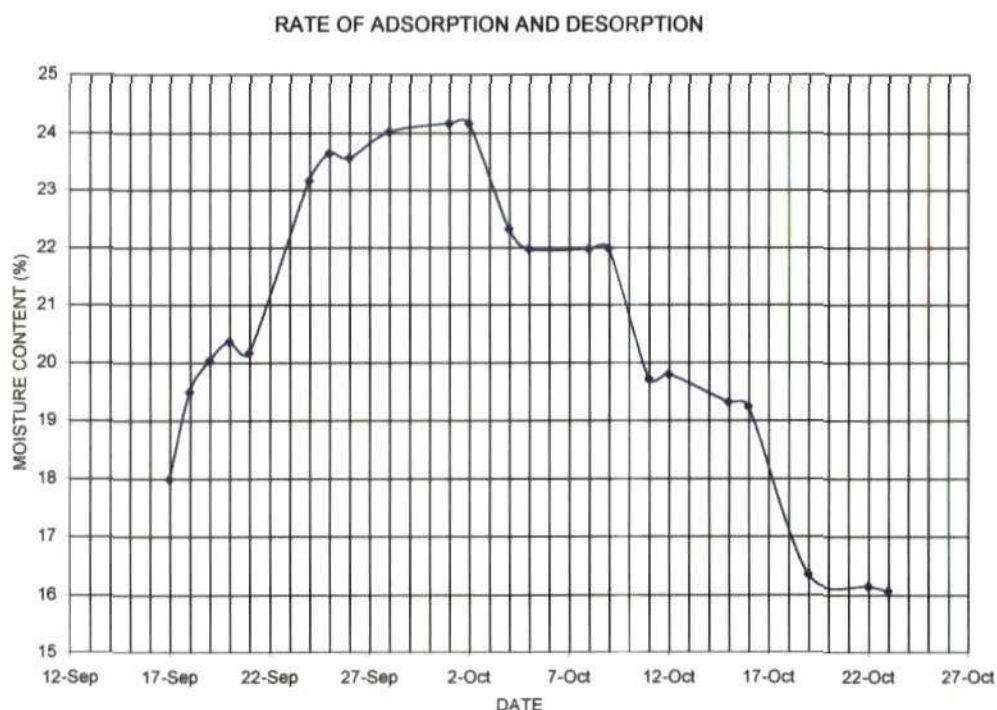
As a result of performing the sorption and desorption isotherms in a continuous sequence with the same samples of straw throughout, it is possible to get an idea of the speed with which straw reacts to changes in RH.

*Fig.53 Rate of increase and decrease in straw moisture content.
(Average of six samples in environmental chamber, RH not shown)*

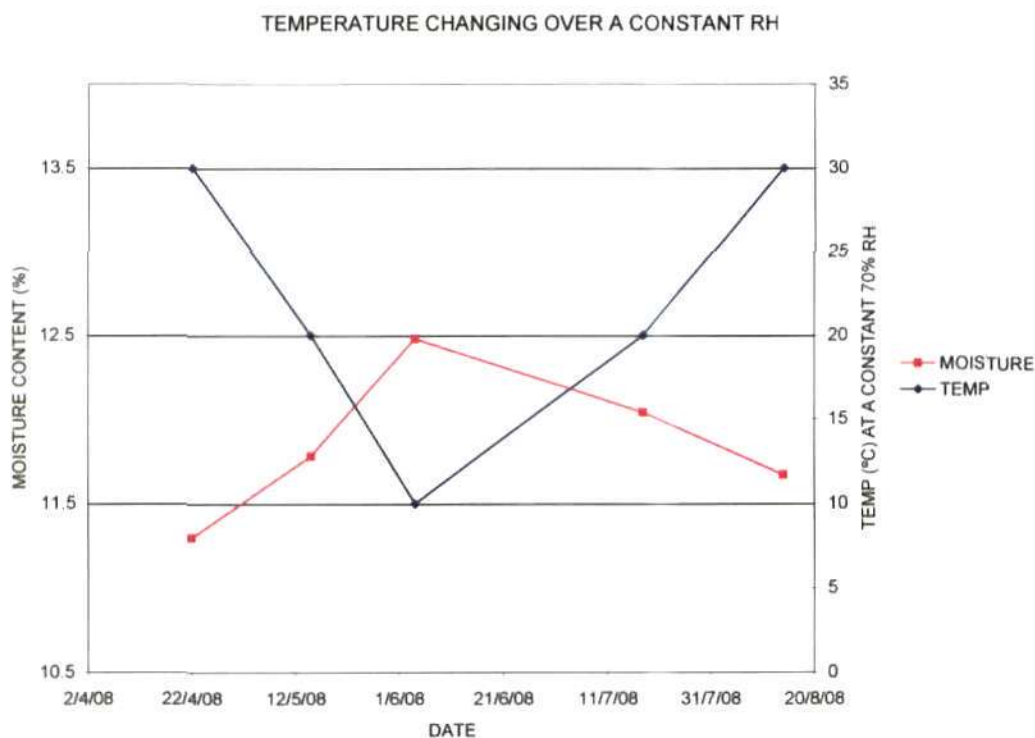
In this experiment, instead of changing RH at a constant temperature, the same samples of straw were subjected to an increase and decrease in temperature at a constant RH.

Fig.54 Hysteresis exhibited by straw after change in temperature at a constant RH.

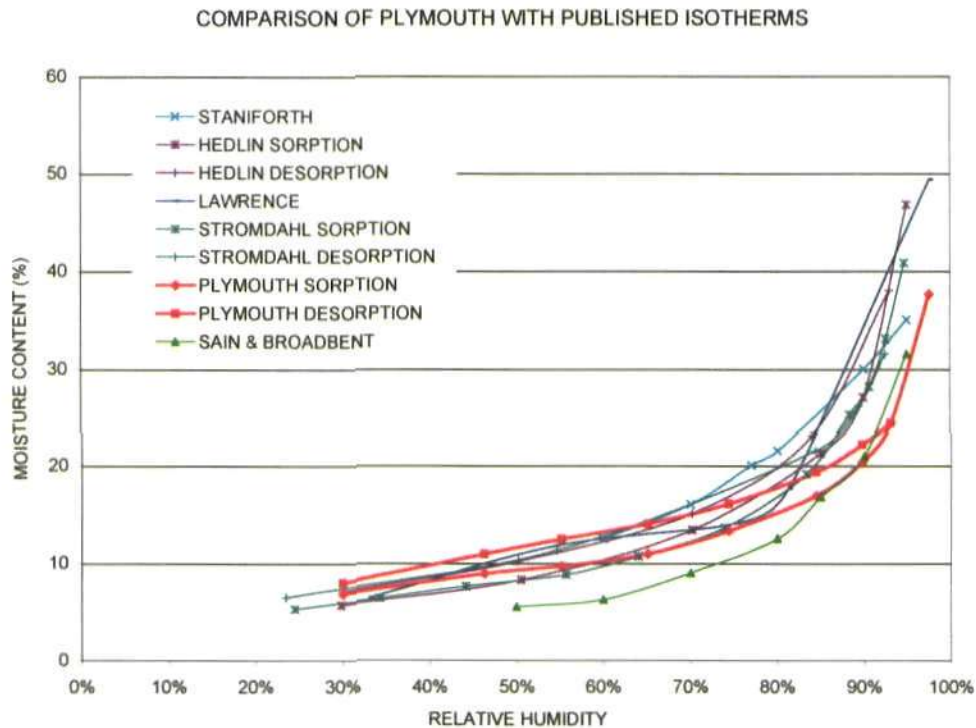
Fig.55 Plymouth results compared to all previously published isotherms

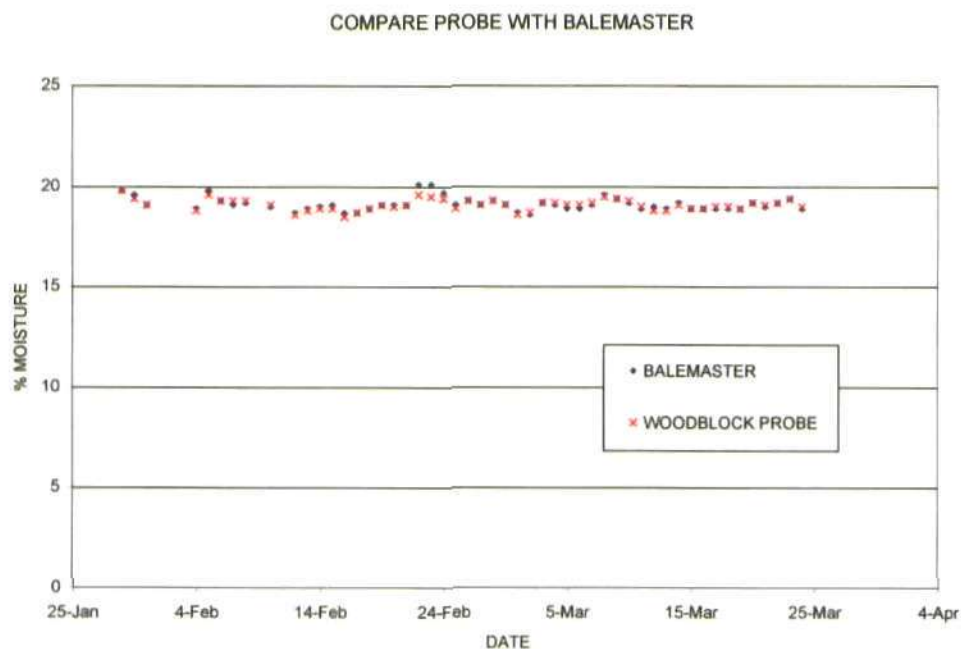
In the development of the improved woodblock probes, readings from the woodblock probes were compared to readings from the 'Balemaster' probe at the same place in a straw bale wall. The Balemaster had previously been calibrated against a sample of the same straw, and was found to be accurate to within $\pm 1.5\%$. The results showed a strong consistency between the readings from the woodblock probes and the 'Balemaster', shown in Fig.56 below.

Fig.56 Comparison between readings from the woodblock probes and the 'Balemaster'

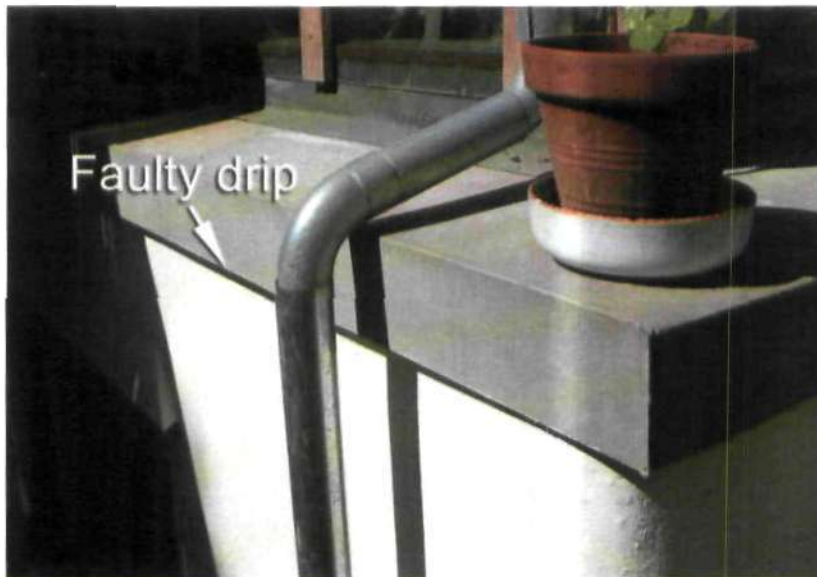
Fig.71 Location of faulty drip detail above bedroom 1

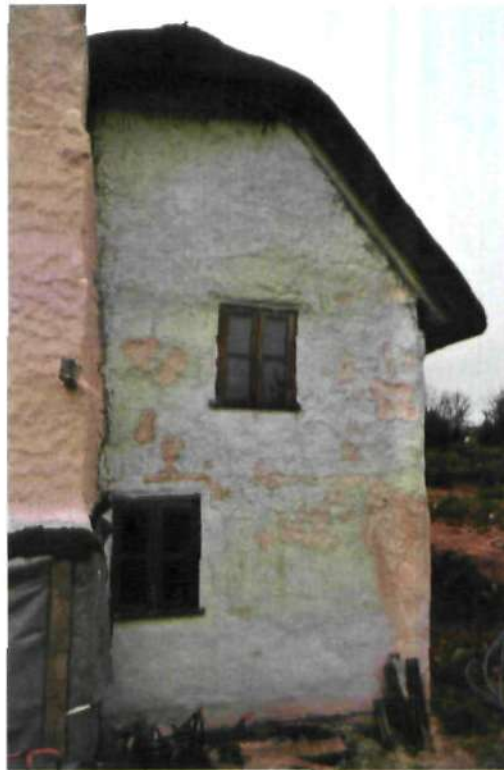
Fig.88 Poor quality of render on NE wall at Cuckoo Farm

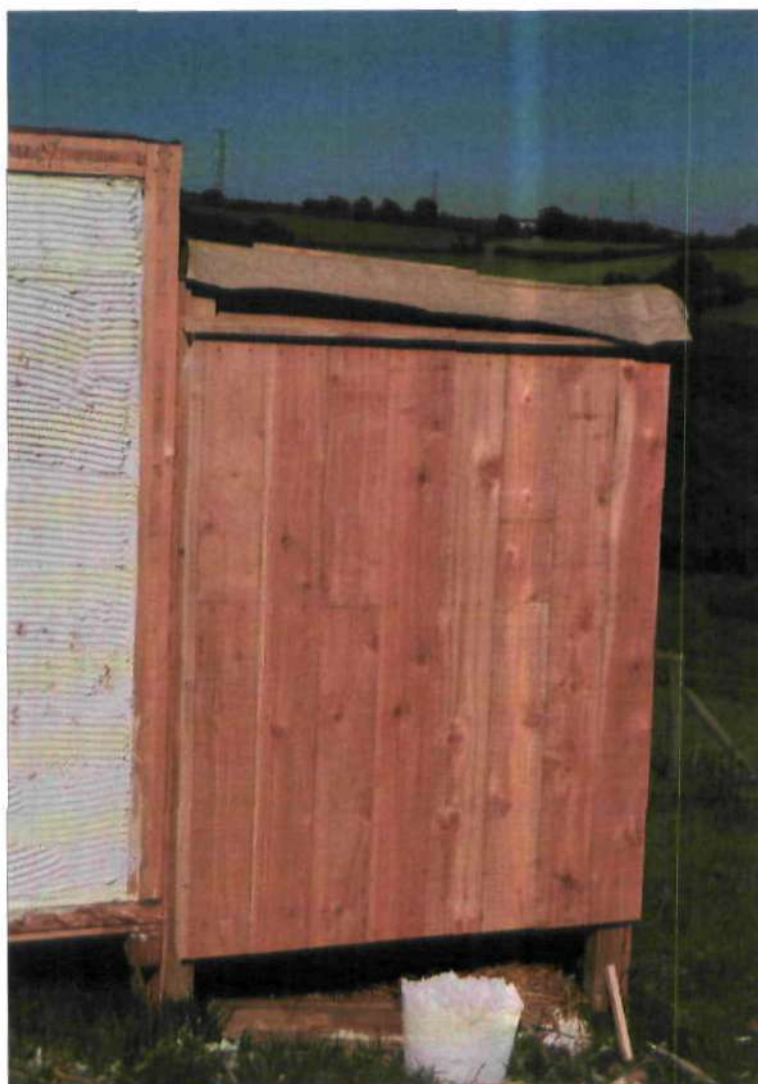
Fig.91 Panel at Liskeard with timber cladding

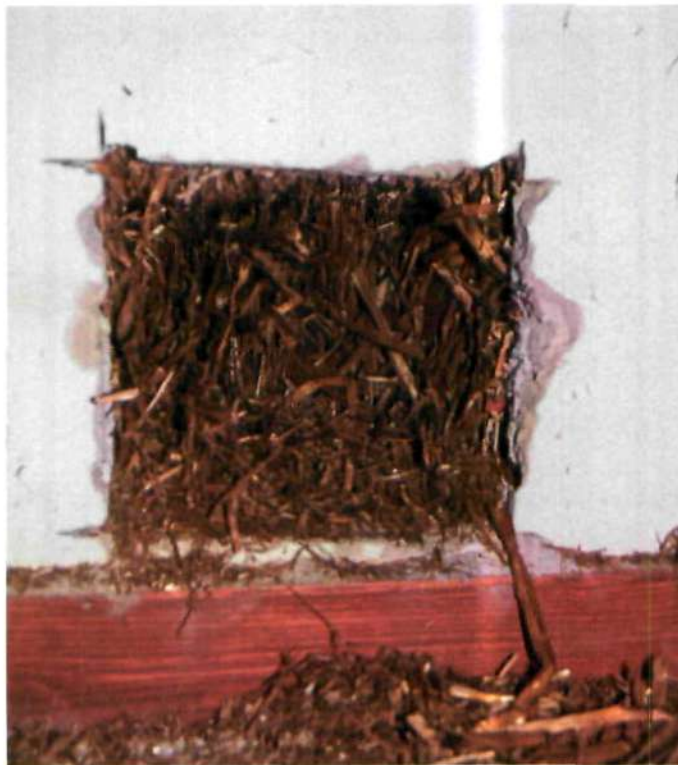
Fig.93 Bottom of damp wall at the Totnes House

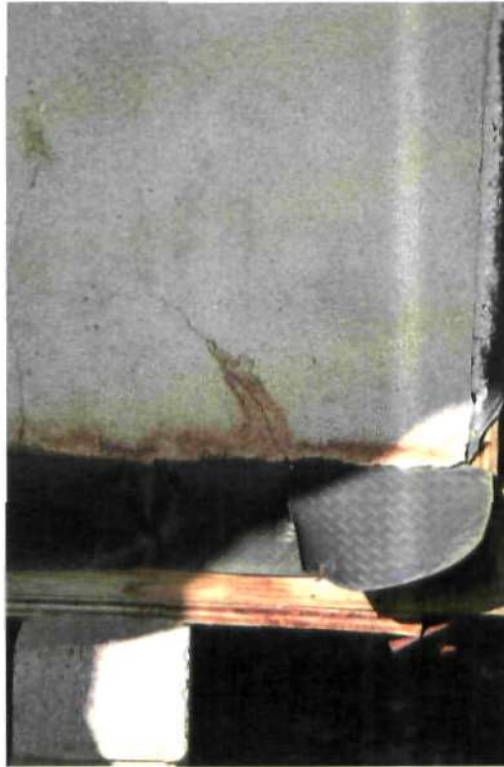
Fig.A10 Base of panel at UWE

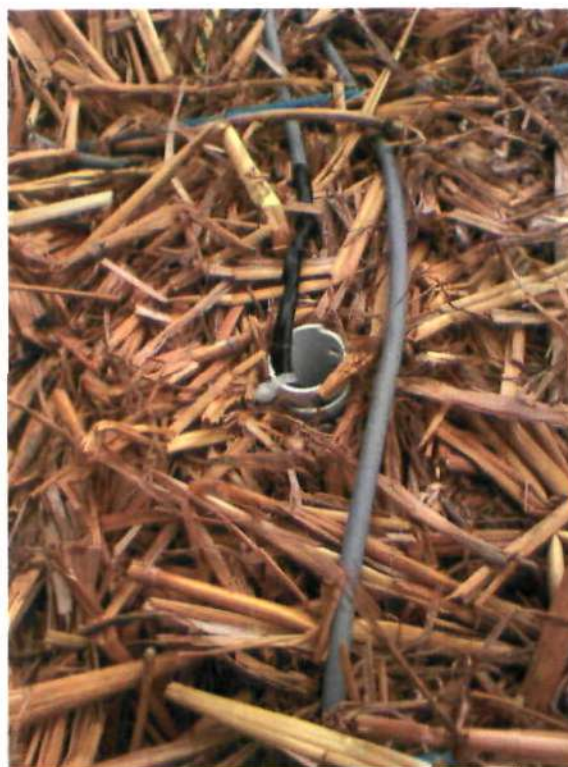
Fig.A13 RH and temperature sensors inserted into straw bale

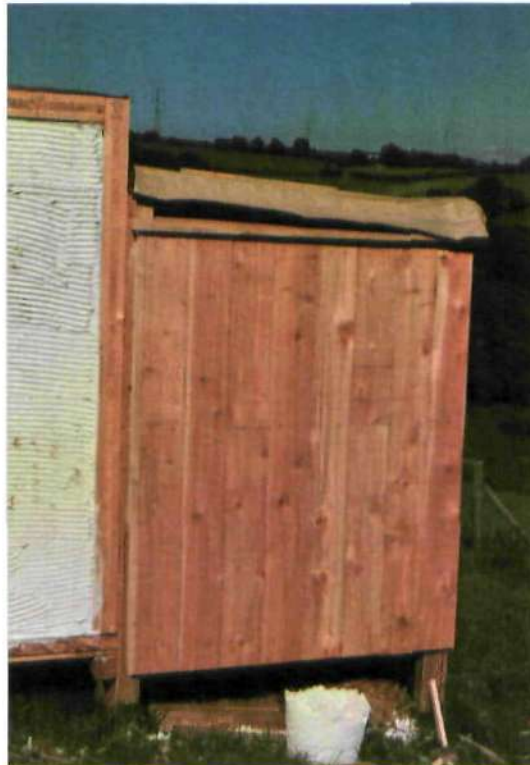
Fig.A14 Timber cladding on panel

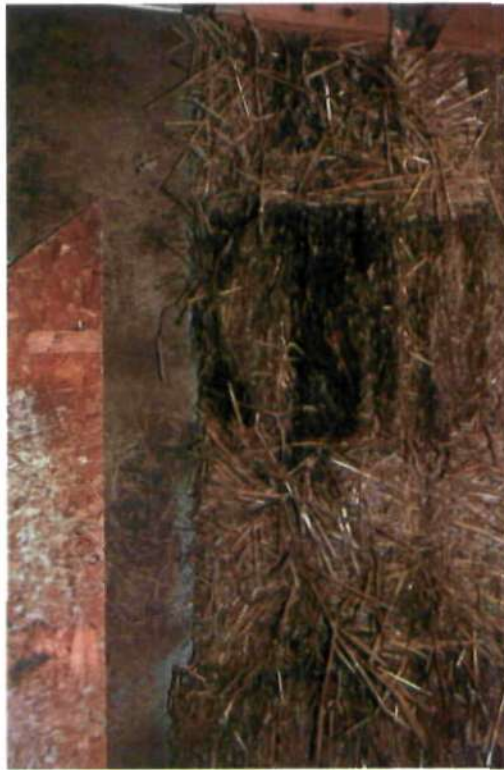
Fig.A23 Water damage at Atkinson Cottage

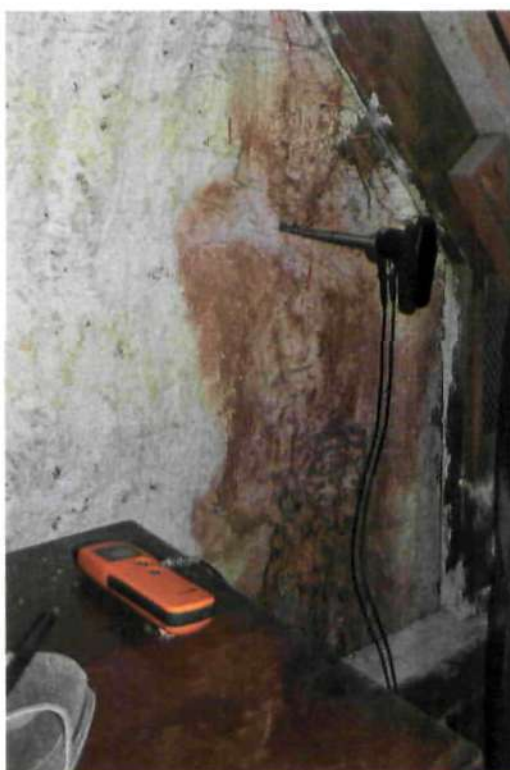
Fig.A36 Moisture damage to bedroom wall at Cuckoo Farm
