Building defect detection: External versus internal thermography

Building and Environment

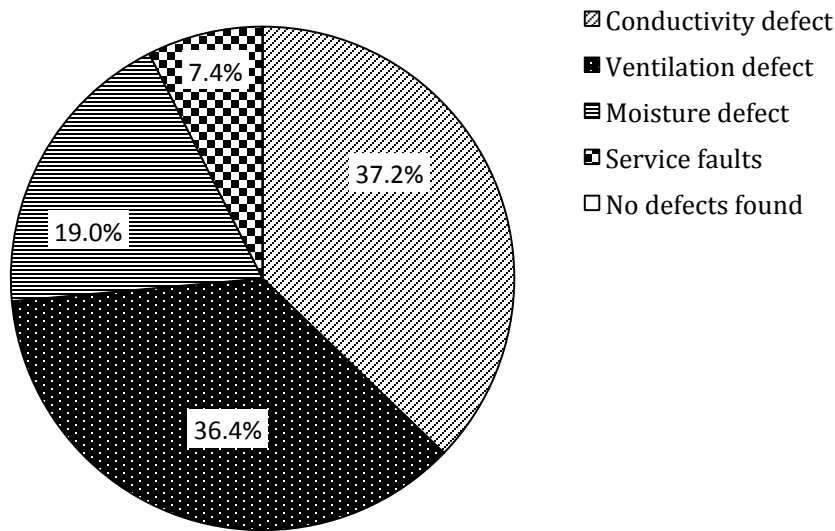
Of these, the most commonly identified were ventilation and conductivity heat losses (Figure 4). Together, these accounted for almost three quarters (73%) of the total defects detected using a walk-through methodology.

Figure 4. Proportion of thermally significant building defects (by overall defect group) detected in all walk-through case studies.

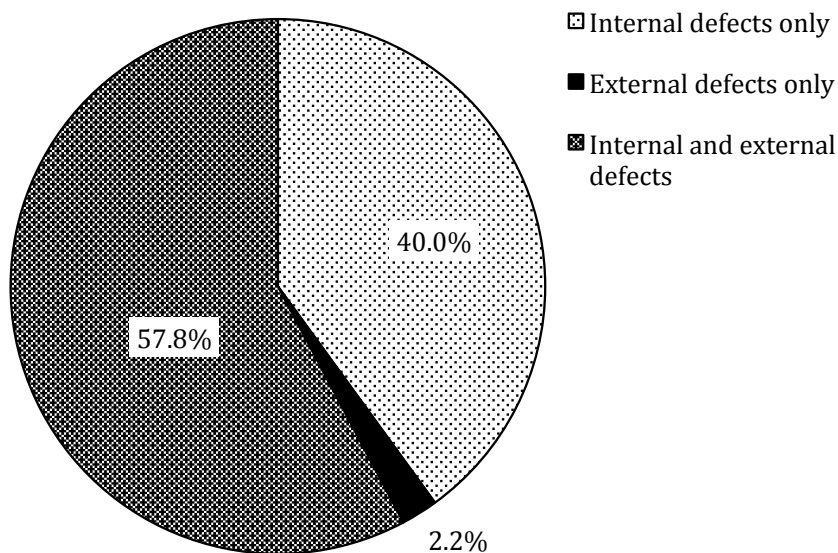
Figure 5. Location of detected defects (internally/externally).

Having performed external and internal thermography as part of the walk-through inspections, it was possible to further categorise defects into those viewed from the outside (looking at the external surface of a building), and those viewed from the inside (looking at the internal surface of a building). Figure 5 illustrates the percentage of dwellings where at least one potential defect was detected on either the internal, external or both surfaces of the same dwelling.

Of the 45 dwellings inspected, 27 (60%) exhibited thermally significant defects that could be detected using external thermography. Of all the defect groups, there were only potential signs of conductivity (cold bridging and missing insulation), ventilation (draughts from windows and doors) and service

anomalies (un-insulated pipes) detected externally. In contrast, analysis showed that 44 out of 45 (97.8%) dwellings inspected presented defects that could be observed using internal thermography, and that all of the defect groups were potentially detected.

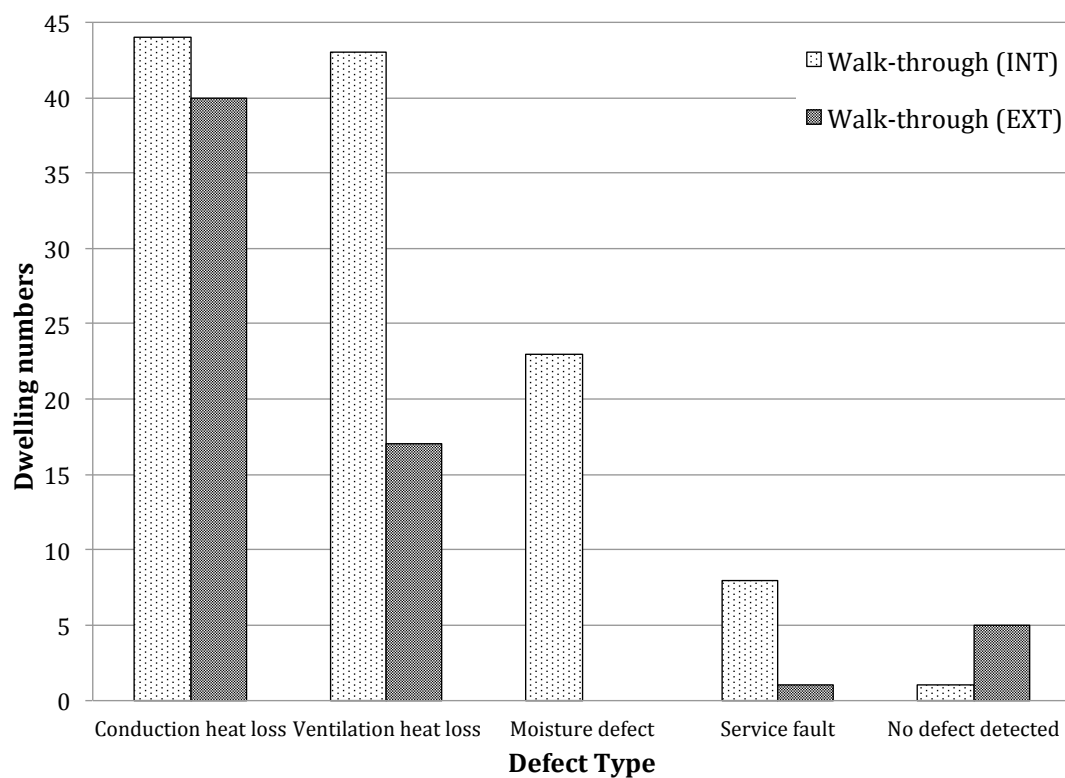
Combining data on the location of potential defects with that of the different defect groups, figure 6 shows that for each overall group, defects were more likely to have been detected using internal thermography compared with external thermography. Other observations included noticing that conductivity defects were almost as commonly detected externally as they were internally, also there were no instances of moisture defect detection using external thermography.

Figure 6. Incidence of thermally significant defect by location and overall group for walk-through thermography surveys.

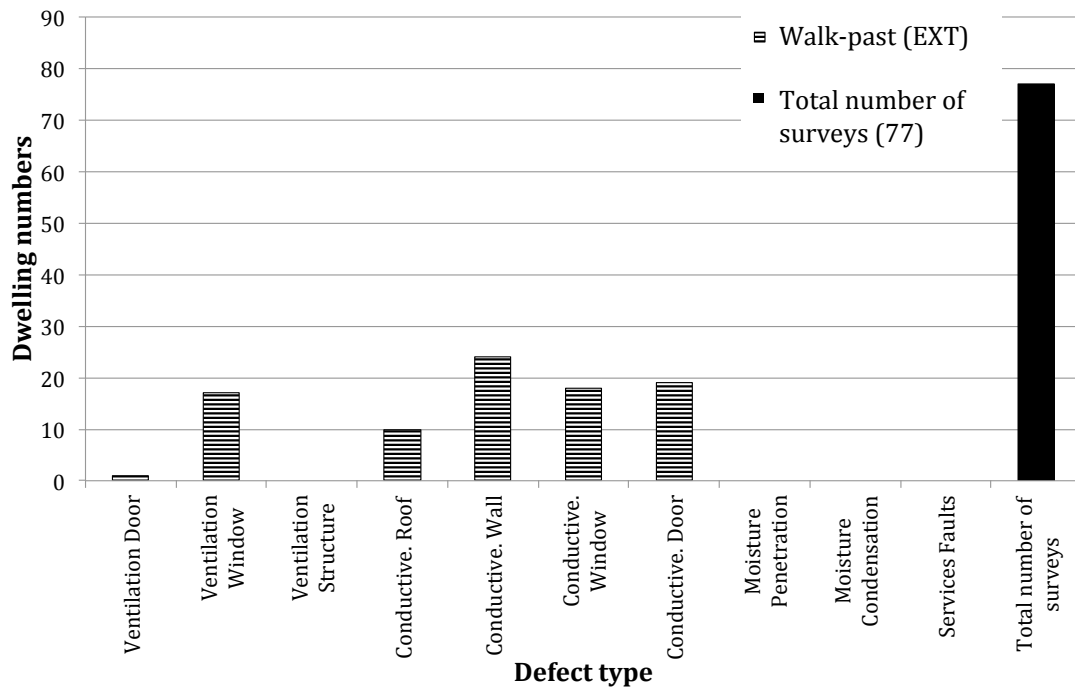
Figure 10. Incidence of thermally significant defect by location and sub-category (Walk-past thermography).

Figure 10 presents a detailed breakdown of the occurrence of potential building defects detected by location and specific sub-category. Compared with the total number of buildings surveyed as part of this study, it is clear that few potential building defects were detected during the walk-past surveys. Further observations from these findings included:

- The vast majority (94%) of all ventilation heat loss defects came from windows, whilst none were detected from structural draughts. This might have been due to the increased number of windows compared with doors, and common weaknesses found at the seal between windows and frames.
- Conductivity heat losses were the most common source of potential building defect. However, heat loss from roofs was less common than conductivity heat losses from walls, windows and doors. The likely explanation for this is the acute viewing angle (and emissivity problems) that the camera was at relative to a pitched roof and construction of the roof, such as the location of insulation.

Results from both walk-through and walk-past case studies were combined for cross comparison analysis. Figure 12 illustrates these results by combining figures 7 and 10. Splitting the walk-through thermography results into external (EXT) and internal (INT) locations helps to corroborate the results from the external only walk-past thermography surveys.

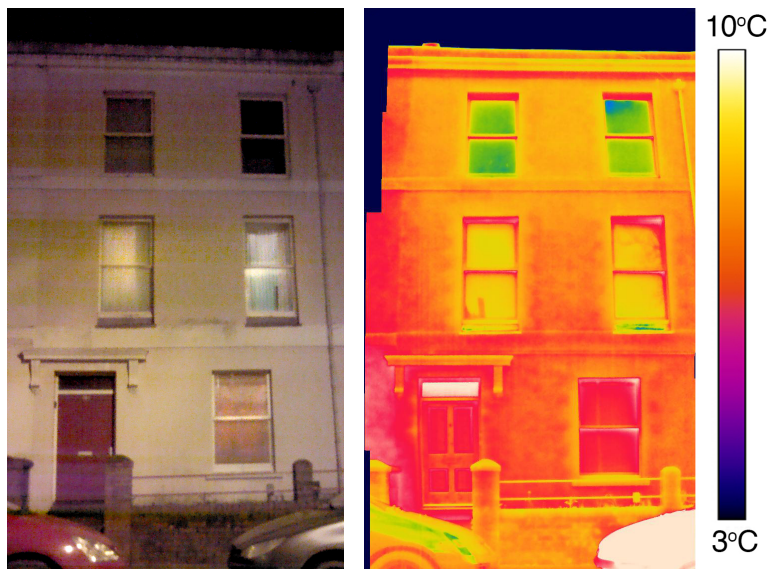
Although inspecting dwellings without making contact with occupants can be viewed as a benefit, this is also found to be a limitation. When inspecting a dwelling, it became difficult to ascertain whether dwellings were currently occupied and what the internal heating program was. One method to ascertain whether the dwelling was currently occupied was to look for signs such as lights being on. Figure 14 presents an example of this where a photograph was recorded at the same time as the thermal image. In this example, each floor corresponds to a different tenanted flat. Whilst the photograph helps to indicate occupancy on the ground and first floor, it cannot confirm whether someone was home on the second floor and using rooms at the rear, rather than the front of the dwelling. This photo also cannot confirm the numbers of people (whether one person was there or if there was a party with lots of people) within the flats, the internal air temperature or whether the heating had been on for the whole day, a couple of hours or a couple of minutes prior to the survey. Even if the second floor flat was unoccupied, the heating program might have been on for longer and to a higher temperature than one of the illuminated flats below.

Figure 14. Photograph showing dwelling lighting to help indicating occupancy during analysis of thermal image.

Without this information it proved difficult to ascertain whether one building or part of a building was better insulated than another, or whether one building had a defect and another did not. This is due to variations in heat transfer through the different construction elements. For example, if the heating had only just been turned on in a dwelling that showed signs of occupancy, it is possible that there will be an insufficient temperature difference between inside and outside to clearly show signs of potential defects.
