Development of a framework for sustainable repair of adobe building in an urban area in Nigeria

**DEVELOPMENT OF A FRAMEWORK FOR SUSTAINABLE REPAIR OF
ADOBE BUILDING IN AN URBAN AREA IN NIGERIA**

School of Architecture, Design and the Environment

April 2012

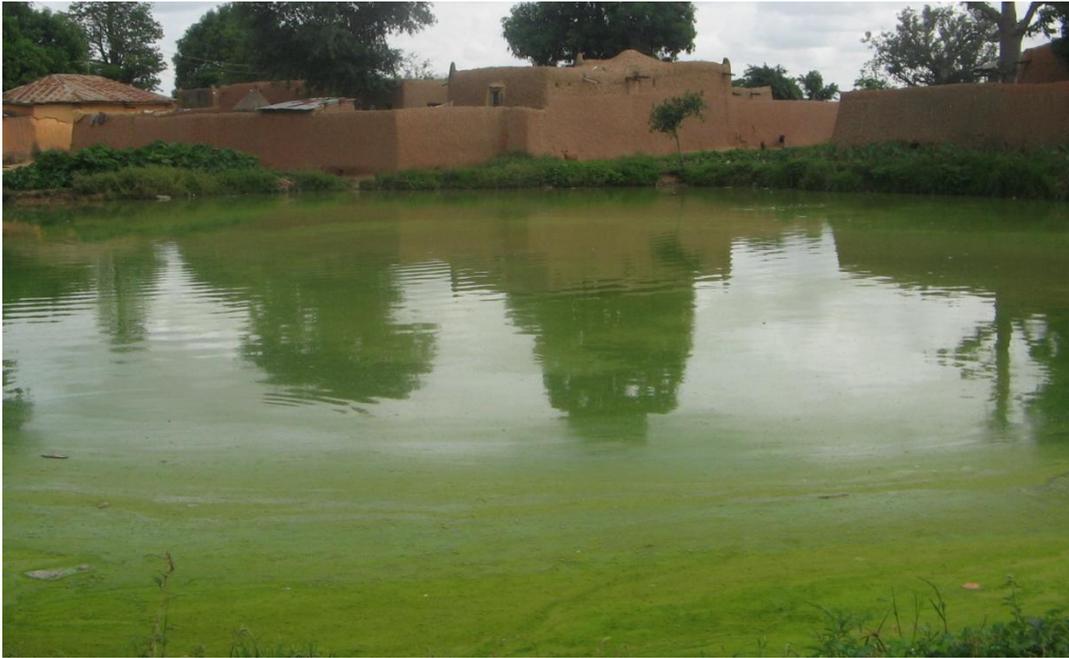
Although earth construction and repair are economically viable in terms of availability of material, however, it constitutes both health and environmental hazards to the inhabitants of Zaria City. These flooded burrowed pits usually become breeding ground for mosquitoes during the rainy seasons. This is a serious issue that will require government's intervention because the burrowed pits will continue to get wider as earth is being dug for building purposes. Schwerdtfeger (1982:322) conducted a survey of the city between 1967 and 1978 and noted that burrowed pits takes about 1.9% (347,740 m²) of total area of Zaria City. This total area of the burrowed pits must have increased by 2006 considering the erosion caused by the continuous sourcing of building earth during the dry season and the effect of rain. Some of the buildings in close proximity to these pits are already being threatened by erosion as shown in figure 5.8. More pictures of these burrowed pits are attached in appendix 2.2.5. The possible solution to this menace is to stop the inhabitants from sourcing building earth from these pits and then backfill all. However, this may further encourage the use of other materials most especially cement for repair and even construction of new buildings. Sadly, not everybody can afford cement, thus this may lead to further deterioration of the adobe buildings in Zaria City.

Figure 5.5: A burrow pit turned to pond during the rainy season in Zaria City and all are mosquitoes infested

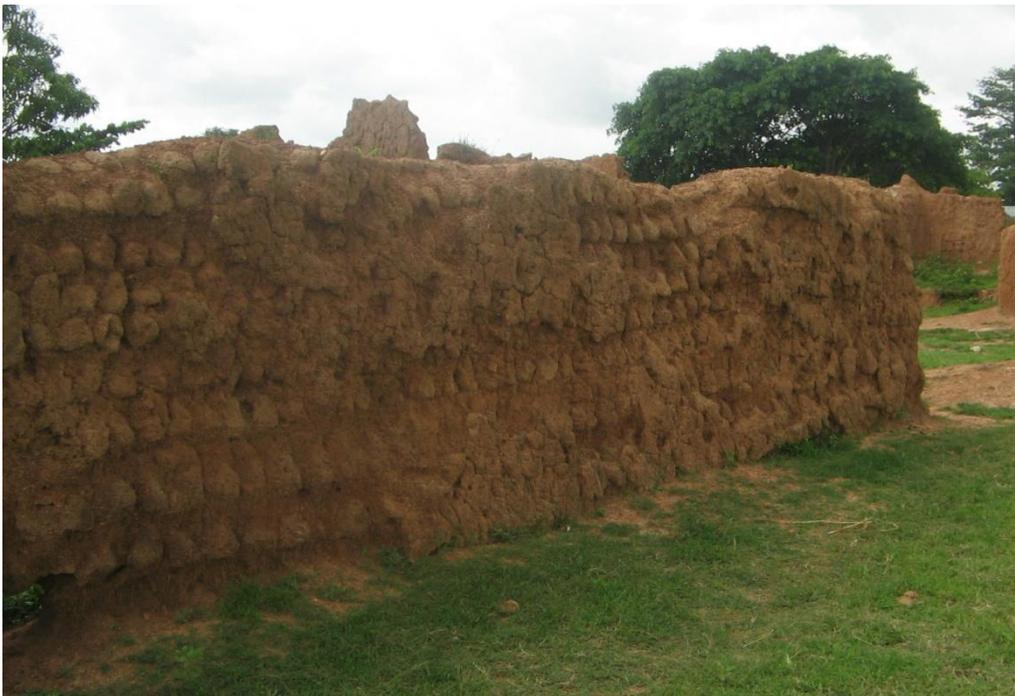
Figure 5.12: A ruined tubali wall in Zaria City

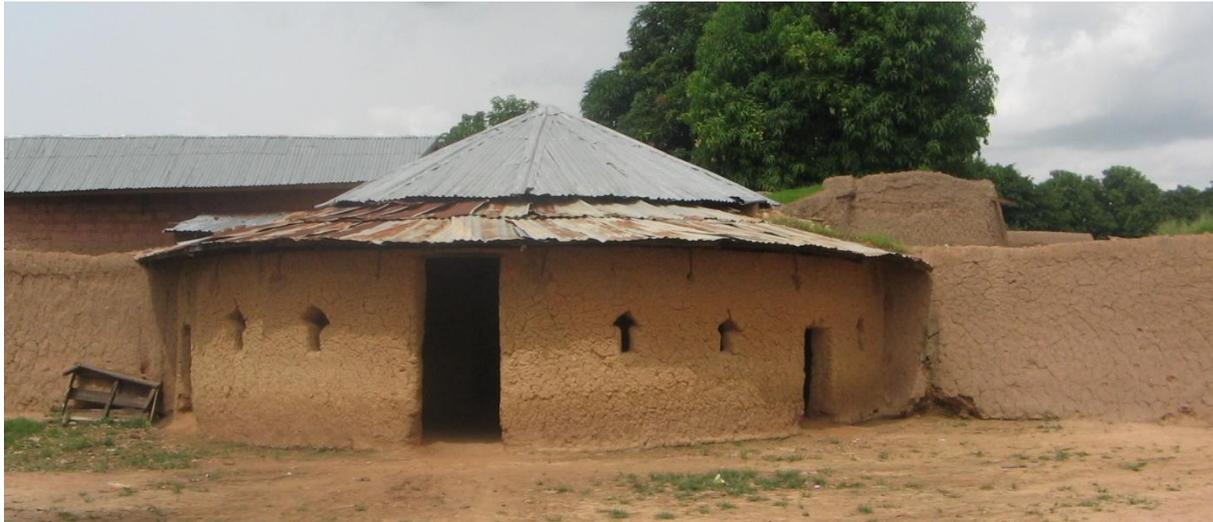
Figure 5.19: Circular plan adobe building with conical roof made from corrugated iron sheets

It was observed that some circular *tubali* buildings have corrugated iron sheets roofs (see figure 5.19). However, the conical shaped roof made of corrugated iron sheets corrodes faster than the roofs of buildings with rectangular plan constructed at the same time, as can be seen in figure 5.19 above. A critical examination of this circular building shows that in order to achieve this conical shape, the rectangular iron sheets were cut and trimmed into various pieces before nailing. These numerous nailed joints are observed to have aided the corrosion of the roof, possibly due to retardation of flow of rainwater at these joints. Leakages were observed from some of these corroded areas.

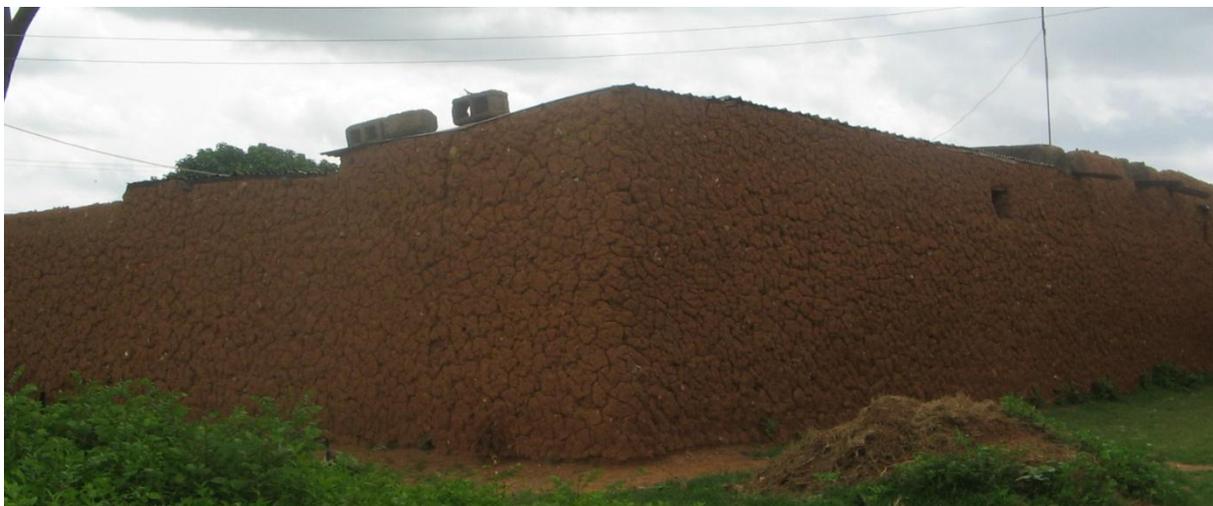
examination of *tubali* building with earth based render shows that the erosion is minimal and even (see figure 5.22). Although the owner of this building cannot remember the exact year that the earth render was last reapplied, however he was confident that it was more than 15 years ago. A further examination of a ruined *tubali* wall (figure 5.9) shows that because of the conical shape of the *tubali*, wider mortar joints are created at the top of the bricks than at the bottom. These irregular vertical mortar joints when filled up ensure that both the earth mortar and later the render are keyed together, thus, creating a strong and structurally stable wall (see figure 5.22; see also Dmochowski, 1990, vol. 1:1.20). Consequently, the earth render are not usually easily eroded and when it does the effect is minimal.

Figure 5.22: A traditional adobe building with earth based render showing minimal and even surface erosion despite the lack of roof overhang

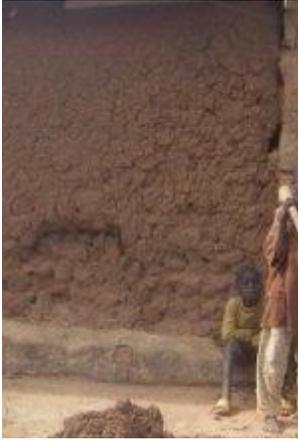
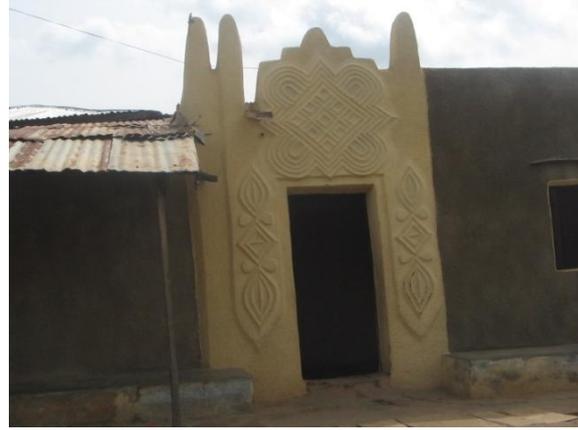
Another implication of thinner walls in the case of the adobe is that erosion could have a fatal consequence if not treated immediately, unlike the traditional types that can still be structurally stable for long period of time. Untreated eroded earth wall can lead to collapse of the wall and this may cause injury or even death. It was observed that the building owners have devised a means of countering this effect by constructing an external plinths with concrete blocks, which is usually between 450 and 600mm above the ground level (see figures 5.23 and 5.24). This concrete plinth called *dakali* in Hausa also serves as sitting area in addition to its primary structural purpose. However, the use of *dakali* as sitting area has another negative effect on the adobe buildings. It was observed that the paints on walls of adobe buildings with *dakali* have flaked and some of the wall render have cracked. The cause of these actions was observed to be as a result of the constant friction by both humans and animals that sit and stand on the *dakali*.

Figures 5.23 and 5.24: Adobe buildings with dakali

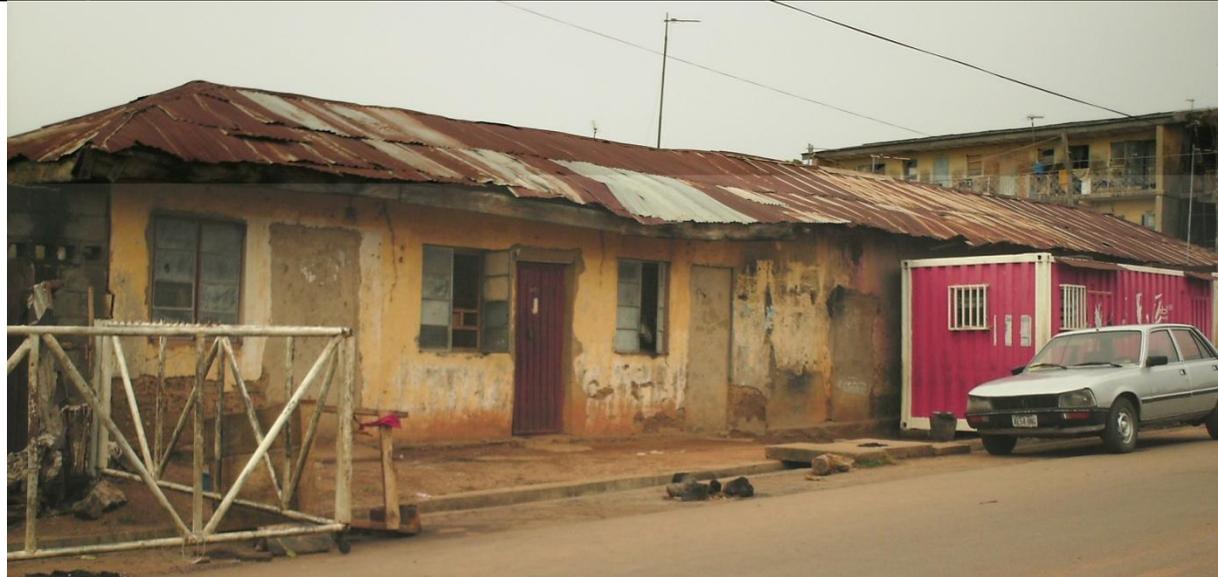
Building No: 01

Defects	Possible causes	Survey method / Evidence
Sagged roof	Ageing and lack of maintenance	Physical inspection and occupants account
Roof leakage	Rusting of roofing sheets and sagging of roof trusses. Due to ageing, lack of repair and maintenance.	Leakages noticed 2 years ago and reported to land lord but roof was never repaired. Sagging was noticed last year that was when some of the roofing sheets were replaced. 1 of the occupants confirmed that the roof was never repaired for more than 20 years that he has been living in the house until last year (2005) when some of the roofing sheets were replaced.
Sagged and rotten roof facial board	Sagging of roof trusses, due to ageing. Excessive moisture from leakages. Possible termite attack due to non treatment of the timber facial board.	Same as above
Cracks on adobe walls	i. Remodelling and use of inappropriate materials. ii. Unsympathetic repair. iii. Lack of ventilation in two of the rooms iv. Introduction of burglary proofs and mosquito's screens v. Lack bonding between old and newly added walls	Physical inspection and occupants accounts. Cracks severe in areas with new electrical wiring. There are no windows in two of the middle rooms.

Dampness on walls	i. Cementious rendering. Use of impermeable oil based paints ii. Underground moisture (capillary action) due to cracking of cementious floor screed	Physical inspection and comparison with other adobe buildings not rendered with cementious material
Basal erosion	Cementious rendering, lack of roof guttering and site drainage as well flooding caused by road rehabilitation.	Observation.
Cracked cementious floor screed	The thick of the cementious screeding on rammed earth floor bed is only 35mm as against the standard 150mm thickness concrete floor slab	The crack is wide and deep in one of the rooms so it is possible to measure the depth of the cementious screed and to see the material used.

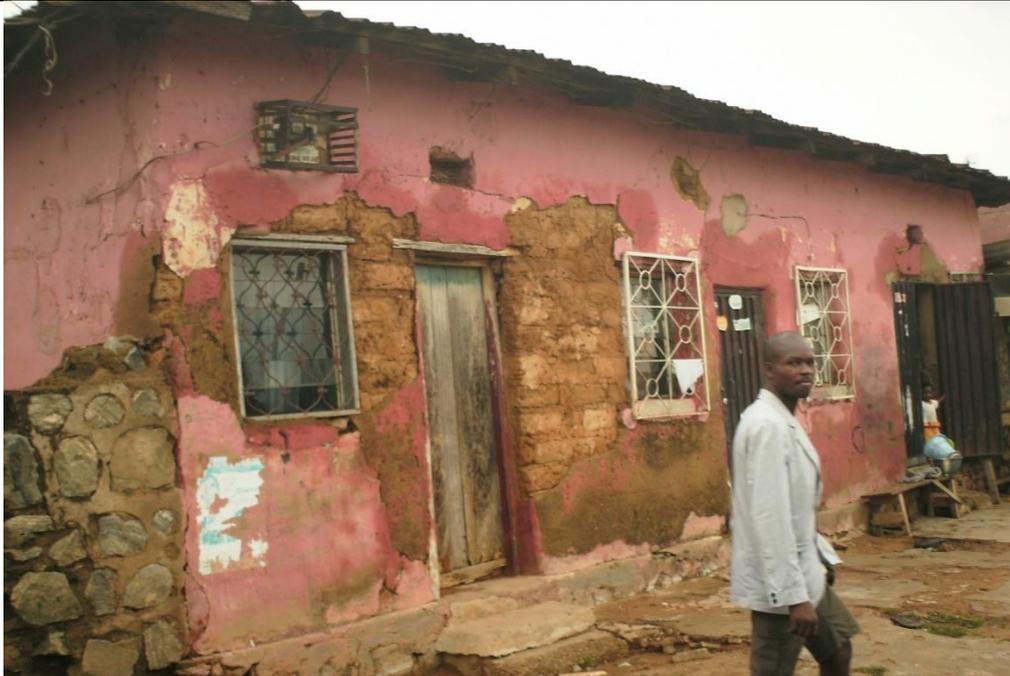
Building No: 02

Defects	Possible causes	Survey method / Evidence
Missing roof facial boards	Ageing and lack of maintenance	Physical inspection and tenants accounts
Crack cementious render	i. Incompatibility of cementious rendering and adobe. ii. Remodelling iii. Introduction of burglar proofs and mosquito nets iv. lack of bonding between rubble stone dwarf fence in cementious mortar and the adobe building	Physical inspection
Cracked adobe walls	i. Incompatibility of cementious rendering and adobe. ii. Remodelling iii. Introduction of burglar proofs and mosquito nets iv. lack of bonding between rubble stone dwarf fence in cementious mortar and the adobe building	Physical inspection
Damp walls	i. Cracked cementious render ii. Oil based paint on the rendered adobe walls iii. Underground moisture (capillary action) due to cracking of cementious floor screed	Physical inspection
Cracked cementious floor screed	The thick of the cementious screeding on rammed earth floor bed is only 25mm as against the standard 150mm thickness concrete floor	The crack is wide and deep in one of the rooms so it possible to measure the depth of the cementious screed and to see the material used.

Basal erosion	Cementious rendering, lack of roof guttering and site drainage.	Physical inspection and tenants accounts

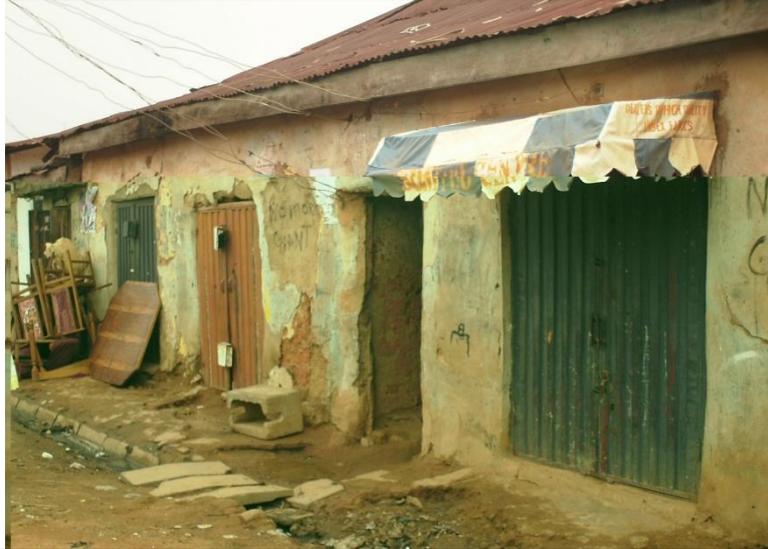
Building No: 03

Defects	Possible causes	Survey method / Evidence
Sagged roof	Ageing and lack of maintenance	Physical inspection and occupants account
Sagged and partially rotten facial	Ageing and lack of maintenance	Physical inspection and occupants account
Roof leakage	Ageing and lack of maintenance	Physical inspection and occupants account
Crack cementious render	i. Incompatibility of cementious rendering and adobe. ii. Introduction of a canopy for signage at the entrance of one of the shops iii. Remodelling iv. Lack bonding between old and newly added walls v. Construction of an addition shop using concrete blocks	Physical inspection
Cracked adobe walls	i. Incompatibility of cementious rendering and adobe. ii. Introduction of a canopy for signage at the entrance of one of the shops iii. Remodelling iv. Construction of an addition shop using concrete blocks v. Failure of timber lintels due to the span of the doors and windows (spans too wide)	Physical inspection and occupants account

Damp walls	i. Cementious rendering ii Entrance canopy iii. Flooding caused by road rehabilitation iv. Underground moisture (capillary action) due to cracking of cementious floor screed	Physical inspection
Crack floor	The thick of the cementious screeding on rammed earth floor bed is only 25mm as against the standard 150mm thickness concrete floor.	The crack is wide and deep in one of the rooms so it possible to measure the depth of the cementious screed and to see the material used.
Basal erosion	Cementious rendering, lack of roof guttering and site drainage as well flooding caused by road rehabilitation.	Physical inspection

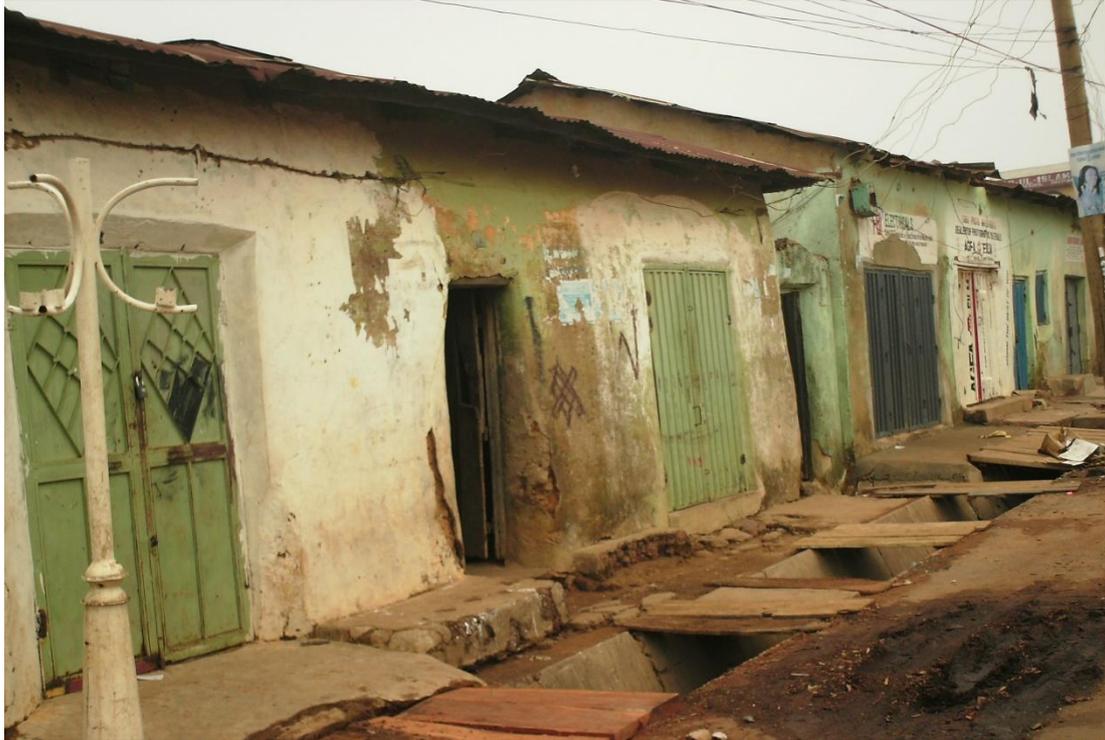
Buildings No: 04, 05 and 06

Defects	Possible causes	Survey method / Evidence
Sagged roof	Ageing and lack of maintenance	Physical inspection and occupants account
Missing facial	Ageing and lack of maintenance	Physical inspection and occupants account
Crack cementious render	<ul style="list-style-type: none"> i. Incompatibility of cementious rendering and adobe. ii. Use of walls as signage in building number 05 iii. Remodelling iv. Construction of an additional shop using concrete blocks in building number 06 	Physical inspection and occupants account
Cracked adobe walls	<ul style="list-style-type: none"> i. Incompatibility of cementious rendering and adobe. ii. Use of walls as signage in building number 05 iii. Remodelling iv. Construction of an additional shop using concrete blocks in building number 06 v. Lack bonding between old and newly added walls 	Physical inspection and occupants account
Damp walls	<ul style="list-style-type: none"> i. Cementious rendering ii. Oil based paint on the rendered adobe walls iii. Flooding caused by road rehabilitation iv. Underground moisture (capillary action) due to cracking of cementious floor screed v. Use of walls as signage in building number 05 	Physical inspection

Crack floor	Insufficient thickness (25mm thick in building number 05, 35mm thick in buildings number 04 and 06)	The crack is wide and deep in one of the rooms so it possible to measure the depth of the cementious screed and to see the material used.
Basal erosion	Cementious rendering, lack of roof guttering and site drainage as well flooding caused by road rehabilitation.	Physical inspection

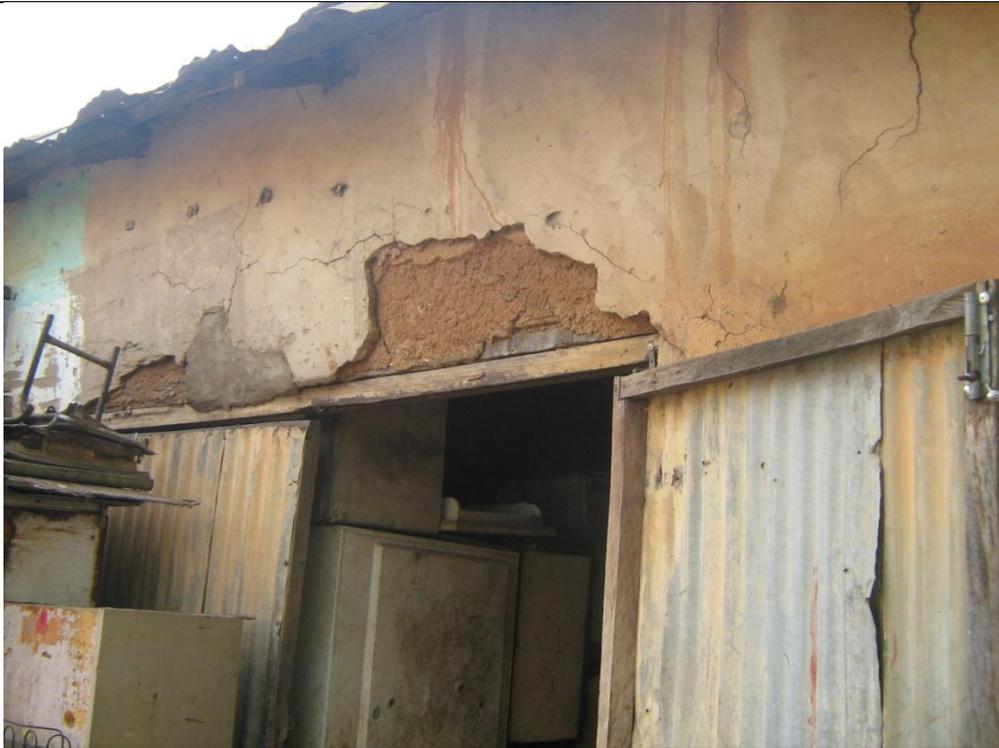
Building No: 07

Defects	Possible causes	Survey method / Evidence
Missing facial	Ageing and lack of maintenance	Physical inspection and occupants account
Crack cementious render	i. Incompatibility of cementious rendering and adobe. ii. Remodelling iv. New electrical installations	Physical Inspection and occupants account
Cracked adobe wall	i. Remodelling using inappropriate material and technique ii. New electrical installations iii. Rain water from the roof of adjoining property iv. Failure of timber lintels due to the span of the doors and windows (spans too wide) v. Lack bonding between old and newly added walls	Physical inspection and occupants account
Sagged timber lintel	i. Remodelling ii. Lintel span too wide to carry the load above	Physical inspection and occupants account
Cracked floor	Use of cementious screed only instead of mass concrete	Physical inspection

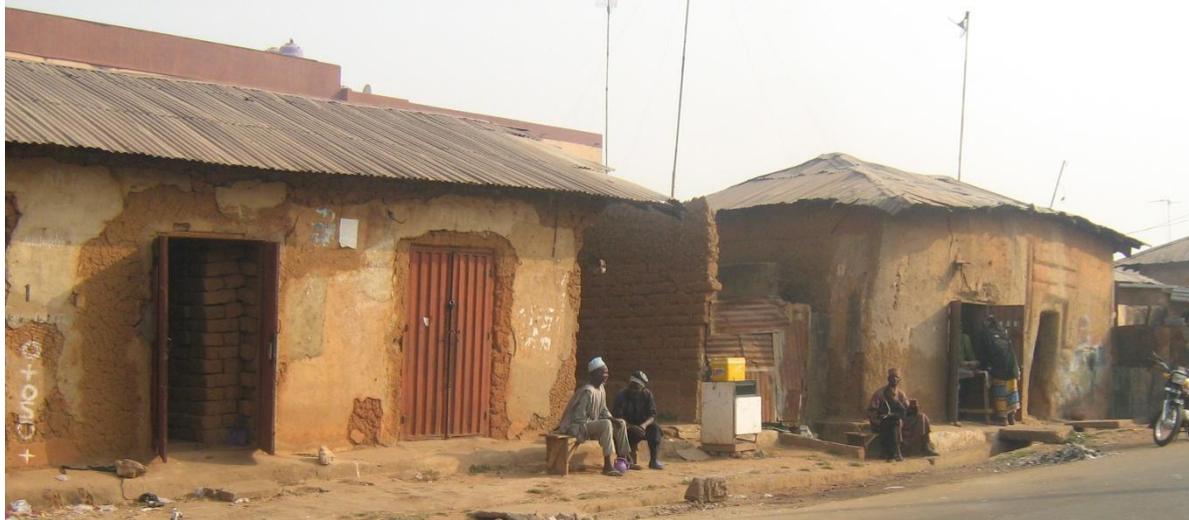
Buildings No: 08 and 09

Defects	Possible causes	Survey method / Evidence
Sagged roof (building no. 09 on the right)	Ageing and lack of maintenance	Physical inspection and occupants account
Leaking roof (building no. 09 on the right)	Ageing and lack of maintenance	Physical inspection and occupants account
Cracked cementious render	i. Incompatibility of cementious rendering and adobe. ii. Remodelling iv. New electrical installations	Physical inspection and occupants account
Cracked adobe wall	i. Remodelling using inappropriate material and technique ii. New electrical installations iii. Lack bonding between old and newly added walls	Physical inspection and occupants account
Damp walls	i. Incompatibility of cementious rendering and adobe. ii. Lack of ventilation no windows in all the front rooms (3 rooms in building number 08 and 2 rooms in building number 09) iii. Underground moisture (capillary action) due to cracking of cementious floor screed	Physical inspection and occupants account

Partial collapse of adobe wall (building no 08 on the left)	i. Negligence and lack of maintenance ii. Consistent remodelling	Physical inspection and occupants account
Cracked floor	Use of cementious screed only instead of mass concrete	Physical inspection
Basal erosion	Cementious rendering, lack of roof guttering and site drainage.	Physical inspection

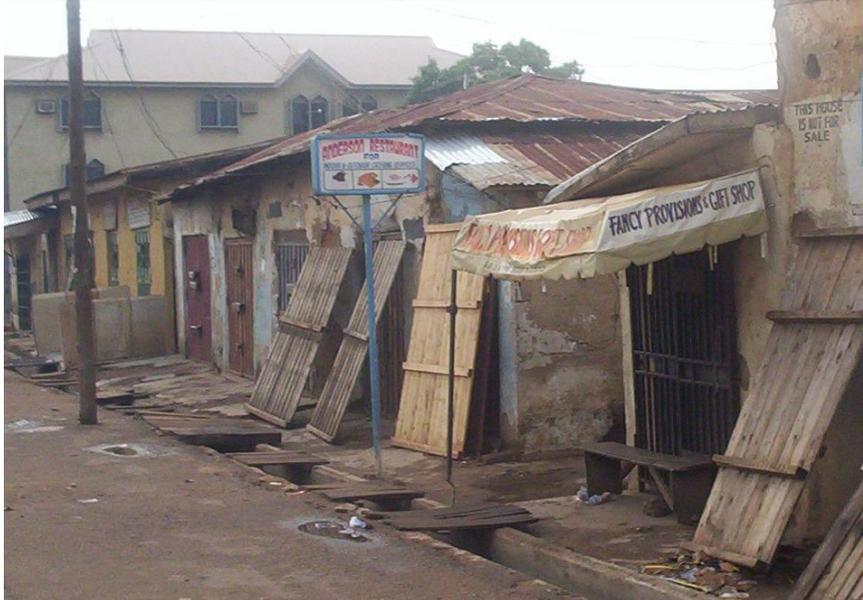
Building No: 10

Defects	Possible causes	Survey method / Evidence
Roof leakage	Ageing	Physical inspection and occupants account
Cracked cementious render	i. Incompatibility of cementious rendering and adobe. ii. Remodelling iv. New electrical installations	Physical inspection and occupants account
Cracked adobe wall	i. Incompatibility of cementious rendering and adobe. ii. Remodelling iii. New electrical installation iv. Failure of timber lintels due to the span of the doors and windows (spans too wide) v. Introduction of burglary proofs and mosquito's screens vi. Lack bonding between old and newly added walls	Physical inspection and occupants account
Damp walls	i. Incompatibility of cementious rendering and adobe. ii. Lack of ventilation no window in 3 rooms used both as shops and bedrooms iii. Underground moisture (capillary action) due to cracking of cementious floor screed	Physical inspection
Cracked floor	Use of cementious screed only instead of mass concrete	Physical inspection

Basal erosion	Cementious rendering, lack of roof guttering and flooding caused by recent road rehabilitation.	Physical inspection

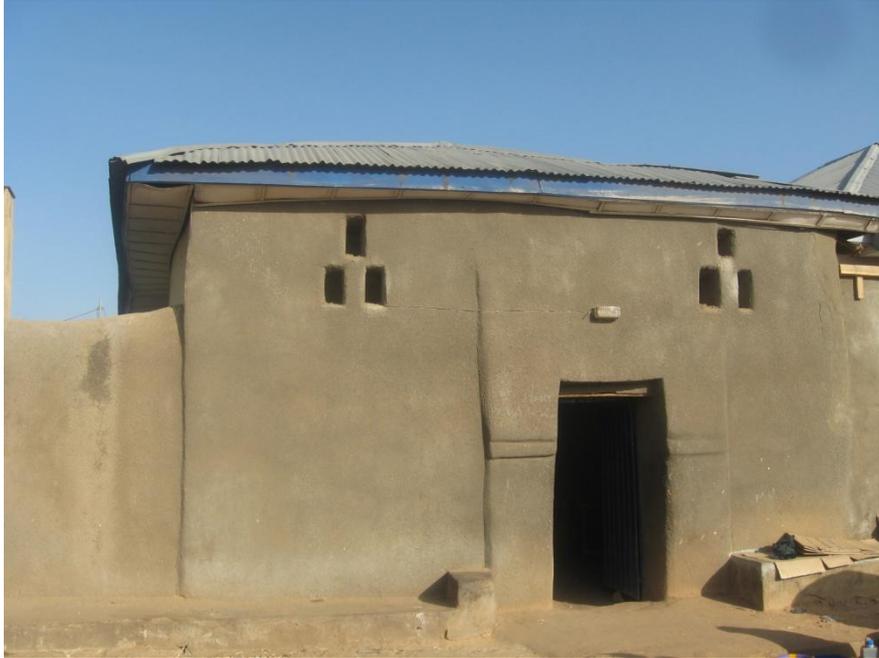
Building No:11

Defects	Possible causes	Survey method / Evidence
Sagged ceiling and facial board	Warping of untreated timber facial board, noggins and joists	Physical inspection and occupants account
Damp walls	<ul style="list-style-type: none"> i. Incompatibility of cementious rendering and adobe. ii. Lack of ventilation no window in 2 rooms iii. Underground moisture (capillary action) due to cracking of cementious floor screed 	Physical inspection and occupants account
Cracked floor	Use of cementious screed only instead of mass concrete	Physical inspection

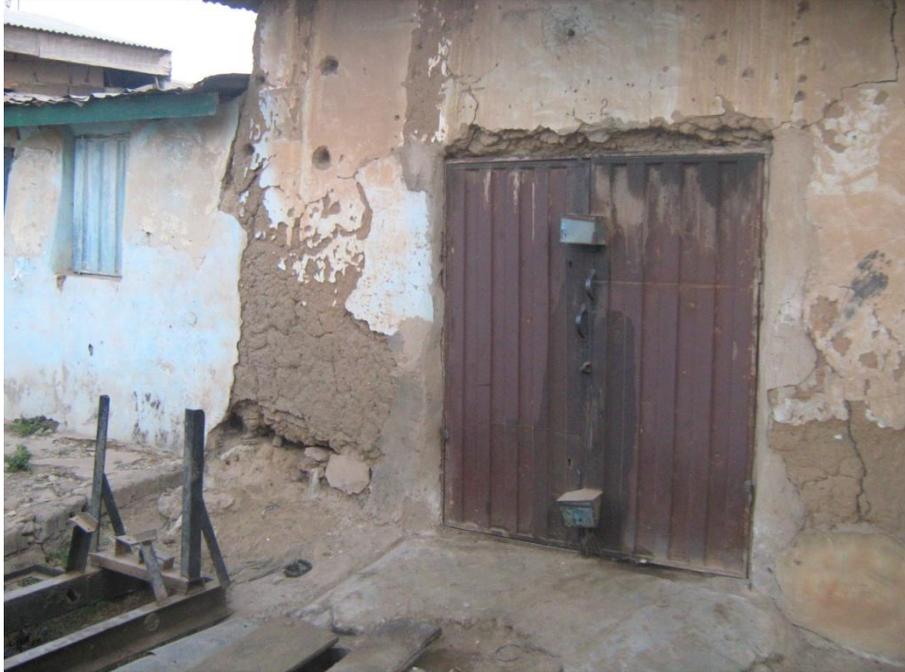
Building No: 12

Defects	Possible causes	Survey method / Evidence
Cracked cementious render	<ul style="list-style-type: none">i. Incompatibility of cementious rendering and adobe.ii. Remodellingiii. Introduction of burglar proofs and mosquito nets	Physical inspection and occupants account
Cracked adobe walls	<ul style="list-style-type: none">i. Incompatibility of cementious rendering and adobe.ii. Remodellingiii. Introduction of burglar proofsiv. Adjoining propertyv. Failure of timber lintels due to the span of the doors and windows (spans too wide)vi. Lack of bonding between old and newly added walls	Physical inspection and occupants account
Cracked cementious screed floor	<ul style="list-style-type: none">i. Use of cementious screed only instead of mass concrete.	Physical inspection
Basal erosion	Cementious rendering, lack of roof guttering and site drainage.	Physical inspection

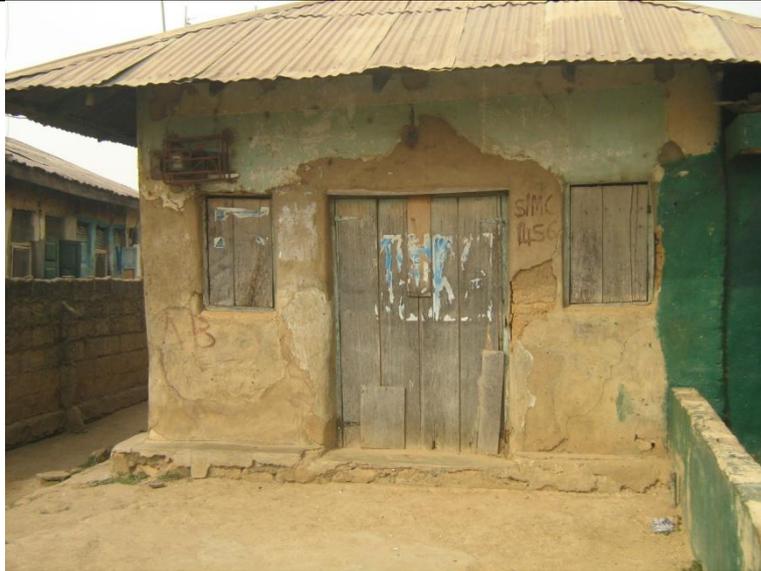
Building No: 13

Defects	Possible causes	Survey method / Evidence
Cracked cementious render	<ul style="list-style-type: none">i. Incompatibility of cementious rendering and adobe.ii. Remodellingiii. Introduction of burglar proofs and mosquito nets	Physical inspection and occupants account
Cracked adobe walls	<ul style="list-style-type: none">i. Incompatibility of cementious rendering and adobe.ii. Remodellingiii. Introduction of burglar proofs and mosquito netsiv. Failure of timber lintels due to the span of the doors and windows (spans too wide)v. Lack of bonding between old and newly added walls	Physical inspection and occupants account
Cracked cementious screed floor	<ul style="list-style-type: none">i. Use of cementious screed instead of mass concrete.ii. Underground moisture (capillary action) due to cracking of cementious floor screed	Physical inspection
Basal erosion	Cementious rendering, lack of roof guttering and site drainage.	Physical inspection

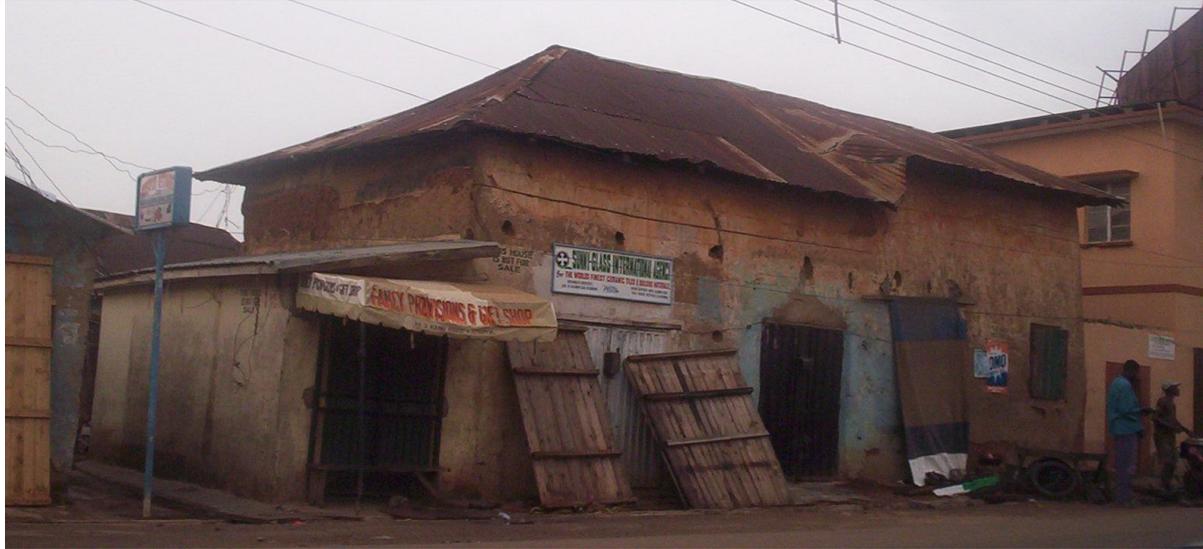
Building No: 14

Defects	Possible causes	Survey method / Evidence
Sagged roof	Ageing and lack of maintenance	Physical inspection
Cracked cementious render	i. Incompatibility of cementious rendering and adobe. ii. Remodelling iii. Introduction of burglar proofs and mosquito nets iv. Use of walls for signage (products advertisement) v. Erection of entrance canopy	Physical inspection
Cracked adobe walls	i. Incompatibility of cementious rendering and adobe. ii. Remodelling iii. Introduction of burglar proofs and mosquito nets iv. Use of walls for signage (products advertisement) v. Erection of entrance canopy vi. Failure of timber lintels due to the span of the doors and windows (spans too wide) vii. Lack of bonding between old and newly added walls	Physical inspection and occupants account
Cracked cementious screed floor	Use of cementious screed instead of mass concrete.	Physical inspection and occupants account

Damp	i. Cementious render ii. Application of oil paint iii. Inappropriate remodelling v. Lack of ventilation vi. Underground moisture (capillary action) due to cracking of cementious floor screed. vii. Flooding caused by road rehabilitation	Physical inspection and occupants account
Basal erosion	Cementious rendering, lack of roof guttering and site drainage.	Physical inspection and occupants account

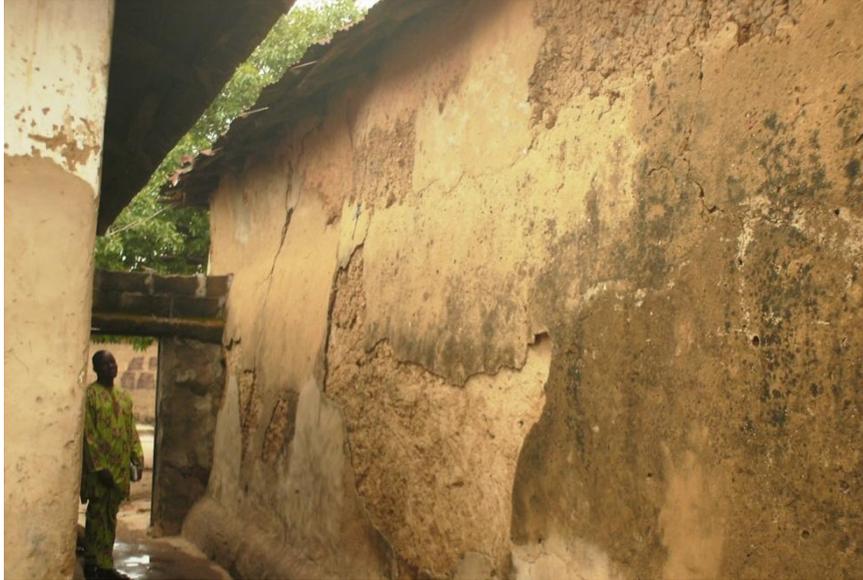
Building No: 15

Defects	Possible causes	Survey method / Evidence
Cracked cementious render	i. Incompatibility of cementious rendering and adobe. ii. Remodelling iii. Rain water from the roof of the adjoining a building in the adjoining compound	Physical inspection
Cracked adobe walls	i. Inappropriate remodelling ii. New electrical wiring iii. Introduction of burglary proofs and mosquito's screens iv. Lack of bonding between old and newly added walls	Physical inspection
Cracked cementious screed floor	Use of cementious screed instead of mass concrete.	Physical inspection and occupants account
Damp	i. Cementious render ii. Inappropriate remodelling iii. Lack of ventilation iv. Underground moisture (capillary action) due to cracking of cementious floor screed v. Rain water from the roof of the adjoining a building in the adjoining compound.	Physical inspection and occupants account
Basal erosion	Cementious rendering, lack of roof guttering and site drainage.	Physical inspection and occupants account

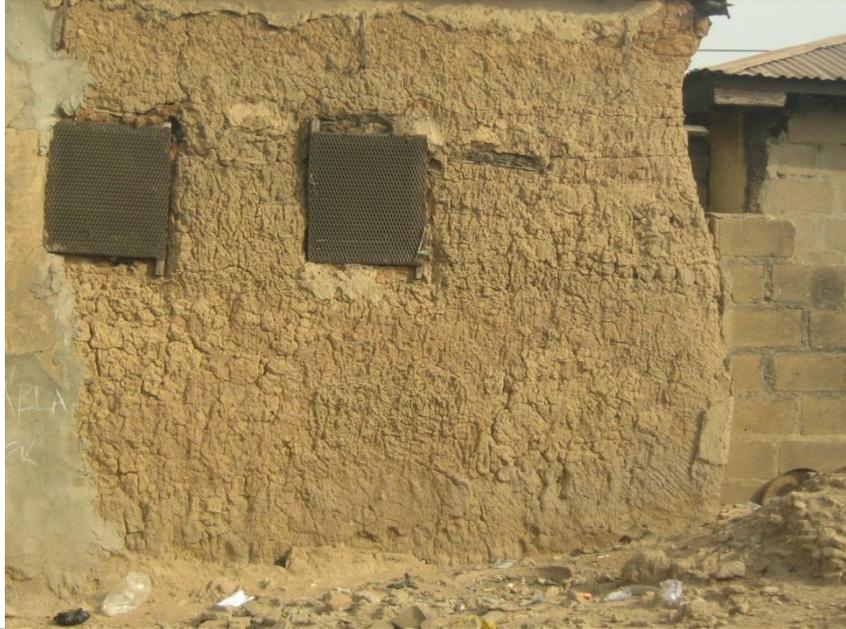
Building No: 16

Defects	Possible causes	Survey method / Evidence
Eroded earth based render	<ul style="list-style-type: none"> i. Inadequate roof overhang ii. Neglect and lack of maintenance iii. Introduction burglary proof and mosquito's nets screens iv. Incompatibility of concrete block used for the construction of the adjoining building 	Physical inspection
Cracked adobe walls	<ul style="list-style-type: none"> i. Inadequate roof overhang ii. Neglect and lack of maintenance iii. Introduction burglary proof and mosquito's nets screens iv. Lack of bond between the concrete blocks used for the construction of the adjoining building. 	Physical inspection
Cracked cementious screed floor	<ul style="list-style-type: none"> i. Use of cementious screed instead of mass concrete. ii. Underground moisture (capillary action) due to cracking of cementious floor screed 	Physical inspection
Basal erosion	Cementious rendering, lack of roof guttering and site drainage.	Physical inspection and occupants account

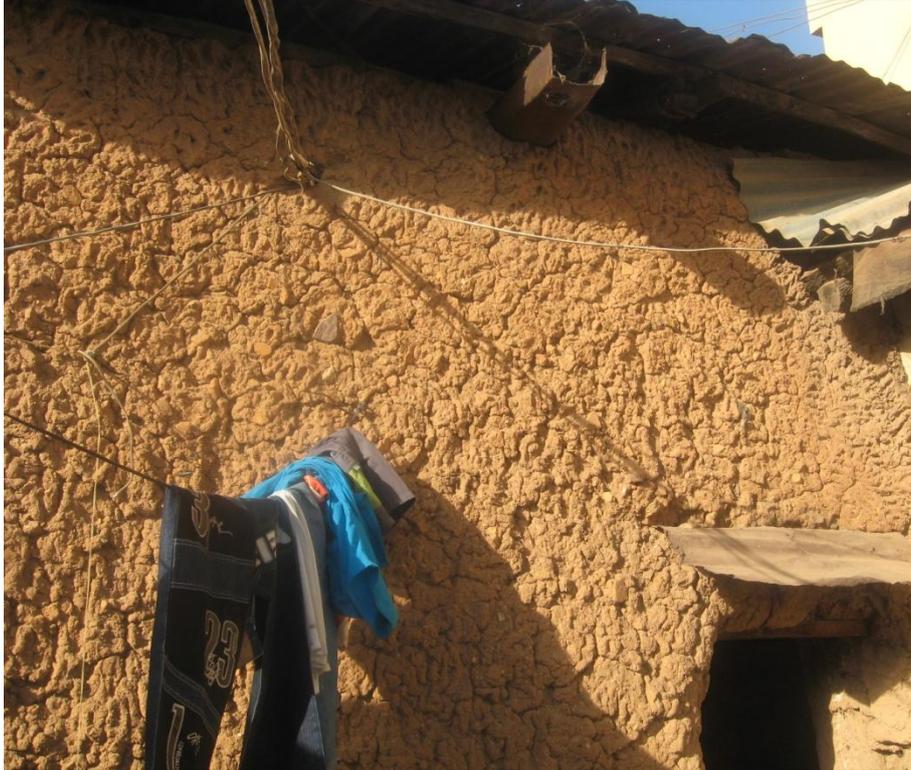
Building No: 17

Defects	Possible causes	Survey method / Evidence
Eroded earth based render	<ol style="list-style-type: none">i. Inadequate roof overhangii. Neglect and lack of maintenanceiii. Inappropriate remodellingiv. Incompatibility of concrete block used for the construction of the adjoining buildingv. Misuse	Physical inspection and occupants account
Cracked adobe walls	<ol style="list-style-type: none">i. Inadequate roof overhangii. Neglect and lack of maintenanceiii. Inappropriate remodellingiv. Incompatibility of concrete block used for the construction of the adjoining buildingv. Misusevi. Introduction of burglary proofs and mosquito's screensvii. Lack of bonding between old and newly added walls	Physical inspection and occupants account
Cracked cementious screed floor	<ol style="list-style-type: none">i. Use of cementious screed instead of mass concrete.	Physical inspection and occupants account

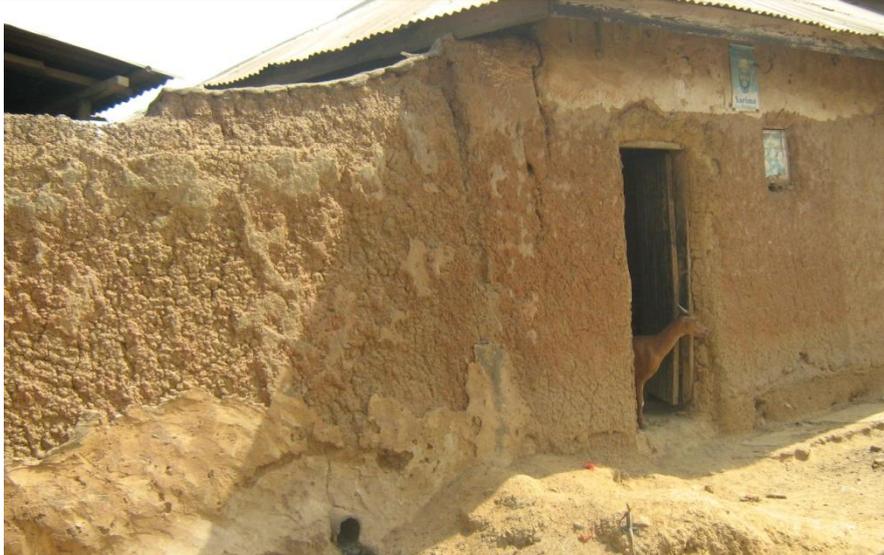
Building No: 18

Defects	Possible causes	Survey method / Evidence
Cracked cementious render	<ul style="list-style-type: none"> i. Incompatibility of cementious rendering and adobe. ii. Inappropriate remodelling iii. Neglect and lack of maintenance iv. abrasion caused human and animal (goats) movements 	Physical inspection and occupants account
Cracked adobe walls	<ul style="list-style-type: none"> i. Incompatibility of cementious rendering and adobe. ii. Inappropriate remodelling iii. Neglect and lack of maintenance iv. abrasion caused human and animal (goats) movements v. Introduction of burglary proofs and mosquito's screens vi. Lack of bonding between old and newly added walls 	Physical inspection and occupants account
Cracked cementious screed floor	Use of cementious screed instead of mass concrete.	Physical inspection and occupants account
Damp	<ul style="list-style-type: none"> i. Inappropriate remodelling ii. Lack of ventilation iii. Underground moisture (capillary action) due to cracking of cementious floor screed 	Physical inspection and occupants account

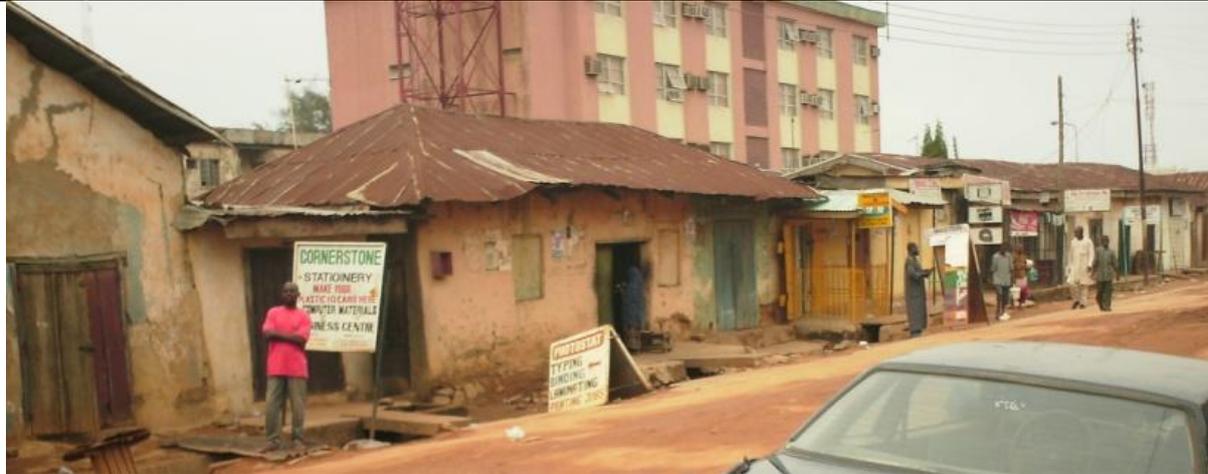
Buildings No: 19 and 20

Defects	Possible causes	Survey method / Evidence
Cracked cementious render	<ul style="list-style-type: none"> i. Incompatibility of cementious rendering and adobe. ii. Inappropriate remodelling iii. Neglect and lack of maintenance iv. Introduction of entrance canopies v. Use of walls as signage for products and services advertisements 	Physical inspection and occupants account
Cracked adobe walls	<ul style="list-style-type: none"> i. Incompatibility of cementious rendering and adobe. ii. Inappropriate remodelling iii. Neglect and lack of maintenance iv. Introduction of entrance canopies v. Use of walls as signage for products and services advertisements vi. Failure of timber lintels due to the span of the doors and windows (spans too wide) in building number 08 vii. Introduction of burglary proofs and mosquito's screens viii. Lack of bonding between old and newly added walls 	Physical inspection and occupants account

Damp walls and floors	<ul style="list-style-type: none"> i. Incompatibility of cementious rendering and adobe. ii. Inappropriate remodelling iii. Neglect and lack of maintenance iv. Introduction of entrance canopies v. Use of walls as signage for products and services advertisements vi. Lack of ventilation vii. Underground moisture (capillary action) due to cracking of cementious floor screed viii. Moisture from water leaking from the plumbing pipes in buildings number 19 and 20 	Physical inspection and occupants account
Cracked cementious screed floor	Use of cementious screed instead of mass concrete.	Physical inspection and occupants account
Basal erosion	Cementious rendering, lack of roof guttering and site drainage.	Physical inspection and occupants account
