# Damage assessment and refurbishment of steam turbine blade/rotor attachment holes

# Damage Assessment and Refurbishment of Steam Turbine Blade/Rotor Attachment Holes

D G Hattingh <sup>\*1</sup>, M N James <sup>\*1,2</sup>, M Newby <sup>3</sup>, R Scheepers <sup>3</sup> and P Doubell <sup>3</sup>

This paper presents a case study dealing with the assessment of cracking observed at steam turbine blade attachment holes, and subsequent use of an innovative repair solution based on a friction processing technique, friction hydro-pillar processing (FHPP). This was performed with a bespoke welding platform developed specifically for repair of radially cracked or incorrectly drilled blade attachment holes in LP turbine rotors. The paper initially outlines a fracture mechanics analysis of observed in-service cracking aimed at assessing critical defect sizes to support repair or replacement scenarios. It then briefly discusses development of the FHPP process before focusing on characterisation of the residual stresses resulting from the welding process and their amelioration by heat treatment; a necessary part of the procedure approval for turbine refurbishment.

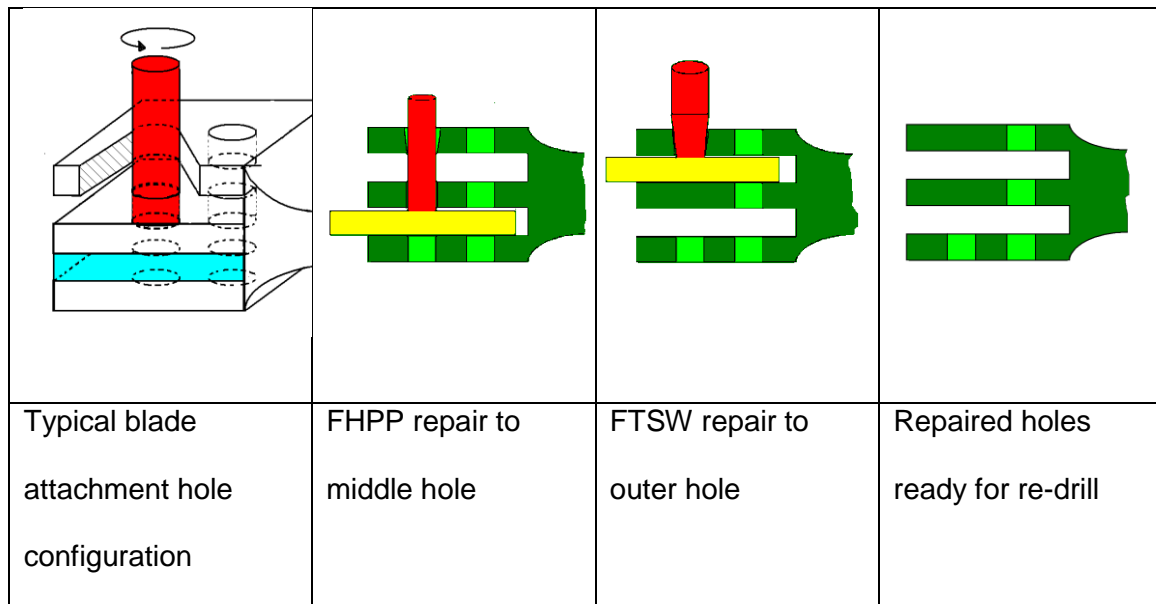
Figure 1 Schematic illustrating the repair of finger blade attachment points by FHPP.

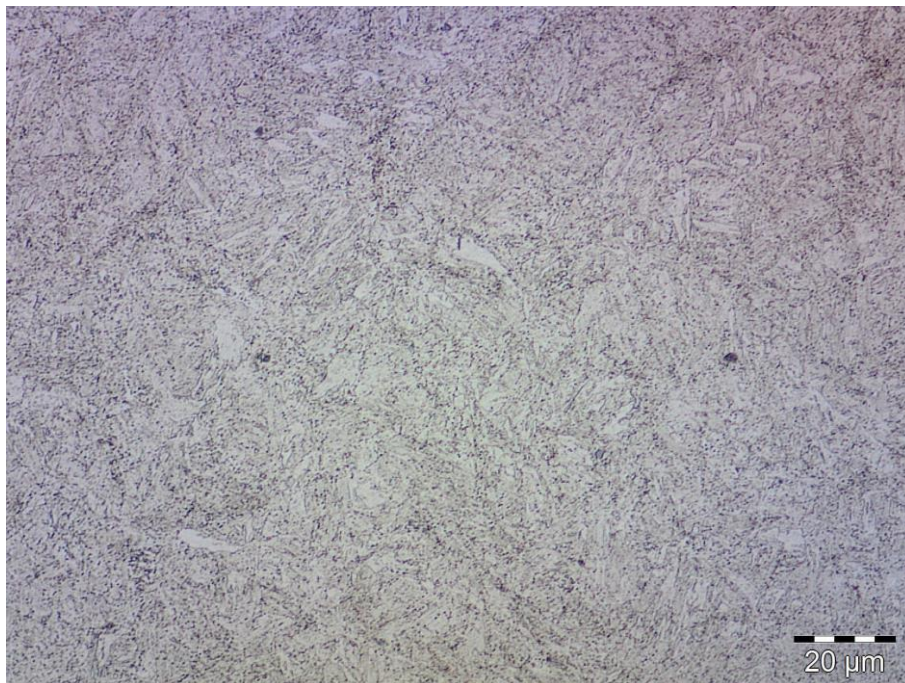
Typical microstructures in the as-forged rotor comprise a mixture predominantly of tempered bainite and some tempered martensite; although small amounts of retained austenite are also present (see Figure 8). The work reported in this paper used 5 specimens intended to simulate the various stages in applying the FHPP process to repair of damaged blade attachment holes in a rotor. Figure 9 illustrates the steel test piece (size 95 x 95 x 18 mm) used to simulate the repair process. A thickness of 18 mm was chosen to be representative of the upper limit of finger thickness found in actual turbine discs.

Figure 8 Parent plate microstructure of the 26NiCrMoV14-5 steel alloy at a magnification of approximately 500x, the scale bar is accurate.

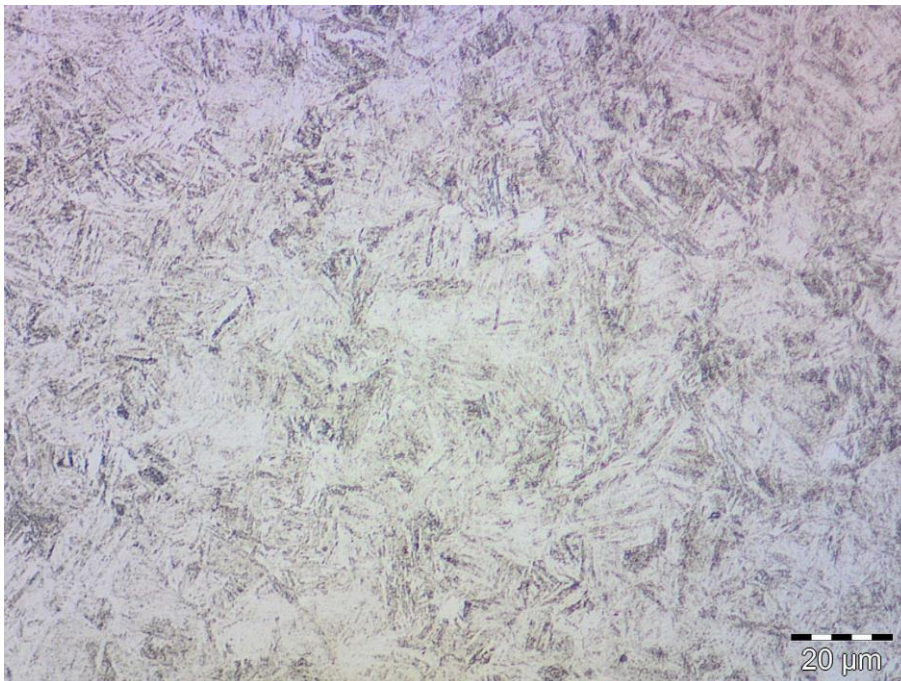
Figure 11 HAZ region in specimen W2; the microstructure is little changed from the parent plate and hardness values in the two regions would be expected to be similar.

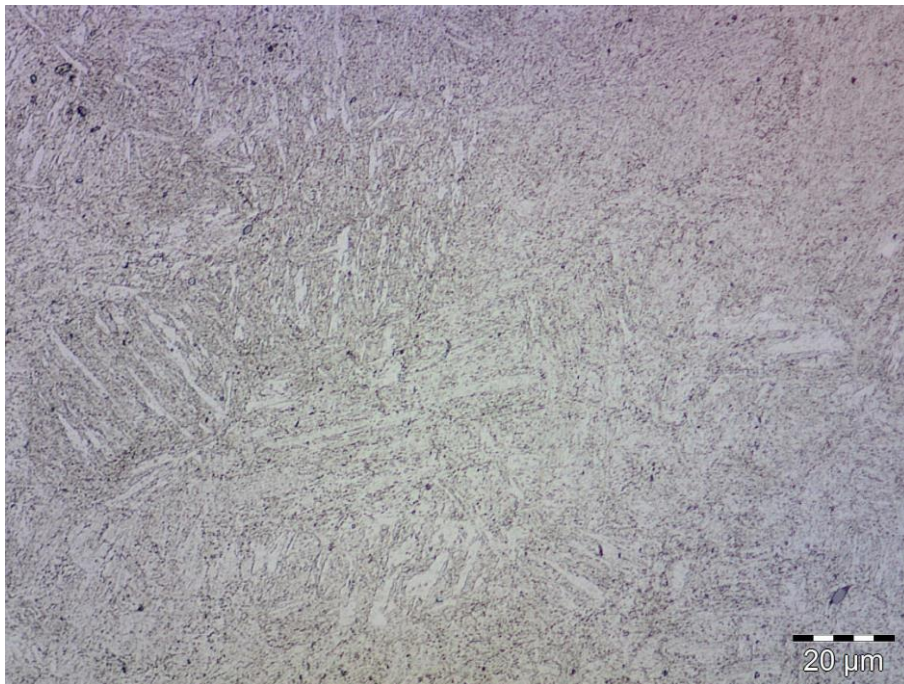
Figure 12 Tool core zone in specimen W2; the micrograph shows evidence of a fast cooling rate and hence a higher hardness than the parent plate.

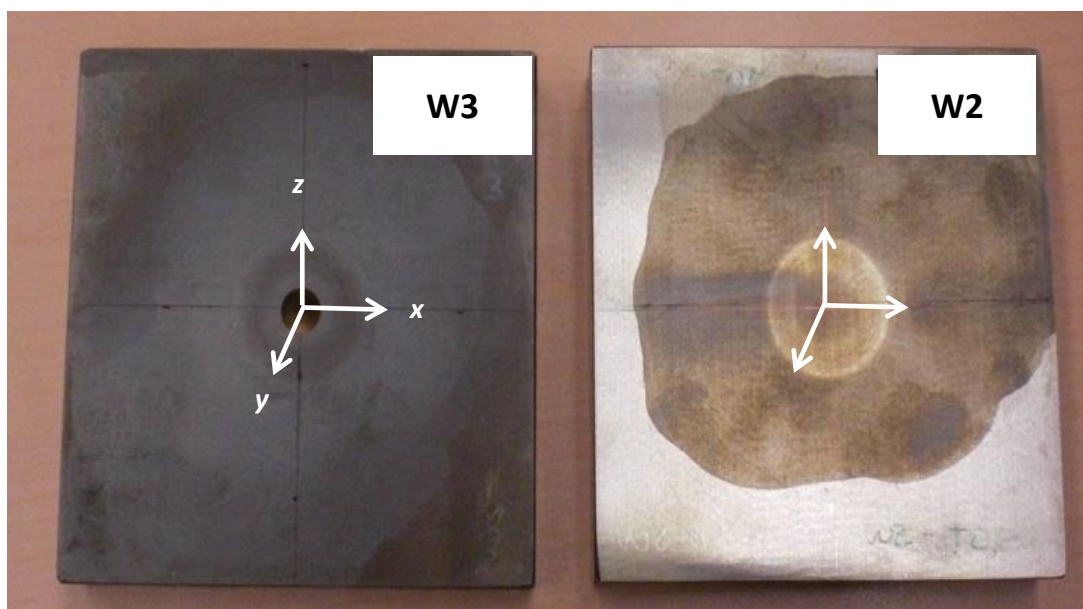
Figure 13 Tool core region in specimen W4 after PWHT at 680°C; there is little discernible difference between this microstructure and the parent plate.

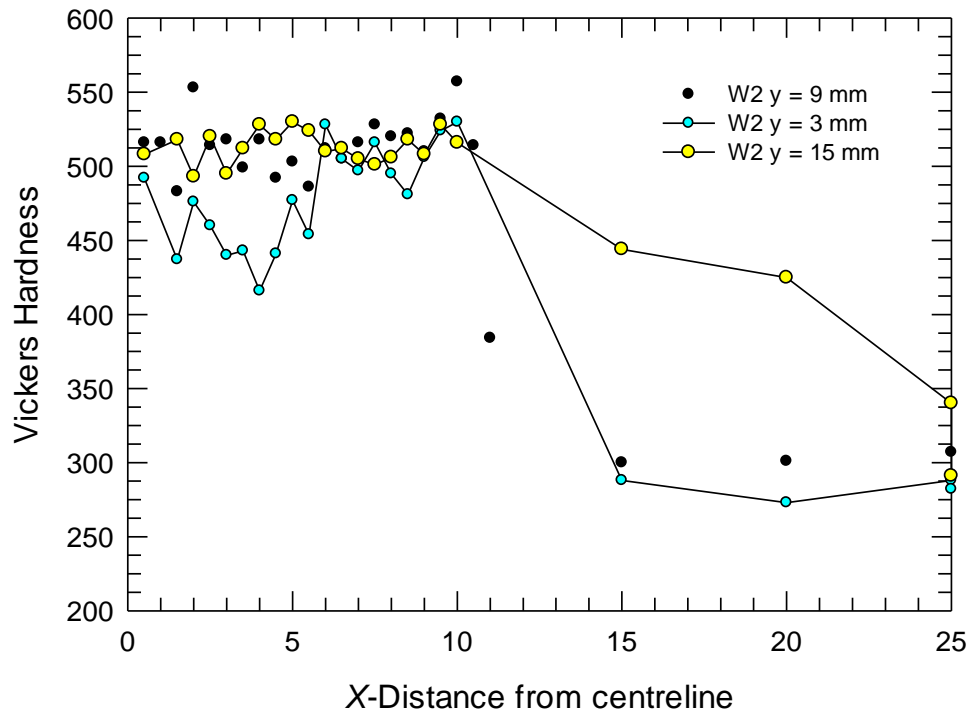
In specimens W4 and W5 that were subject to PWHT the hardness curves at all three depths (3 mm, 9 mm and 15 mm) were almost identical, while small systematic variations were apparent in the as-welded specimens W2 and W3 (Figure 16). It is clear that in specimen W2 (Figure 16a) the hardness in the welded zone at 3 mm is lower, while the

hardness decays more slowly outside the welded zone at the 15 mm depth, than observed at the other two depths. Figure 16b shows that the extent of the high hardness zone in specimen W3 gets progressively slightly larger as the depth in the specimen increases from 3 mm to 15 mm. These hardness variations as a function of depth are related to details of the thermomechanical forging process and the interaction with the backing plate, i.e. heat input across a larger region coupled with cooling at similar rates; however, exact mechanisms remain unclear.

Figure 16a Vickers hardness at three depths in the as-welded W2 specimen; the hardness in the welded zone at 3 mm is lower, while the hardness decays more slowly outside the welded zone at the 15 mm depth, than observed at the other two depths.

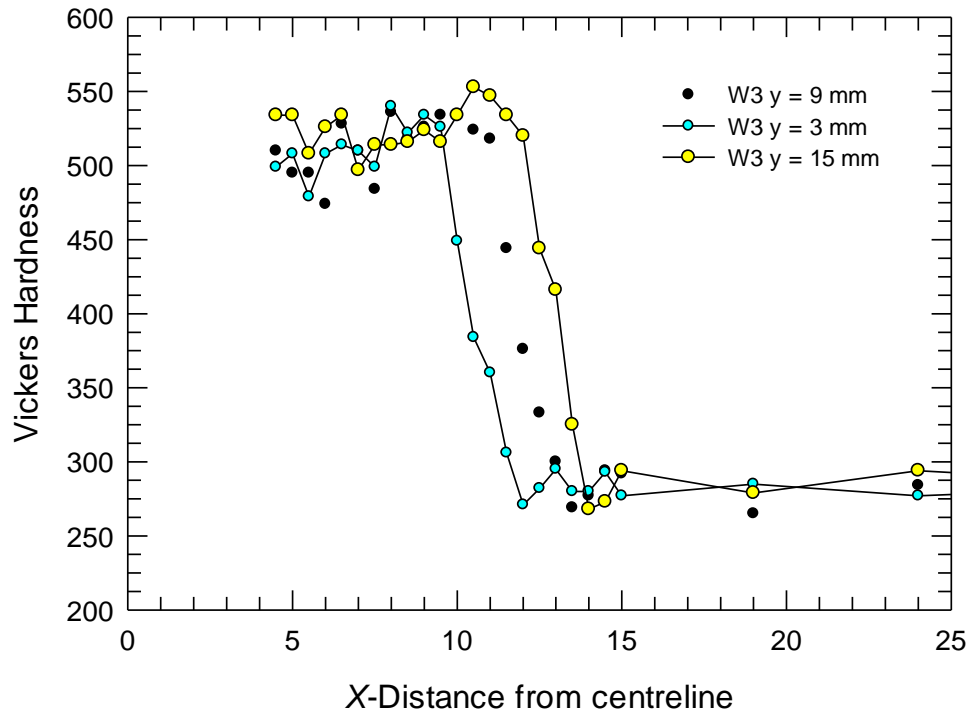
Figure 16b Vickers hardness at three depths in the as-welded W3 specimen drilled with an 8 mm hole; the extent of the high hardness zone gets progressively slightly larger as the depth in the specimen increases from 3 mm to 15 mm.

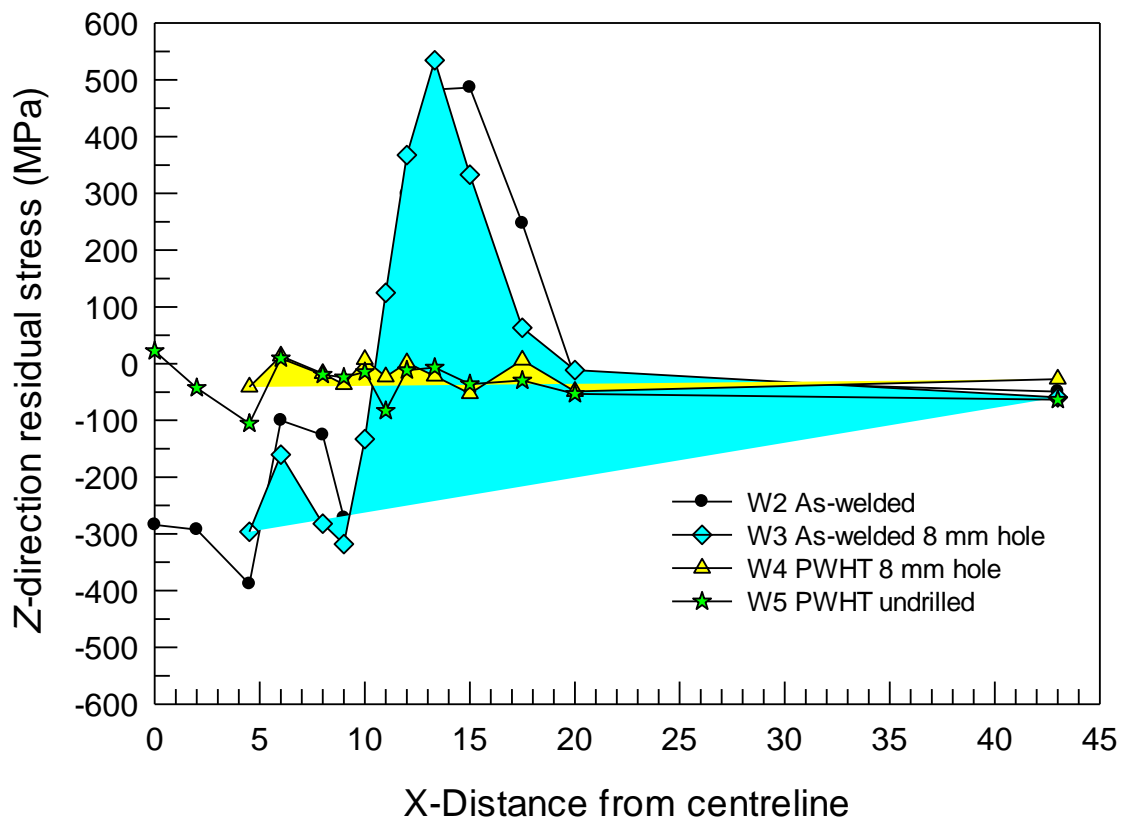
The calculated residual stress values for all three coordinate directions are given in Figure 17 for the various measurement positions in the  $x$ -direction. The key coordinate directions for crack initiation and growth are  $x$  and  $z$  and the data show that the PWHT process is very effective in relaxing the substantial residual stress peaks in the weld zone. Reductions are achieved in the  $x$ -direction stress (Figure 17a) from peak values around -380 MPa near the HAZ boundary in specimens W2 and W3 to values below 100 MPa at similar positions in specimens W4 and W5. In the case of the  $z$ -direction stresses (Figure 17b) the reduction is even more marked, from peak tensile values of circa 500 MPa in W2 and W3 to values close to zero in W4 and W5. It is also apparent that drilling an 8 mm diameter hole in the as-welded specimen leads to a positive residual stress near the edge of the hole in the  $x$ -

Figure 17b Mid-depth residual stress ( $y = 9$  mm) in the z-coordinate direction for all specimens.

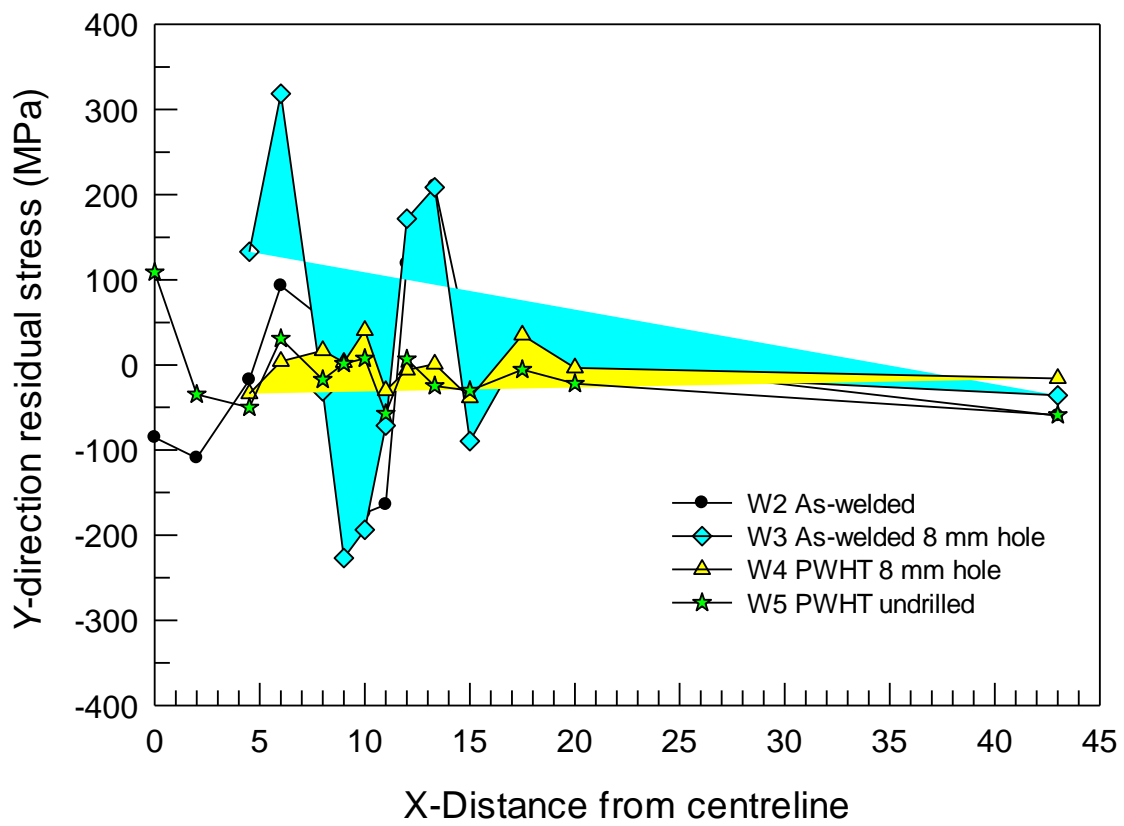
Figure 17c Mid-depth residual stress ( $y = 9$  mm) in the  $y$ -coordinate direction (through-thickness) for all specimens.

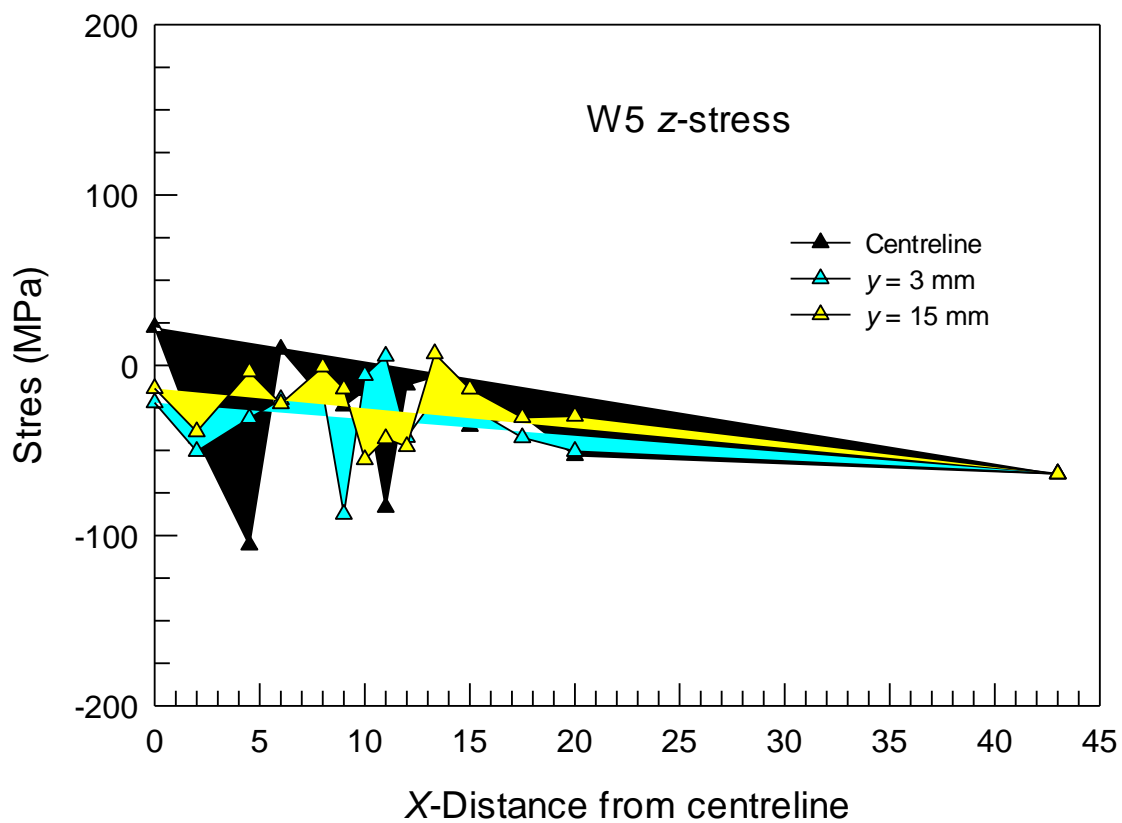
It is also interesting to compare the residual stress levels at the three different  $y$ -positions where measurements were made, i.e. 3 mm, 9 mm and 15 mm below the top surface of the specimen. Figure 18 shows this data for the  $z$ -coordinate direction in specimens W5 (undrilled PWHT) and W4 (drilled PWHT). In all cases, peak stress values in the  $x$  and  $z$ -coordinate directions do not exceed approximately 100 MPa.

Figure 18a Stress at all three depths in the z-coordinate direction for the undrilled PWHT specimen W5.

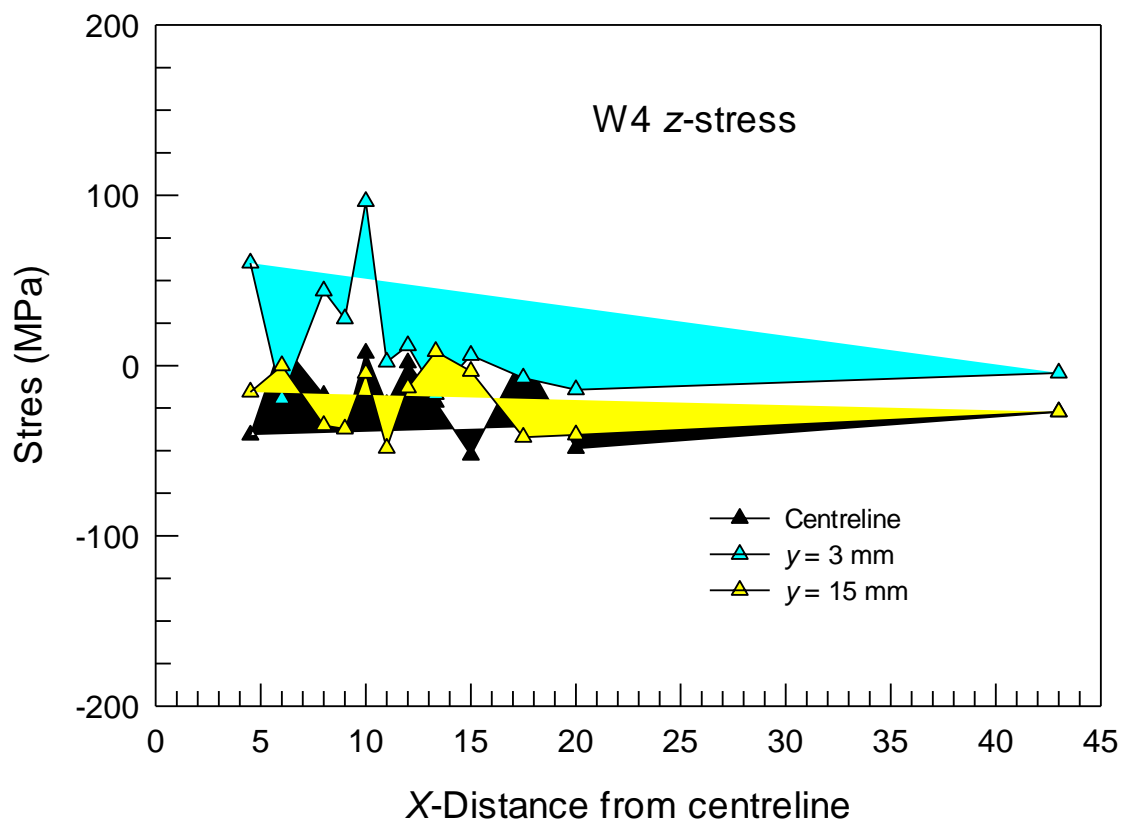
Figure 18b Stress at all three depths in the z-coordinate direction for the drilled PWHT specimen W4.

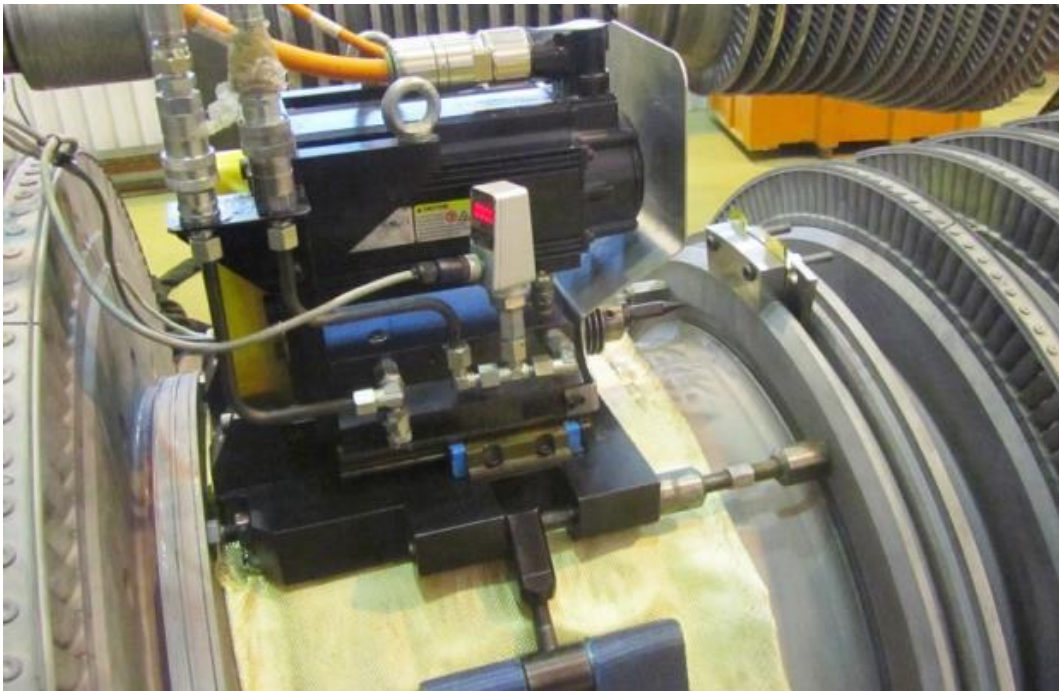
A FHPP technique has been developed for use with a bespoke welding platform that is suitable for cost-effective repair of disc/blade attachment hole cracking in-situ on a steam turbine rotor (Figure 20). The WeldCore® process has been registered and can also be used to extract samples for creep damage analysis. The case study presented in this paper relates to cracking experienced at the attachment holes of finger-pinned stage 1 LP steam turbine blades on a 200MW unit. Neutron diffraction residual strain scanning was performed at the ILL in Grenoble, France on test specimens machined from ex-service rotors, intended to simulate various stages in the repair process (see Figure 3); as-welded and undrilled (W20, as-welded and subsequently drilled for the blade attachment pin (W3), undrilled and PWHT (W5), drilled and PWHT (W4). PWHT has been shown to substantially reduce the peak magnitudes of the residual stress associated with the welding process, from peak tensile values of around 500 MPa in W2 and W3 to values close to zero in W4 and W5. Drilling an 8 mm hole in the as-welded specimen (W3), to simulate a new pin attachment

Figure 20 Illustration of the bespoke FHHP platform in position on a stream turbine rotor. It uses the registered WeldCore® process and in this case, is being used to extract samples for creep damage analysis.
