# Exceptional river gorge formation from unexceptional floods

L. Anton<sup>1</sup>, A.E. Mather<sup>2</sup>, M. Stokes<sup>2</sup>, A. Muñoz-Martin<sup>3</sup> & G. De Vicente<sup>3</sup>

An understanding of rates and mechanisms of incision and knickpoint retreat in bedrock rivers is fundamental to perceptions of landscape response to external drivers, yet only sparse field data are available. Here we present eye witness accounts and quantitative surveys of rapid, amphitheatre-headed gorge formation in unweathered granite from the overtopping of a rock-cut dam spillway by small-moderate floods ( $\sim 100\text{--}1,500\text{ m}^3\text{ s}^{-1}$ ). The amount of erosion demonstrates no relationship with flood magnitude or bedload availability. Instead, structural pattern of the bedrock through faults and joints appears to be the primary control on landscape change. These discontinuities facilitate rapid erosion ( $>270\text{ m}$  headward retreat;  $\sim 100\text{ m}$  incision; and  $\sim 160\text{ m}$  widening over 6 years) principally through fluvial plucking and block topple. The example demonstrates the potential for extremely rapid transient bedrock erosion even when rocks

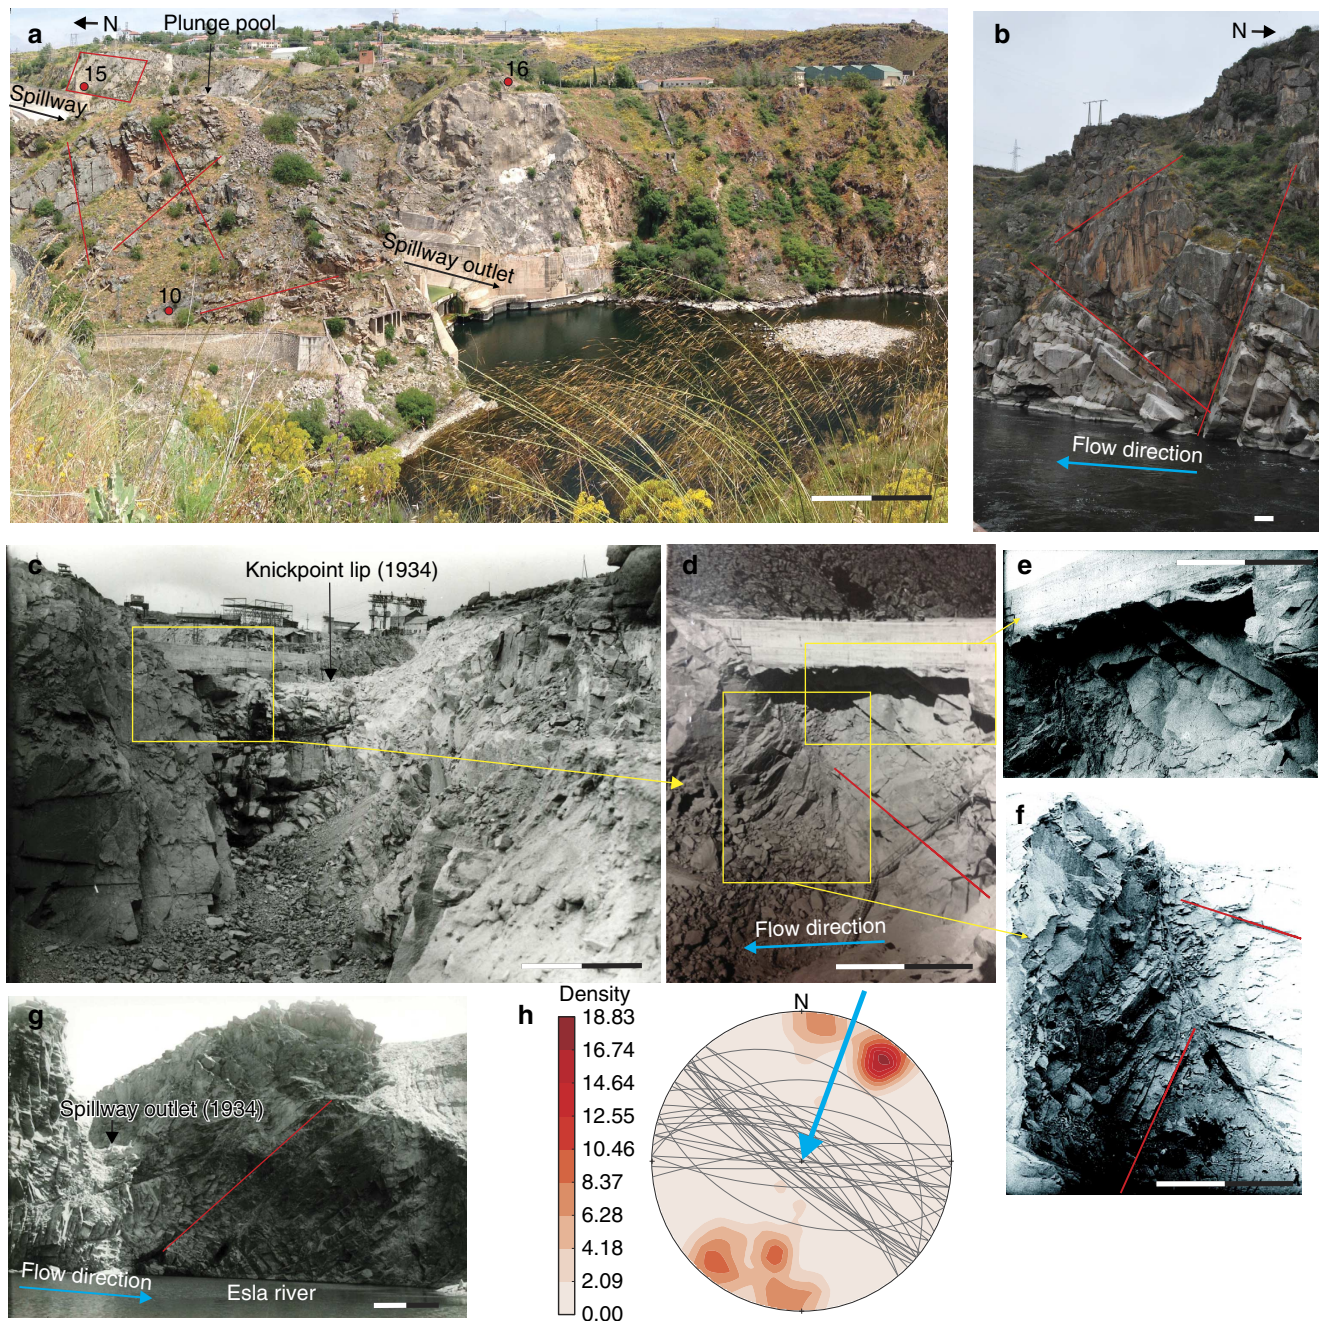
**Figure 4 | Field photographs illustrating fracture geometry at the spillway site and Río Eslla.** (a) Present spillway outlet and fracture pattern. Red dots indicate measurement sites (Fig. 1), red lines indicate fracture planes. Red box at site 15 represents a  $\sim$ N-S fault plane outcrop, parallel to the spillway gorge orientation. Scale bar,  $\sim$ 50-m long. (b) Western side of the Río Eslla in front of site 11 (Fig. 1b). Fracture set dipping against and toward the flow. Scale bar,  $\sim$ 1-m long. (c) Spillway lip and gorge formed during 1933-1934 hydrologic year (scours 1-3; Fig. 3); scale bar,  $\sim$ 50-m long, (credit Iberdrola). Yellow box indicates location of photograph (d). (d) Fracture pattern at the knickpoint lip by summer 1934 when retreat had significantly slowed (credit Iberdrola). Scale bar,  $\sim$ 25-m long; Yellow boxes indicate location of photographs (e,f). (e) Detail of fracture orientation (dipping against the flow) at the knickpoint lip. Scale bar,  $\sim$ 25-m long. (f) Detail of fracture orientation (dipping predominantly toward the flow) downstream of the knickpoint lip. Scale bar,  $\sim$ 25-m long; (g) Fracture sets dipping predominantly against the flow at the  $\sim$ 30-m height knickpoint formed at the spillway outlet (confluence with the Río Eslla) by March 1934. This knickpoint disappeared during the fourth main scour (Fig. 3d,e) in March 1935. Scale bar, 25 m. (h) Orthogonal to flow fracture planes dipping towards and against the flow. Stereoplot and density plot of ESE trending fractures, measured at the Ricobayo sites (see Methods).

**Bedrock discontinuities.** Systematic measurements of fractures (joints and faults, see Methods) revealed a pattern in the Ricobayo area dominated by NNE–SSW striking fractures (Fig. 1d). This included a primary NNE left-lateral strike-slip fault system concordant with previous field-based regional structural geological analyses<sup>34,35</sup>. This primary pattern exerts a significant control on drainage network orientation, as observed in the lower Río Esla reach (Supplementary Fig. 1). Secondary fracture sets oriented NNW–SSE and ESE–WNW are encountered and are significant at outcrop scale (Figs 1d and 4). Most fractures were vertical or near-vertical, although minor subhorizontal unloading joints were also present. Fracture spacing was locally in a 0.3–3 m range (Supplementary Table 1) and fracture length is typically more than several tens of metres, with a vertical persistence along the whole outcrop (Fig. 4). Exposures of discontinuity surfaces revealed a dominance of fresh, tight and unweathered planes. Fracture plots suggest that the primary fracture sets influence river incision and the progression of erosion in the spillway. Vertical and sub-vertical NNW to NNE trending structures determine the bedrock river and spillway gorge orientation (for example, site 15 in Figs 1 and 4a). ESE trending fractures are orthogonal to flow direction in the spillway with sets dipping both against and towards the flow (Figs 1d and 4).

patterns are found in the regional geological context. However, discontinuity patterns through fracture density and orientation interactions play an important role in the gorge development<sup>12,20,36</sup>. The existence of several fracture sets with different orientations resulted in the formation of bedrock blocks that were susceptible to removal by plucking and probable block topple

(Fig. 4). Similar (m-scale) blocks can be found elsewhere in the natural reaches of the Río Eslla suggesting this is not just localized to the spillway area. The NNW to NNE structures regionally determines channel orientation patterns. Furthermore, although they are quantitatively less represented, the orthogonal to flow fracture sets within these channels play a key role in the gorge

progression. This structural pattern (Fig. 4) enhances headward erosion when the fractures dipped towards flow and favoured incision when fractures dipped predominantly against flow<sup>20,36</sup>.

by anti-flow oriented fracture sets, implying that that structural differences along the gorge, with local predominance of fracture sets dipping against the flow, became significant in suppressing the retreat progression<sup>30</sup> (Fig. 4d–g).

**Fracture population analysis.** Field survey was undertaken to identify the bedrock fracture pattern. Orientation (trend and dip) of 151 fracture (fault and joint) planes were measured at 11 sites in the Ricobayo area (Fig. 1d). This task was preceded by field reconnaissance to select representative outcrops that encapsulated all of the fracture types and patterns. Stereoplots, histograms, rose diagrams and density plots were used to analyse the data. The fracture pattern is dominated by NNE–SSW striking structures, while secondary fracture sets oriented NNW–SSE and ESE–WNW take weight at outcrop scale (Fig. 1d). Together with the statistical analysis, the dominant trends were identified from aerial and field imagery and then compared with published regional fault patterns<sup>34</sup> (Supplementary Fig. 1). Due to the relevance of dip and dip direction of the orthogonal to flow fracture sets in the erosional process<sup>36,57</sup> and based on field experience (Fig. 4a–d), ESE trending sets were analysed separately. Planes striking within  $\text{N}85^\circ \text{ E}$  and  $\text{N}140^\circ \text{ E}$  were extracted from the whole population and represented by a stereoplot and density diagram (Fig. 4h).

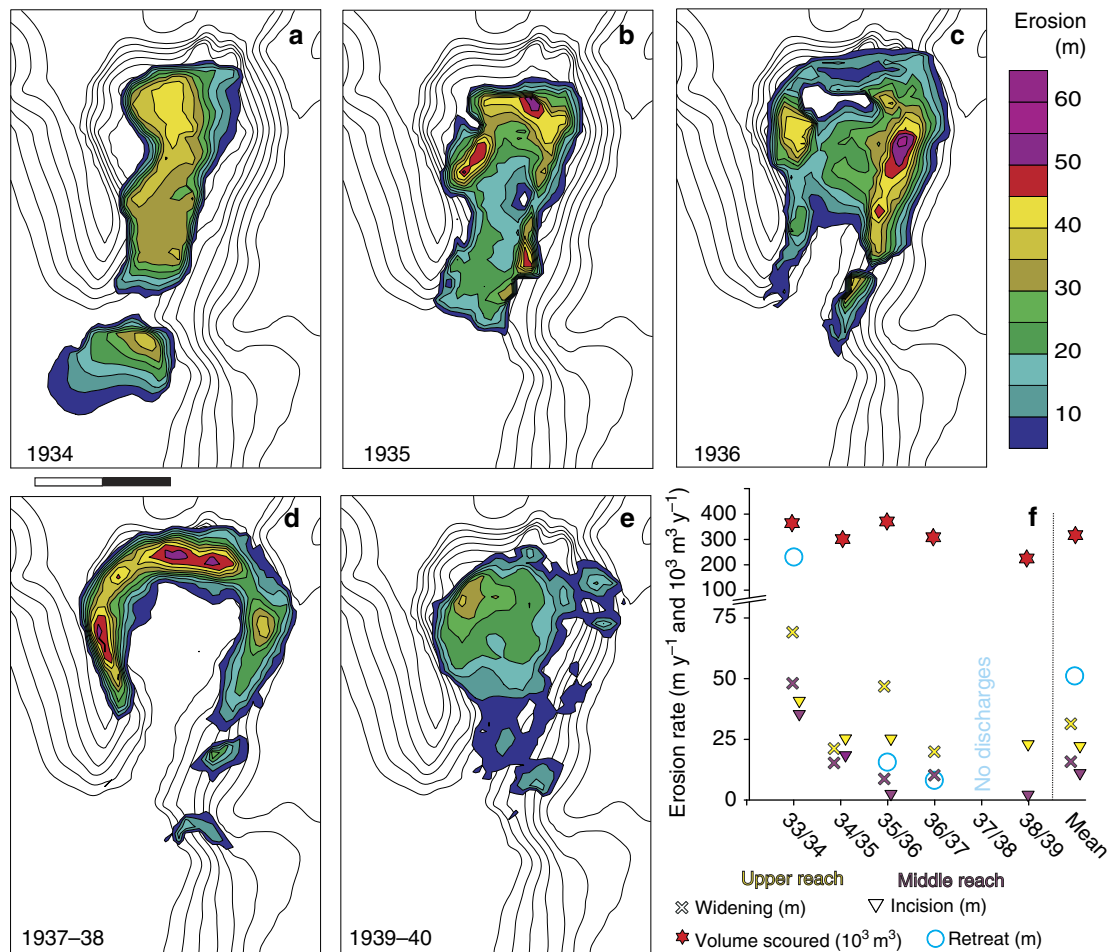
**Figure 6 | Spillway erosion pattern and erosion rates.** (a–e) Contour maps of erosion (spillway surface lowering) that occurred during a series of scour events (1934–1940). Contour interval = 10 m. Scale bar, 100-m long. Bottom left dates indicate the years when the topographic surveys were performed. (a–c) Maps represent a 1-year period; (d,e) maps correspond to 2-year intervals. (f) Plot of erosion that occurred in the spillway for successive years (1933–1939). Erosion values obtained through DEM reconstruction and measured along selected sections (Methods) illustrate the evolution of the upper and middle reaches (yellow and purple symbols, sections II-II' and III-III', respectively, in Fig. 5). Mean erosion values (retreat, incision, widening and eroded volume) are total erosion over the years when discharges occurred (that is, 5 years, as there were no spillway discharges in 1937–1938 hydrologic year—see Fig. 7). Where data for the same year are presented (for example, 35/36) symbols for the upper and middle reaches are represented with a small horizontal offset to facilitate visualization.

during the erosion events (1934–1940) was performed through analysis of historic topographic maps<sup>28,29</sup> (Methods). Digital elevation model (DEM) generation illustrates the former topography of the spillway site and how the bedrock erosion proceeded (Fig. 5). Comparison of successive DEMs enabled spatial and temporal erosion patterns to be quantified for successive stages and allows the calculation of erosion rates (incision, widening, retreat and eroded volume; Fig. 6).

Knickpoint upstream propagation was extremely rapid (> 230 m per y) during the first stages of the gorge formation (main scours 1–3; Fig. 3), but decreased rapidly thereafter (Fig. 6f), superseded by incision and gorge widening (Figs 5–7). The knickpoint lip reinforcement attempts made in summer 1934 could have some influence on this pronounced slowdown in knickpoint retreat, acting in the manner of a resistant cap rock<sup>37</sup>. Observations and flow data (Figs 2b, 3 and 4), however, suggest otherwise. Between scour event 3 (spring 1934) and the introduction of the artificial reinforcement (summer 1934) there were several spillway overtopping discharges that were similar or higher in magnitude to the events that created the initial gorge (Fig. 2b) but these spillway floods did not cause knickpoint retreat. This would imply that the pronounced decrease in headward retreat rates had already occurred before the introduction of the artificial reinforcement (Fig. 7). Furthermore, the knickpoint reinforcements were only a temporary feature as they were ripped out by flooding in March 1936. While waterfall lip shape, length and height are thought to be influential in affecting waterfall retreat rates<sup>38</sup>, other studies have highlighted bedrock structure and fracture geometry as playing a fundamental role in block stability<sup>36,39</sup>, knickpoint morphology and retreat rate<sup>6,11,20,40</sup>. In this example, the slowdown in retreat rate appears to mirror the timing of when the knickpoint interacts spatially with the area dominated

During the initial stage of spillway operation, the jet produced by the ~70 m waterfall at the confluence of the spillway channel with the Río Esla, created the lower plunge pool at the riverbed (Figs 5b and 6a). Rapid modification of the spillway bed morphology by episodic, predominantly headwall retreat during the ensuing gorge creation ensured that this initial knickpoint was only temporary (months) and thus the lower plunge pool was limited in extent. As the headward retreat slowed (1934), a new near-vertical face (~30-m height, Fig. 4c) was formed at the spillway channel outlet, 230-m upstream. The position of this knickpoint was fixed in place over a relatively longer timescale (years), thus having the opportunity to develop a more pronounced, upper plunge pool feature. During the following hydrologic year, this upper headwall significantly increased in height, by scouring (March 1935), while the former waterfall that had existed at the confluence was almost completely erosionally removed (Figs 3 and 5). Under this latter configuration the lower plunge pool that initially formed in the lower reach (sections IV–IV', Fig. 5) progressed no further (Fig. 6), but instead a new (upper) plunge pool was initiated in the upper reach, at the base of the active headwall (sections II–II' in Fig. 5). During subsequent overtopping periods, the upper plunge pool was developed, initially by the water jet impact over the knickpoint directly onto the riverbed. Thereafter, as the water

This example demonstrates retreat, incision and widening rates of  $10\text{--}10^2 \text{ m}$  per year (Fig. 6f). In comparison with worldwide data<sup>2,47</sup> both the long-term and short-term knickpoint recession rates of this example are extremely high. Even when compared with the biggest waterfalls in the world, retreat rates observed at Ricobayo are orders of magnitude higher (1.2–2 m per year for Niagara<sup>37</sup> and  $>0.15 \text{ m}$  per year Victoria<sup>48</sup> Falls). However, when compared with existing rare eye witness examples of a sudden disequilibrium that affects a river system, for example, drainage diversion<sup>21,22</sup>, extraordinary flood<sup>17</sup>, differential uplift along the riverbed<sup>20,23</sup> or dam removal<sup>49</sup> similar rates of the river adjustment to new conditions (incision, retreat and widening) are found. Such data imply that the response of bedrock rivers to external environmental perturbations, even in mechanically strong rock, can be extremely rapid in the initial stages, and episodic rather than quasi-continuous. Long-term landscape erosion rates generally tend to be orders of magnitude smaller as these initial rapid phases of adjustment are concealed by relative hiatuses in erosional activity over longer time periods<sup>24</sup>.

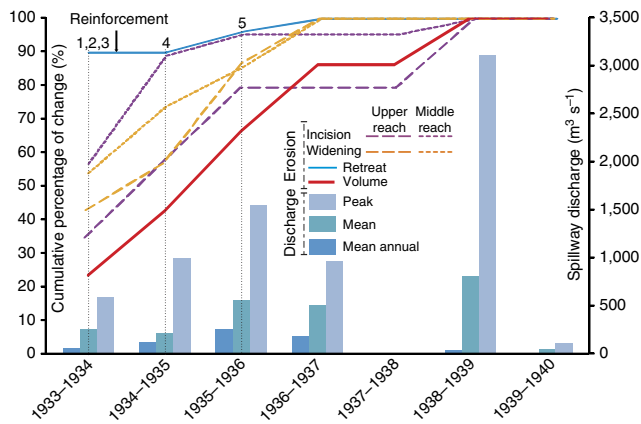
**Figure 7 | Plots of spillway gorge erosion and spillway flood discharges by hydrologic year.** Numbers on chart area indicate the scour events (1–5). Erosion values are those obtained by DEM reconstruction (Figs 5 and 6) per hydrologic year. Cumulative percentage plot of volume eroded, retreat (measured along section I–I' in Fig. 5), and incision and widening measured in the upper and middle reaches (sections II–II' and III–III', respectively, in Fig. 5). Mean discharge is calculated as the total spillway discharge during a hydrologic year averaged over the overtopping period. Mean annual discharge is calculated as the total spillway discharge averaged over a hydrologic year. Peak discharge is the maximum spillway overtopping flood occurring during the hydrologic year.

By the summer of 1934 scour events had formed a 230-m long, 35-m deep and 90-m wide bedrock canyon, excavating a 20-m deep plunge pool in the Esla riverbed at the spillway outlet and achieving ~90% of the overall gorge headward erosion (Figs 5b,g,h and 7). Collectively, 369,300 m<sup>3</sup> of rock was removed (Fig. 6a,f). The 1935 map (Fig. 5c) shows the spillway topography after the fourth large scour event. In 1 year, overtopping discharges created widening (20 ± 2 m) and incision (20-m mean) along the previous canyon (Fig. 6f), with localized incision (>50 m) in the newly formed plunge pool (Figs 5g and 6b). By this time, the middle reach had accomplished almost 90% of its total incision, while the upper reach had accomplished <60% (Fig. 5h). The volume of rock removed was 302,561 m<sup>3</sup>. From late 1935–1937, most of the gorge widening (~70 m, Fig. 6f) took place in the upper reach, leading to the development of an amphitheatre-headed valley (Fig. 5d,e). During this period, the maximum incision (>50 m) occurred along the uppermost external edge of the gorge producing headwall retreat of ~30 m (mean) (Fig. 6c,d) and thus the destruction of the spillway lip reinforcements (March 1936). This is a stage where headward erosion and widening dominated (Fig. 6c,d,f). The volume of rock removed during this phase was 687,857 m<sup>3</sup>. After late July 1937 no discharges were evacuated though the spillway with the exception of the January 1939 event previously described (Fig. 2b), during which erosion was focussed in the floor of the amphitheatre (Figs 5f and 6e), achieving 20% of the total incision in the upper reach (Fig. 5h) and removing a volume of 221,495 m<sup>3</sup>. Thus, a ~270-m long, ~100-m deep and ~100–160-m wide canyon was carved over 6 years, and ~1.58 × 10<sup>6</sup> m<sup>3</sup> of granite bedrock was removed from the spillway site and mostly deposited downstream along the Esla riverbed (see images in Fig. 3). The cumulative percentage of incision, widening and headcut over time exhibit different step patterns indicating the episodic nature of the erosional process (Figs 5h and 7). Moreover, the spatial analysis of erosion along different sections of the canyon illustrates how erosion migrates with headwall retreat (Fig. 5g,h). For the studied period, 100% of erosion is achieved during the first hydrologic year in the lower reach, while in the middle and upper reaches incision and widening is sustained over a further 3–4 hydrologic years. Thus, the gorge progressively changed shape, initially dominated by headward retreat, then widening and vertical incision into the existing amphitheatre-headed gorge (Figs 6 and 7).
