# Exceptional river gorge formation from unexceptional floods

# ARTICLE

DOI: 10.1038/ncomms8963

L. Anton<sup>1</sup>, A.E. Mather<sup>2</sup>, M. Stokes<sup>2</sup>, A. Muñoz-Martin<sup>3</sup> & G. De Vicente<sup>3</sup>

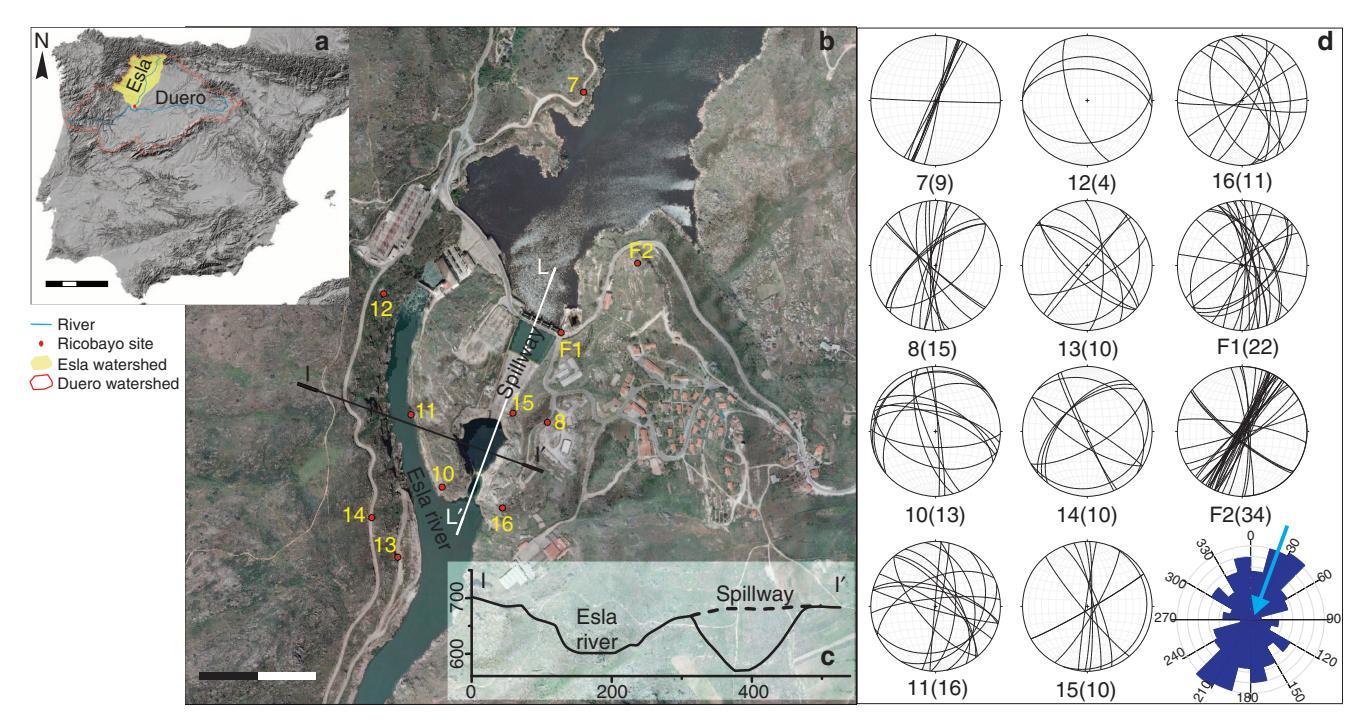
**Figure 1 | Field area and fracture pattern. (a)** The Río Esla and Duero watersheds and the study area location. Scale bar, 200-km long; (b) the Ricobayo dam, its spillway and sites of measurements and sampling (orthophotograph, IGN, 2011). Location of longitudinal profile shown in Fig. 3i is indicated by L-L'; I-I' indicates the section shown in **c**; scale bar, 250-m long (bottom left corner); (c) cross-section showing pre-scour (dashed line) and present topography. (d) Stereoplots of fracture orientations (numbers = location, in brackets the number of fractures plotted). Rose diagram of the whole-fracture population (class interval 15°, maximum percentage 14.6, percentage interval 2%). Arrow shows flow direction of spillway.

jointed/fractured. The top edge of the granite spillway coincides with a regional low-relief surface  $\sim 100$  m above the modern Río Esla channel (Fig. 1c).

Bedrock discontinuities. Systematic measurements of fractures (joints and faults, see Methods) revealed a pattern in the Ricobavo area dominated by NNE-SSW striking fractures (Fig. 1d). This included a primary NNE left-lateral strike-slip fault system concordant with previous field-based regional structural geological analyses<sup>34,35</sup>. This primary pattern exerts a significant control on drainage network orientation, as observed in the lower Río Esla reach (Supplementary Fig. 1). Secondary fracture sets oriented NNW-SSE and ESE-WNW are encountered and are significant at outcrop scale (Figs 1d and 4). Most fractures were vertical or near-vertical, although minor subhorizontal unloading joints were also present. Fracture spacing was locally in a 0.3-3 m range (Supplementary Table 1) and fracture length is typically more than several tens of metres, with a vertical persistence along the whole outcrop (Fig. 4). Exposures of discontinuity surfaces revealed a dominance of fresh, tight and unweathered planes. Fracture plots suggest that the primary fracture sets influence river incision and the progression of erosion in the spillway. Vertical and sub-vertical NNW to NNE trending structures determine the bedrock river and spillway gorge orientation (for example, site 15 in Figs 1 and 4a). ESE trending fractures are orthogonal to flow direction in the spillway with sets dipping both against and towards the flow (Figs 1d and 4).

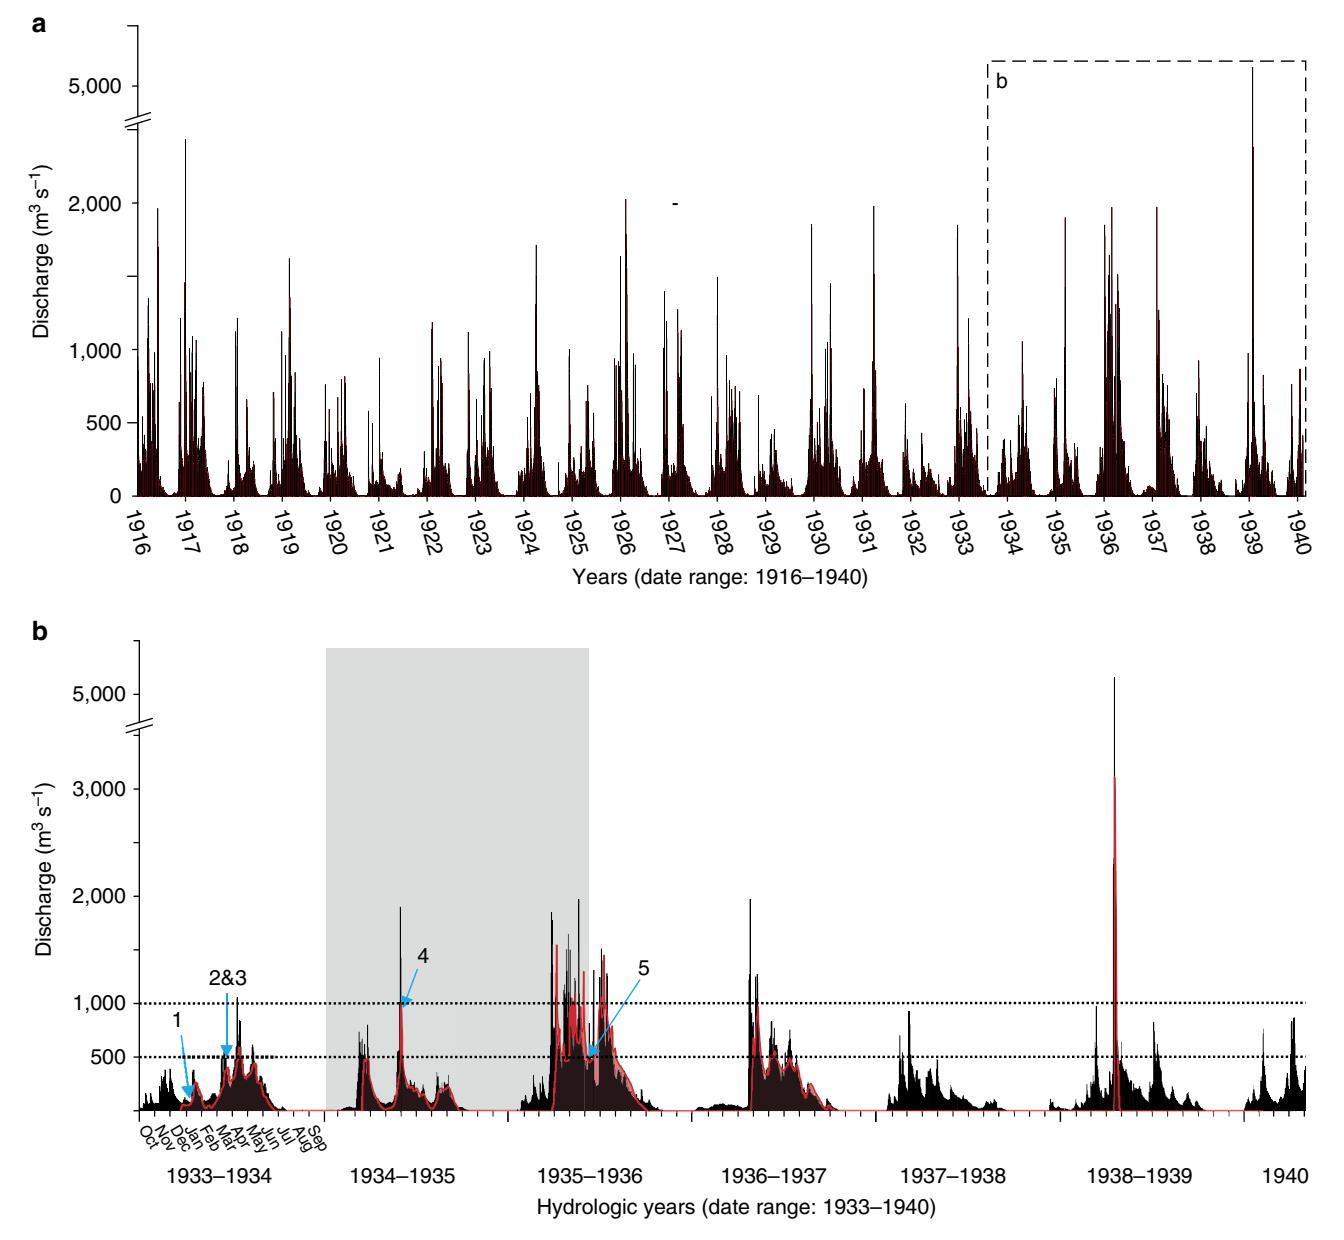
**Figure 2 | Floods entering the reservoir and spillway overtopping discharges. (a)** Histogram of the Río Esla water discharge series at Breto Gauging station<sup>30,58</sup> (1916-1940), which is located upstream of the current dam position close to the current upstream limit of the modern reservoir. (b) Detailed water discharge series (1933-1940 hydrologic years, October-September) showing winter rainfall dominance and scour events. Numbers indicate when main scour events 1-5 occurred. Grey area illustrates the period when spillway lip reinforcements were present. Peak flood discharge in the Río Esla is represented in black and flood discharges exiting the spillway are shown in red.

The dam and unlined spillway were simultaneously constructed from 1929 to 1933. The reservoir filled with water by the end of 1933 after which a series of spillway overtopping floods occurred<sup>28</sup> characterized by spillway discharges of between ~100 and ~1,500 m<sup>3</sup> s<sup>-1</sup> (Fig. 2b).

These spillway overtopping floods occurred from the middle of December to late June of the 1933–1936 hydrologic years and late January 1936 to the middle of July 1937 (Fig. 2b). This led to installation of flood gates at the spillway entrance that increased the reservoir water storage, and evacuation conduits were constructed<sup>29</sup>. After these modifications, only a single but large flood event (a flood of  $>5,000 \text{ m}^3 \text{ s}^{-1}$ ) in January 1939 utilized

the spillway. The overtopping spillway discharges from this flood (up to 3,000 m<sup>3</sup> s<sup>-1</sup>) exited over a period of 10 days (Fig. 2b)<sup>26,28</sup>. From January 1934 to March 1936, the flows overtopping the spillway induced scouring that occurred predominantly in five large scour events (Fig. 3). The process was reported by eye witnesses and documented<sup>28–30</sup>. Scour event 1 occurred on 10th January 1934 associated with a spillway discharge of ~ 80 m<sup>3</sup> s<sup>-1</sup>. As a consequence, a 65-m long, 55-m deep gorge was formed (Fig. 3b,i). Scour event 2 occurred on 22nd March 1934 associated with a spillway discharge of ~ 400 m<sup>3</sup> s<sup>-1</sup>, producing 75 m of headward erosion and 30–40 m of incision. Further scour (event 3) occurred the next day associated with a ~ 400 m<sup>3</sup> s<sup>-1</sup> spillway discharge, producing a further 100 m of retreat (Fig. 3c). The floods continued during April and May and the next winter, but only in 1935 (4th March) during a spillway discharge event of

Before and during dam construction, much larger floods (up to  $2,500 \text{ m}^3 \text{ s}^{-1}$ ) occurred in the Río Esla (Fig. 2)<sup>26,46</sup> but they were not associated with any significant erosion within the spillway gorge. The elevated stream power caused by the artificially created waterfall in the 'spillway channel' outlet is suggested as the driving mechanism for rapid knickpoint retreat and gorge formation.

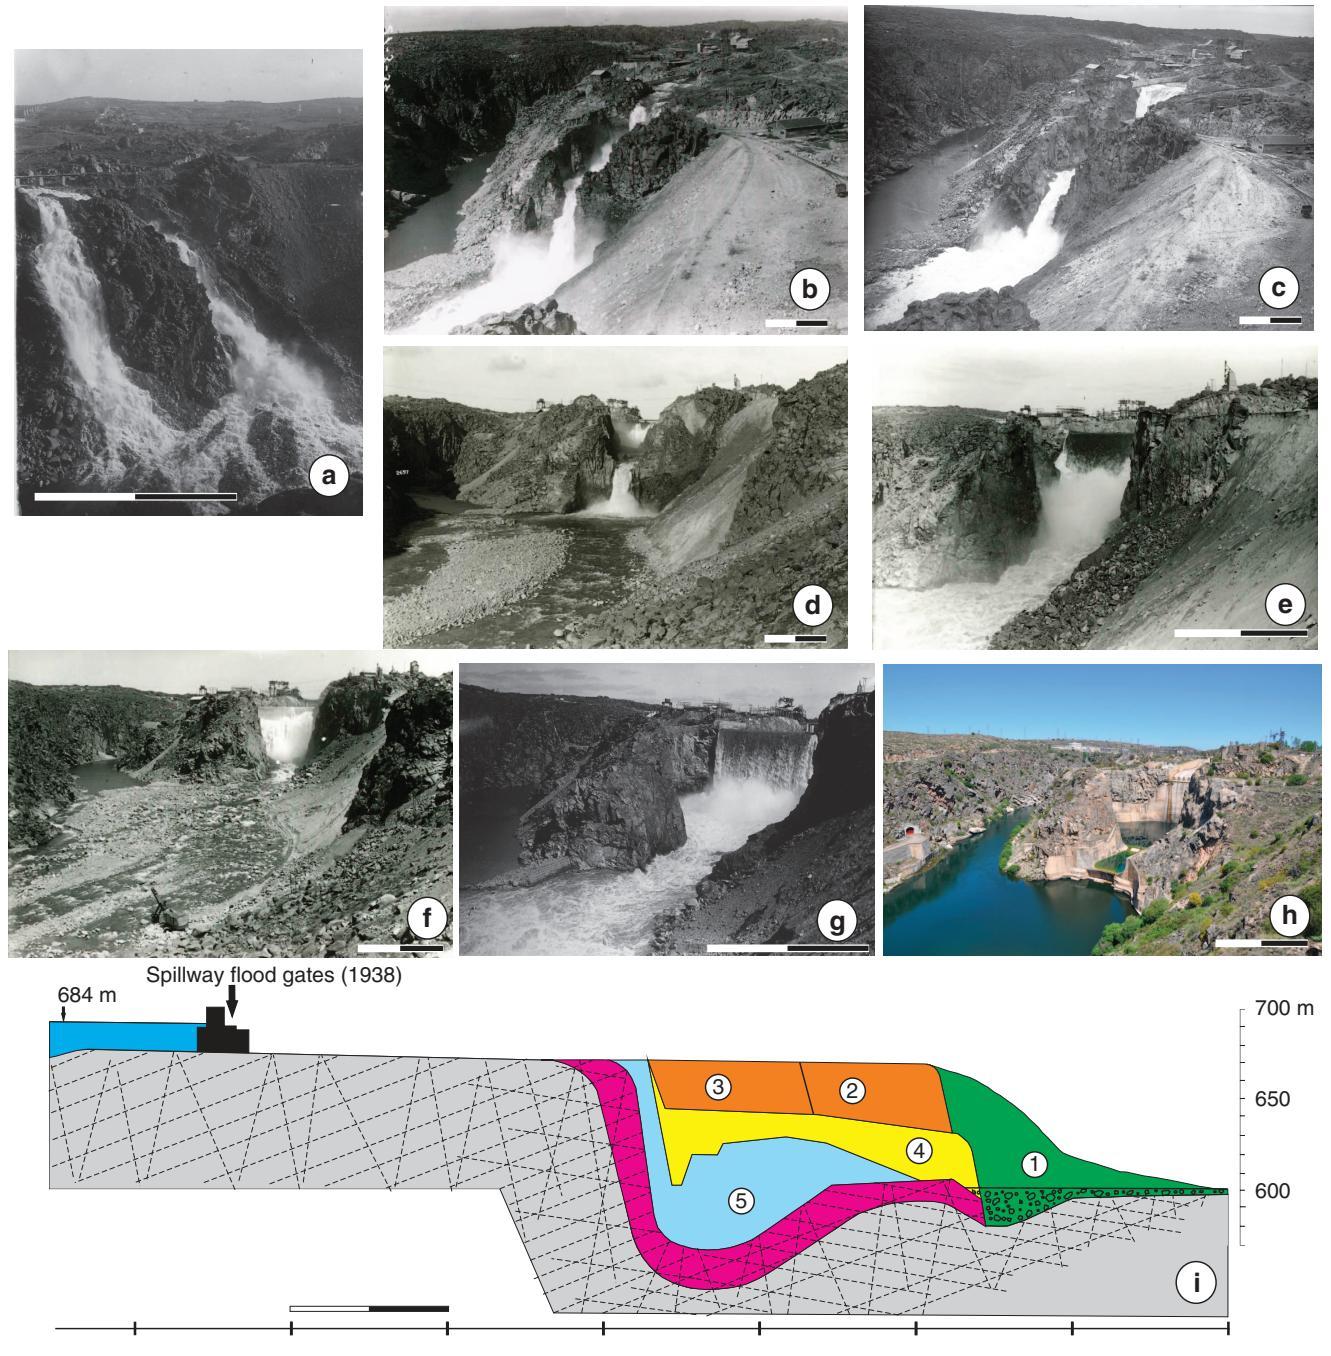
**Figure 3 | Historical imagery looking upstream into the Ricobayo spillway and spillway longitudinal section.** Photograph dates: (a) 27/12/1933 before scour event 1; scale bar, ~50-m long; (b) 21/3/1934 after scour event 1; (c) 26/3/1934 2 days after scour event 3; (d) 24/1/1935 scour event 4; (e) 5/3/ 1935 after scour event 4; (f) 6/7/1935 after scour event 4; (g) 7/4/1936 after scour event 5; (h) 2012. Scale bar, ~100-m long (photographs **b-h**). (i) Historical long profile sketch of the spillway depict the material removed in each stage (modified from Iberdrola<sup>30</sup>). Scale bar, ~100-m long. Location is indicated by L-L' on Fig. 1b. Flow from left to right. Successive erosion stages (represented by different colours) include the main scour events (1-5) and minor inter-event scouring. Pink area indicates the bedrock reinforced during the concrete revetment work post gorge formation (1940s onwards, **h**). Spillway flood gates represented were installed in 1938. (Imagery credit Iberdrola).

~1,000 m<sup>3</sup> s<sup>-1</sup> was a new large scour (event 4) produced (Fig. 3d–f), with an incision of 22 m below the previous erosion level. The last large scour (event 5) occurred in March 1936 (some 500 m<sup>3</sup> s<sup>-1</sup>; Figs 2b and 3g). Although the erosion occurred predominantly as a result of 5 scour events, minor, intervening erosion from smaller events cannot be ruled out, although eye witness information (survey and photographic data, for example, Figs 3, 5 and 6) suggest these modifications were minor. However, after events 4 and 5, there were several subsequent floods that

caused further widening, and block movement at the base of the plunge pool (stage 5 in Fig. 3i). Thus, we refer to the main scours as 'events', and in Fig. 3i refer to 'stages' that incorporate both the major event and any minor inter-event modification.

Before the erosion events dam workers established a low gradient (<1°) unlined rock spillway channel. The channel, 400-m long, was inset ~20 m into the bedrock on a topographic high (~70 m above the riverbed; Figs 3i and 5a). The downstream boundary of the spillway was formed by a high angle (~30°) knickpoint lip perpendicular to flow that had been artificially created in the spillway mouth (Figs 3 and 5a,g).

Knickpoint upstream propagation was extremely rapid (>230 m per y) during the first stages of the gorge formation (main scours 1-3; Fig. 3), but decreased rapidly thereafter (Fig. 6f), superseded by incision and gorge widening (Figs 5-7). The knickpoint lip reinforcement attempts made in summer 1934 could have some influence on this pronounced slowdown in knickpoint retreat, acting in the manner of a resistant cap rock<sup>37</sup>. Observations and flow data (Figs 2b, 3 and 4), however, suggest otherwise. Between scour event 3 (spring 1934) and the introduction of the artificial reinforcement (summer 1934) there were several spillway overtopping discharges that were similar or higher in magnitude to the events that created the initial gorge (Fig. 2b) but these spillway floods did not cause knickpoint retreat. This would imply that the pronounced decrease in headward retreat rates had already occurred before the introduction of the artificial reinforcement (Fig. 7). Furthermore, the knickpoint reinforcements were only a temporary feature as they were ripped out by flooding in March 1936. While waterfall lip shape, length and height are thought to be influential in affecting waterfall retreat rates<sup>38</sup>, other studies have highlighted bedrock structure and fracture geometry as playing a fundamental role in block stability<sup>36,39</sup>, knickpoint morphology and retreat rate<sup>6,11,20,40</sup>. In this example, the slowdown in retreat rate appears to mirror the timing of when the knickpoint interacts spatially with the area dominated

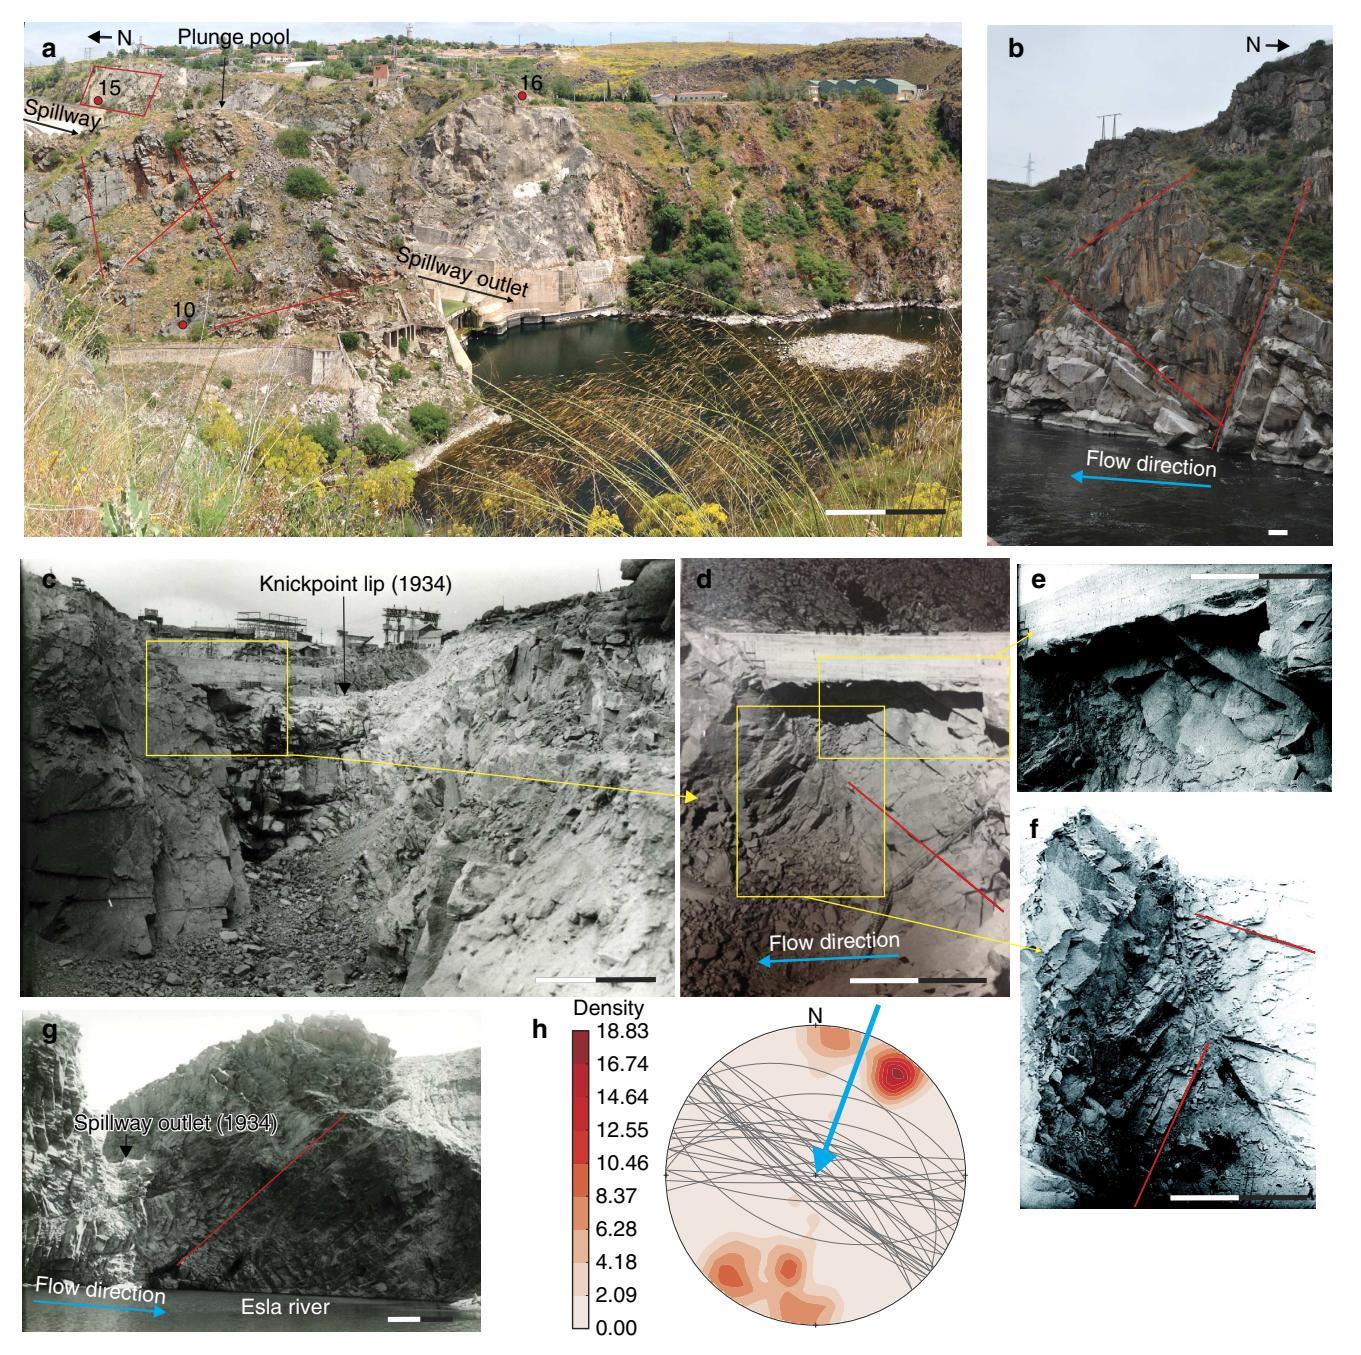
**Figure 4 | Field photographs illustrating fracture geometry at the spillway site and Rio Esla. (a)** Present spillway outlet and fracture pattern. Red dots indicate measurement sites (Fig. 1), red lines indicate fracture planes. Red box at site 15 represents a  $\sim$ N-S fault plane outcrop, parallel to the spillway gorge orientation. Scale bar,  $\sim$ 50-m long. (b) Western side of the Rio Esla in front of site 11 (Fig. 1b). Fracture set dipping against and toward the flow. Scale bar,  $\sim$ 1-m long. (c) Spillway lip and gorge formed during 1933-1934 hydrologic year (scours 1-3; Fig. 3); scale bar,  $\sim$ 50-m long, (credit Iberdrola). Yellow box indicates location of photograph **d**. (d) Fracture pattern at the knickpoint lip by summer 1934 when retreat had significantly slowed (credit Iberdrola). Scale bar,  $\sim$ 25-m long; Yellow boxes indicate location of photographs (e,f). (e) Detail of fracture orientation (dipping against the flow) at the knickpoint lip. Scale bar,  $\sim$ 25-m long. (f) Detail of fracture orientation (dipping predominantly toward the flow) downstream of the knickpoint lip. Scale bar,  $\sim$ 25-m long; (g) Fracture sets dipping predominantly against the flow at the  $\sim$ 30-m height knickpoint formed at the spillway outlet (confluence with the Rio Esla) by March 1934. This knickpoint disappeared during the fourth main scour (Fig. 3d,e) in March 1935. Scale bar, 25 m. (h) Orthogonal to flow fracture planes dipping towards and against the flow. Stereoplot and density plot of ESE trending fractures, measured at the Ricobayo sites (see Methods).

patterns are found in the regional geological context. However, discontinuity patterns through fracture density and orientation interactions play an important role in the gorge development<sup>12,20,36</sup>. The existence of several fracture sets with different orientations resulted in the formation of bedrock blocks that were susceptible to removal by plucking and probable block topple

(Fig. 4). Similar (m-scale) blocks can be found elsewhere in the natural reaches of the Río Esla suggesting this is not just localized to the spillway area. The NNW to NNE structures regionally determines channel orientation patterns. Furthermore, although they are quantitatively less represented, the orthogonal to flow fracture sets within these channels play a key role in the gorge

progression. This structural pattern (Fig. 4) enhances headward erosion when the fractures dipped towards flow and favoured incision when fractures dipped predominantly against flow<sup>20,36</sup>.

by anti-flow oriented fracture sets, implying that that structural differences along the gorge, with local predominance of fracture sets dipping against the flow, became significant in suppressing the retreat progression<sup>30</sup> (Fig. 4d–g).

**Fracture population analysis.** Field survey was undertaken to identify the bedrock fracture pattern. Orientation (trend and dip) of 151 fracture (fault and joint) planes were measured at 11 sites in the Ricobayo area (Fig. 1d). This task was preceded by field reconnaissance to select representative outcrops that encapsulated all of the fracture types and patterns. Stereoplots, histograms, rose diagrams and density plots were used to analyse the data. The fracture pattern is dominated by NNE-SSW striking structures, while secondary fracture sets oriented NNW-SSE and ESE-WNW take weight at outcrop scale (Fig. 1d). Together with the statistical analysis, the dominant trends were identified from aerial and field imagery and then compared with published regional fault patterns<sup>34</sup> (Supplementary Fig. 1). Due to the relevance of dip and dip direction of the ortogonal to flow fracture sets in the erosional process<sup>36,57</sup> and based on field experience (Fig. 4a–d), ESE trending sets were analysed separately. Planes striking within N85° E and N140° E were extracted from the whole population and represented by a stereoplot and density diagram (Fig. 4h).

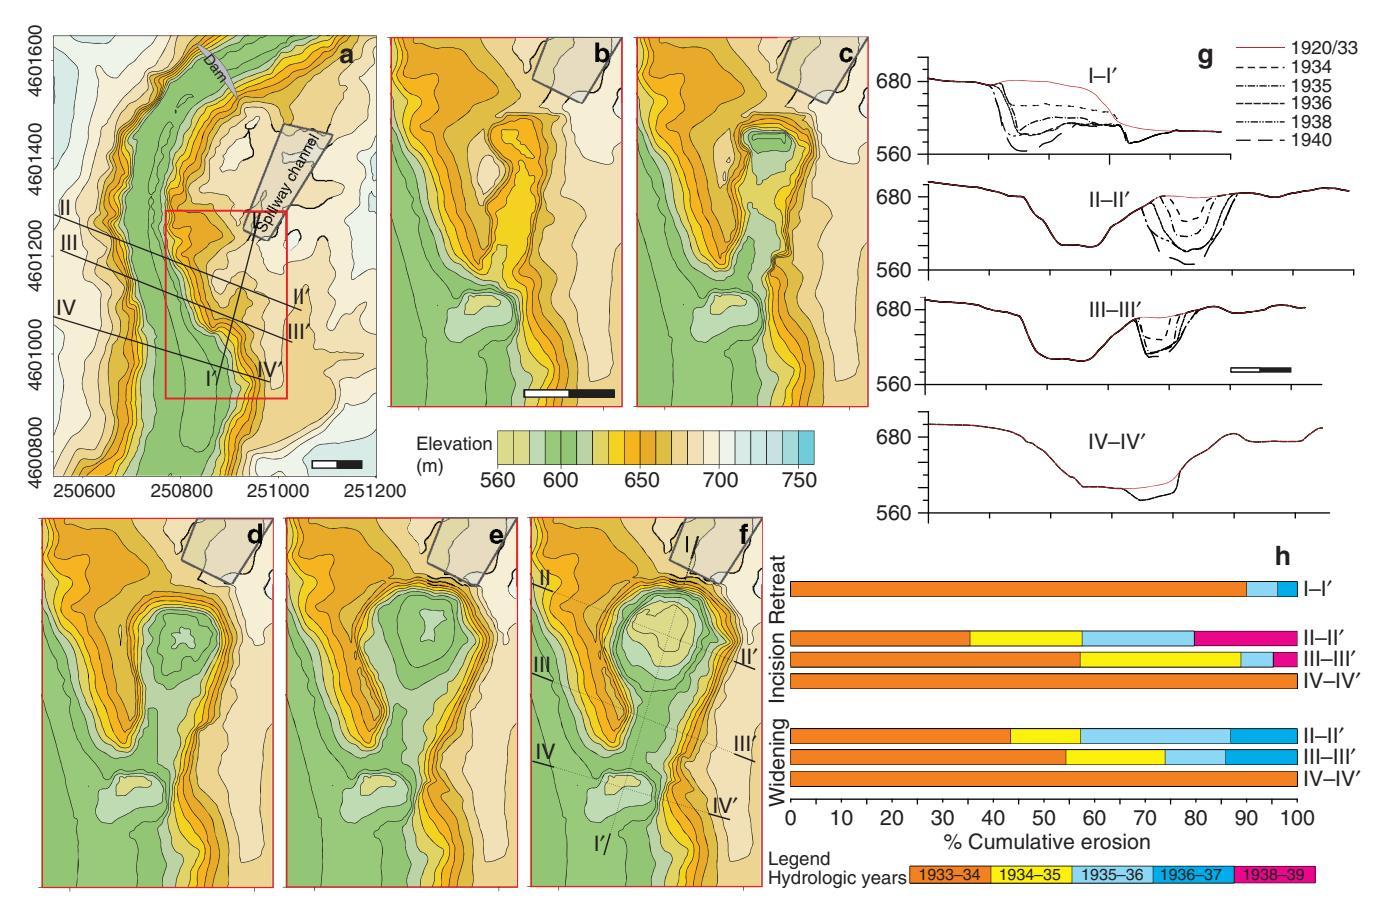
Figure 5 | Contour maps of the spillway topography showing the erosion sequence. Contour lines = 10-m intervals. Map dates: (a) 1920; box = area represented in b-f; Dam and present location of the spillway channel represented. (b) 1934 (after scour events 1-3); (c) 1935 (after scour event 4); (d) 1936 (after scour event 5); (e) 1938; (f) 1940; (g) sections of spillway site in successive years (see a for location). Scale bar, 100-m long. (h) Plot of cumulative percentage of retreat, incision and widening along different gorge sections. Upper reach (II-II'), middle reach (III-III') and lower reach (IV-IV').

depth increased in the plunge pool with successive outflow discharges and progressive scour formation, the water jet energy focused on the developing plunge pool water body<sup>41,42</sup>. Over this time bedrock scours occurred predominately at the base of the plunge pool and incision in the middle reach was minimal (Figs 5g,h and 6). Subsequently, as the channel was deepened and enlarged, the rim of the headwall and the gorge sides became unstable and the canyon began widening. Thus, while headwall retreat moved as a wave of erosion upstream creating the canyon, the slowdown in retreat rate promoted a persistent vertical headwall, allowing incision and widening to progress (Fig. 7) and eventually forming the present amphitheatre-headed valley with a 40 m water depth plunge pool (Figs 5 and 6).

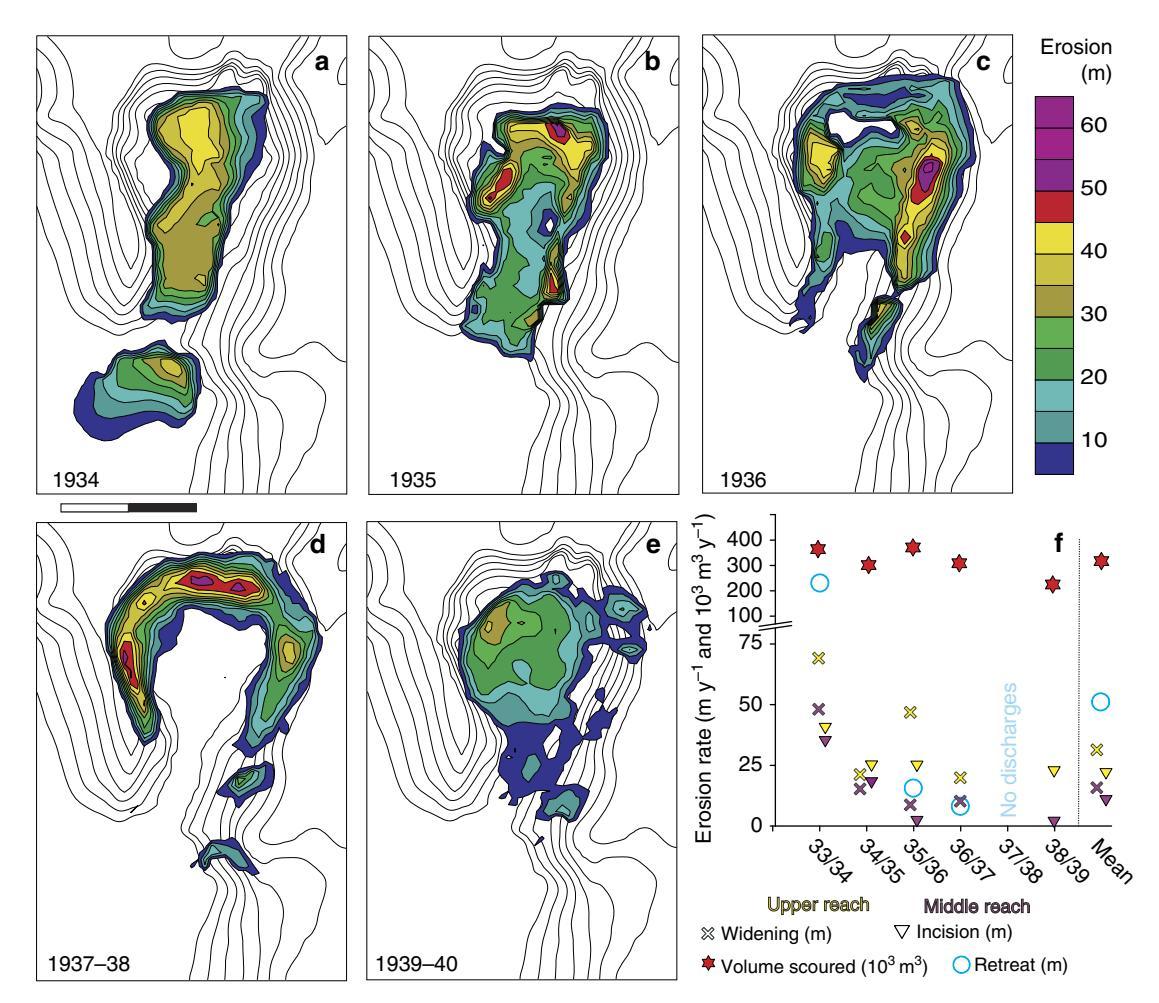
**Figure 6 | Spillway erosion pattern and erosion rates. (a-e)** Contour maps of erosion (spillway surface lowering) that occurred during a series of scour events (1934-1940). Contour interval = 10 m. Scale bar, 100-m long. Bottom left dates indicate the years when the topographic surveys were performed. (a-c) Maps represent a 1-year period; (**d**,**e**) maps correspond to 2-year intervals. (**f**) Plot of erosion that occurred in the spillway for successive years (1933-1939). Erosion values obtained through DEM reconstruction and measured along selected sections (Methods) illustrate the evolution of the upper and middle reaches (yellow and purple symbols, sections II-II' and III-III', respectively, in Fig. 5). Mean erosion values (retreat, incision, widening and eroded volume) are total erosion over the years when discharges occurred (that is, 5 years, as there were no spillway discharges in 1937-1938 hydrologic year—see Fig. 7). Where data for the same year are presented (for example, 35/36) symbols for the upper and middle reaches are represented with a small horizontal offset to facilitate visualization.

during the erosion events (1934–1940) was performed through analysis of historic topographic maps<sup>28,29</sup> (Methods). Digital elevation model (DEM) generation illustrates the former topography of the spillway site and how the bedrock erosion proceeded (Fig. 5). Comparison of successive DEMs enabled spatial and temporal erosion patterns to be quantified for successive stages and allows the calculation of erosion rates (incision, widening, retreat and eroded volume; Fig. 6).

By the summer of 1934 scour events had formed a 230-m long, 35-m deep and 90-m wide bedrock canyon, excavating a 20-m deep plunge pool in the Esla riverbed at the spillway outlet and achieving  $\sim 90\%$  of the overall gorge headward erosion (Figs 5b,g,h and 7). Collectively, 369,300 m<sup>3</sup> of rock was removed (Fig. 6a,f). The 1935 map (Fig. 5c) shows the spillway topography after the fourth large scour event. In 1 year, overtopping discharges created widening  $(20 \pm 2 \text{ m})$  and incision (20-m mean) along the previous canyon (Fig. 6f), with localized incision (>50 m) in the newly formed plunge pool (Figs 5g and 6b). By this time, the middle reach had accomplished almost 90% of its total incision, while the upper reach had accomplished <60% (Fig. 5h). The volume of rock removed was 302,561 m<sup>3</sup>. From late 1935–1937, most of the gorge widening ( $\sim$ 70 m, Fig. 6f) took place in the upper reach, leading to the development of an amphitheatre-headed valley (Fig. 5d,e). During this period, the maximum incision (>50 m) occurred along the uppermost external edge of the gorge producing headwall retreat of  $\sim 30 \text{ m}$ (mean) (Fig. 6c,d) and thus the destruction of the spillway lip reinforcements (March 1936). This is a stage where headward erosion and widening dominated (Fig. 6c,d,f). The volume of rock removed during this phase was 687,857 m<sup>3</sup>. After late July 1937 no discharges were evacuated though the spillway with the exception of the January 1939 event previously described (Fig. 2b), during which erosion was focussed in the floor of the amphitheatre (Figs 5f and 6e), achieving 20% of the total incision in the upper reach (Fig. 5h) and removing a volume of 221,495 m<sup>3</sup>. Thus, a  $\sim$  270-m long,  $\sim$  100-m deep and  $\sim$  100-160-m wide canyon was carved over 6 years, and  $\sim 1.58 \times 10^6 \text{ m}^3$ of granite bedrock was removed from the spillway site and mostly deposited downstream along the Esla riverbed (see images in Fig. 3). The cumulative percentage of incision, widening and headcut over time exhibit different step patterns indicating the episodic nature of the erosional process (Figs 5h and 7). Moreover, the spatial analysis of erosion along different sections of the canyon illustrates how erosion migrates with headwall retreat (Fig. 5g,h). For the studied period, 100% of erosion is achieved during the first hydrologic year in the lower reach, while in the middle and upper reaches incision and widening is sustained over a further 3-4 hydrologic years. Thus, the gorge progressively changed shape, initially dominated by headward retreat, then widening and vertical incision into the existing amphitheatre-headed gorge (Figs 6 and 7).

This example demonstrates retreat, incision and widening rates of 10-10<sup>2</sup> m per year (Fig. 6f). In comparison with worldwide data<sup>2,47</sup> both the long-term and short-term knickpoint recession rates of this example are extremely high. Even when compared with the biggest waterfalls in the world, retreat rates observed at Ricobayo are orders of magnitude higher (1.2-2 m per year for Niagara<sup>37</sup> and >0.15 m per year Victoria<sup>48</sup> Falls). However, when compared with existing rare eye witness examples of a sudden disequilibrium that affects a river system, for example, drainage diversion<sup>21,22</sup>, extraordinary flood<sup>17</sup>, differential uplift along the riverbed<sup>20,23</sup> or dam removal<sup>49</sup> similar rates of the river adjustment to new conditions (incision, retreat and widening) are found. Such data imply that the response of bedrock rivers to external environmental perturbations, even in mechanically strong rock, can be extremely rapid in the initial stages, and episodic rather than quasi-continuous. Long-term landscape erosion rates generally tend to be orders of magnitude smaller as these initial rapid phases of adjustment are concealed by relative hiatuses in erosional activity over longer time periods<sup>24</sup>.

in different sections of the gorge (longitudinally and in the upper, medium and lower reaches), retreat, incision and widening occurred in successive hydrologic years was measured along selected sections (I-I' to IV-IV', in Fig. 5). Cumulative percentages of erosion along these sections are illustrated in Fig. 5h. The geometry and volume of the gorge produced by successive scour events were calculated through subtraction of DEM topography of consecutive years. The resulting contour erosion maps for successive periods are shown in Fig. 6.

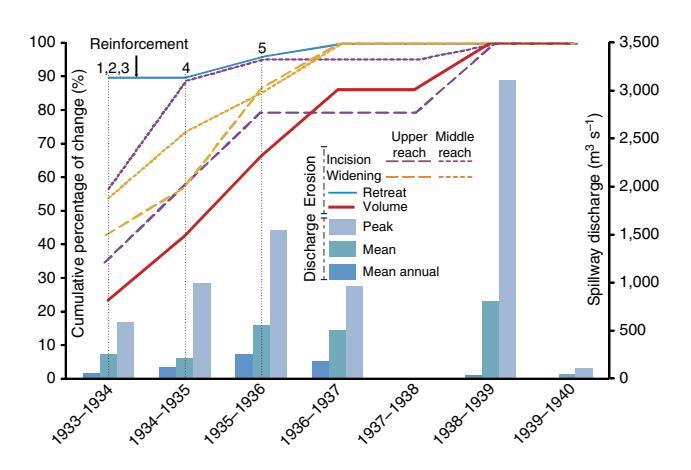
**Figure 7 | Plots of spillway gorge erosion and spillway flood discharges by hydrologic year.** Numbers on chart area indicate the scour events (1–5). Erosion values are those obtained by DEM reconstruction (Figs 5 and 6) per hydrologic year. Cumulative percentage plot of volume eroded, retreat (measured along section I–I' in Fig. 5), and incision and widening measured in the upper and middle reaches (sections II–II' and III–III', respectively, in Fig. 5). Mean discharge is calculated as the total spillway discharge during a hydrologic year averaged over the overtopping period. Mean annual discharge is calculated as the total spillway overtopping flood occurring during the hydrologic year.
