8th International Conference on Sustainability in Energy and Buildings, SEB-16, 11-13 September 2016, Turin, ITALY

A new methodology for the selective measurement of building performance and safety

Littlewood, J. R.^{a*}, Alam, M.^a, Goodhew, S.^b

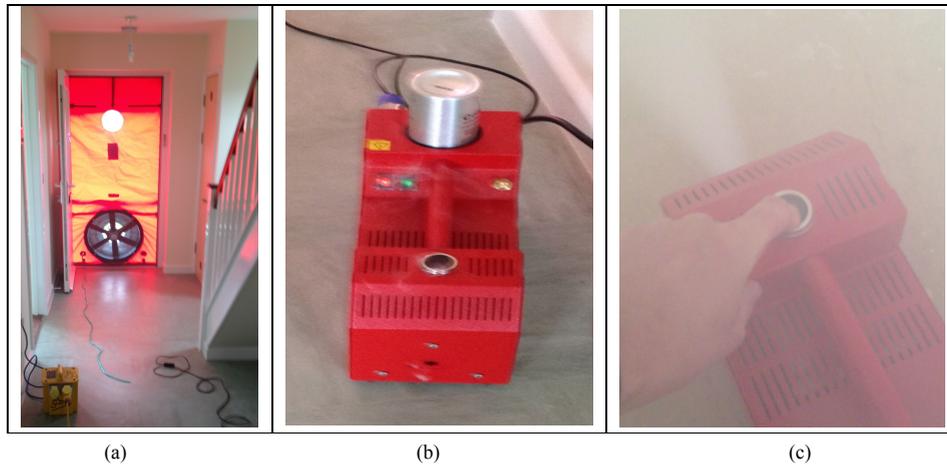
Fig. 1. (a) Blower door setup for pressure test (b) Cold smoke generator (c): Smoke generation with water based oil

For smoke spread testing, the iCT methodology has used domestic air permeability test equipment operated as a pressure test (at 35Pa) and combined with cold smoke (Figure 1a) to identify air leakage paths and defects in compartmentation. Currently, iCT for smoke spread uses water based cold smoke which is a mixture of purified de-ionised water and glycol or glycerol as smoke fluid for creating cold smoke (Figure 1b). Glycol smoke starts to layer at 35-45°C while glycerol smoke at 50-60°C [19]. The iCT process involves fully filling a dwelling with the cold smoke, and then activating the blower door pressure test (Fig 1c). Smoke is then filmed with digital video cameras as it escapes from adjoining dwellings (vertically and horizontal) and also observed through a sense of smell, if it is not visible depending on the concentration in the adjoining dwellings, circulation routes for means of escape and also the roof space. The use of cold smoke testing is a useful test method, which may be representative of conditions of very small fire sizes where buoyancy effect of the fire heat will be negligible and smoke will follow the existing air circulation paths. However, cold smoke tests do not reproduce the real conditions of smoke, as in a real sizeable fire situation, where temperature of the smoke is similar to the fire and movement of smoke will be affected by buoyancy forces due to density difference between hot gases in smoke and ambient air, as well as the air expansion forces generated by heat from the fire. These initial tests were conducted at 35 Pa, which is much less than that will build up in real fire situations. Van den Brink [20] experimentally found that within a minute of fire ignition, in a fire test room size of 3.6m × 2.4m × 2.4m (length × width × height) peak pressure of 172 Pa was reached. Van den Brink [20] also

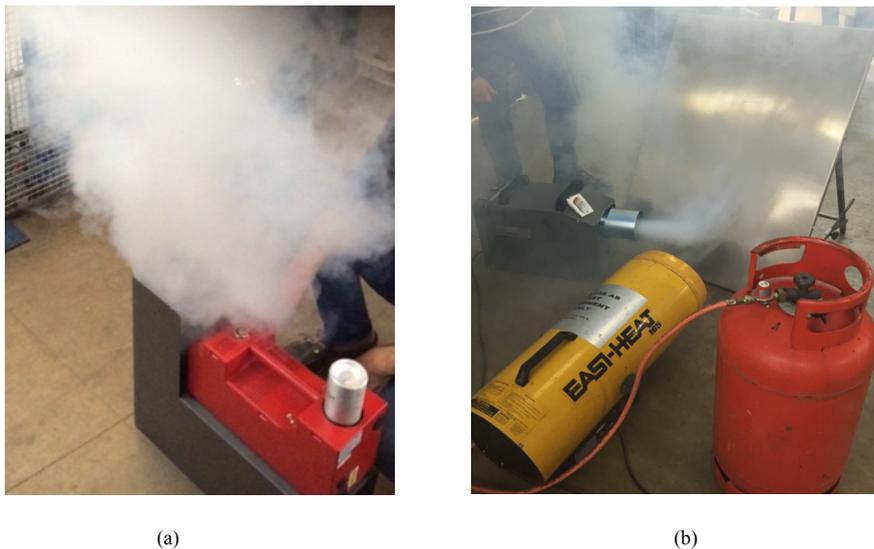
Fig. 2. Heated smoke testing apparatus being trialled (a) water based cold smoke heated with electrical space heater (b) oil based smoke heated with propane gas heater [19].

One potential method that is being explored is heating the water based cold smoke by mixing it with hot air generated by a space heater, in a vertical tube, replicating a ‘chimney’. However, one limitation of using water based smoke is that there is significantly low temperature resistance i.e. 35°C to 50°C and at increasing temperatures cold smoke starts to evaporate and disappear. This challenge can be overcome by using - mineral oil based smoke, which can resist temperatures up to 200°C [19]. Heating of oil based smoke can be achieved by using controlled alcohol fires, such as in a hot smoke test. Hot smoke tests are currently undertaken to test smoke control systems, such as smoke management systems in enclosed spaces of large volumes. For example, shopping centre atrium [21], tunnels [22], airports [23] underground car parks, exhibition halls and railway stations [24]. Hot smoke tests can produce thermally buoyant smoke using controlled alcohol fires directly beneath the smoke, where the smoke is generated with pyrotechnic smoke generators and this test has also been adopted in Australian National Standard ANS 4391:1999 [25]. Hot smoke tests require careful control of the fire source and the hot smoke to avoid damage to building materials. In hot smoke testing temperatures at ceiling height of a building is required to be less than 55°C, to avoid activation of sprinkler systems [26] and damage to plastic components in buildings, such as PVC cables with a melting point - between 75°C and 110°C. Therefore, this test does not replicate the smoke temperature conditions as in real fire situation in buildings where temperatures are more than 600°C in the vicinity of fire flame and is greater than 100°C at the ceiling height [26]. Also, building contractors and developers may not be in support of carrying out hot smoke testing with controlled alcohol fires due to potential increase in building insurance costs associated with naked flames on a live construction site where there may be flammable materials present on site. Therefore, researchers at Cardiff Metropolitan University are exploring how to generate thermally buoyant smoke, which can simulate real fire conditions without any risk to buildings. Such non-destructive testing should have more acceptability in the UK construction industry. Risks associated with controlled fires can be eliminated by using the space heater as a source of heat to produce thermally buoyant smoke. Figure 2 (a) shows the setup for heating water based cold smoke with the help of electrical heater and chimney [19]. Figure 2 (b) shows the use of oil based cold smoke heated with a propane heater and being directed vertically, using deflector plate [19].
