X International Conference on Structural Dynamics, EURODYN 2017

Modal testing of offshore rock lighthouses around the British Isles

James Brownjohn^a*, Alison Raby^b, James Bassitt^a, Emma Hudson^a, Alessandro Antonini^b

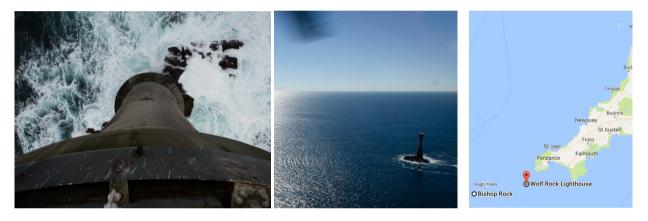
Fig. 1. Left to right: Bishop Rock, approach to Wolf Rock, locations off South West England.

Six lighthouses were selected for modal testing and possible monitoring, with five modal tests carried out in 2016. Bishop Rock, Wolf Rock and Longships Lighthouses were accessed by helicopter from Land's End Cornwall, Les Hanois Lighthouse from Guernsey and Fastnet Lighthouse from Castletown-Bearhaven, Ireland. The sixth structure is expected to be Dubh Artach Lighthouse, near Colonsay, Scotland. The paper focuses on two extreme examples, Bishop Rock (Fig. 1 left), Wolf Rock (Fig. 1 middle), whose locations are shown in Fig. 1 (right).

Wolf Rock, 8 miles off Land's End, was tested on 7th July 2016. Completed in 1869, its 43 m height is topped by the first helideck installed on a lighthouse. Bishop Rock Lighthouse is situated on the world's smallest island 4 miles of the west of the Scilly Isles. Completed in 1857, it was strengthened in 1887 and so is a much larger structure than Wolf Rock, at 48 m tall. For both lighthouses the masonry structure comprises concentric courses of masonry blocks keyed together vertically and circumferentially with lower courses set into recesses hacked out of the rock foundation. Both are exposed to extreme weather of the Atlantic Ocean resulting is large impulsive wave loading and would need reliable system identification to estimate wave forced from monitored response.

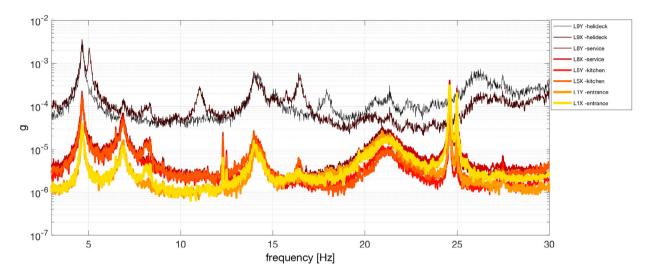
Fig. 3. Wolf Rock: Auto-spectrum for ambient response -all available channels in swipe 1, Run 12.

Auto spectra for selected levels from Run 14 are shown in Fig. 3. System identification on ambient data (eigensystem realization algorithm, ERA) reveals modes at 4.7 Hz and 6.8 Hz as well as at 4.85 Hz and 5.1 Hz. The 4.7 Hz mode involves proportionally very large motion of the helideck while the 4.85 Hz mode seems only to be the helideck moving in x-directions. The 6.8 Hz mode has strong helideck motion, but proportionally less strong than for the 4.7 Hz mode. For the 4.7 Hz and 6.8 Hz modes there are components in the nominal x and y directions; the mode shapes are (later) identified using classical modal analysis using the forced vibration data.

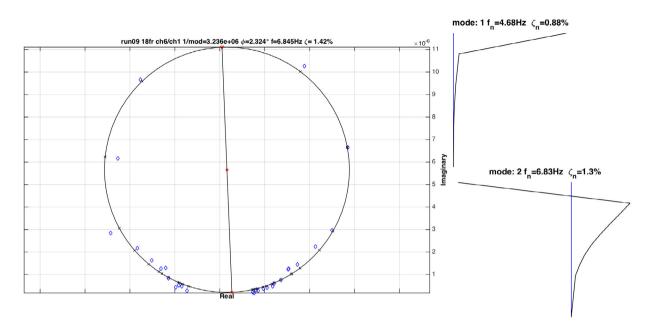
Fig. 5. Wolf Rock: Left: SISO circle fit for x-direction. Right: SIMO mode shapes for y-direction.

Fig. 5 left is a circle fit of the 6.8 Hz mode using x-direction point mobility in the service room at the top of the masonry tower; the modal mass estimate is 330 tonnes (after correction of accelerations to SI units). This is the lowest modal mass measured of any of the lighthouses tested, consistent with the relative small size. The 4.7 Hz mode does not provide a clear circle fit whereas SIMO is more successful and reveals a clean pair of mode shapes for y-direction (Fig. 5, right). Mode shapes were not so clearly identified from ambient data using ERA.

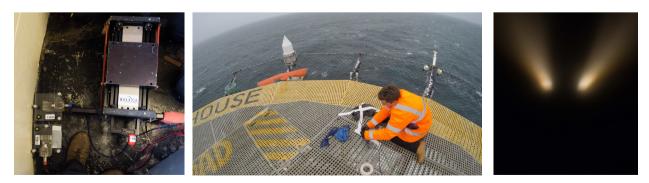
Fig. 6. Bishop Rock: Setting up shaker and accelerometers in battery room; weather protection for helideck sensors; twin beams in foggy night.

A test team of Bassitt, Antonini and Moon flew from St Just on 26/9/2016 arriving at 10.30. All measurements were completed by 16:00 and equipment packed ready for the return flight. However weather had deteriorated and the lighthouse was fogbound until 'visual flight rules' allowed helicopter operations to resume the following morning. Fig. 6 shows modal testing in progress and the eerie night view from the lantern room.

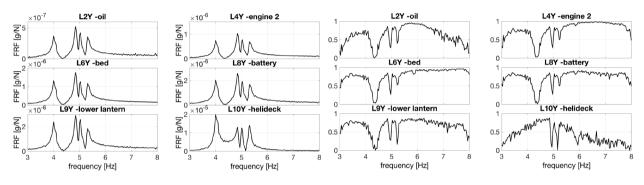
Fig. 7. Bishop Rock: y direction frequency response functions (FRFs) for sweep 1 run 8. H1 FRF (left) and coherence (right).

FRFs are shown in Fig. 7 based on 34 averages of 32-second frames with frequency sweeping (alternately up and down) between 3 and 8 Hz. H1 estimator is used due to the imperfect coherence.

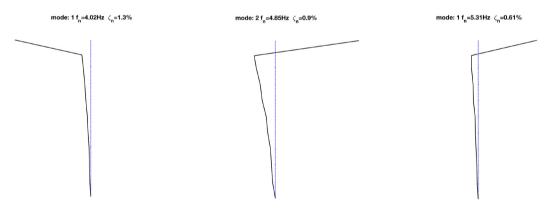
Fig. 8. Bishop Rock: mode shapes.

Mode shapes for three of the peaks in Fig. 7 are given in Fig. 8. Modal mass estimates are 1650 tonnes and 2800 tonnes for the 4.02 Hz and 4.85 Hz modes, considerably larger then for Wolf Rock.
