Crack path and fracture analysis in FSW of small diameter 6082-T6 aluminium tubes under tension-torsion loading

INTERNATIONAL JOURNAL OF FATIGUE

Crack path and fracture analysis in FSW of small diameter 6082 aluminium tubes under tension-torsion loading

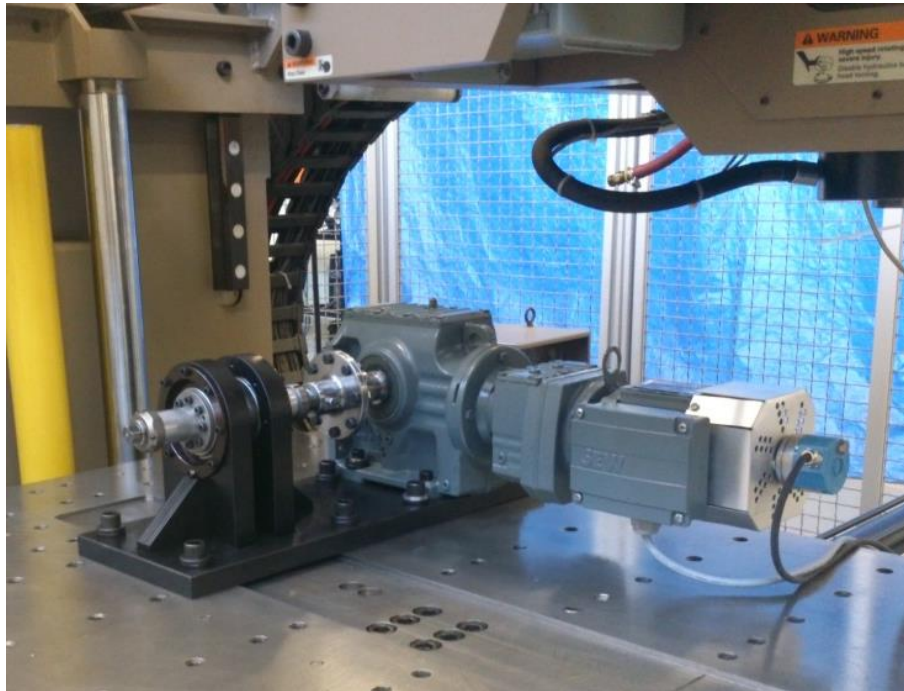
Figure 1 Illustration of a tube specimen in position ready to be welded.

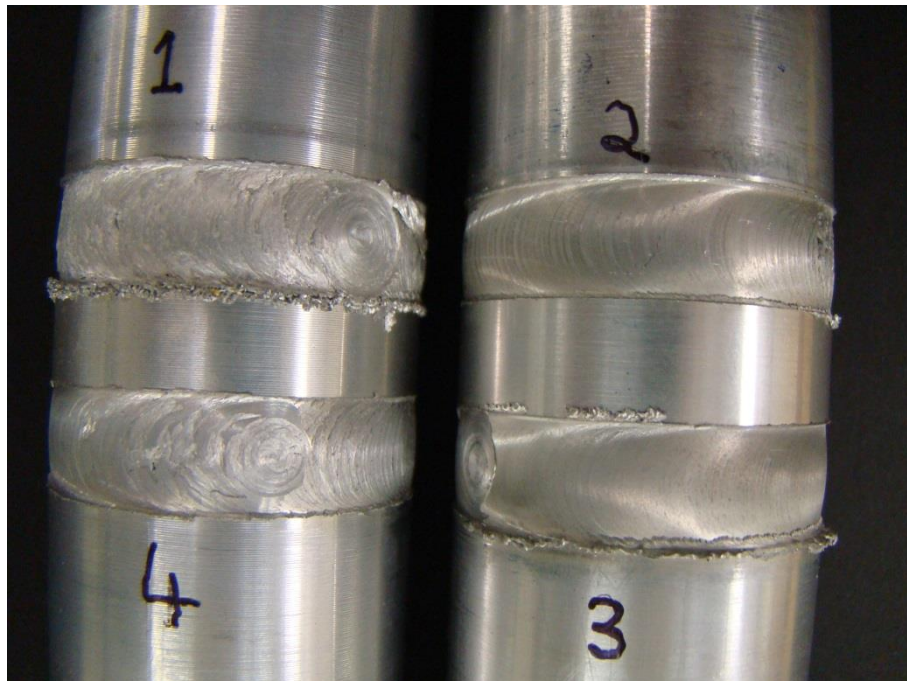
Figure 4 Influence of the weld process parameters of plunge depth, rotational feed rate and tool rotational speed on the quality of weld surface finish.

Table 1 Weld process parameters used to make the trial welds shown in Figure 4.

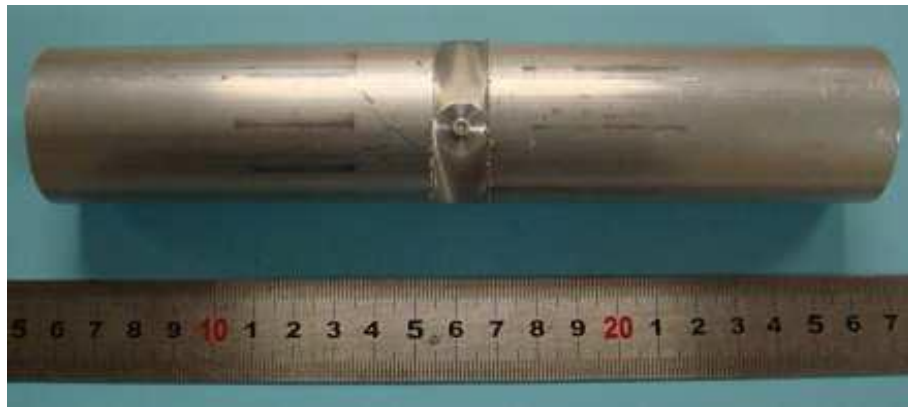
Figure 5

a) Approximate dimensions of the tubular fatigue specimens. b) Image showing a

b)
typical welded specimen.

One hundred fatigue specimens were manufactured by joining two 110 mm lengths of 6082-T6 aluminium tube with friction stir welding, as shown in Figure 5. The chemical composition of this alloy is given in Table 2. Once the samples had been manufactured in South Africa, they were sent to the University of Sheffield and the University of Ferrara for the mechanical testing part of the programme. Tensile fatigue testing was carried out in Ferrara with a load ratios of $R = 0.1$ and $R = -1$, while torsion fatigue and biaxial tension-torsion testing were carried out in Sheffield with load ratios of $R = 0$ and $R = -1$. The tensile fatigue testing used a 250kN MTS servohydraulic fatigue testing machine and a Schenk servohydraulic tension-torsion fatigue testing machine was

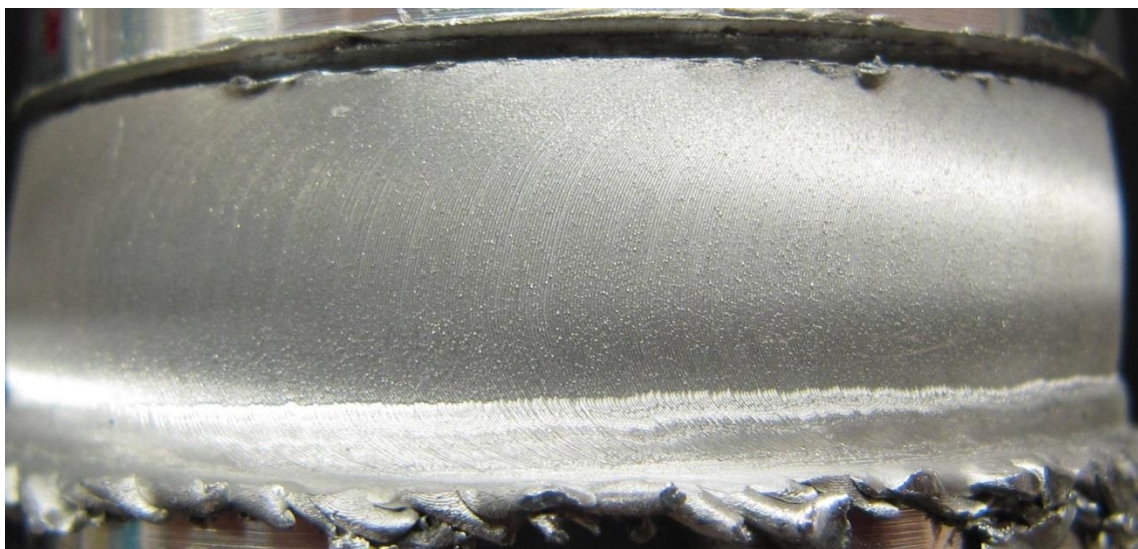
Figure 8b Crack initiation site in specimen T22 tested in torsion at $R = -1$ with a shear stress amplitude of 133 MPa. The crack runs around the undercut groove on the advancing side of the weld. This is the most common mode of failure in both tension and torsion fatigue specimens.

Table 6 presents the data for the torsional specimens, and it should be noted that the torsional loading damages the fracture surfaces and usually makes impossible post-hoc determination of the crack initiation point around the circumference. The torsional data indicates a significant influence of both stress ratio R and shear stress amplitude on the position and crack path associated with crack initiation. Thus under torsional fatigue loading with $R = 0$, crack initiation occurred on the retreating side in all welds examined, whilst under reversed loading with $R = -1$ crack initiation predominantly occurs on the advancing side. Under torsional loading, at the two lowest shear stress ranges used in both $R = 0$ and $R = -1$ loading, the crack path does not follow the undercut zone at the sides of the weld, but instead shows a more classical shear crack initiation at an angle of approximately 45° (see the two images given in Figure 8).

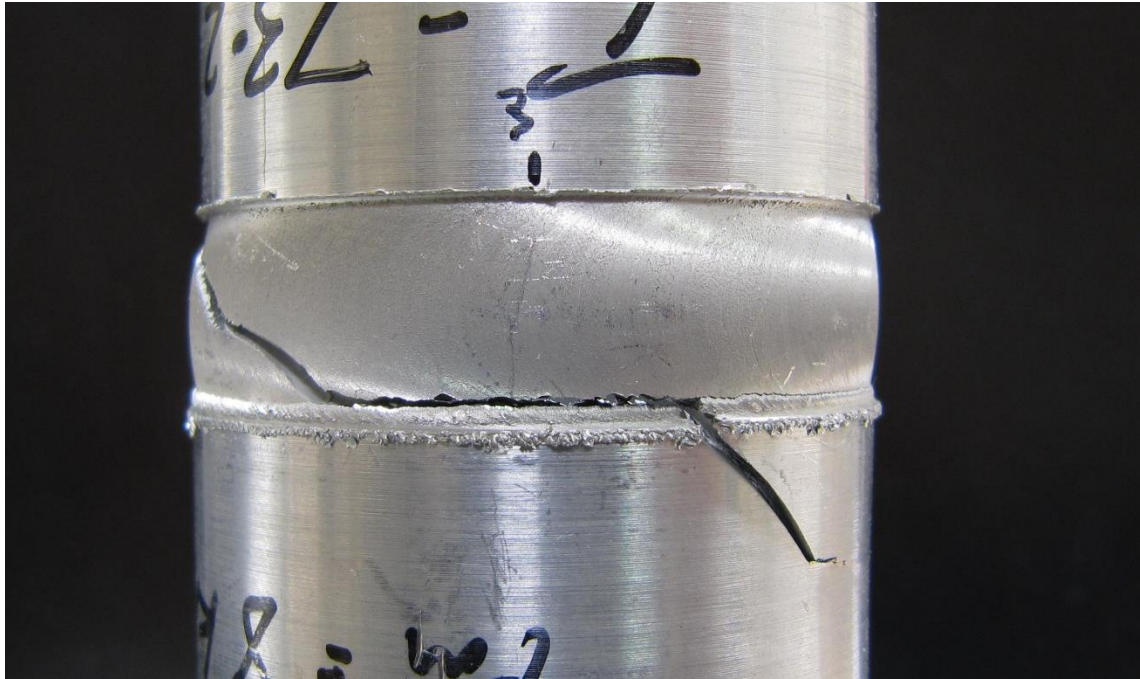
Figure 9 In-phase tension-torsion fatigue test (IPh21) showing that the crack has initiated along the tool shoulder groove on the retreating side and then moved across to the advancing side of the weld.
